**GEOTECHNICAL & GEOLOGIC
HAZARD INVESTIGATION
Horizon Neighbourhood Development
Summit Powder Mountain Resort
Weber County, Utah**

IGES Project No. 01628-013

August 3, 2016

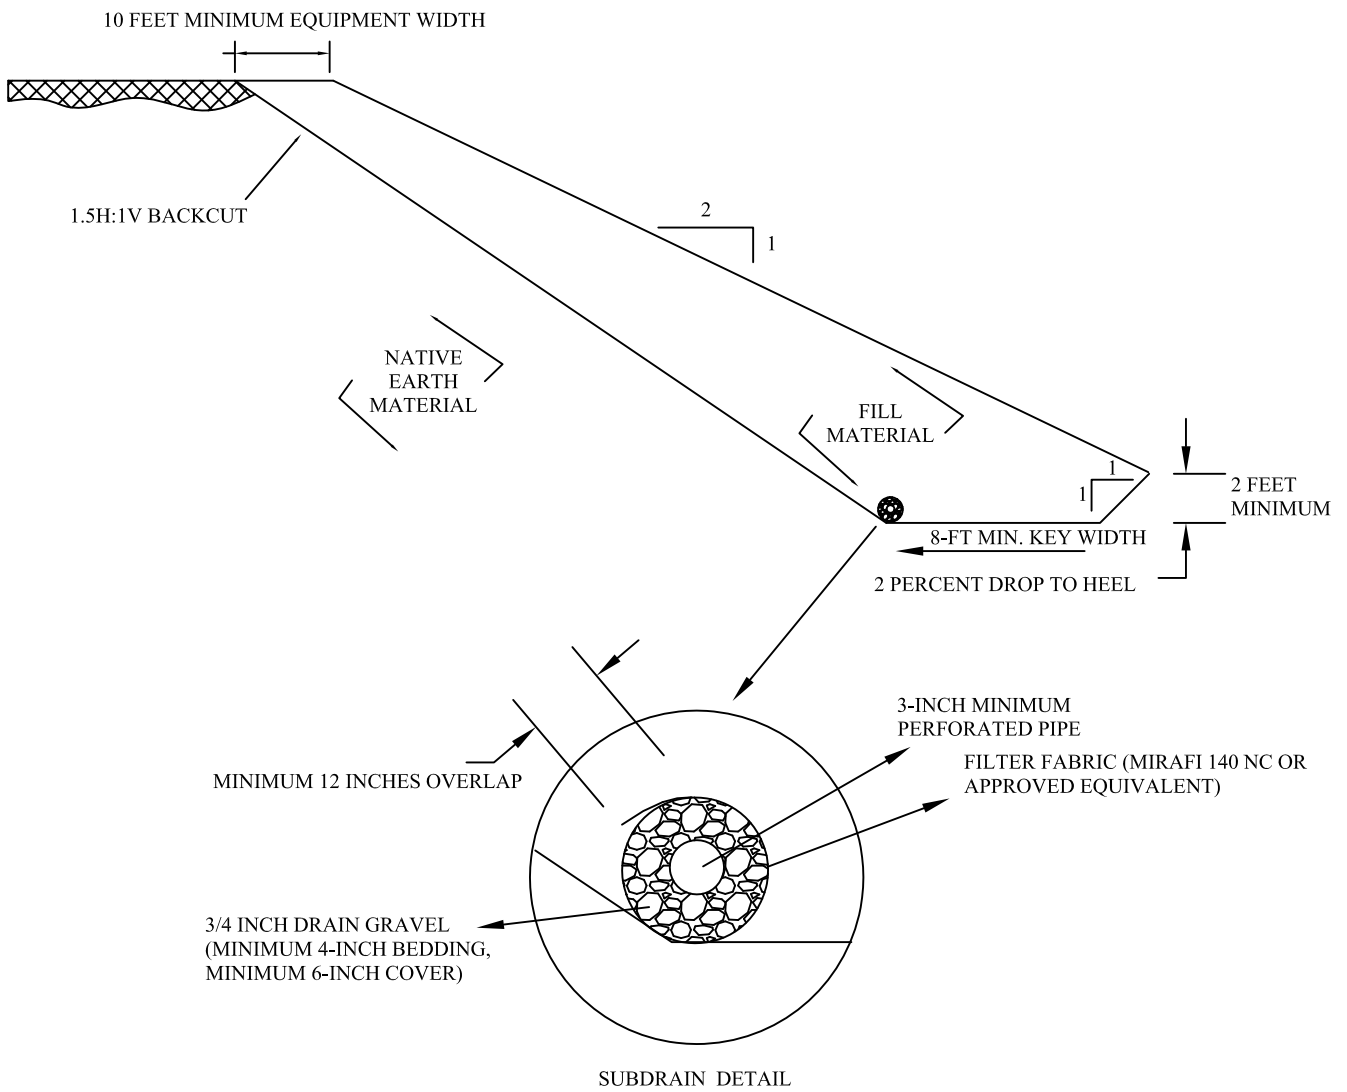
NOTE: FOR THE LODGE STRUCTURE, MIN. KEYWAY DEPTH IS 5 FEET, MIN. KEYWAY LENGTH IS 25 FEET.
