**GEOTECHNICAL AND GEOLOGIC HAZARD INVESTIGATION
The Ridge Nests Development
Powder Mountain Resort
Weber and Cache Counties, Utah**

IGES Project No. 01628-008

July 15, 2016

Geotechnical and Geologic Hazard Investigation
The Ridge Nests Development
Powder Mountain Resort
Weber and Cache Counties, Utah

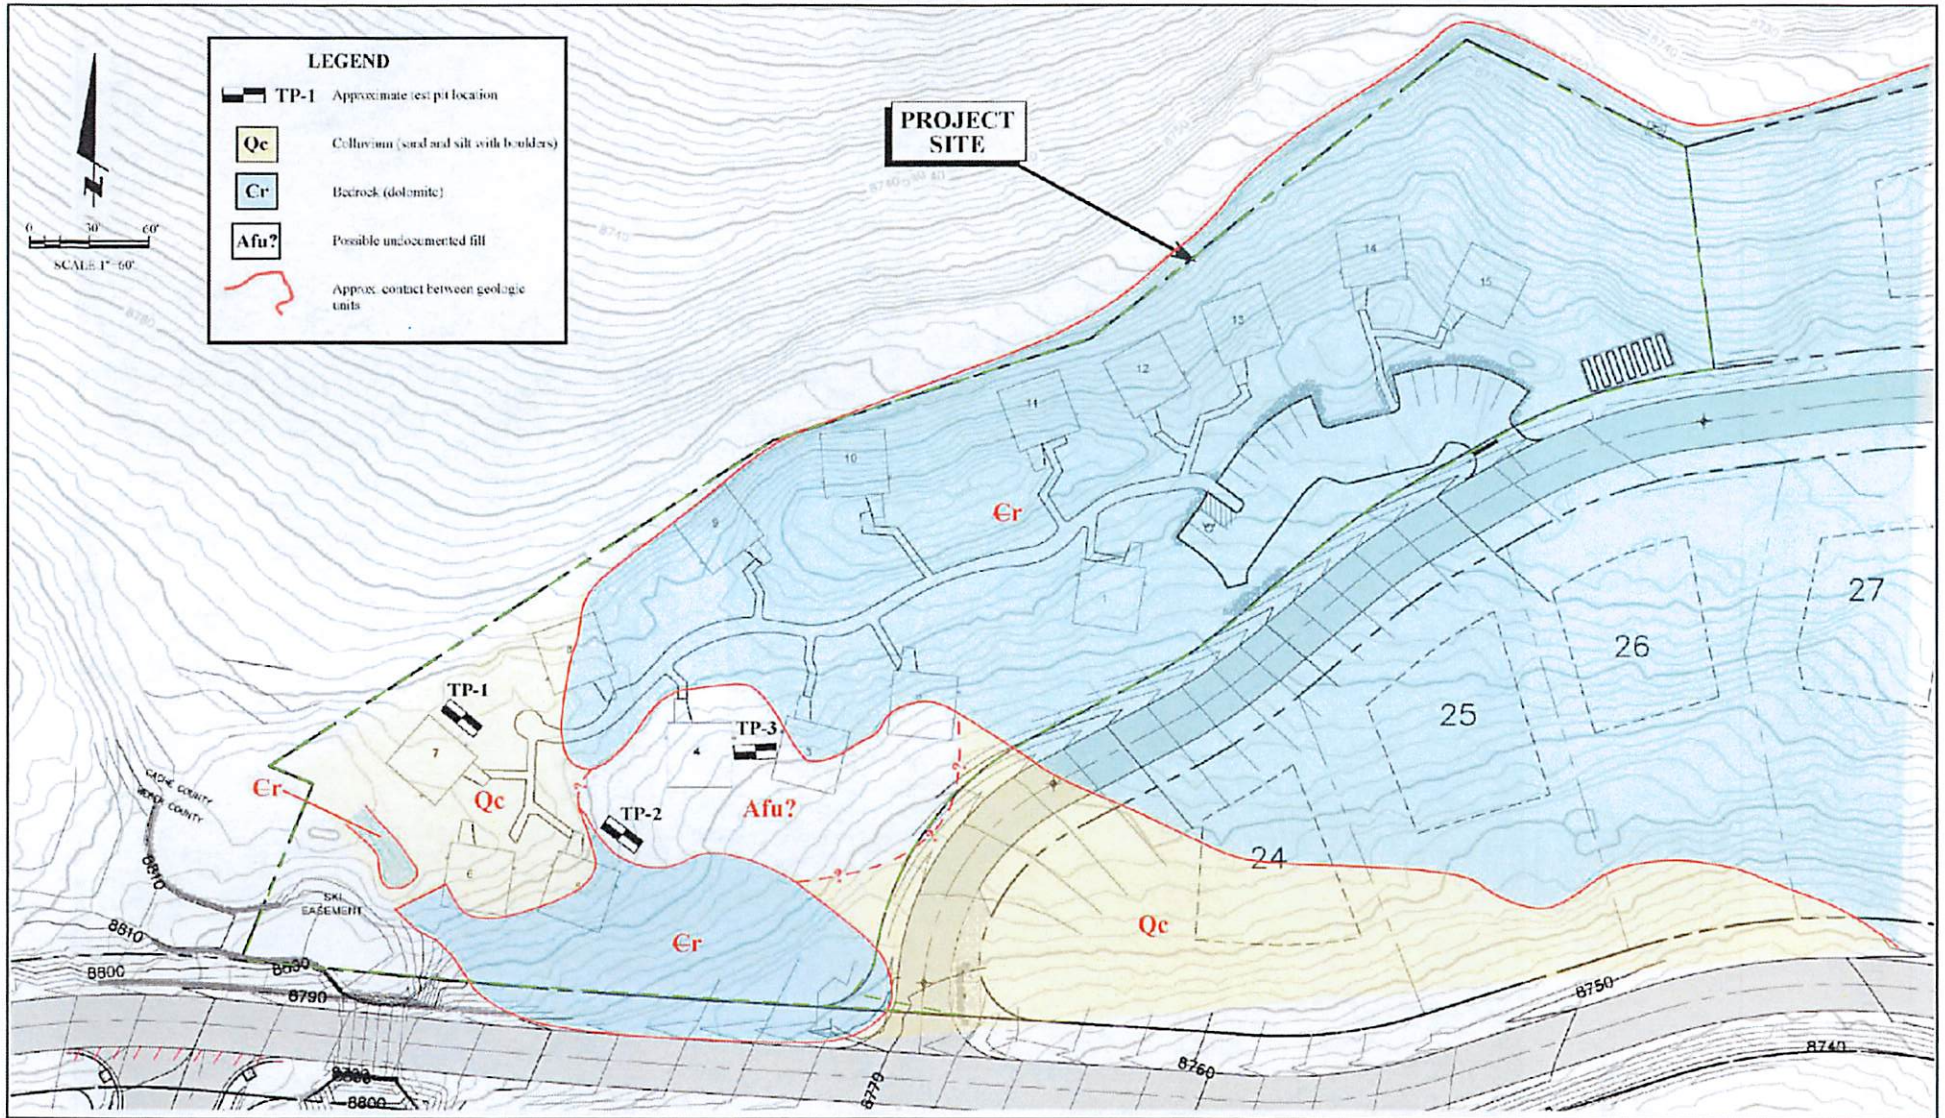
Figure
A-2

Geotechnical Investigation
The Ridge Nests Development
Powder Mountain Resort
Weber County, Utah
GEOTECHNICAL MAP

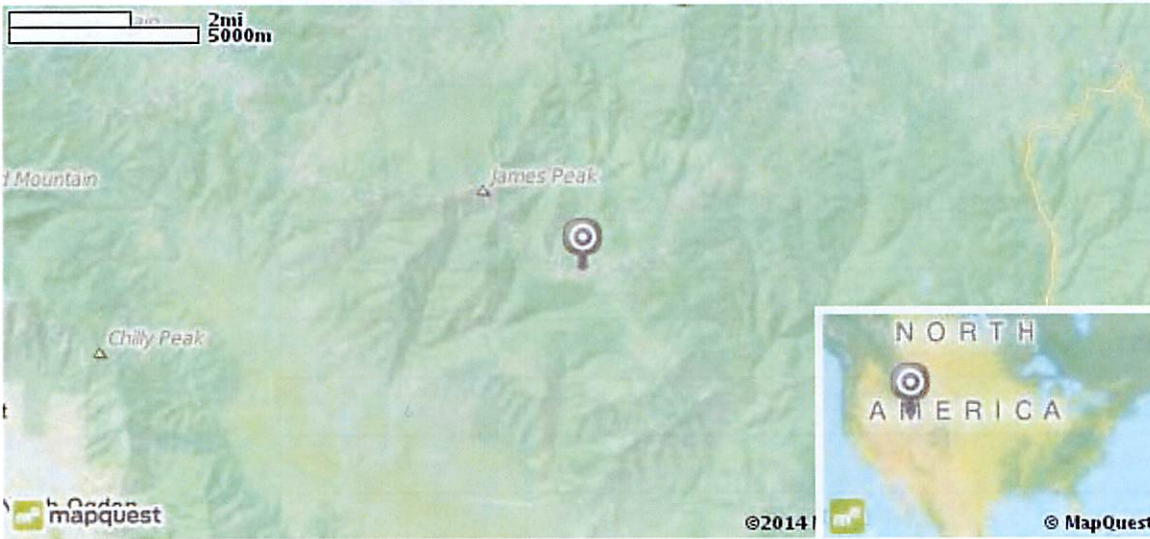
Site Soil Classification Site Class B – “Rock”

$S_s = 0.826 \text{ g}$	$S_{MS} = 0.826 \text{ g}$	$S_{DS} = 0.551 \text{ g}$
$S_1 = 0.274 \text{ g}$	$S_{M1} = 0.274 \text{ g}$	$S_{D1} = 0.183 \text{ g}$

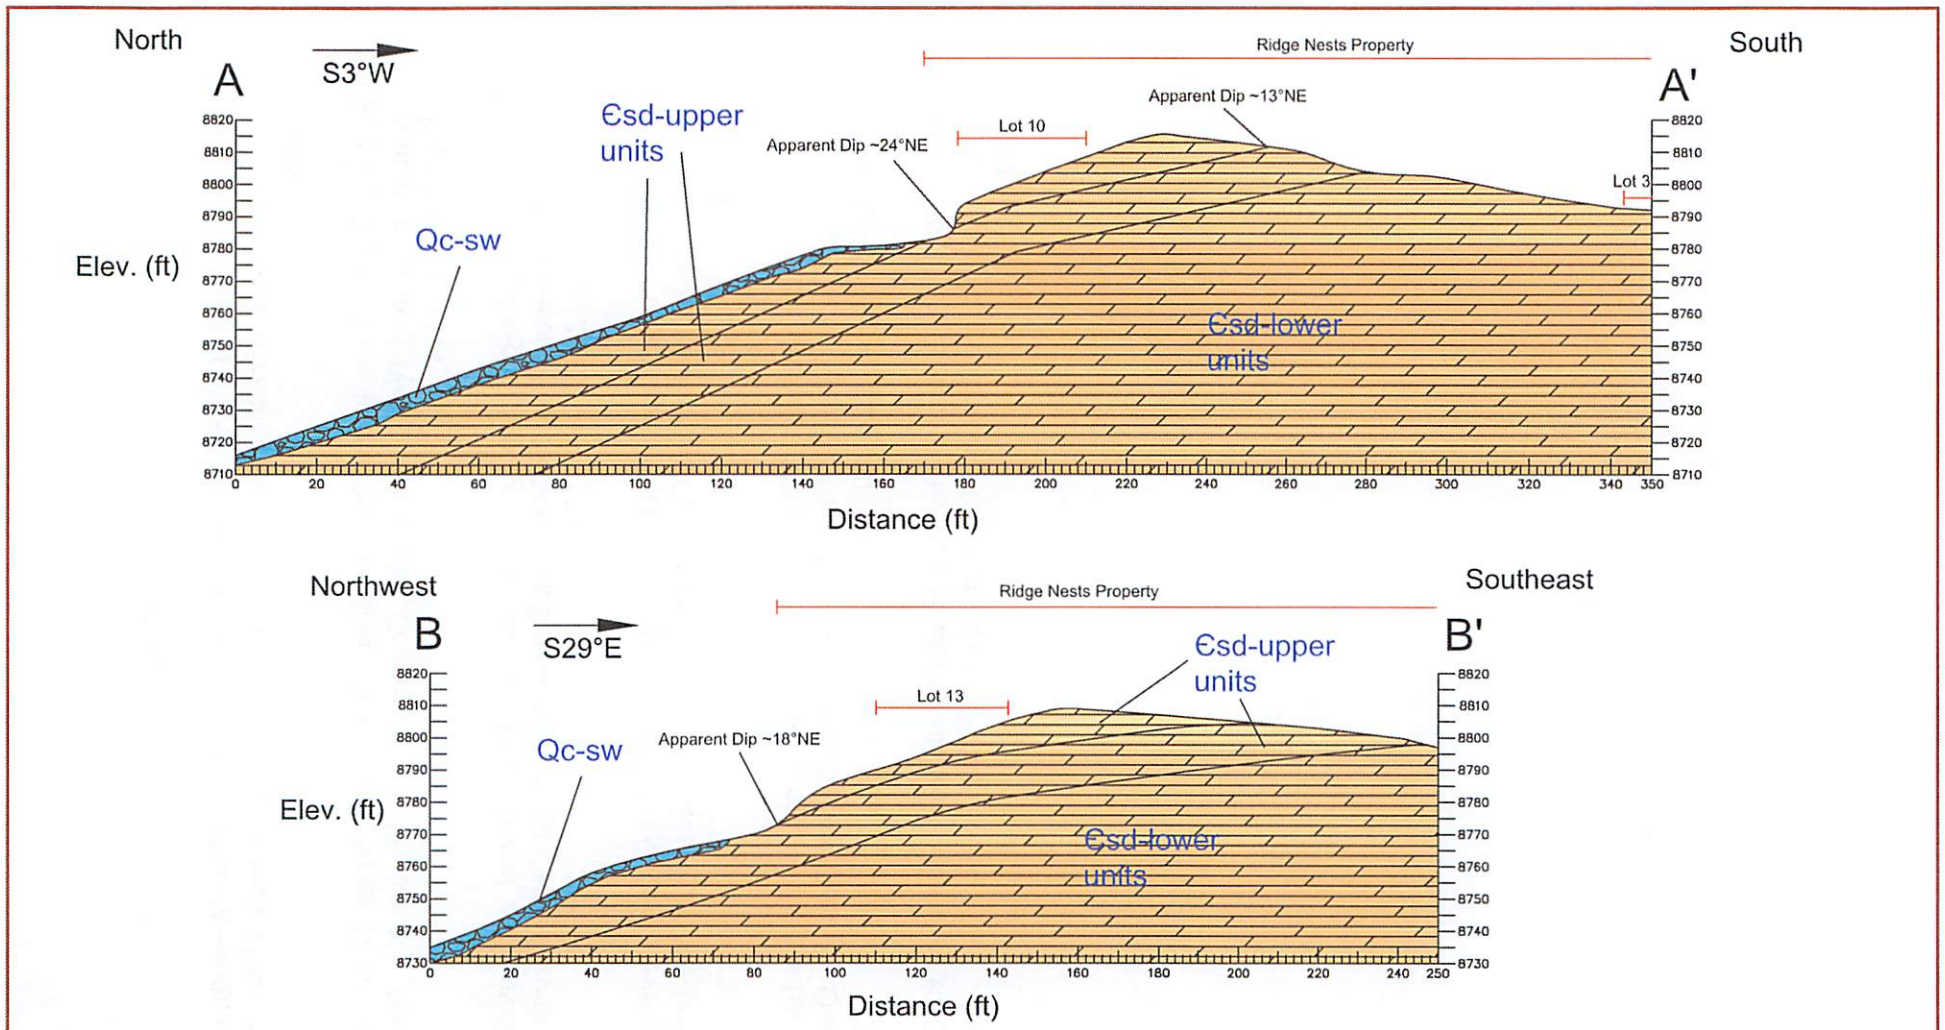
Qc-sw: Colluvium and Slope Wash, Undifferentiated
 Consists of rounded to subrounded clasts of pink to tan to gray quartzite and conglomerate up to 6' in diameter.

CROSS-SECTIONS
 GEOLOGIC INVESTIGATION
 THE RIDGE NESTS DEVELOPMENT
 POWDER MOUNTAIN RESORT
 WEBER COUNTY, UTAH

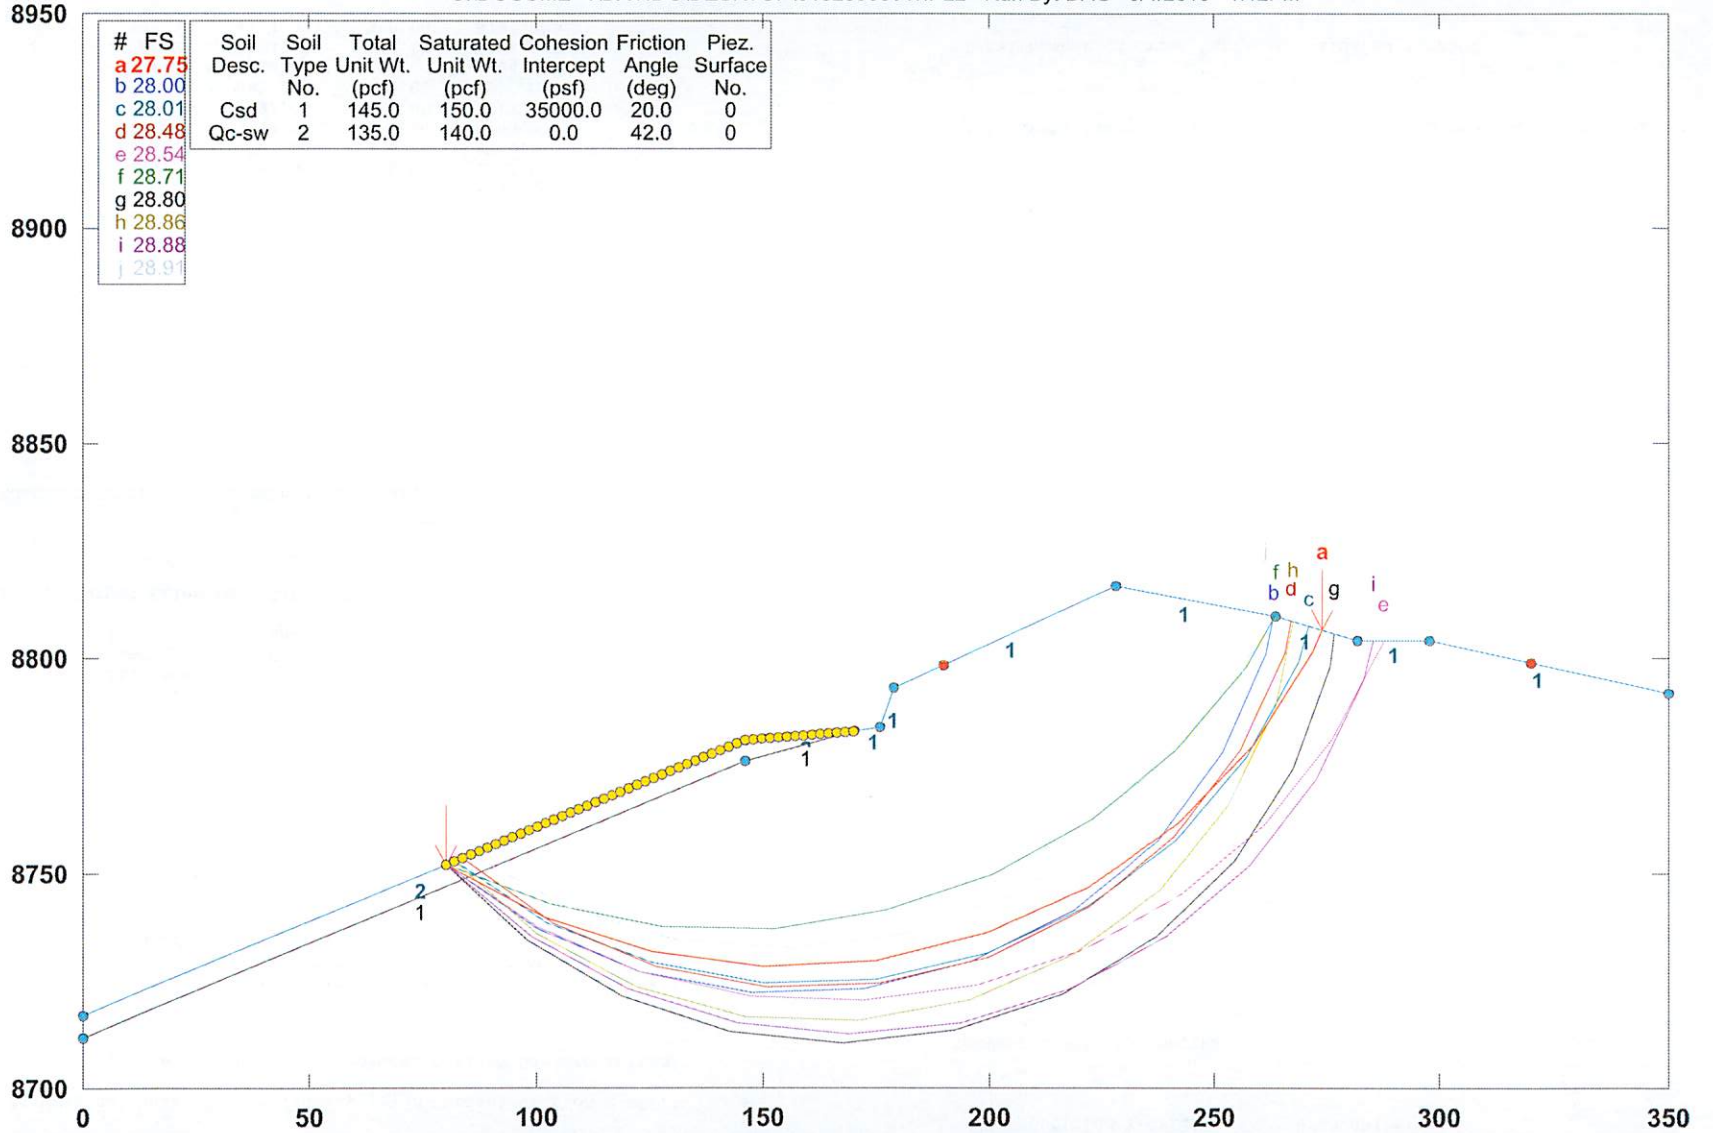
Summit/Ridge Nests; A-A'; Static

GSTABL7 v.2 FSmin=27.75
 Safety Factors Are Calculated By The Modified Bishop Method

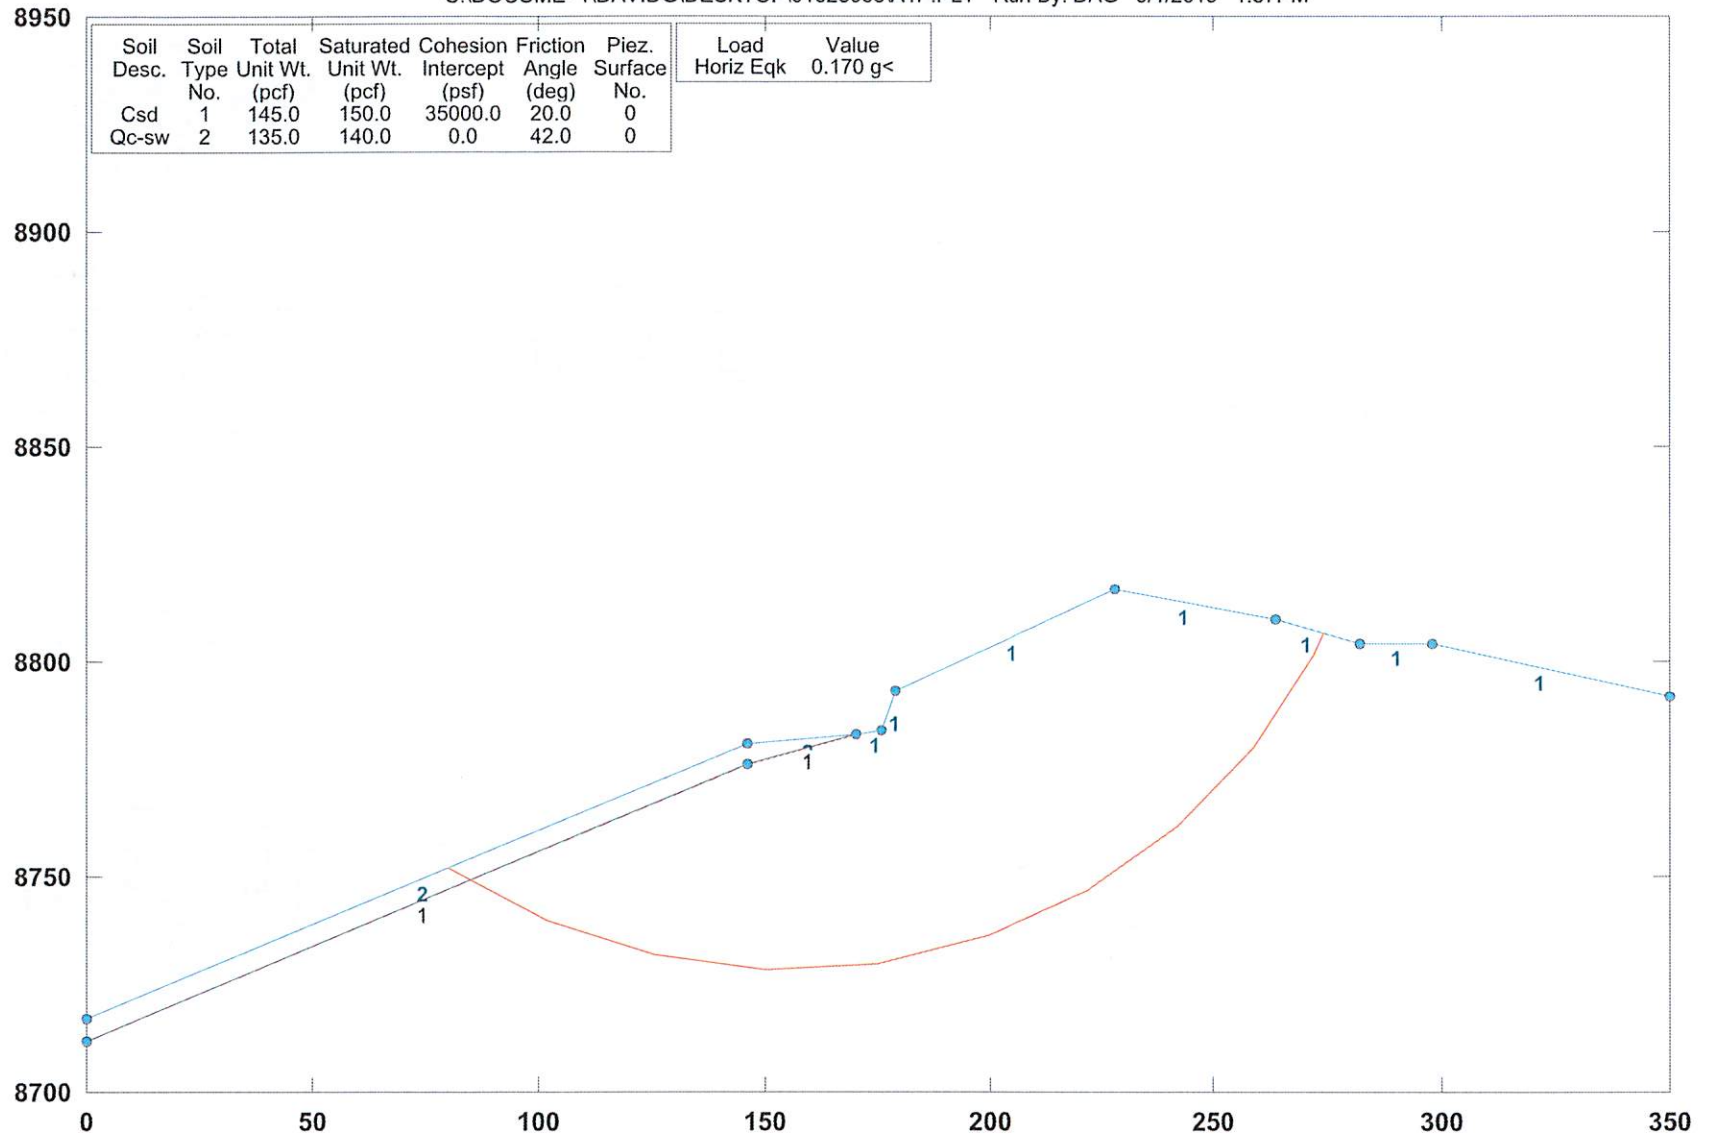
Summit/Ridge Nests; A-A'; Pseudo-Static

GSTABL7 v.2 FSmin=18.49

Factor Of Safety Is Calculated By The Modified Bishop Method

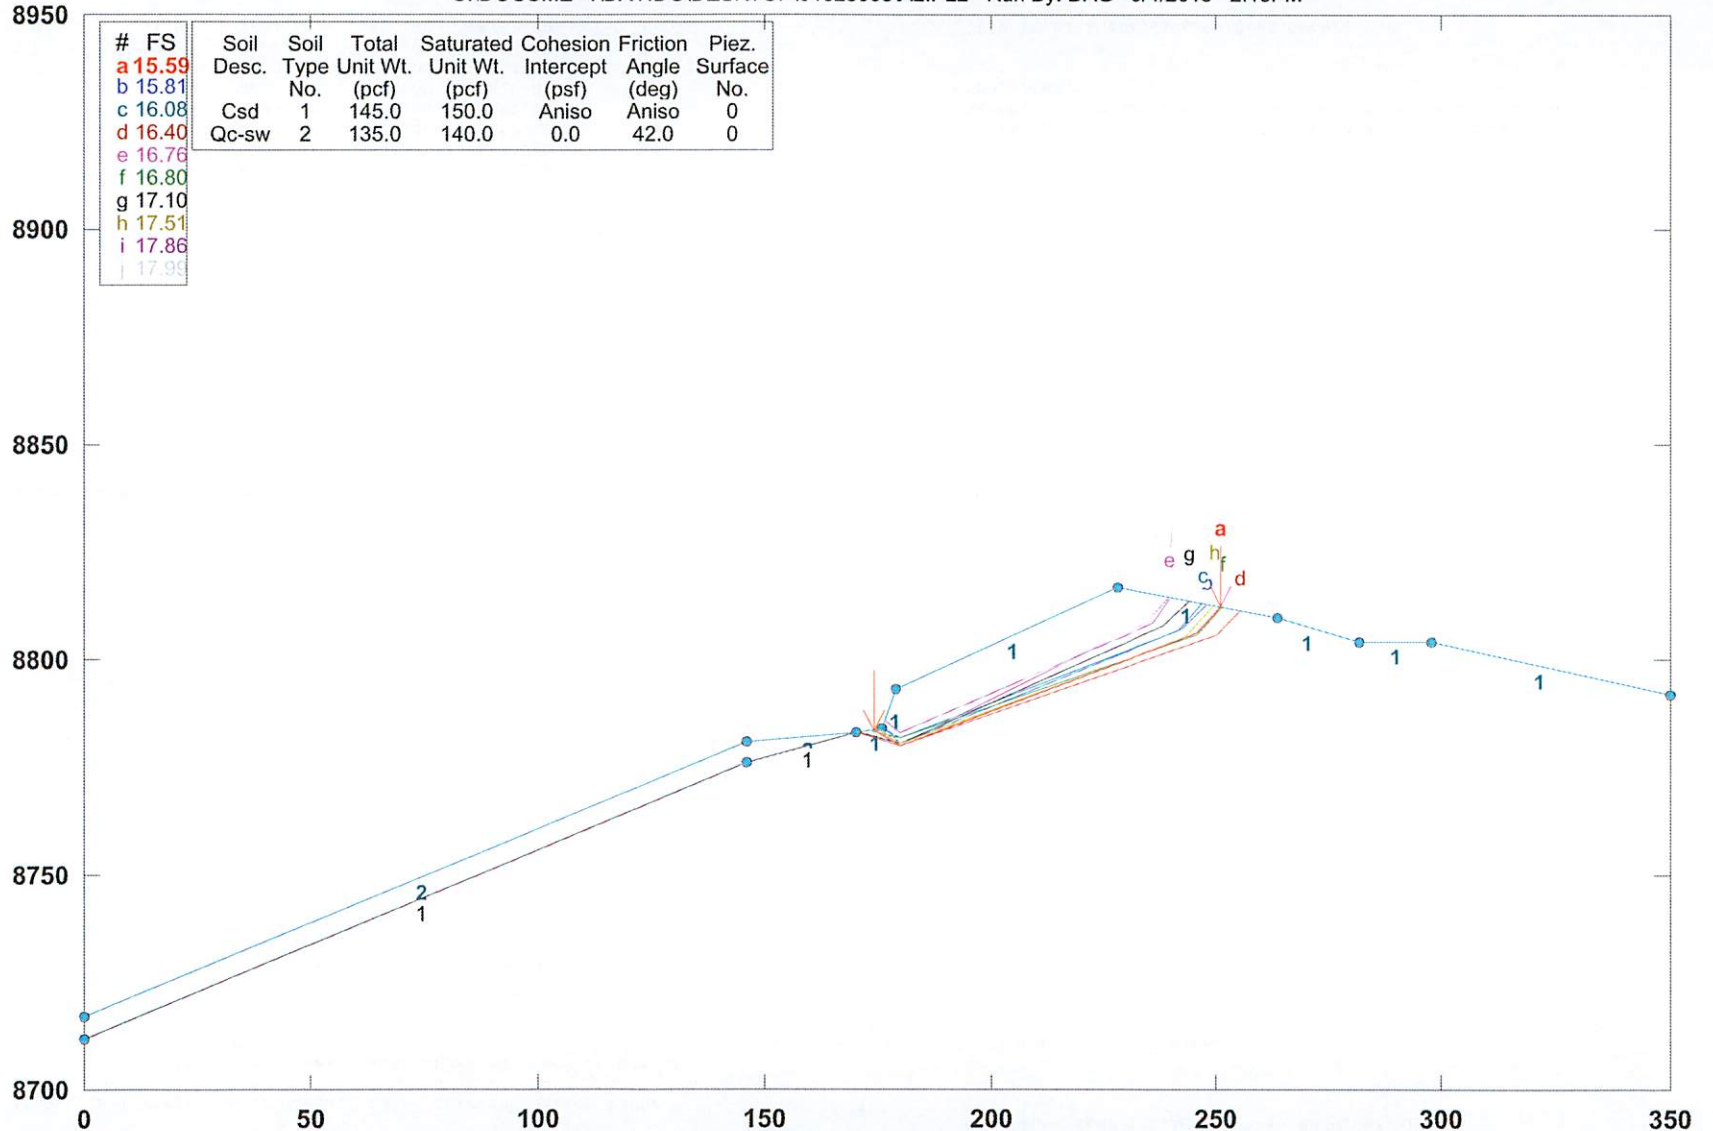
Summit/Ridge Nests; A-A'; Static; bedding 24 deg apparent dip

GSTABL7 v.2 FSmin=15.59

Safety Factors Are Calculated By The Simplified Janbu Method for the case of c & phi both > 0

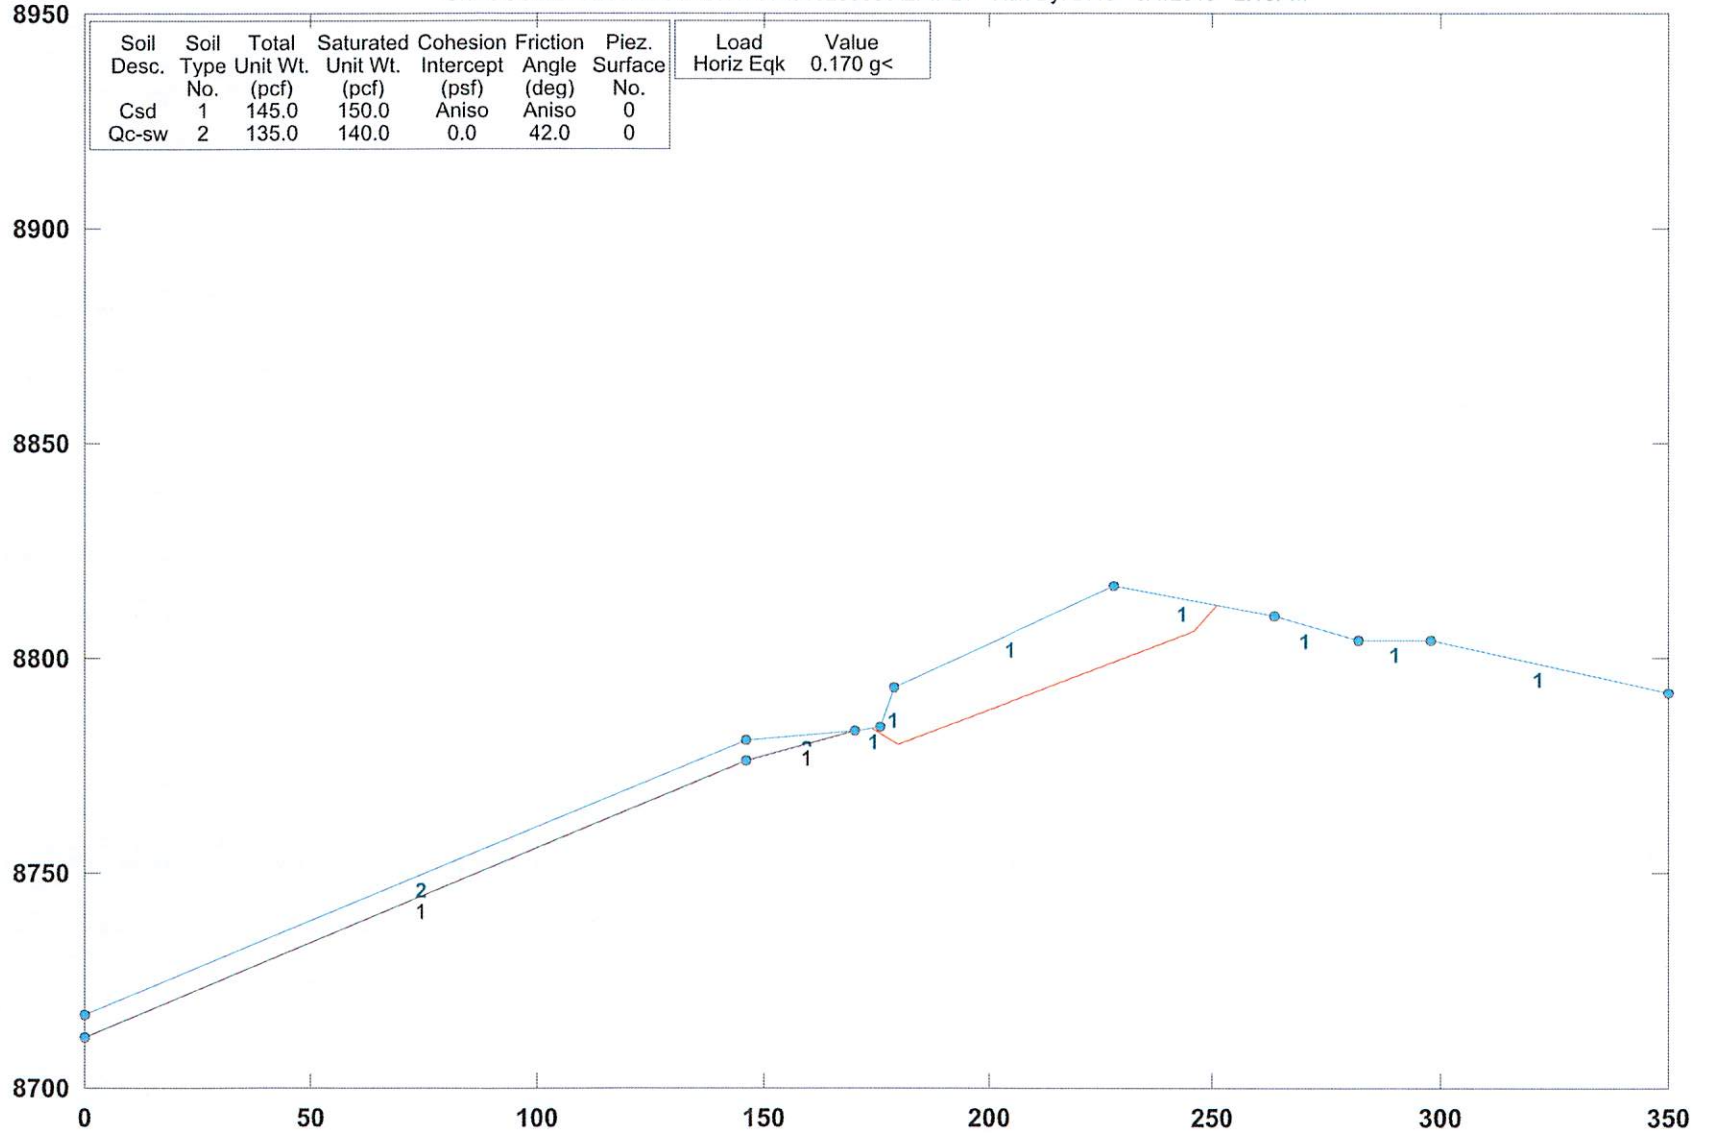
Summit/Ridge Nests; A-A'; Pseudo-Static; bedding 24 deg apparent dip

GSTABL7 v.2 FSmin=10.70

Factor Of Safety Is Calculated By The Simplified Janbu Method

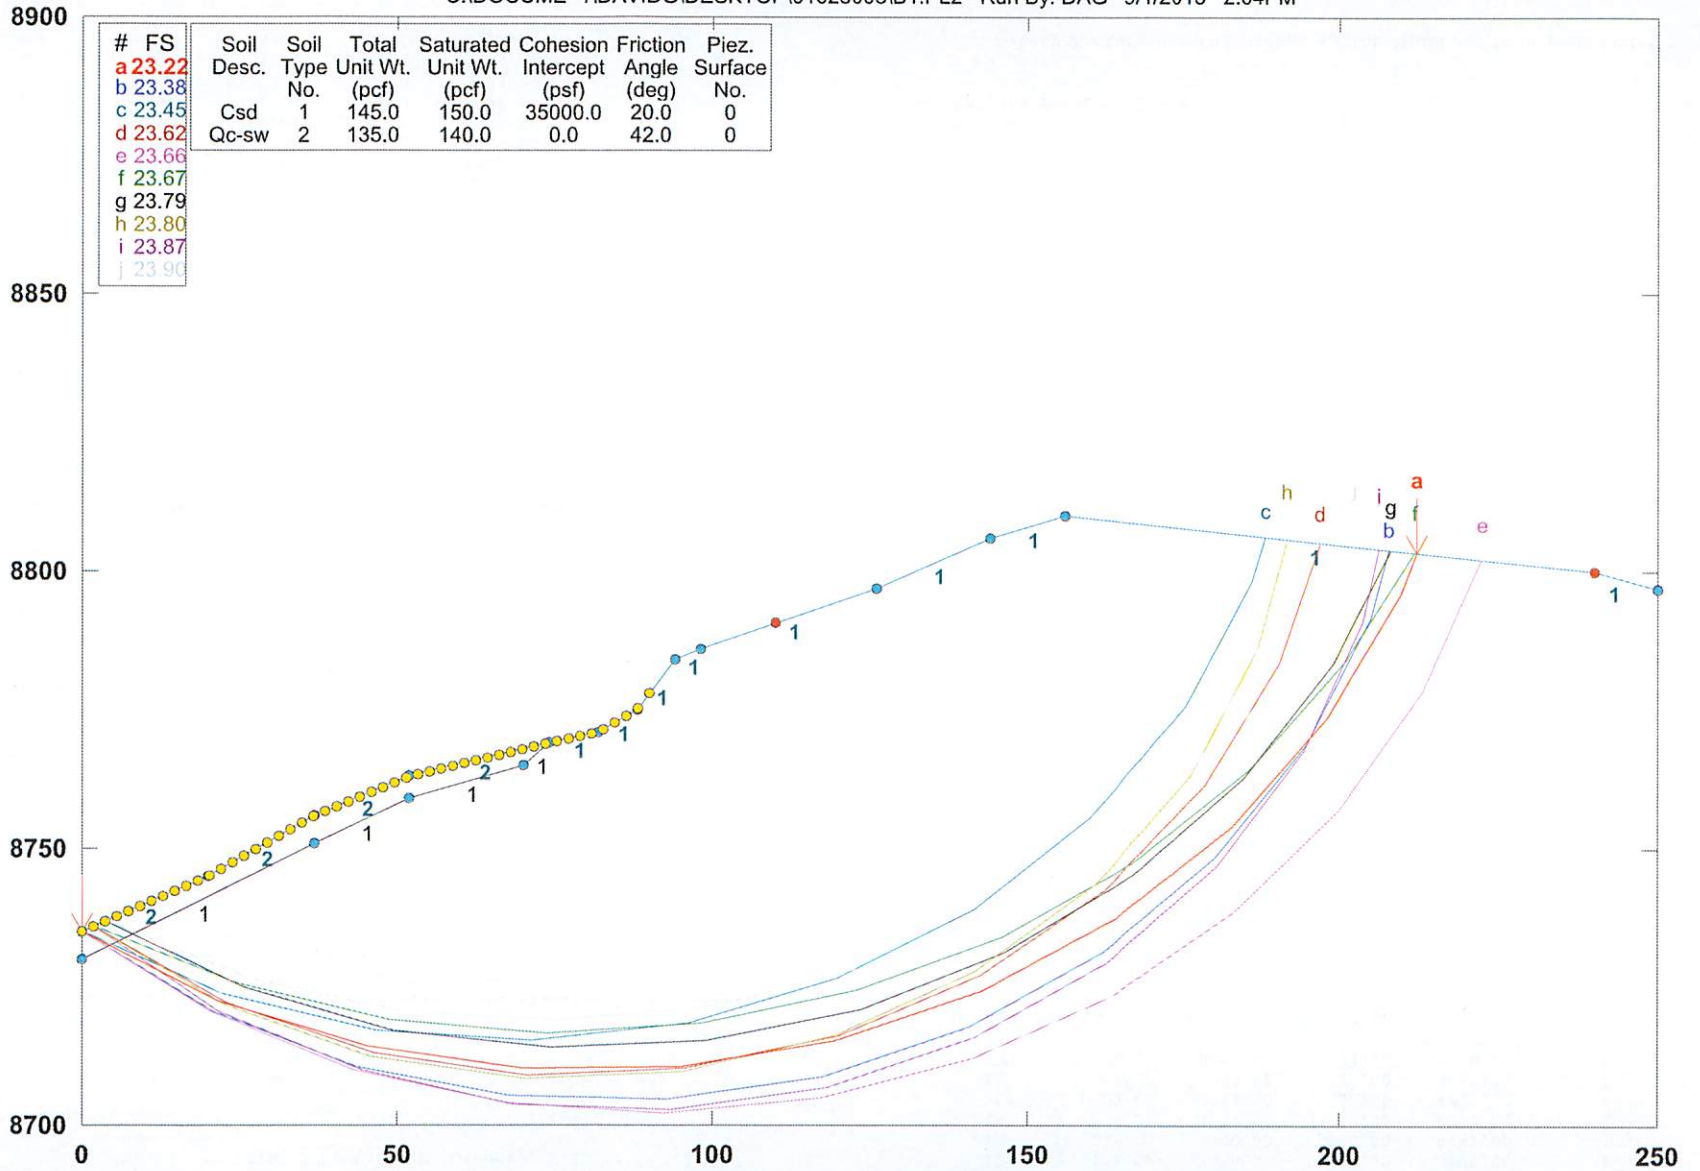
Summit/Ridge Nests; B-B'; Static

GSTABL7 v.2 FSmin=23.22

Safety Factors Are Calculated By The Modified Bishop Method

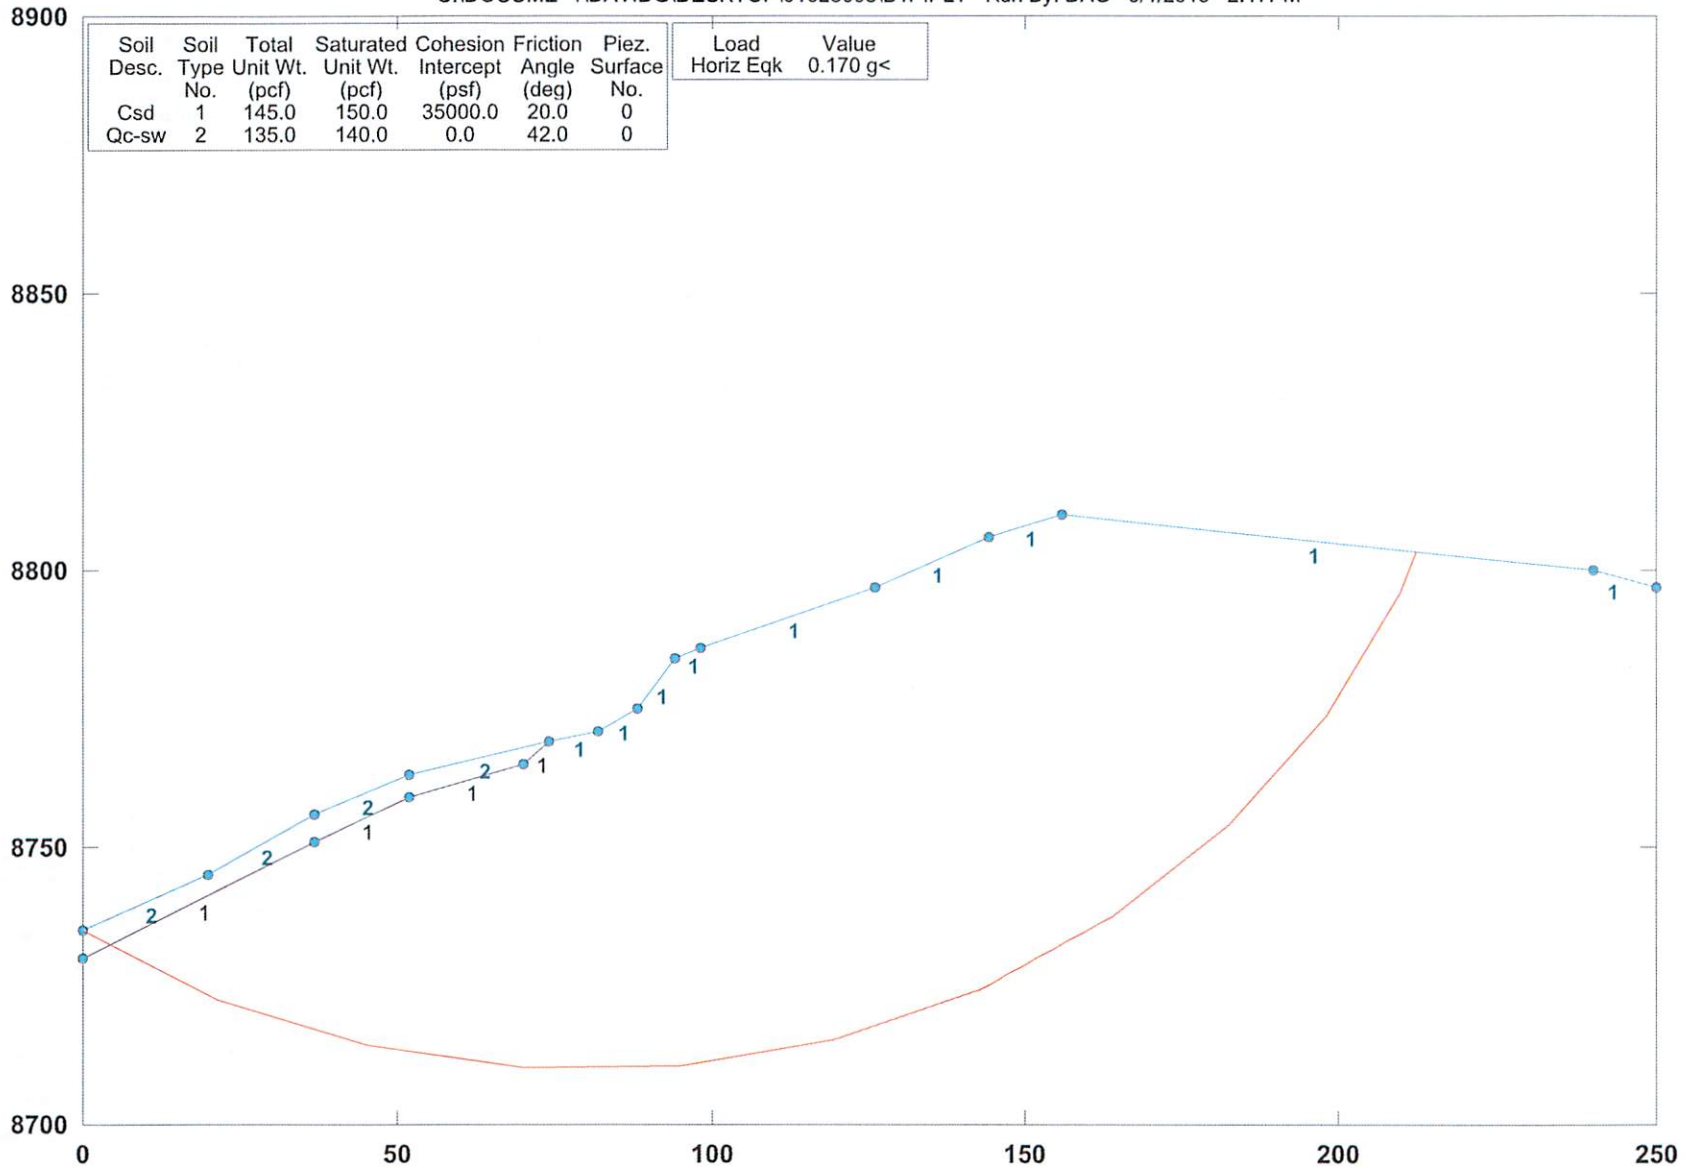
Summit/Ridge Nests; B-B'; Pseudo-Static

Soil Desc.	Soil Type No.	Total Unit Wt. (pcf)	Saturated Unit Wt. (pcf)	Cohesion Intercept (psf)	Friction Angle (deg)	Piez. Surface No.	Load Horiz Eqk	Value
Csd	1	145.0	150.0	35000.0	20.0	0		0.170 g<
Qc-sw	2	135.0	140.0	0.0	42.0	0

GSTABL7 v.2 FSmin=15.85

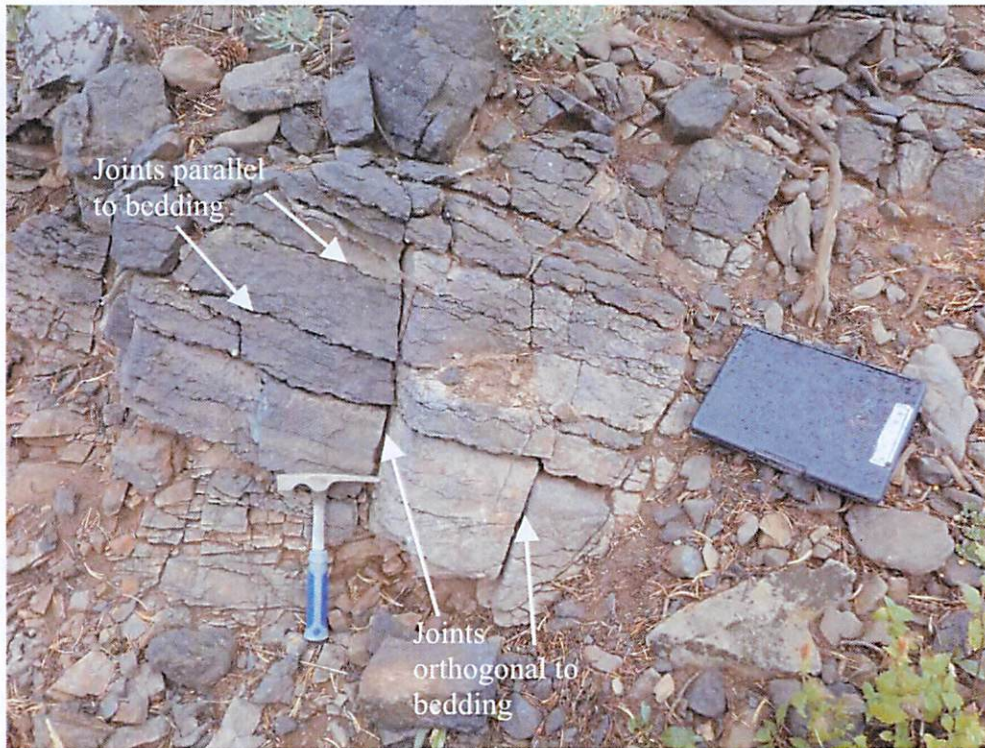
In response to the comment, the following additional details are provided: bedrock was found to be largely moderately fractured (distance between fractures ~0.5-1.0 feet) to little fractured (distance between fractures ~1.0-4.0 feet), with localized areas of intense fracturing (distance between fractures ~0.05-0.1 feet). Joint spacing was largely found to be a product of the lithology. The finer-grained dolomite lithologies were more thinly bedded, and therefore had a smaller distance (approximately 1 to 4 inches) between bedding plane joints. These lithologies also tended to fracture into rectangular blocks generally between 4 and 18 inches in length and width, and contained both bedding-confined and through-going fractures (Photo 1). Coarser-grained dolomite lithologies were more thickly bedded to massive, with bedding plane joints separated by between 6 inches to as much as several feet. These lithologies tended to fracture into rectangular blocks with highly variable dimensions, ranging in width and length from between a couple inches to several feet, though larger blocks (with dimensions of several feet x several feet x several feet) were most common (Photo 2). Most fracturing associated with the coarser-grained dolomite lithologies consisted of large through-going fractures.

Nearly all of the joints encountered in the field investigation were open, had slightly rough to rough surfaces, and did not contain a secondary mineralization, except rare calcite infilling in places. No slickensides were observed on any joint surface. Joint apertures varied from between a few millimeters to a couple inches in width. Joints with smaller apertures tended to be devoid of any sort of fill, while the larger aperture joints were often filled with soil. In the cases of the two identified faults, reddish gray silty gouge was found to be the fill material.

Photo 1. Finer-grained dolomite lithology, exhibiting thinner beds and blocky jointing.

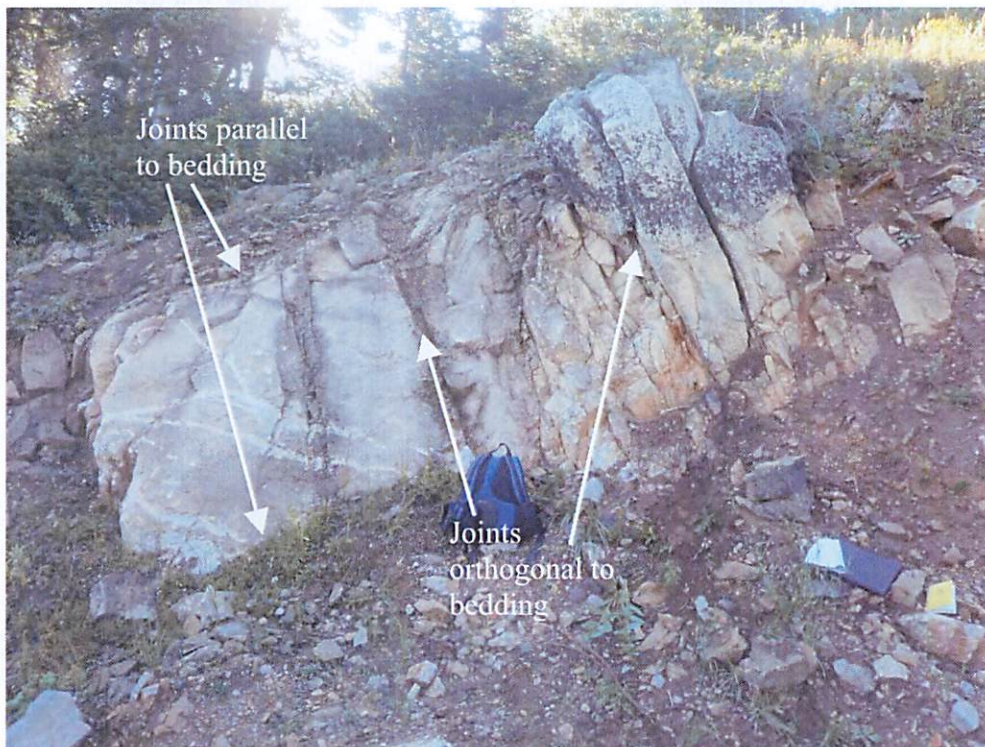
Photo 2. Coarser-grained dolomite lithology, exhibiting thicker beds and wider jointing.
