Staff Report for Administrative Subdivision Approval

Application Request:	Consideration and action on an administrative application for approval of the Emerson Hills Phase 3 Amended.
Type of Decision	Administrative
Agenda Date:	Wednesday, January 11, 2017
Applicant:	Kevin Parkinson
File Number:	UVL 111816

Re: Professional Geologist Review and Supplemental Addendum

Geologic Reconnaissance Study
Buildable Area Expansion
Emerson Hills Subdivision Lot #12
Liberty, Utah
September 23, 2016

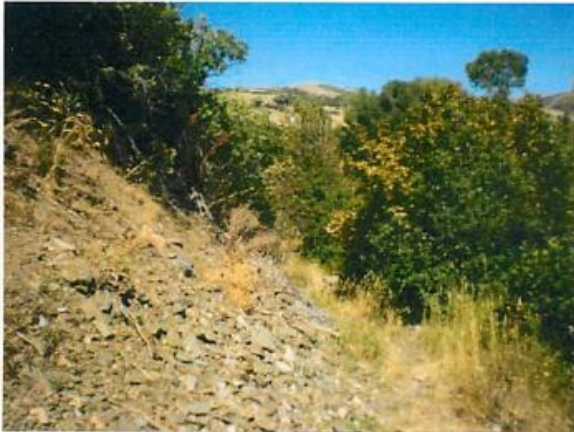
#1 View of roadcut exposed geologic materials comprising the slopes at the site.

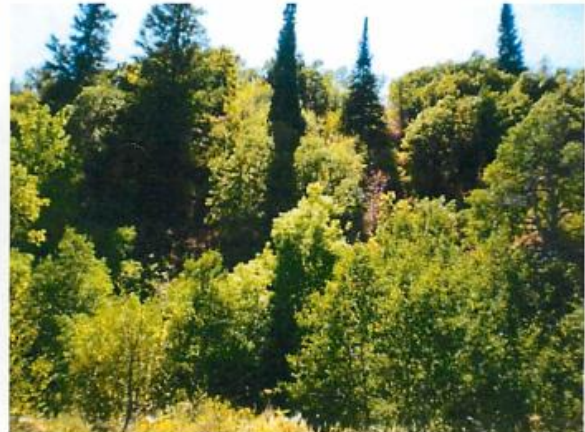
#2 Facing southwest from the buildable area expansion toward the heavily vegetated slope.

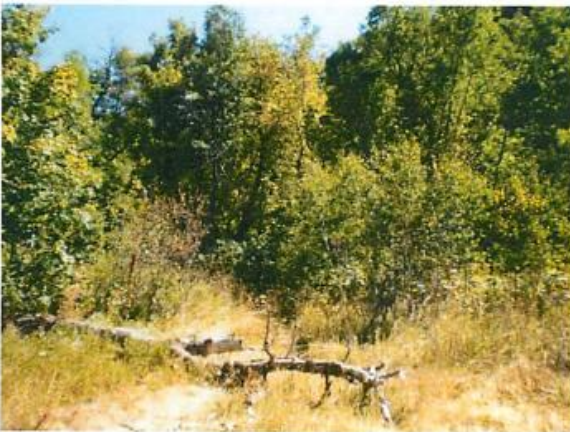
#3 Facing southeast across the proposed building area expansion.

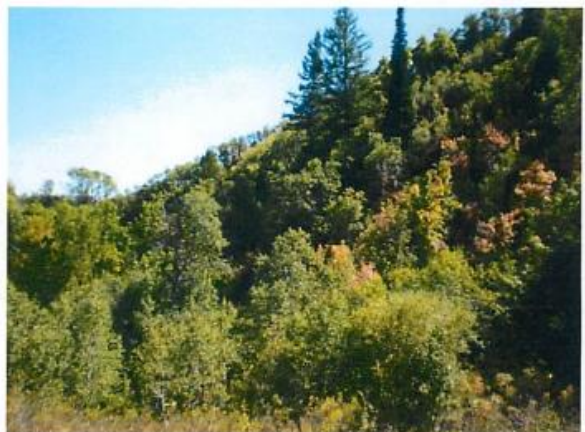
#4 Facing southeast, overall buildable area.

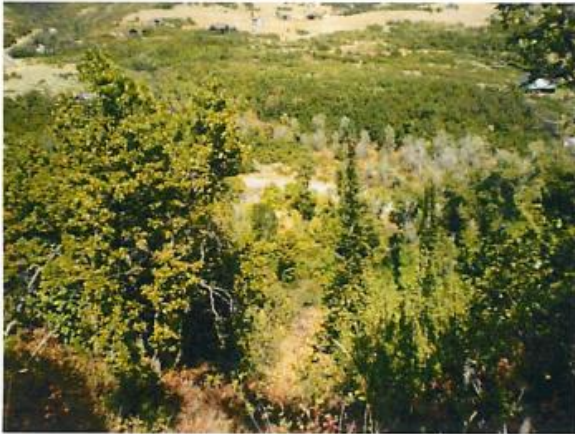
#5 Facing northeast from the top of the 130+ foot slope.

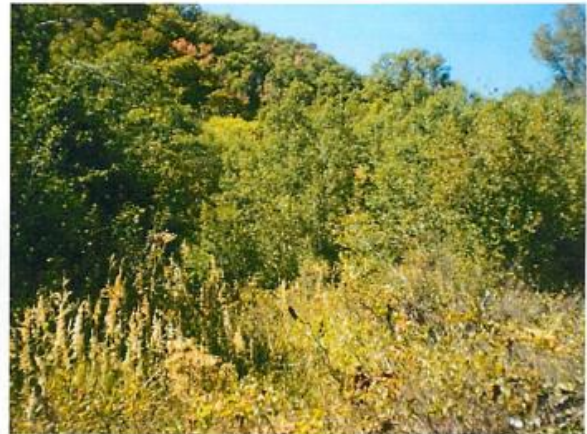
#6 Facing northwest, buildable area.

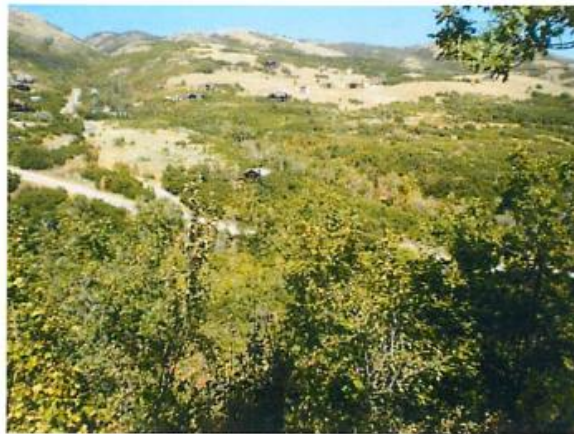
#7 Facing northeast from the top of the large slope across the rest of the subdivision.
