**GEOTECHNICAL & GEOLOGIC
HAZARD INVESTIGATION
Horizon Neighbourhood Development
Summit Powder Mountain Resort
Weber County, Utah**

IGES Project No. 01628-013

August 3, 2016

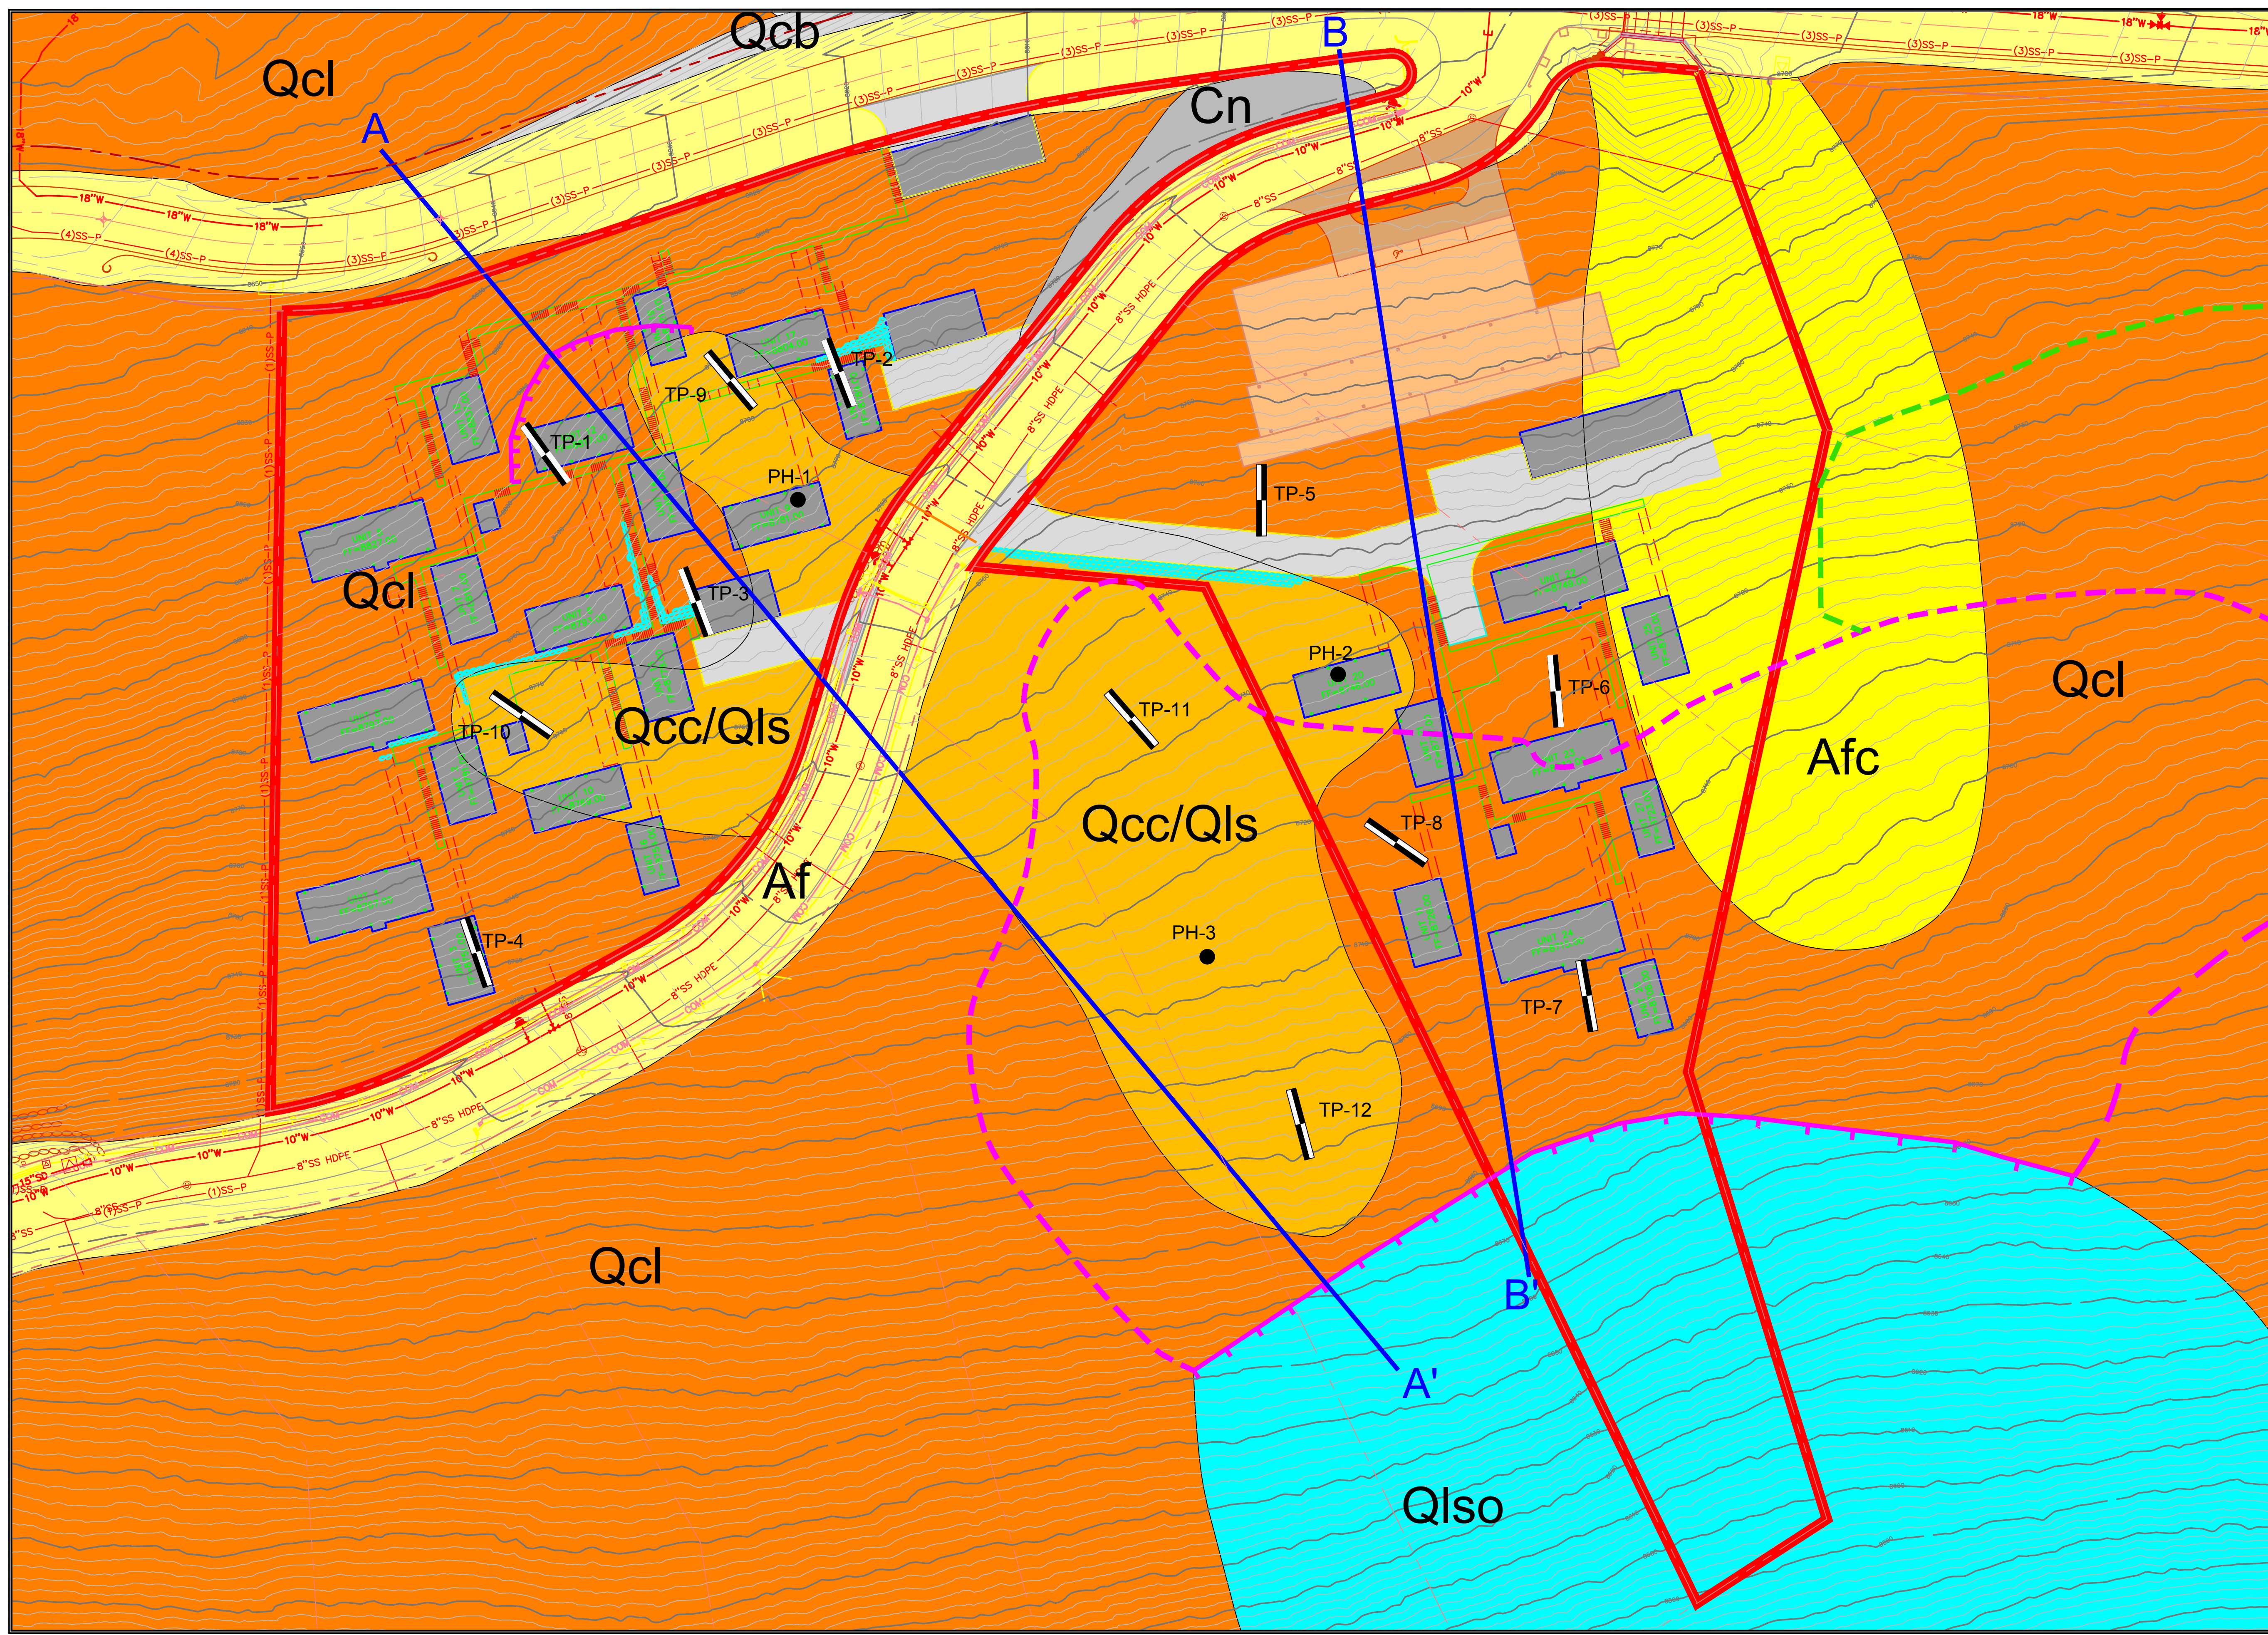
- HORIZON NEIGHBORHOOD PROPERTY BOUNDARY
- TP-10 TEST PIT LOCATION
- PH-3 POTHOLE LOCATION
- CROSS-SECTION LINE
- LANDSLIDE HEADSCARP
- APPROXIMATE SUBSURFACE PLEISTOCENE LANDSLIDE TRACE
- APPROXIMATE PLEISTOCENE LANDSLIDE TRACE (WESTERN GEOLOGIC, 2012)
- Afc: CURRENT CONSTRUCTION
- Af: ARTIFICIAL FILL (ROADS)
- Qcl: LOOSE COLLUVIUM
- Qcc/Qls: CEMENTED LANDSLIDE COLLUVIUM
- Qcb: BEDROCK COLLUVIUM
- Qlso: PLEISTOCENE LANDSLIDE
- Cn: NOUNAN DOLOMITE

The *Geotechnical Map*, Plate A-1 in Appendix A, shows the approximate location of the exploration test pits and potholes and the surficial geologic materials as mapped from the site reconnaissance. The exploration test pits and potholes were specifically located to assess the presence or absence of adverse geologic features, assess the depth to bedrock, and to observe subsurface conditions. Subsurface conditions as encountered in the exploration test pits and potholes were logged at the time of our investigation by a licensed geologist. The test pit logs are presented in Figures A-2 through A-13 of Appendix A. A *Key to Soil Symbols and Terminology* is presented as Figure A-14 and a *Key to Physical Rock Properties* is presented as Figure A-15.

Artificial Fill: Artificial fill (denoted as either Af or Afc on Plate A-1) was observed throughout the site. Af represents asphalt and road embankment fill material found in association with and restricted to the existing roads that bound the property, including North Powder Ridge Road and

Colluvium: Two classes of colluvial units were observed to underlie the topsoil and be the source material for the topsoil (Qcl and Qcc/Qls on Plate A-1). The most prevalent form was a dark brown loosely consolidated unit (map symbol Qcl) that was gradational between lean clay with gravel (CL) and clayey gravel (GC). This form was often silty, poorly sorted, and contained subrounded to subangular quartzite rock fragments that comprised between 15 and 50% of the unit. Boulders were found to be as much as 2 feet in diameter. The second, less common form of colluvium was a light brown, well-cemented, silty clay with gravel (CL-ML) gradational to a silty, clayey gravel (GC, GM) (map symbol Qcc/Qls). This form contained abundant pinhole voids throughout, was poorly sorted, and contained subrounded to subangular quartzite rock fragments that comprised between 25 and 50% of the unit. Boulders were found to be as much as 1.5 feet in diameter, and were on average smaller than the loose colluvium unit. It is possible that this cemented unit is derived, at least in part, from the Qcl unit that was remobilized in a small landslide associated with the small headscarp found between TP-1 and TP-2.

Bedrock Colluvium: This material (denoted as Qcb on Plate A-1) consists of colluvium whose parent material largely consists of dolomite; this material was found to be present along the northeastern part of the Horizon Run roadcut and along the northern road cut of North Powder Ridge Road. It consisted of clasts of dolomite bedrock generally less than 6 inches in diameter that was not associated with any in-place bedrock outcrop.

Pleistocene Landslide: This material (denoted as Qlso on Plate A-1) was found as a lobe extending to the south (downslope) from a noted landslide headscarp in the southernmost part of the property. It was characterized by generally irregular, slightly hummocky topography and was largely devoid of trees within its trace. This unit is part of the previously-mapped landslide deposit that crosses the Horizon Neighbourhood property (Sorensen and Crittenden, Jr. (1979) and Western Geologic (2012); see Section 5.1.2).

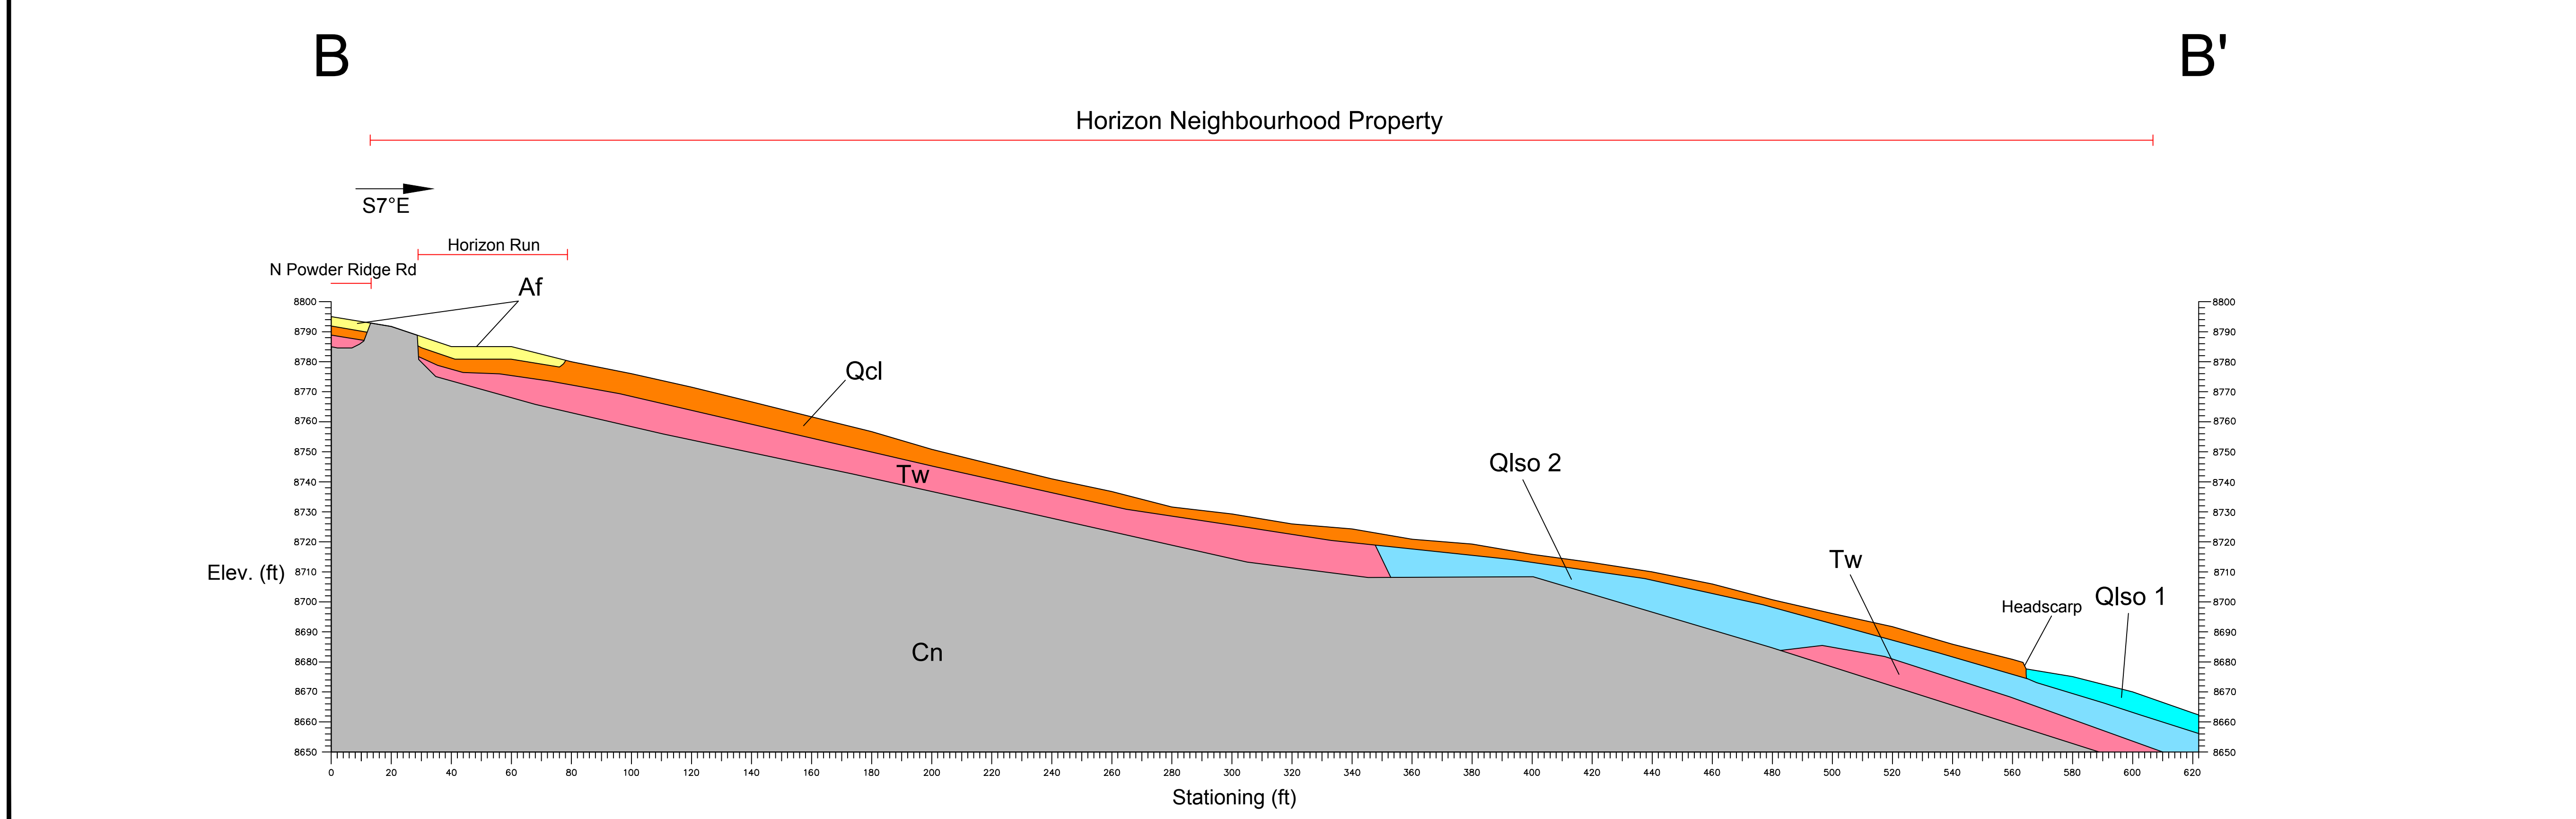
PLATE A-2

CROSS-SECTIONS

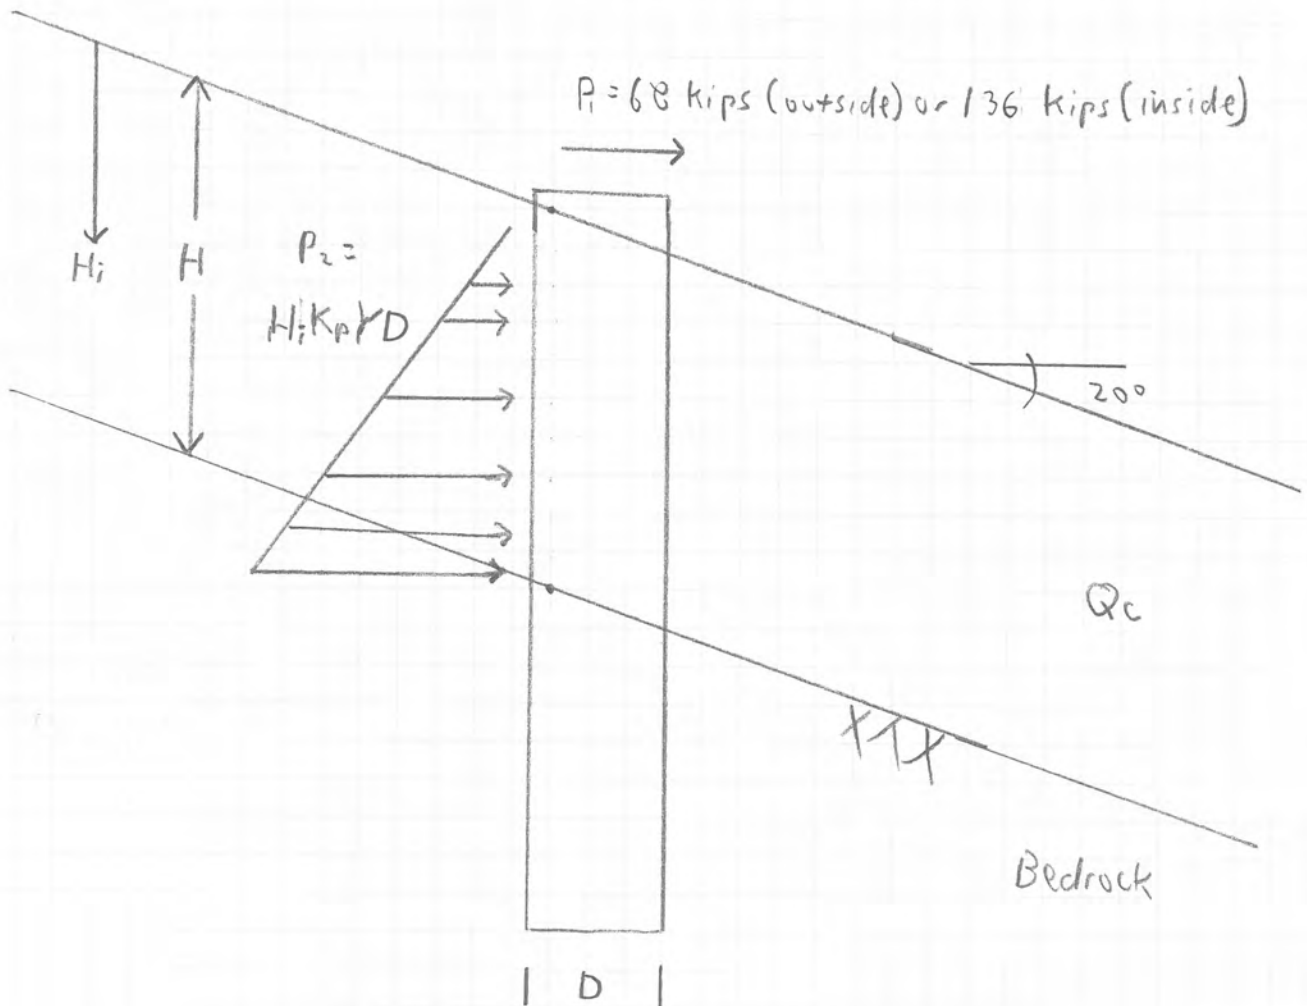
Basis for Drilled Pier Design

Load on grade beam

Sample design calculations are presented in Appendix E. Pier reinforcement should be designed by the structural engineer.

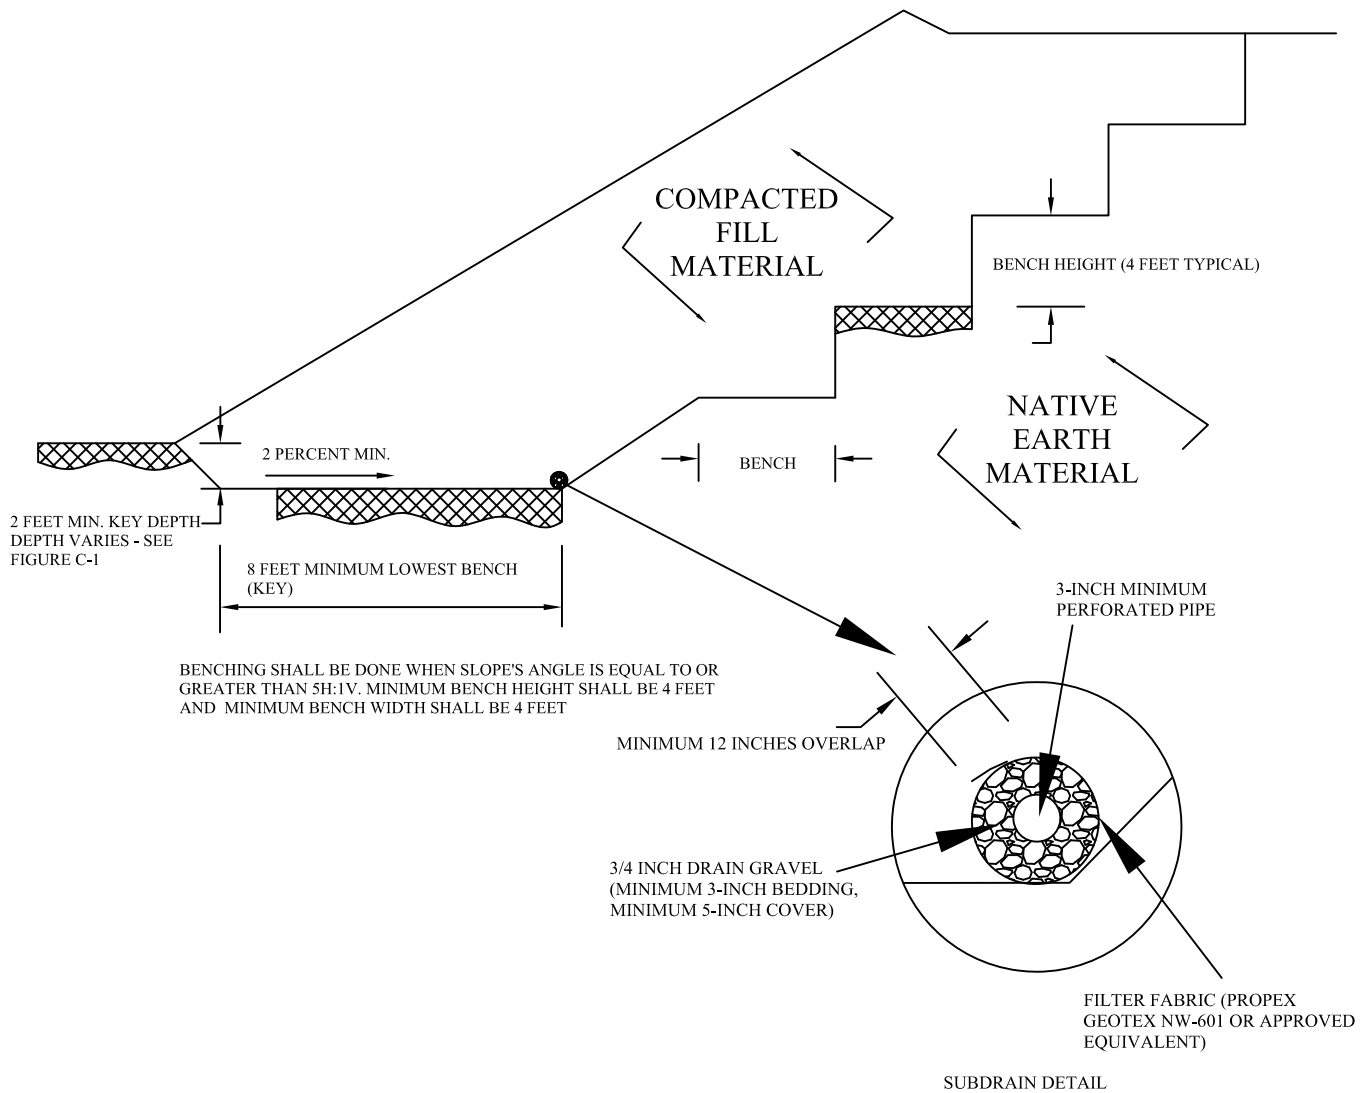
KEYING AND BENCHING DETAIL
