Subject: The Sanctuary – Retaining Walls Analysis

**Re: Global Stability Analysis
The Sanctuary
Huntsville, Utah
Project No. 12-0086G**

PLAN & PROFILE FOR
THE SANCTUARY
A PART OF SECTION 3 & 4, T6N, R2E, AND
A PART OF SECTION 34, T7N, R2E, SLB&M
WEBER COUNTY, UTAH

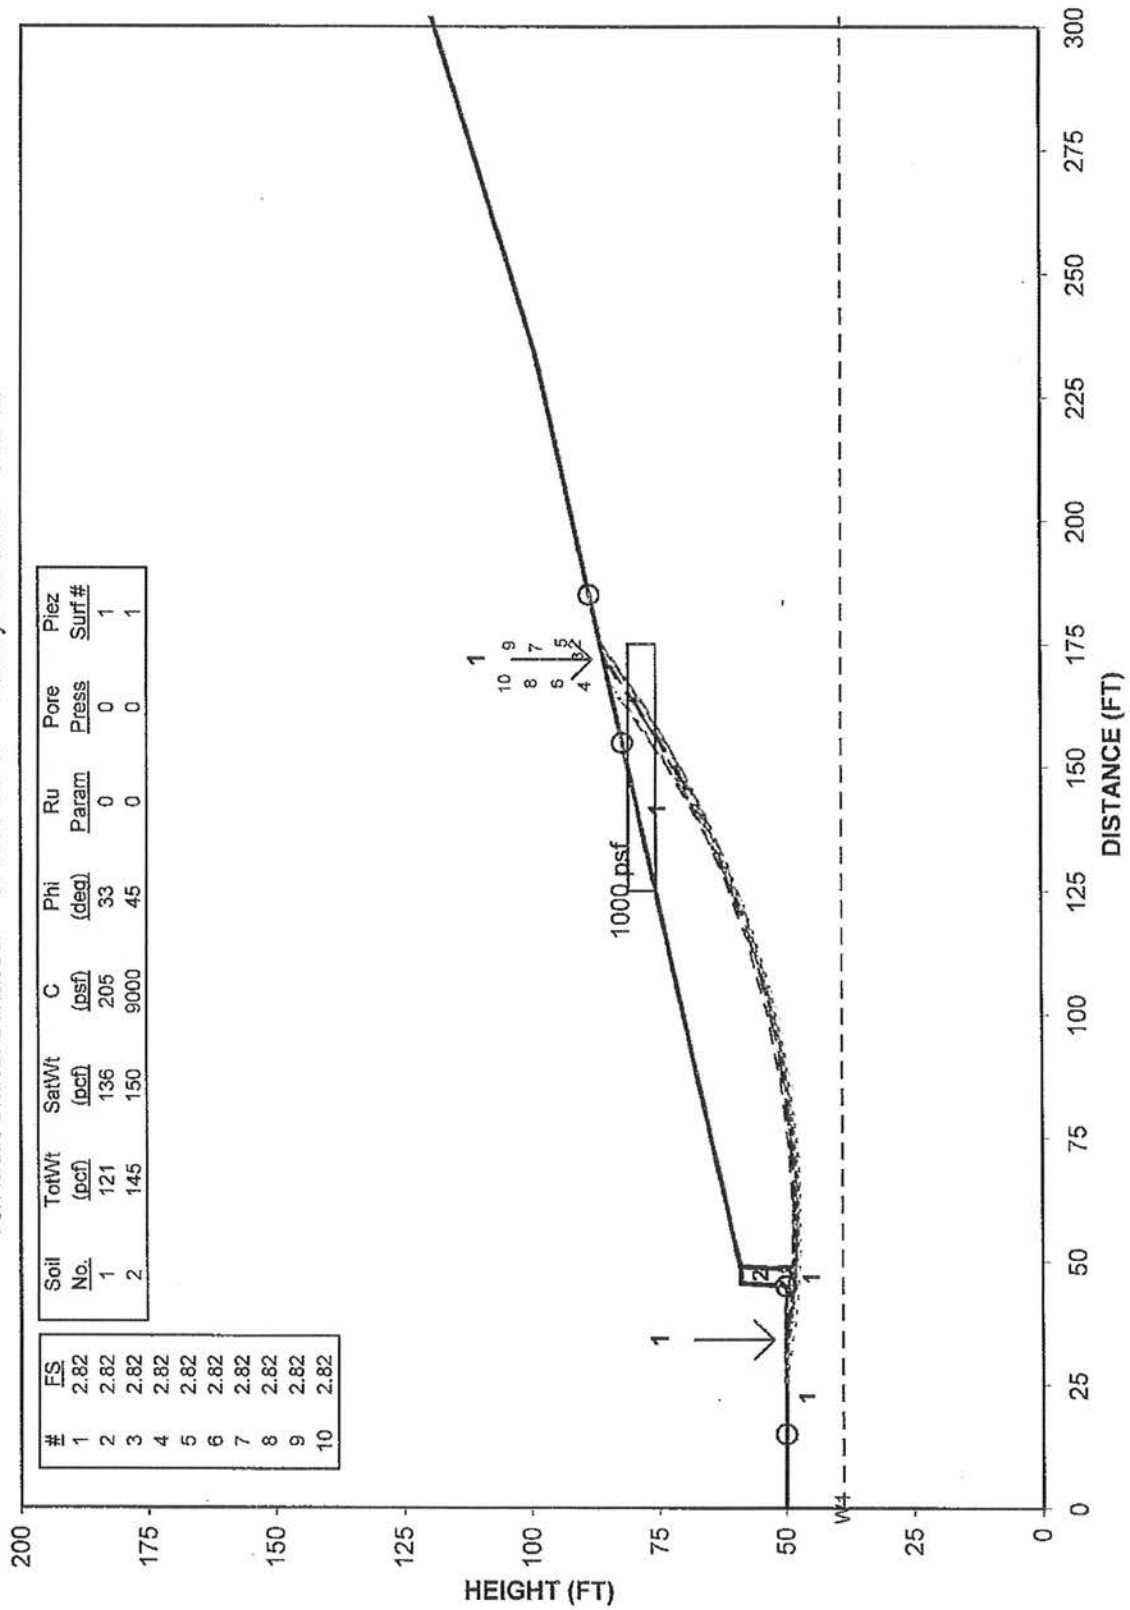
FIGURE NO.: 1

The Sanctuary Static

Ten Most Critical Surfaces. 071950 .OPT Run By: Earthtec 4-02-12

STABILITY RESULTS

We evaluated the global stability of the wall using the computer program *XSTABL*. This program uses a limit equilibrium (Bishop's modified) method for calculating factors of safety against sliding on an assumed failure surface and evaluates numerous potential failure surfaces, with the most critical failure surface identified as the one yielding the lowest factor of safety of those evaluated. The wall configuration and topography at Station 25+65 was utilized for our analysis, including a 1000 psf load for the water storage tank. The configuration analyzed consisted of a 10 foot tall Redi-Rock wall retaining a 30% to 45% slope extending 1000 feet above the wall. Typically, the required global minimum factors of safety are 1.5 for static conditions and 1.1 for seismic (pseudostatic) conditions. The results of our analyses indicate that the existing Redi-Rock wall meets these requirements. The slope stability data is attached as Figures 1 and 2.

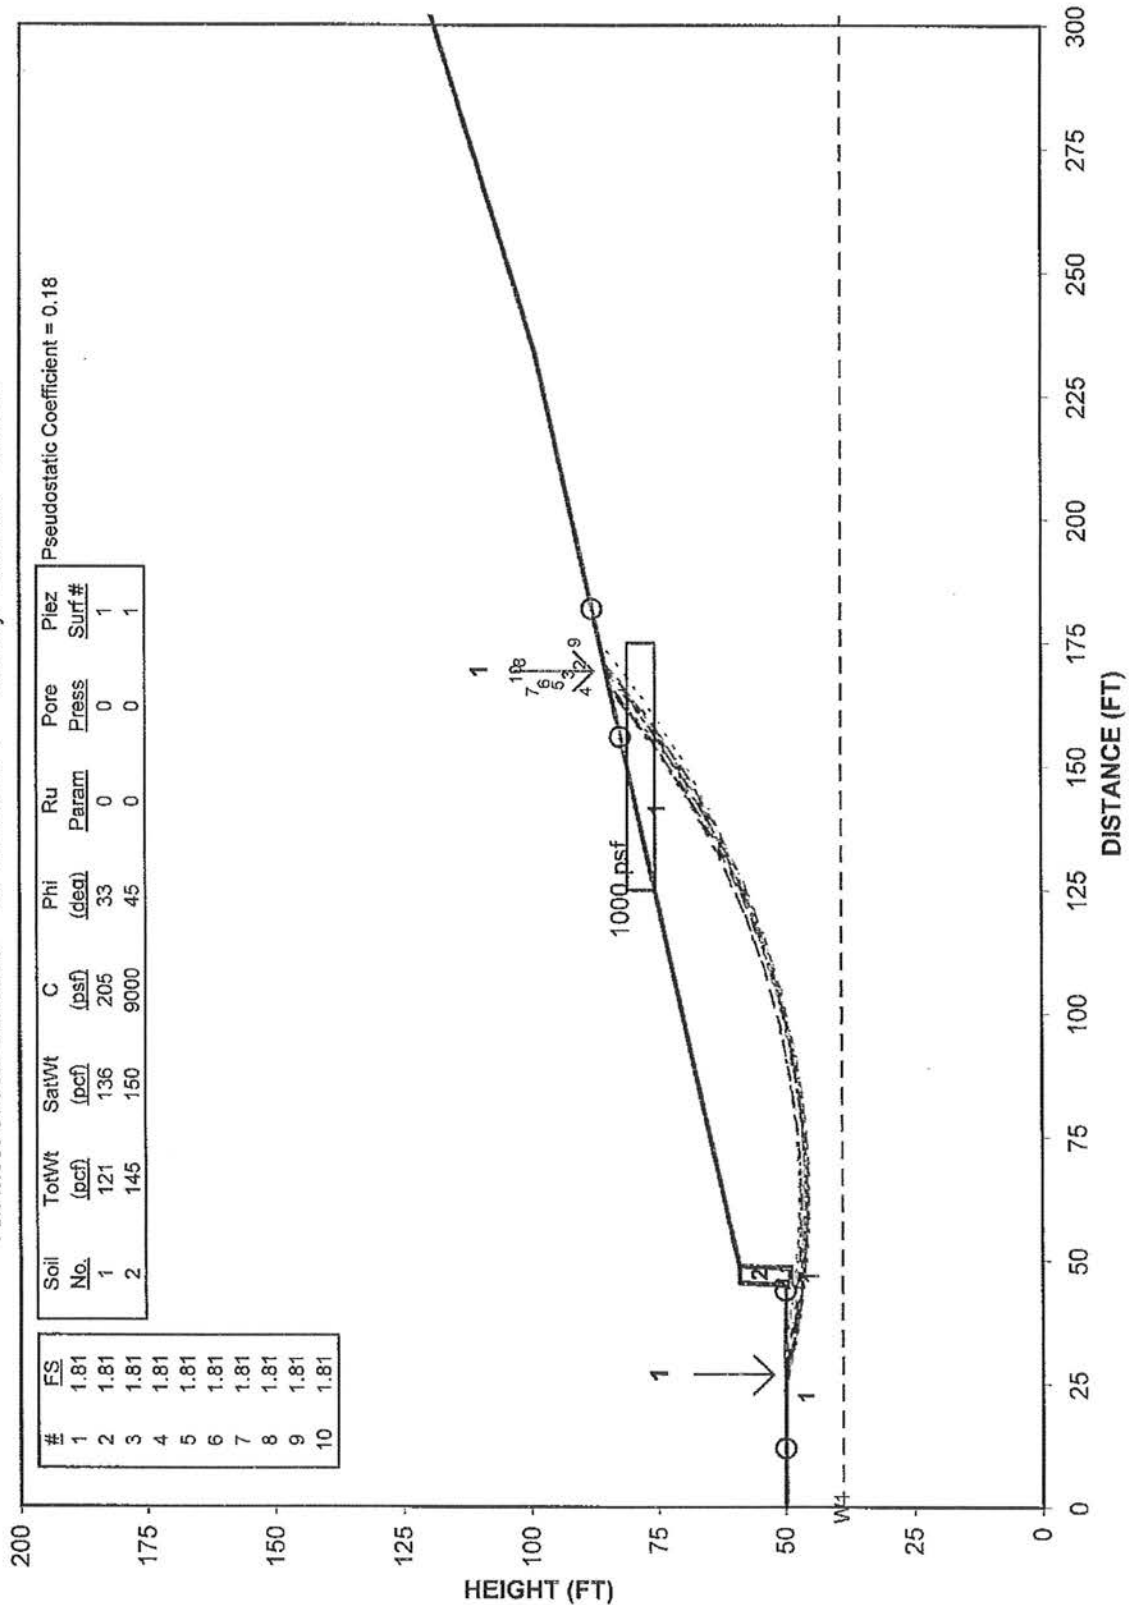
FIGURE NO.: 2

The Sanctuary Seismic
Ten Most Critical Surfaces. 071950S.OPT Run By: Earthtec 4-02-12

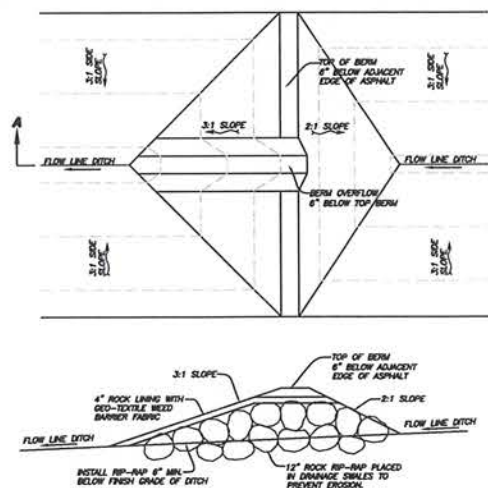
TYPICAL ROCK
CHECK DAM DETAIL
SCALE: NONE

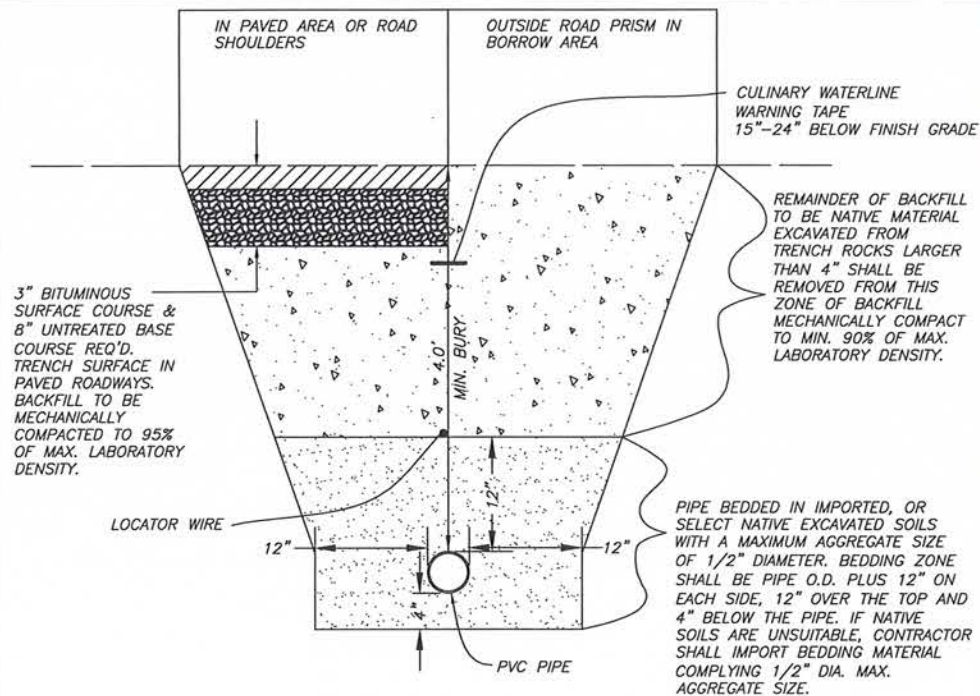
TYPICAL TRENCH SECTION
SCALE: NONE

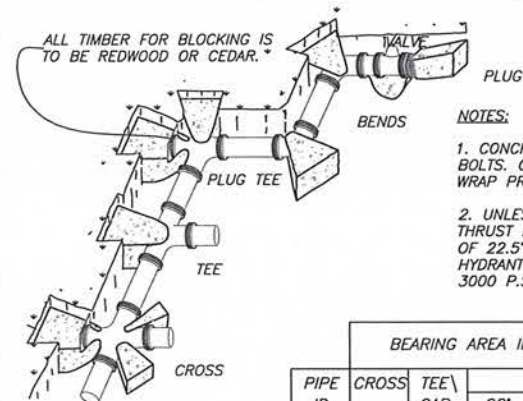
THRUST BLOCKING DETAIL
SCALE: NONE

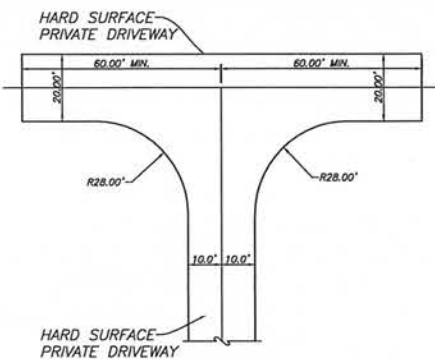
DEAD END HAMMER HEAD
NOT TO SCALE

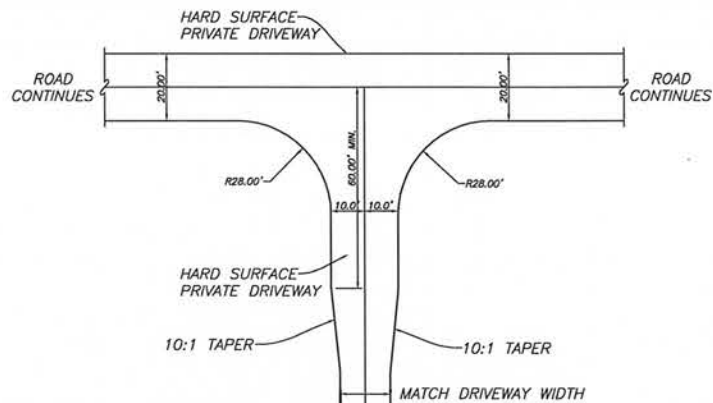
STANDARD ROADWAY HAMMER HEAD
NOT TO SCALE

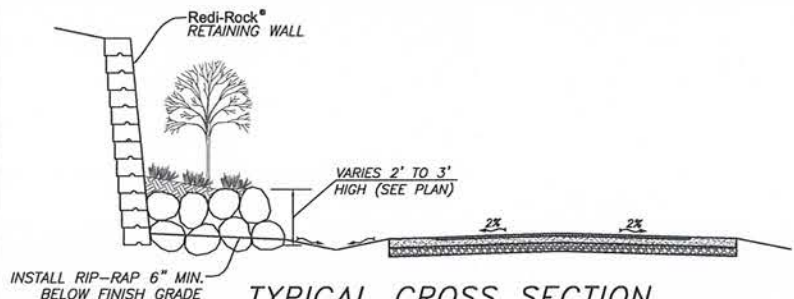
TYPICAL CROSS SECTION
PLANTER WALL DETAIL
SCALE: NONE

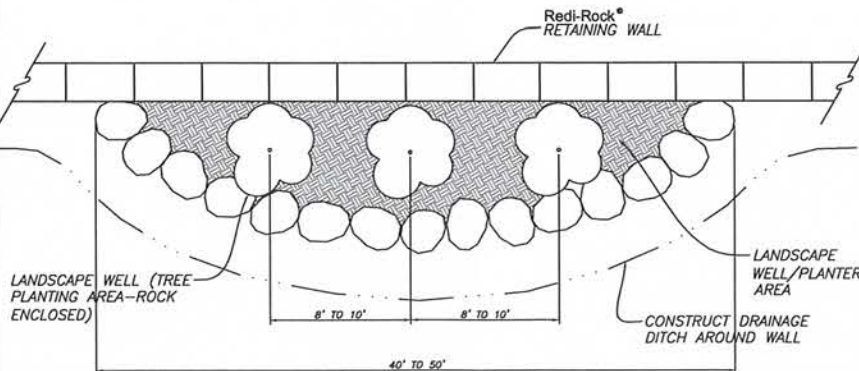
TYPICAL PLAN VIEW
PLANTER WALL DETAIL
SCALE: NONE

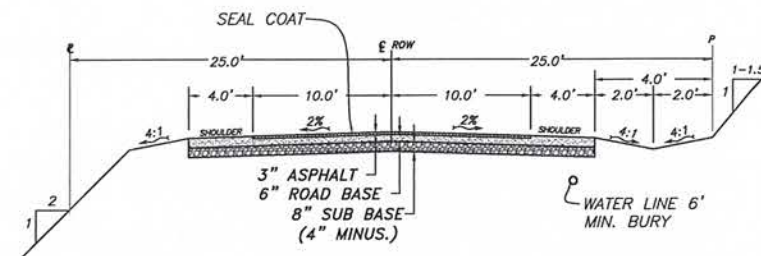
TYPICAL PRIVATE ROADWAY SECTION
MAXIMUM SLOPE = 12%
SCALE: NONE

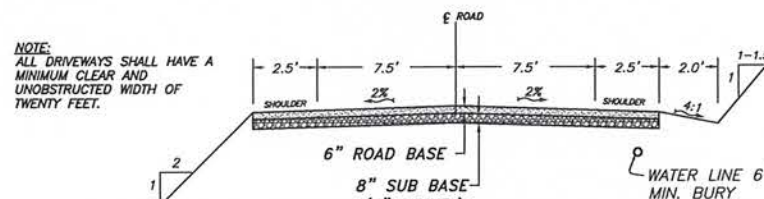
20' WIDE PRIVATE DRIVEWAY
TYPICAL STREET SECTION
MAXIMUM SLOPE = 15%
SCALE: NONE
