WEBER COUNTY PLANNING DIVISION

Administrative Review Meeting Agenda

Staff Report for Administrative Subdivision Approval

Subject: Geologic Hazards Assessment
Phase 1E, 1F, and 1G and Adjacent Areas
Summit Powder Mountain Resort
Weber County, Utah

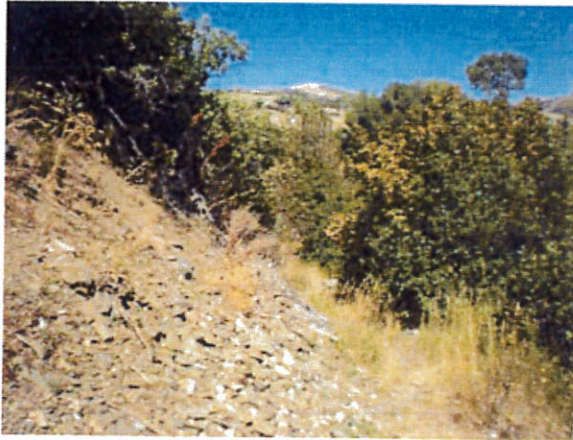
#1 View of roadcut exposed geologic materials comprising the slopes at the site.

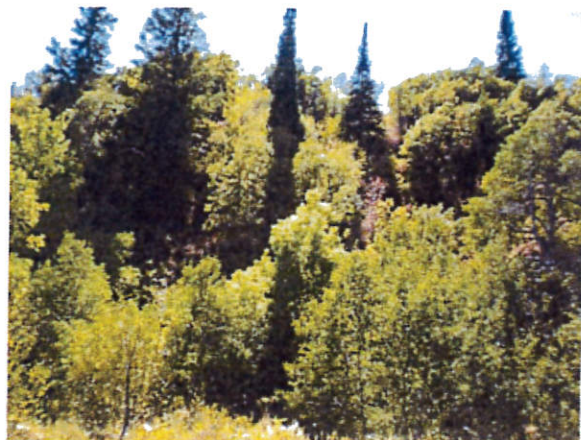
#2 Facing southwest from the buildable area expansion toward the heavily vegetated slope.

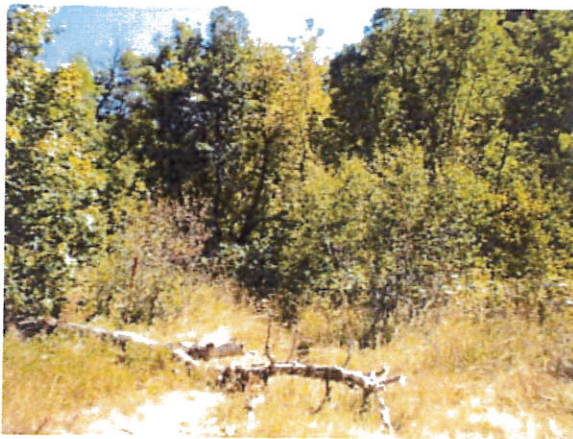
#3 Facing southeast across the proposed building area expansion.

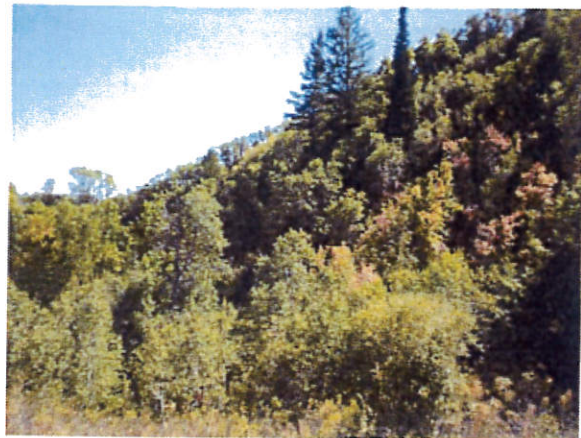
#4 Facing southeast, overall buildable area.

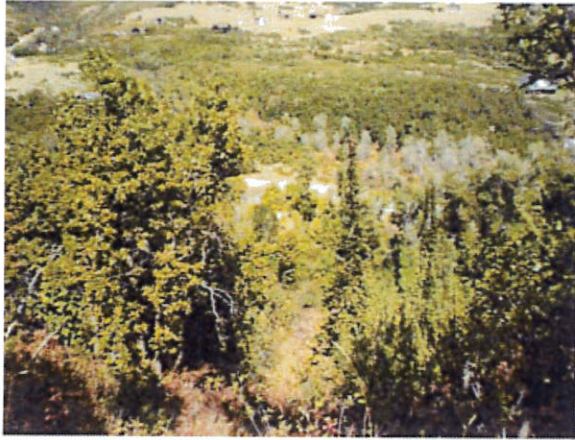
#5 Facing northeast from the top of the 130+ foot slope.

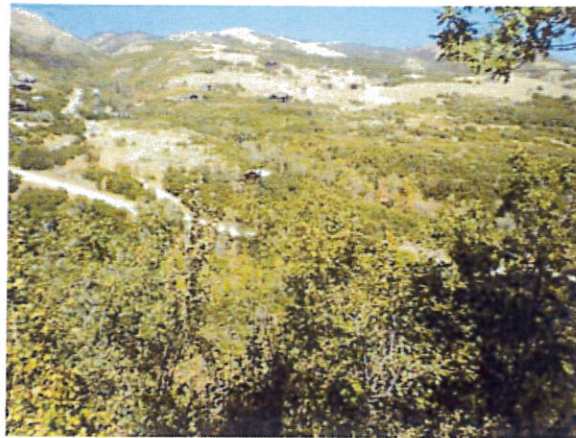
#7 Facing northeast from the top of the large slope across the rest of the subdivision.
