**Geotechnical Study
Hidden Cove Subdivision
6260 South 2125 East
Ogden, Utah**

Project No. 177078

December 4, 2017

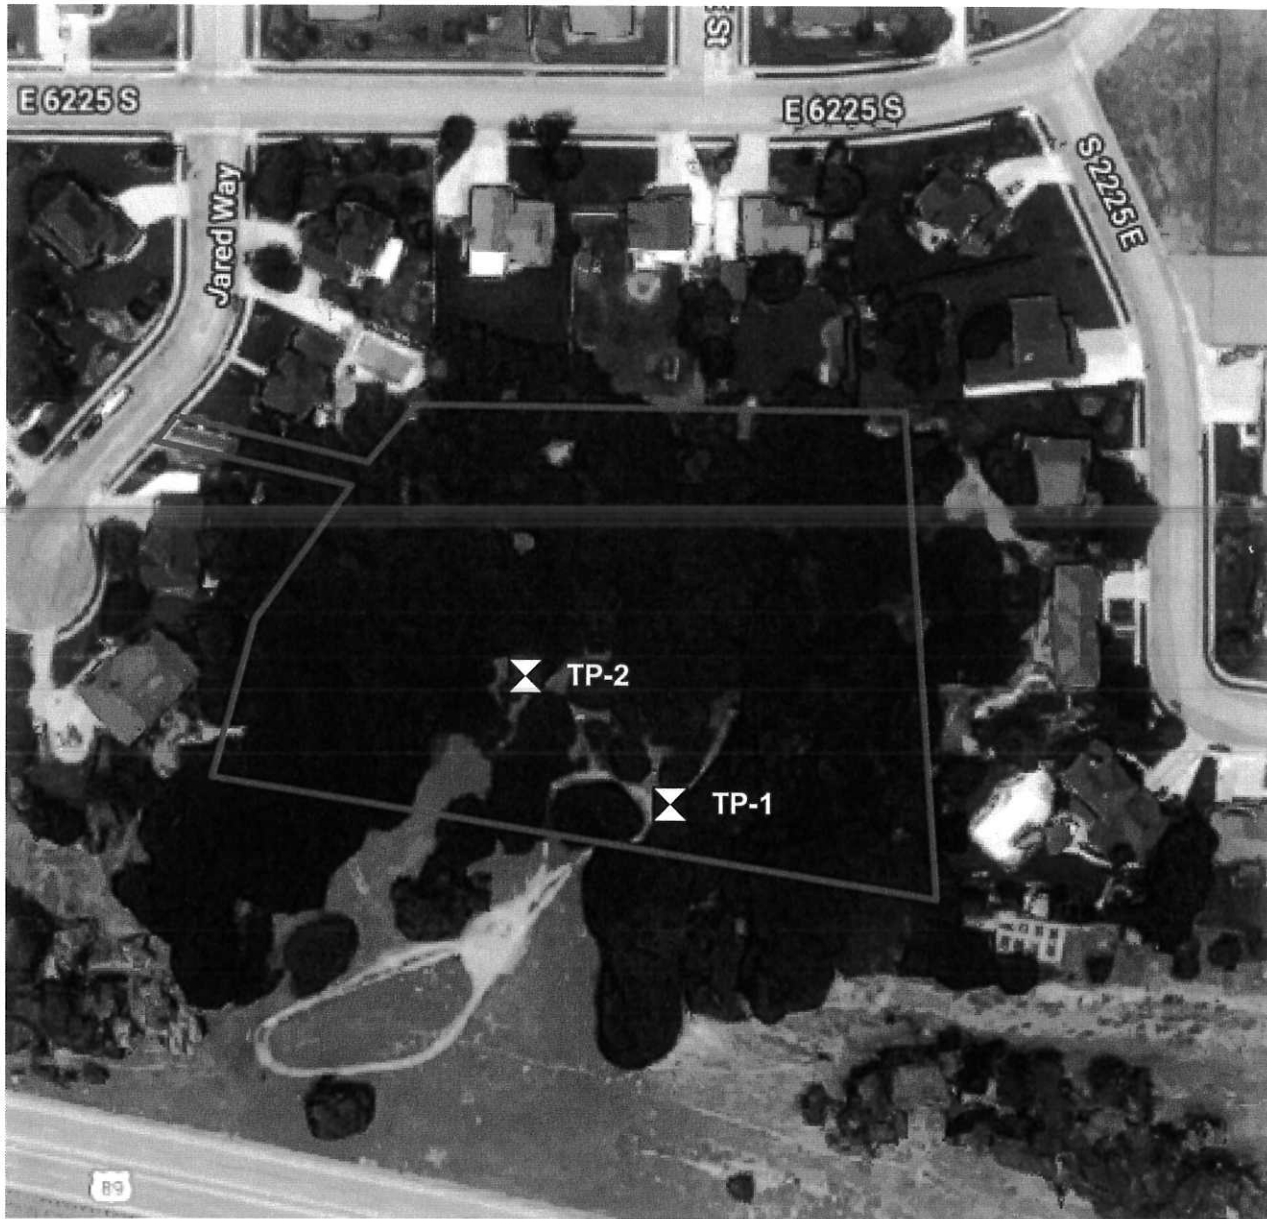
AERIAL PHOTOGRAPH SHOWING LOCATION OF TEST PITS

Approximate Test Pit Location
