# Staff Report for Administrative Approval Hillside Review – Notice of Conditional Approval

**Application Request:** Consideration and action on a request to approve a Hillside Review for the Kimmelman residence located on Lot 16R in the Summit Eden Phase 1A.

**File Number:** HSR 2017-04

**GEOTECHNICAL AND GEOLOGIC HAZARD INVESTIGATION**  
**Lot 16 of Summit Eden Phase 1A**  
**Summit Powder Mountain Resort**  
**Weber County, Utah**

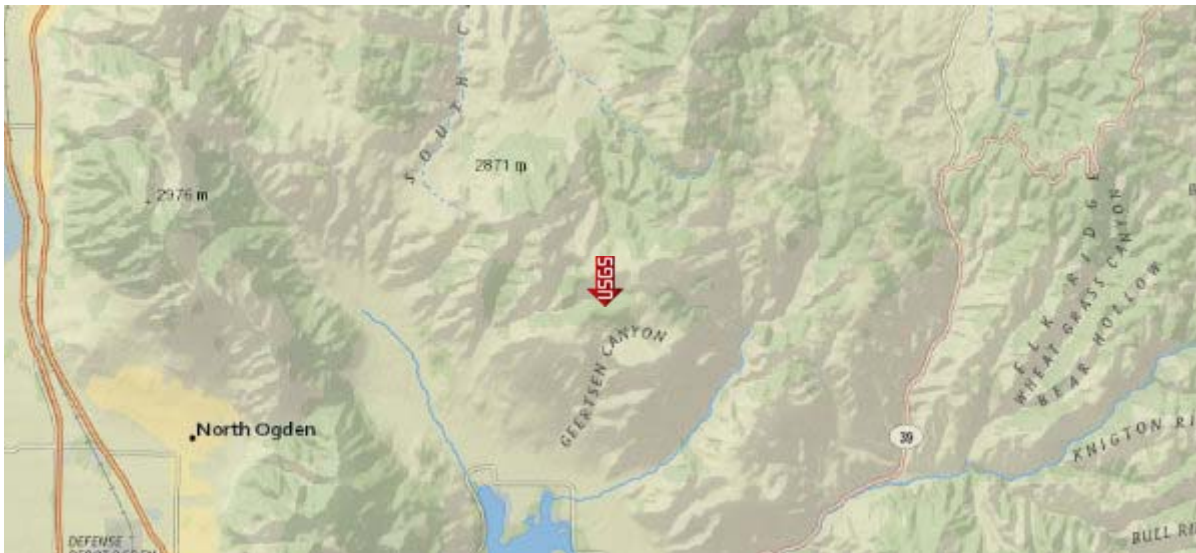
**Site Soil Classification** Site Class C – “Very Dense Soil and Soft Rock”

**Risk Category** I/II/III

**USGS-Provided Output**

$S_s = 0.831 \text{ g}$	$S_{MS} = 0.887 \text{ g}$	$S_{DS} = 0.591 \text{ g}$
$S_1 = 0.276 \text{ g}$	$S_{M1} = 0.421 \text{ g}$	$S_{D1} = 0.281 \text{ g}$

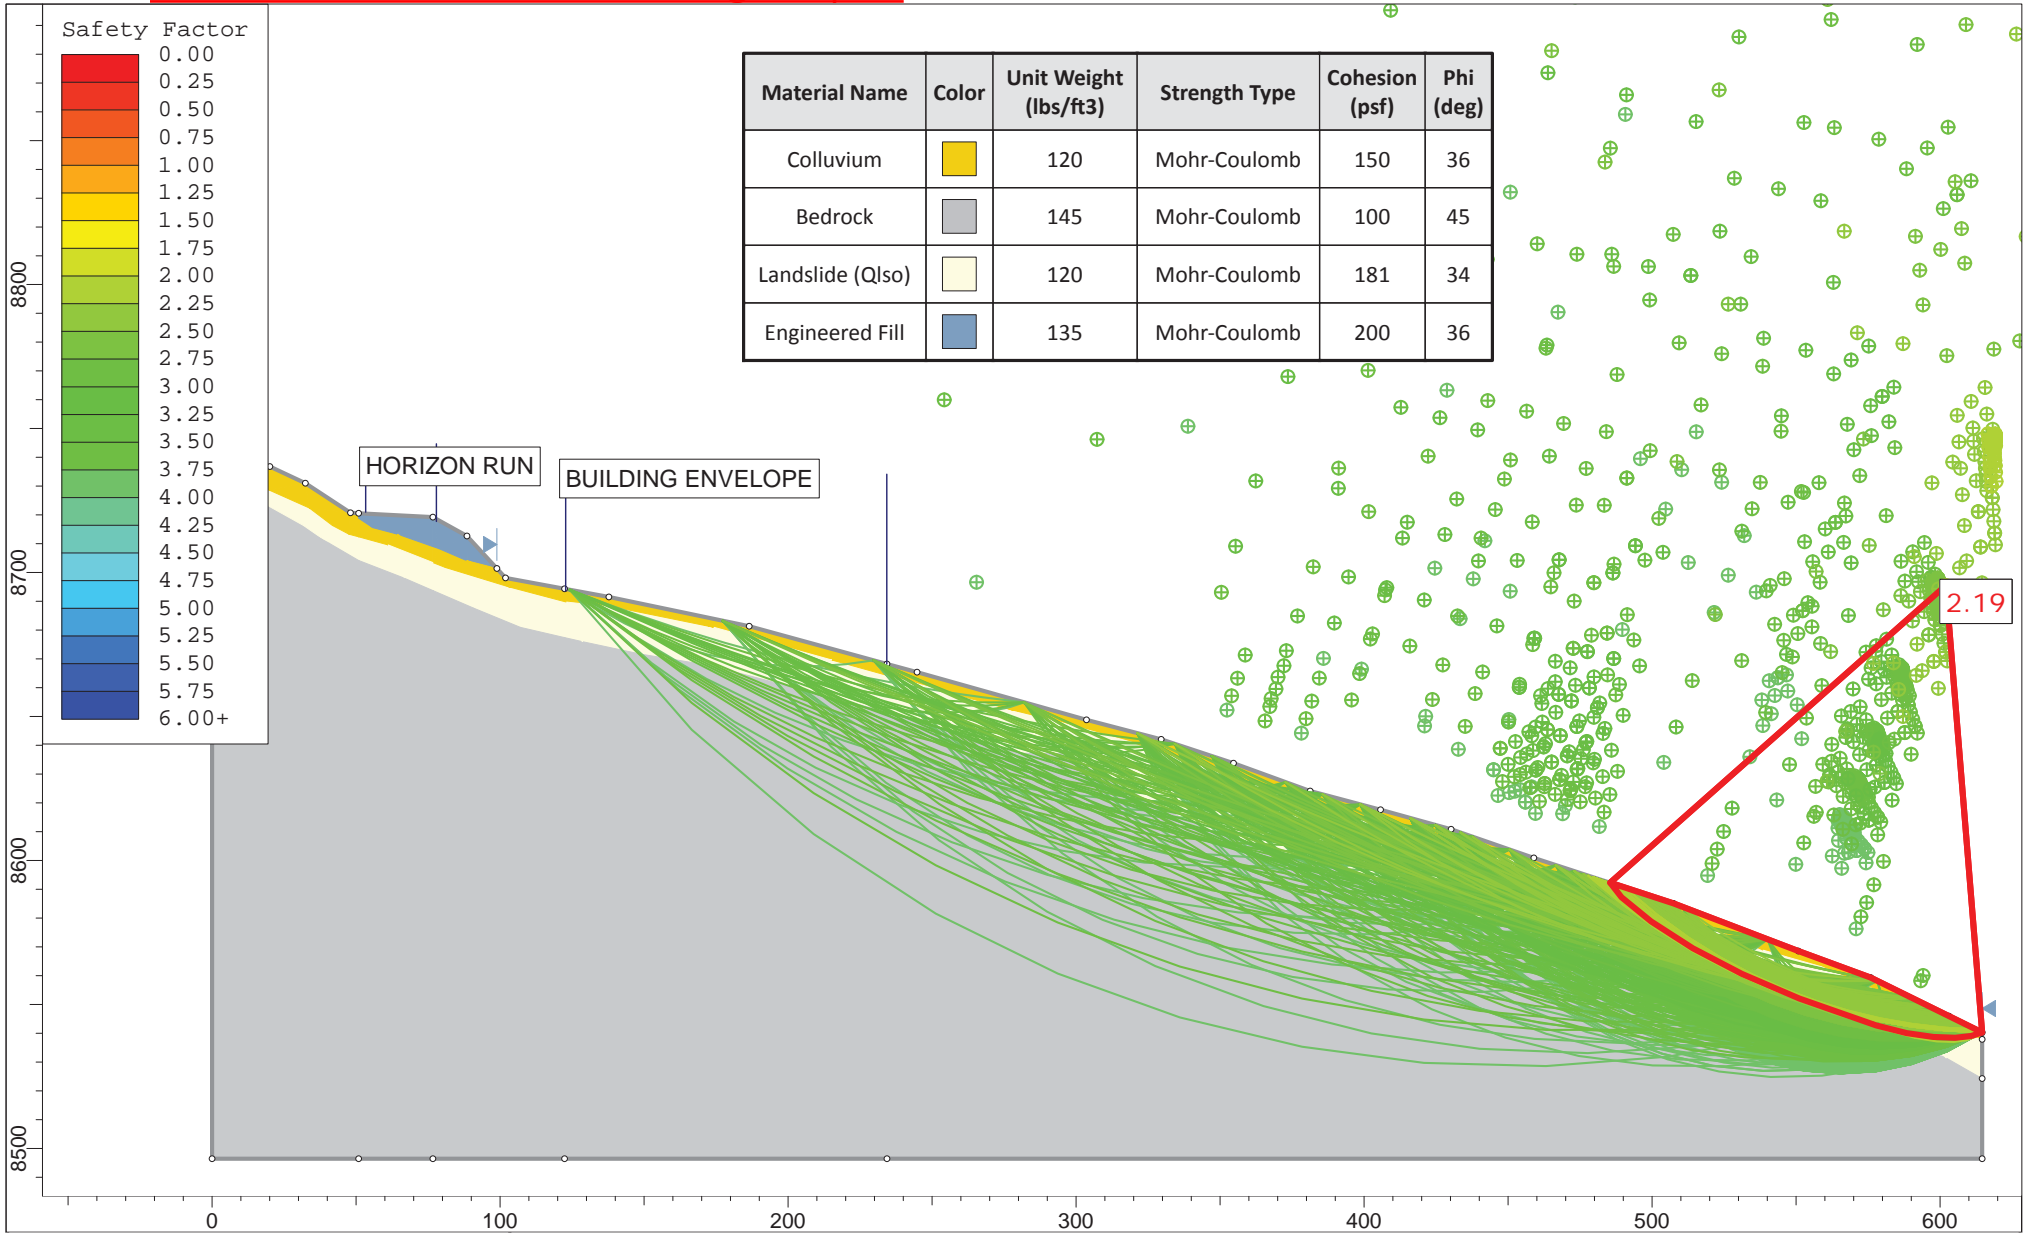
Project		Lot 16R of Summit Eden Phase 1A	
Analysis Description		Section A-A' - Static	
Drawn By	TQH	Scale	1:800
Date	8-8-2017	Company	IGES, Inc.
		File Name	Section A-A' Static.slim
