GEOTECHNICAL AND GEOLOGIC HAZARD INVESTIGATION
Matthew Toliver Property
Parcel No. 20-035-0039, Old Snowbasin Road
Unincorporated Weber County, Utah

IGES Project No. 02489-001

July 19, 2017

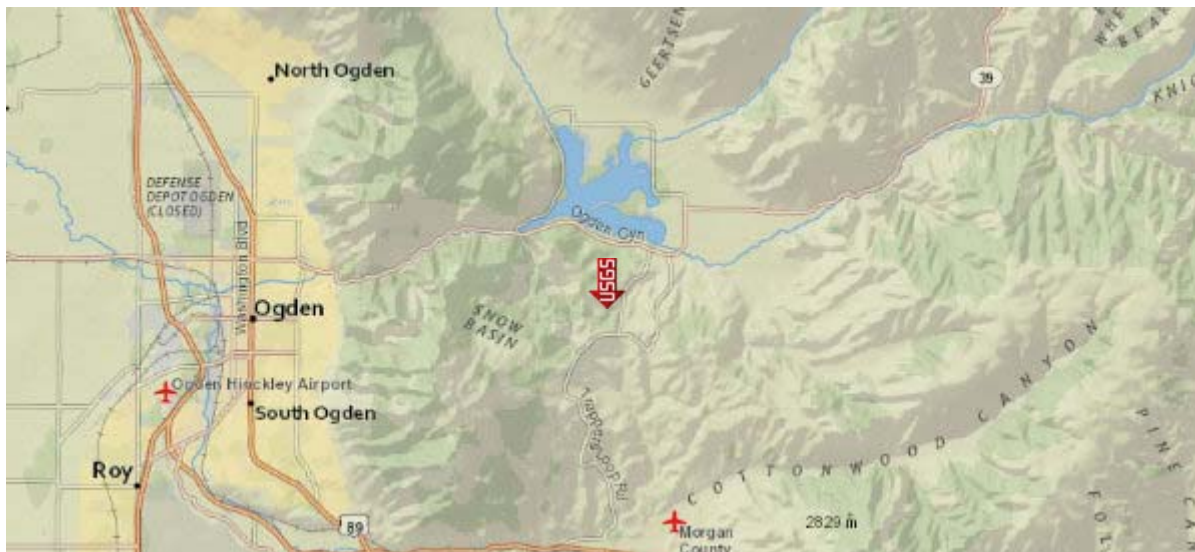
Site Soil Classification Site Class C – “Very Dense Soil and Soft Rock”

$S_s = 0.850 \text{ g}$ $S_{MS} = 0.901 \text{ g}$ $S_{DS} = 0.600 \text{ g}$
 $S_1 = 0.287 \text{ g}$ $S_{M1} = 0.434 \text{ g}$ $S_{D1} = 0.289 \text{ g}$

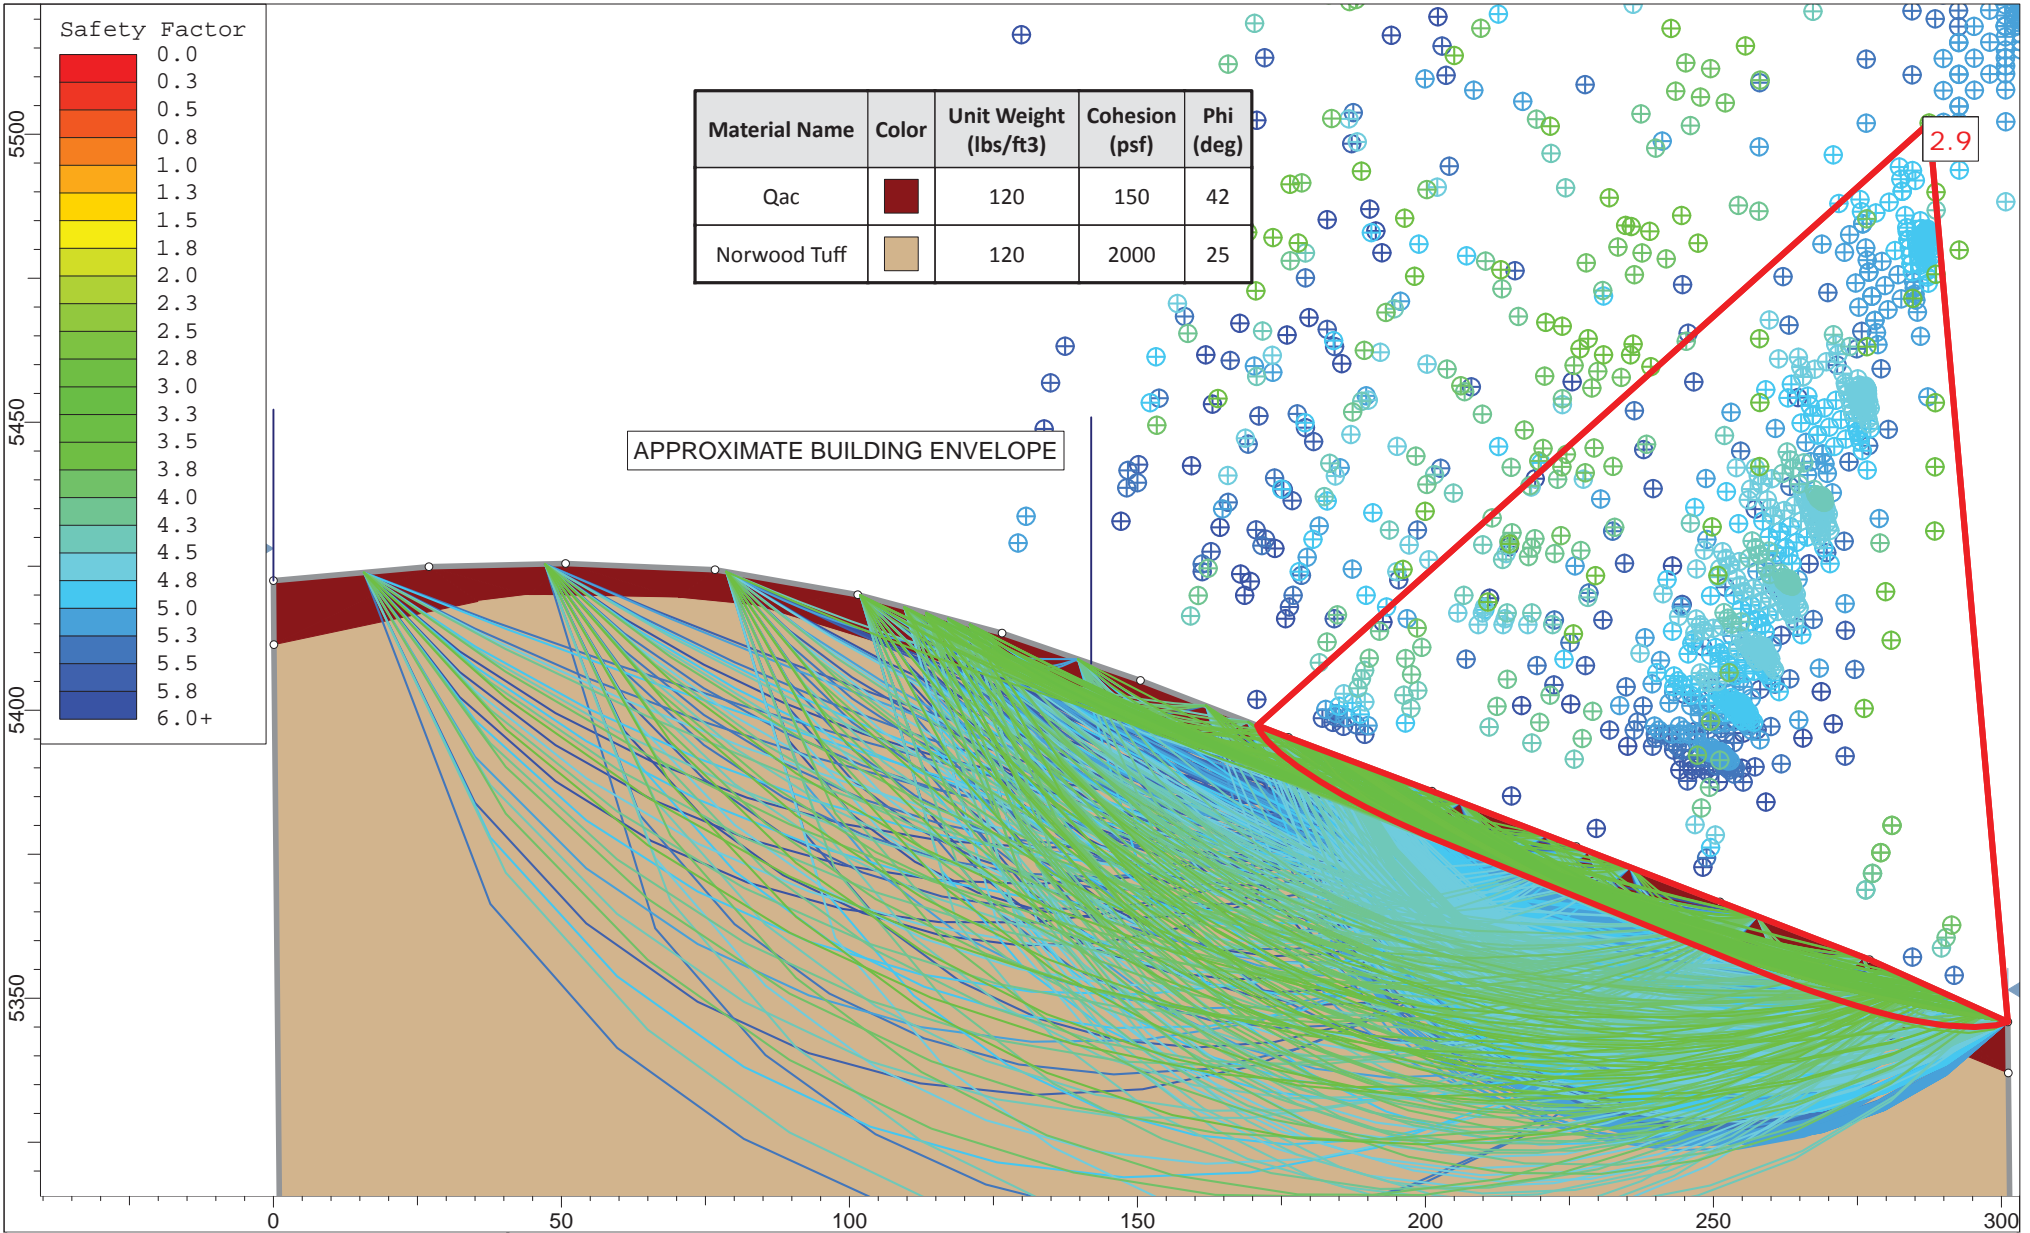
Project			Parcel 200350039		
	Analysis Description			Section B-B' - Static		
	Drawn By	TQH	Scale	1:400	Company	IGES, Inc.
	Date	7/18/2017		File Name	Section B-B'.slim
