**GEOTECHNICAL & GEOLOGIC
HAZARD INVESTIGATION
Horizon Neighbourhood Development
Summit Powder Mountain Resort
Weber County, Utah**

IGES Project No. 01628-013

August 3, 2016

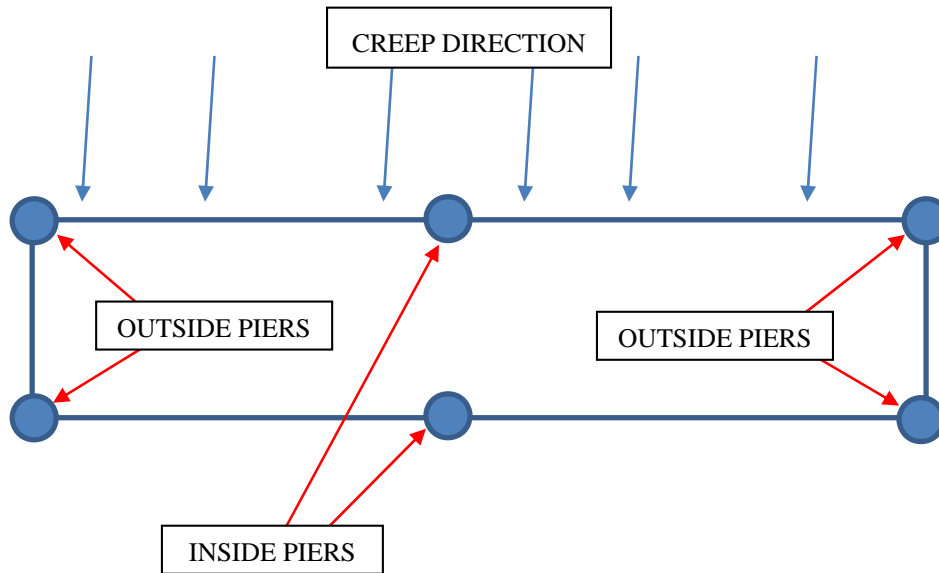
Table 6.3.2-1 is for outside piers, and Table 6.3.2-2 is for inside piers:

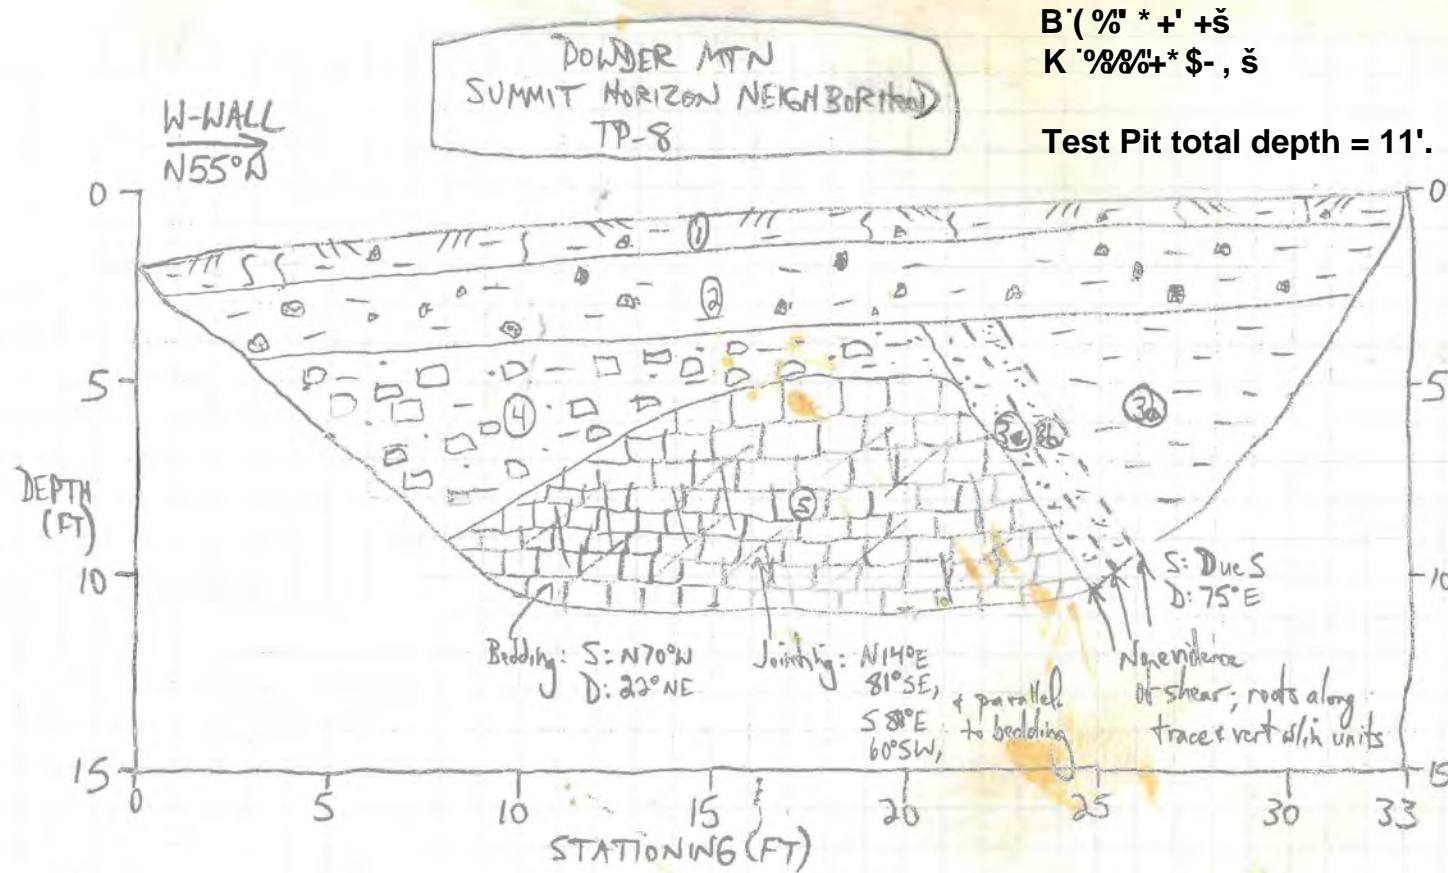
Slow groundwater seepage from N wall of trench at 5' depth.

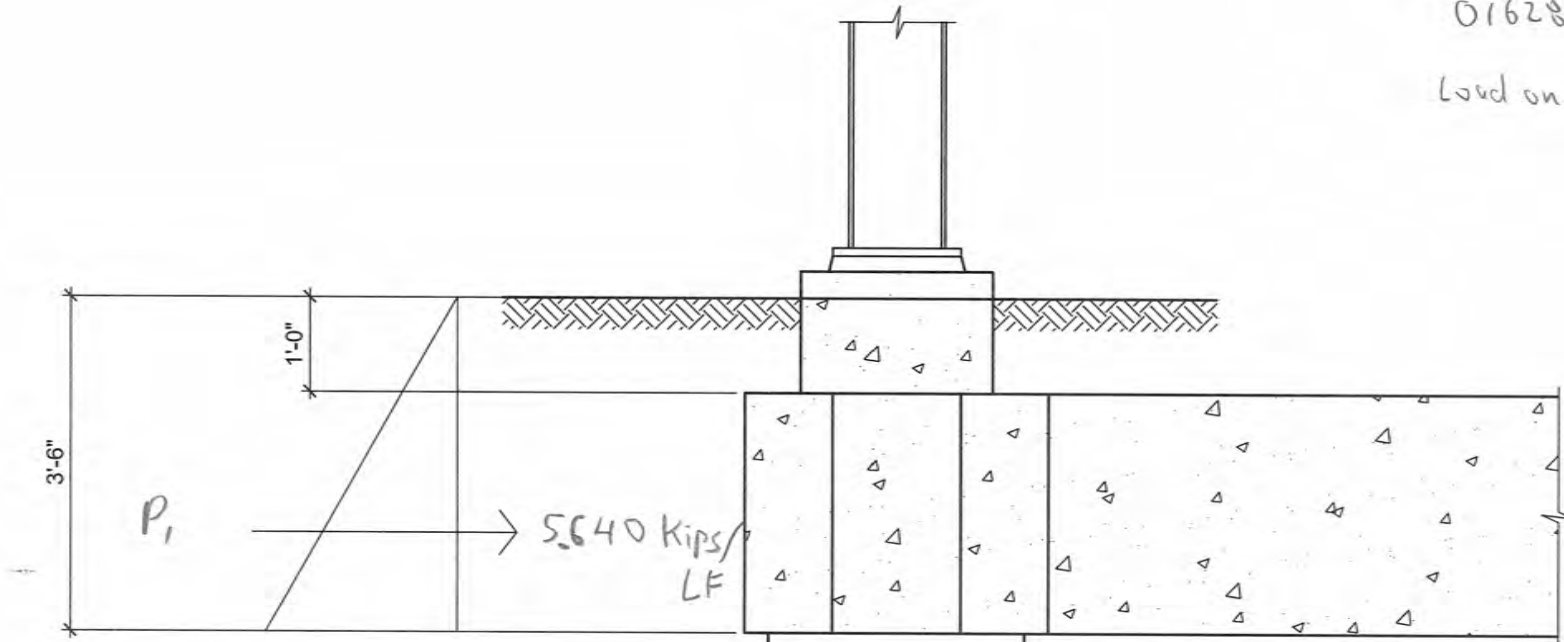
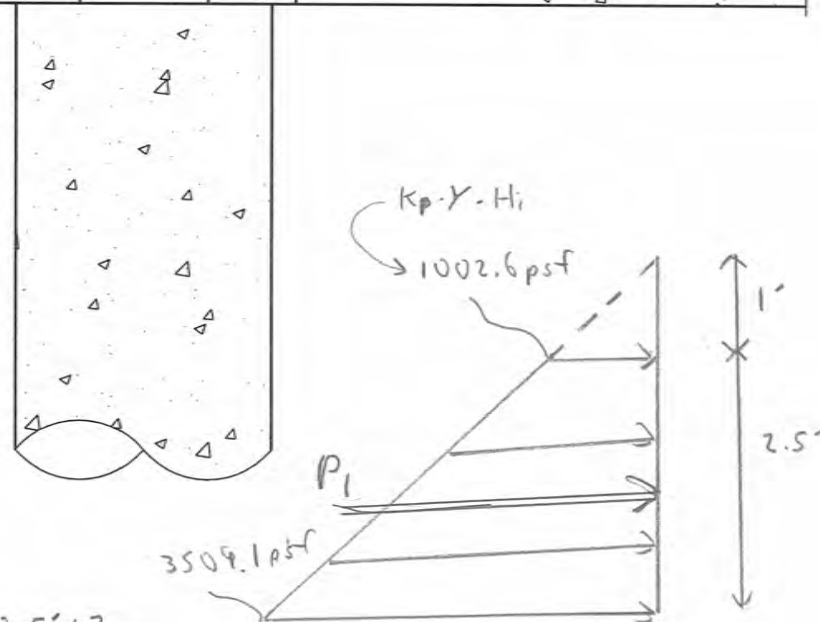
Basis for Drilled Pier Design

Load acting on grade beam

$$K_p = 8.355$$

$$P_1 = 1002.6 \text{ psf} \cdot 2.5' + (3509.1 - 1002.6) \cdot 2.5' \div 2$$
$$= 5640 \text{ lb/LF}$$
