**GEOTECHNICAL AND GEOLOGIC HAZARD INVESTIGATION**  
**West Village Sliver**  
**Summit Powder Mountain Resort**  
**Weber County, Utah**

IGES Project No. 01628-020

January 20, 2017

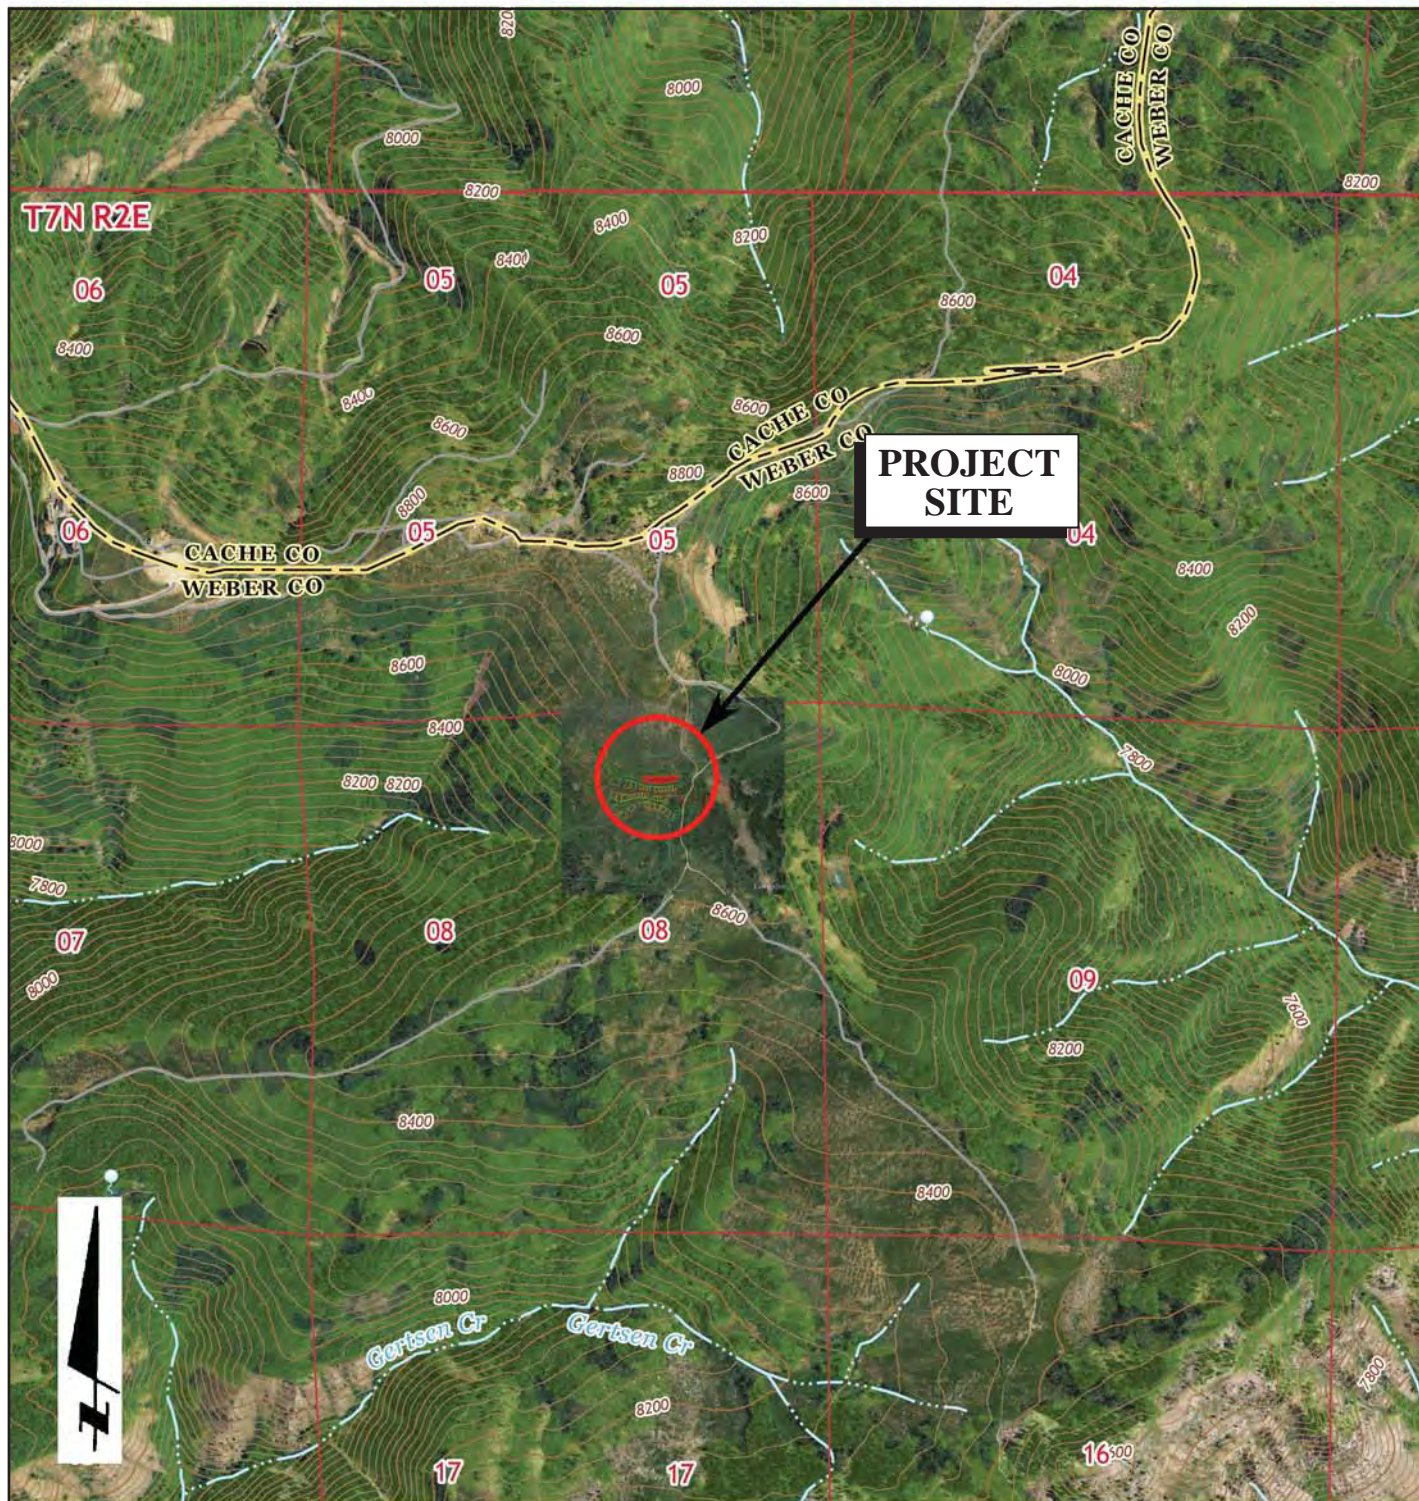
**A-1**

BASE MAP:  
USGS Huntsville, Browns Hole, James Peak and Sharp Mountain  
7.5-Minute Quadrangle Topographic Maps (2011)

The USGS topographic maps for the Huntsville and Brown’s Hole Quadrangles (2014) show that the West Village Sliver project area is situated on a slope, with the topographic gradient down to the southwest towards Lefty’s Canyon (see Figure A-1). No active or ephemeral stream drainages are found on the property, though two small, dry gullies were observed during the site reconnaissance. No springs are known to occur on the property, though it is possible that springs may occur on various parts of the property during peak runoff.
