**GEOTECHNICAL AND GEOLOGIC HAZARD INVESTIGATION**  
**Lot 44R of Summit Eden Phase 1C**  
**8645 E. Copper Crest**  
**Summit Powder Mountain Resort**  
**Weber County, Utah**

IGES Project No. 02732-001

March 19, 2018

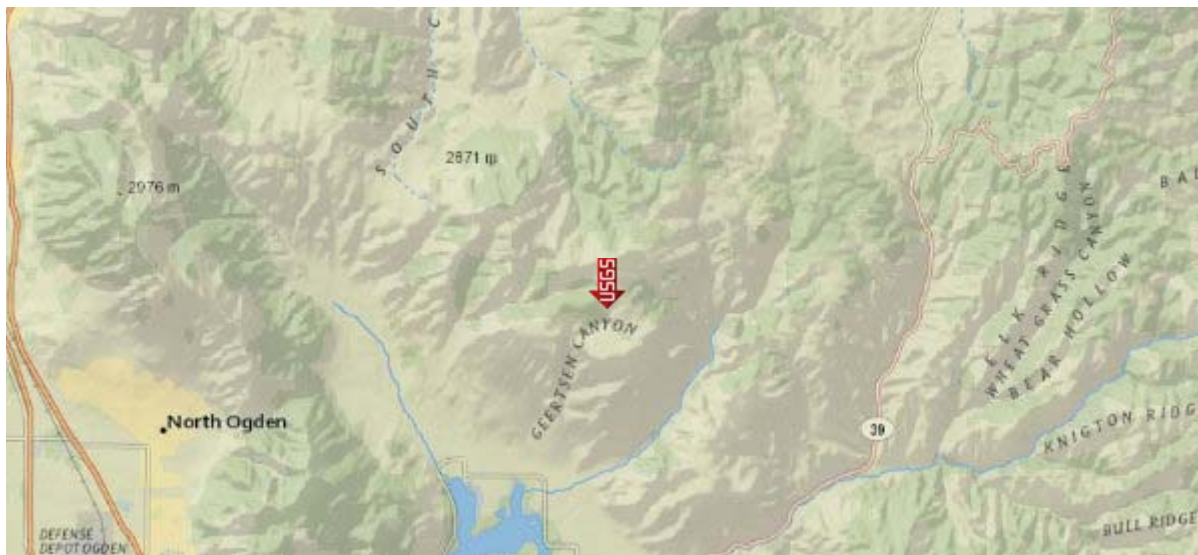
**Site Soil Classification** Site Class C – “Very Dense Soil and Soft Rock”

**Risk Category** I/II/III

## USGS-Provided Output

$S_S = 0.813 \text{ g}$	$S_{MS} = 0.874 \text{ g}$	$S_{DS} = 0.582 \text{ g}$
$S_1 = 0.270 \text{ g}$	$S_{M1} = 0.413 \text{ g}$	$S_{D1} = 0.275 \text{ g}$

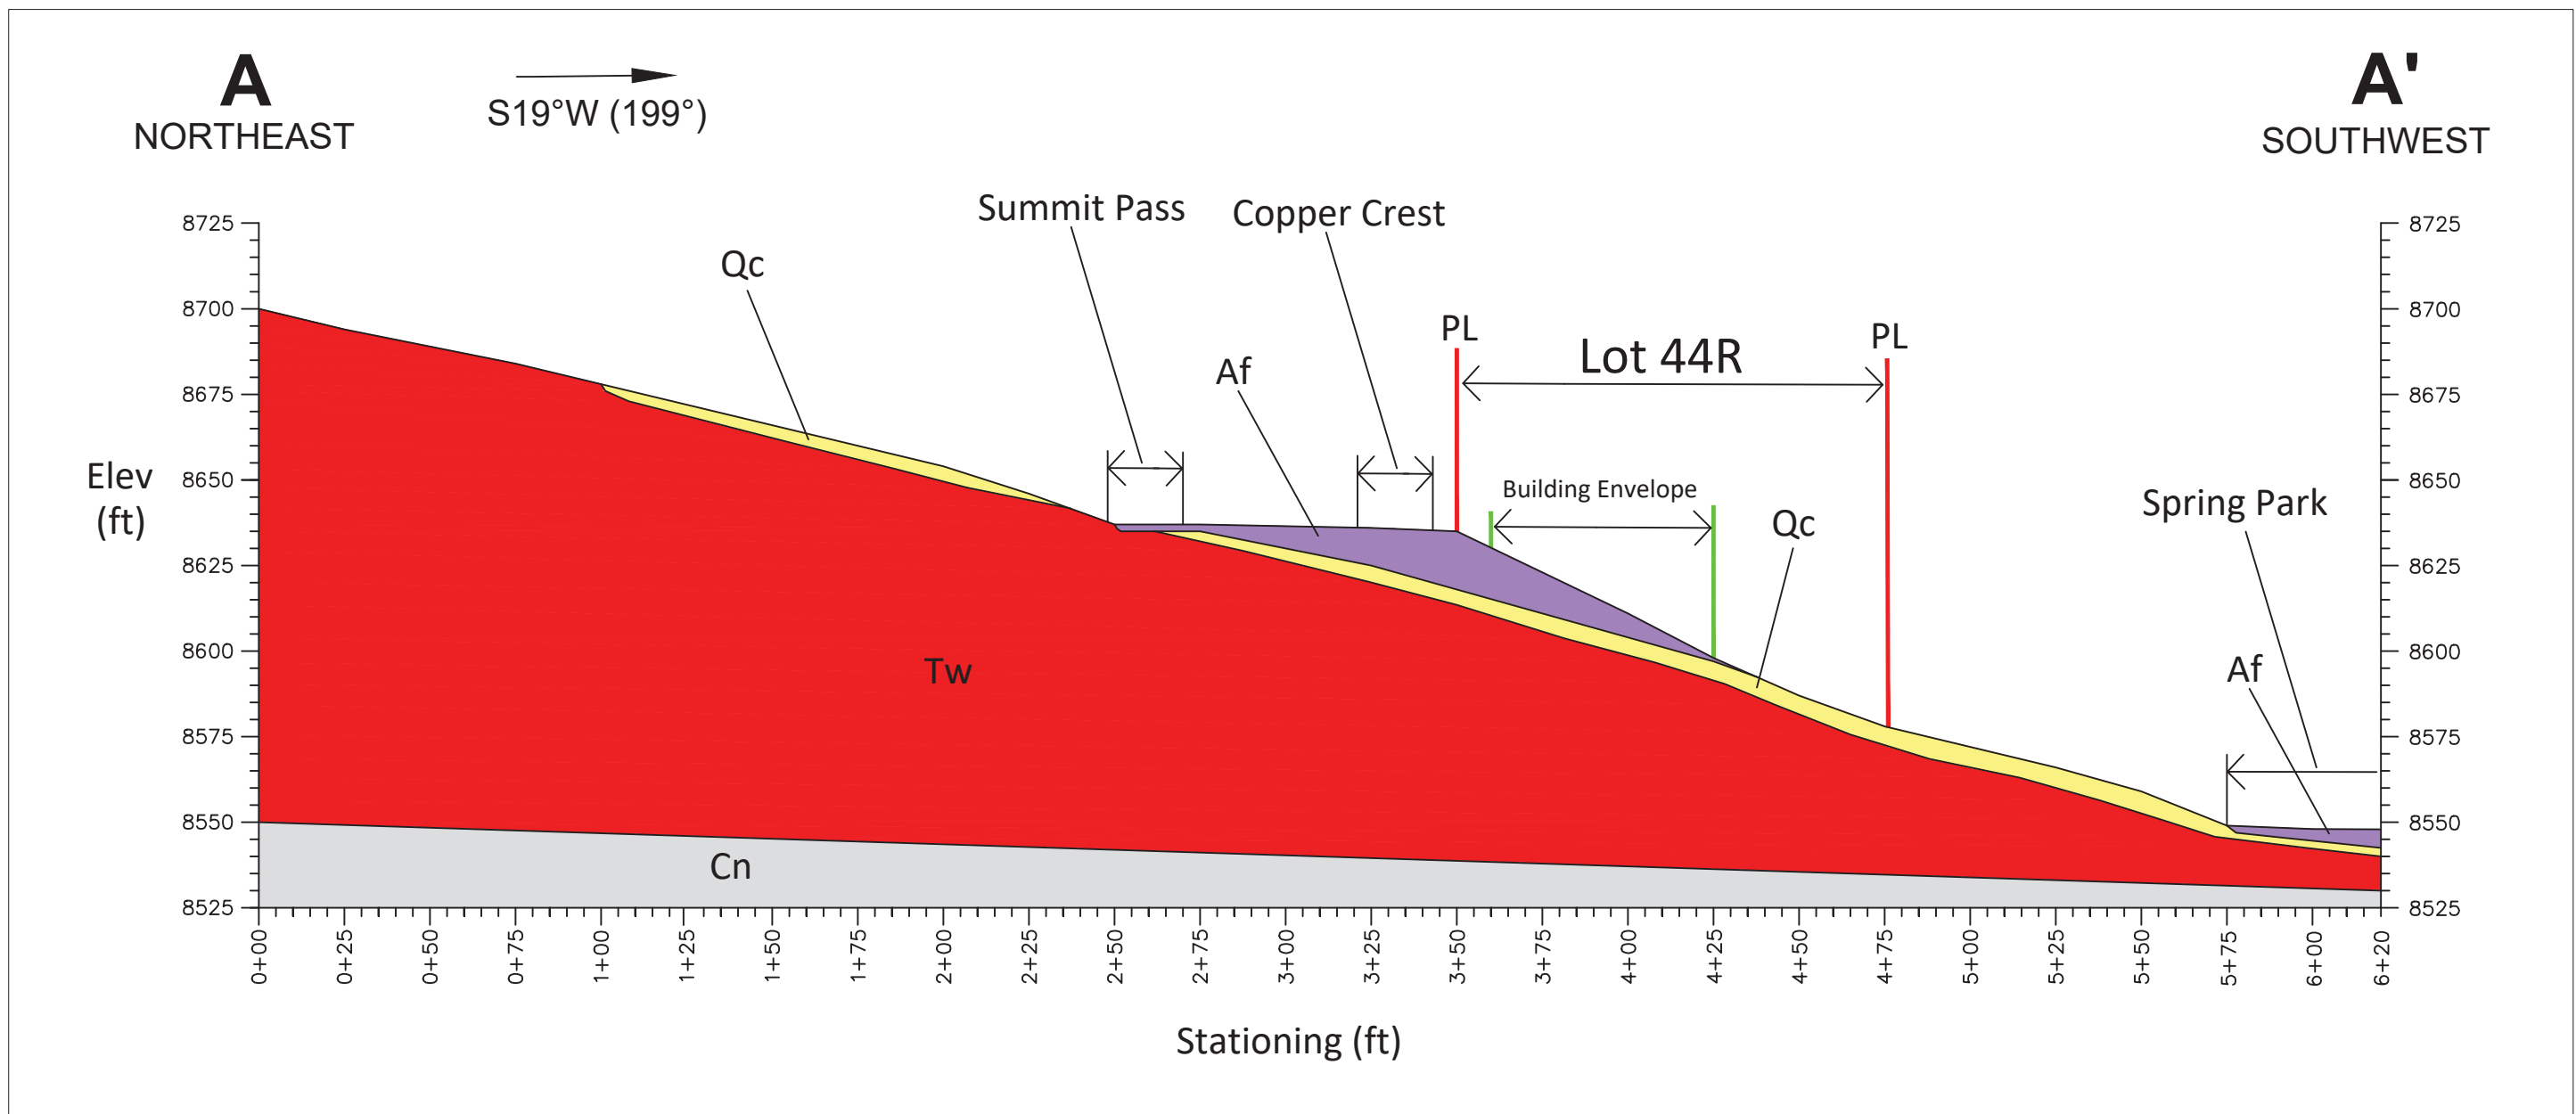
# CROSS-SECTION A - A'

- Af = Artificial Fill
- Tw = Wasatch Formation
- Qc = Colluvium
- Cn = Nounan Dolomite

SCALE:  
1"=50'

The stability of the existing fill slope has been assessed in accordance with methodologies set forth in Blake et al. (2002) and AASHTO LRFD for Bridge Design Specifications with respect to a representative cross-section, illustrated on Figure D-1 in Appendix D (the section is identified in plan-view on Figure A-2). The stability of the slope was modeled using SLIDE, a computer application incorporating (among others) Spencer's Method of analysis. Calculations for stability were developed by searching for the minimum factor of safety for a rotational-type failure occurring through surficial soils (primarily embankment fill and colluvium), just above the underlying conglomerate bedrock. Analysis was performed for both static and seismic (pseudo-static) cases.

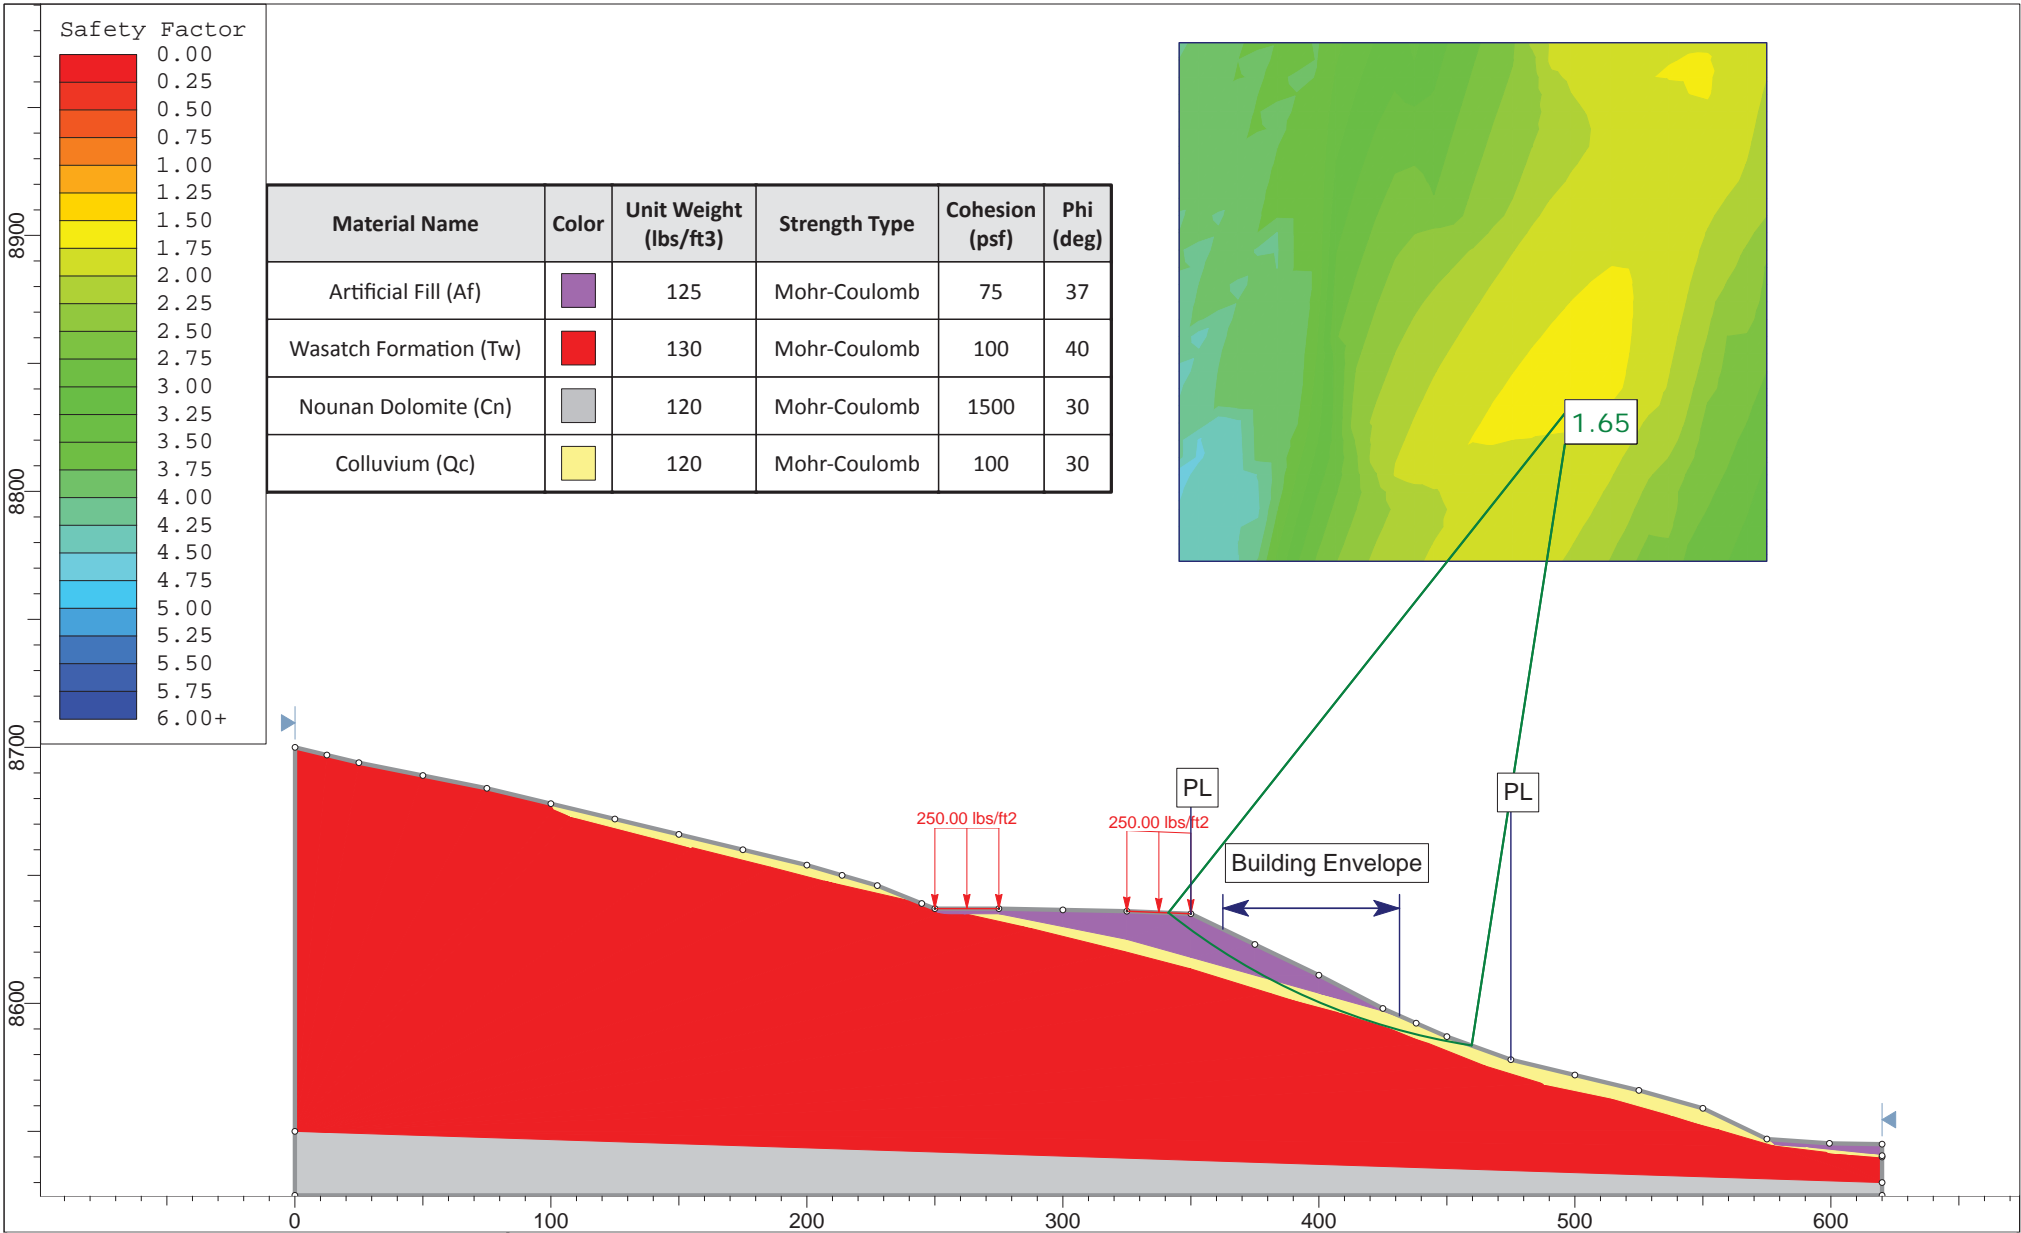
<b>IGES</b> ®	Project			Lot 14R	
	Analysis Description			Slope Stability	
	Drawn By	EBF	Scale	1:900	Company
	Date	3/6/2018, 7:57:47 AM		File Name	02732-001 Xsec A-A'.slim
SLIDEINTERPRET 7.029

Section	Static Factor of Safety	Pseudo-Static Factor of Safety
Existing Condition	1.65	1.13

The results of the analysis indicate the existing conditions meet the minimum required factors-of-safety of 1.5 and 1.0 for both the static and seismic (pseudo-static) case, respectively. A summary of the slope stability analysis is presented in Appendix D.
