GEOTECHNICAL AND GEOLOGIC HAZARD INVESTIGATION
The Ridge Nests Development
Powder Mountain Resort
Weber and Cache Counties, Utah

IGES Project No. 01628-008

July 15, 2016

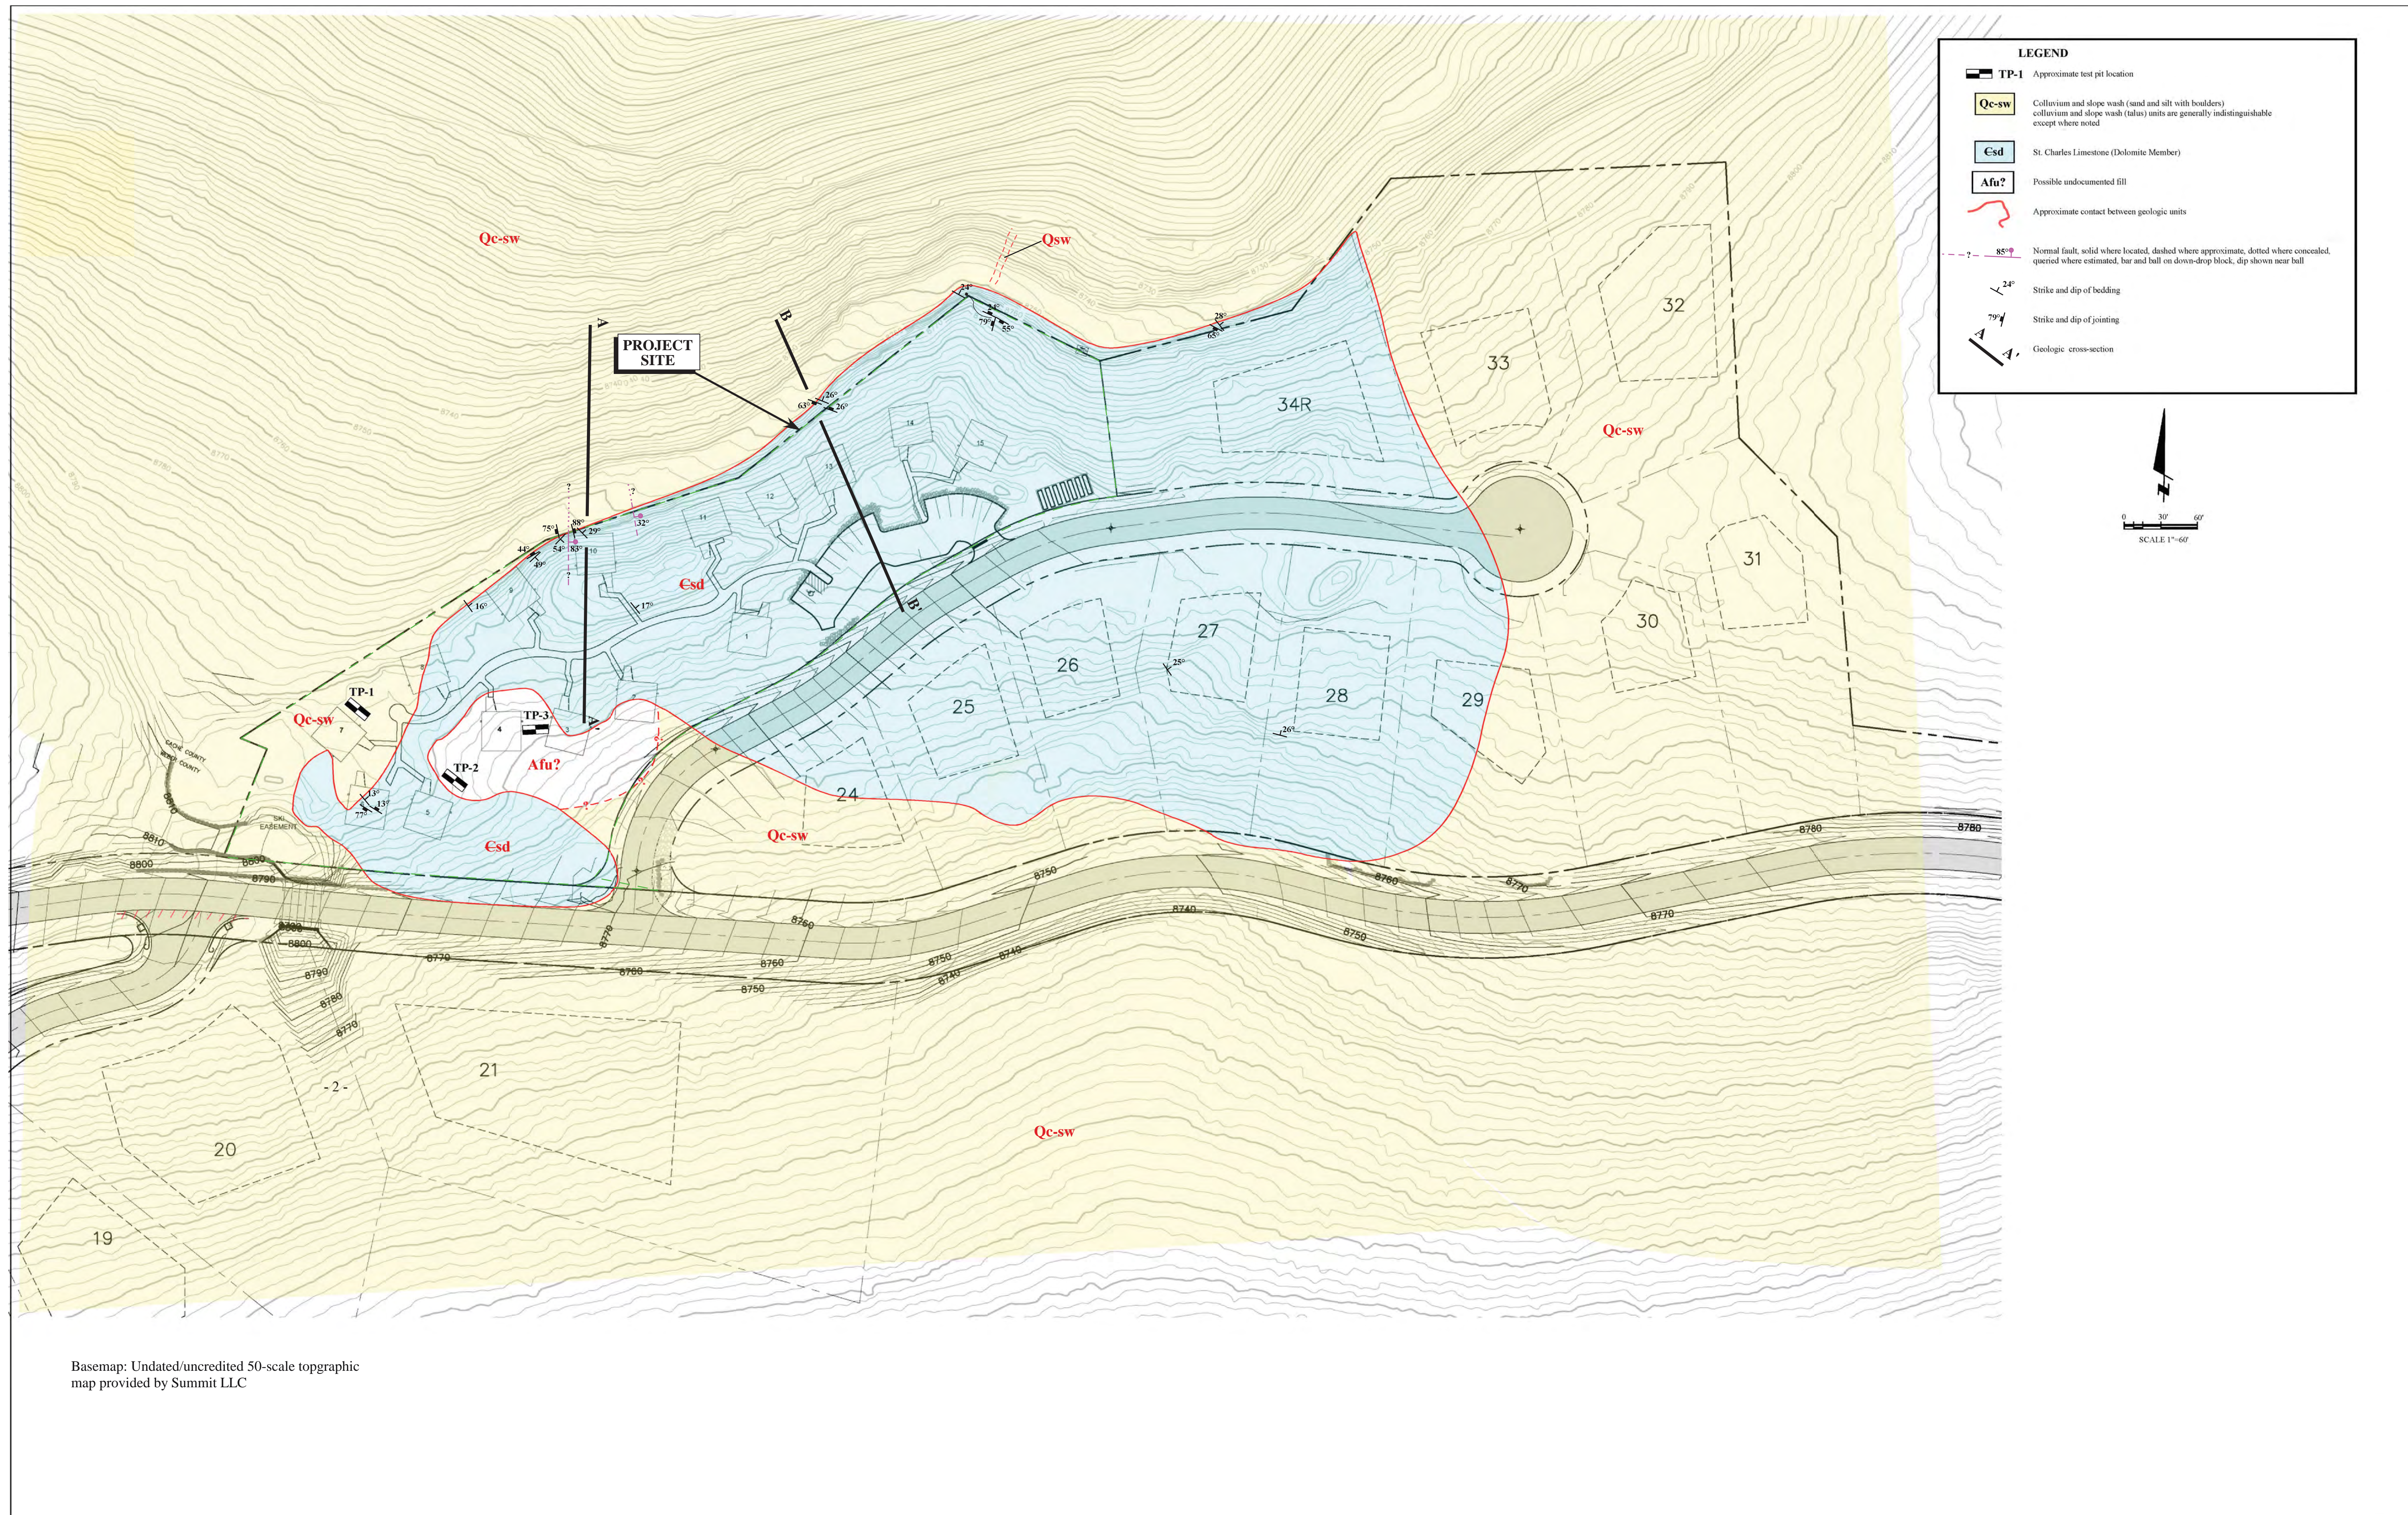
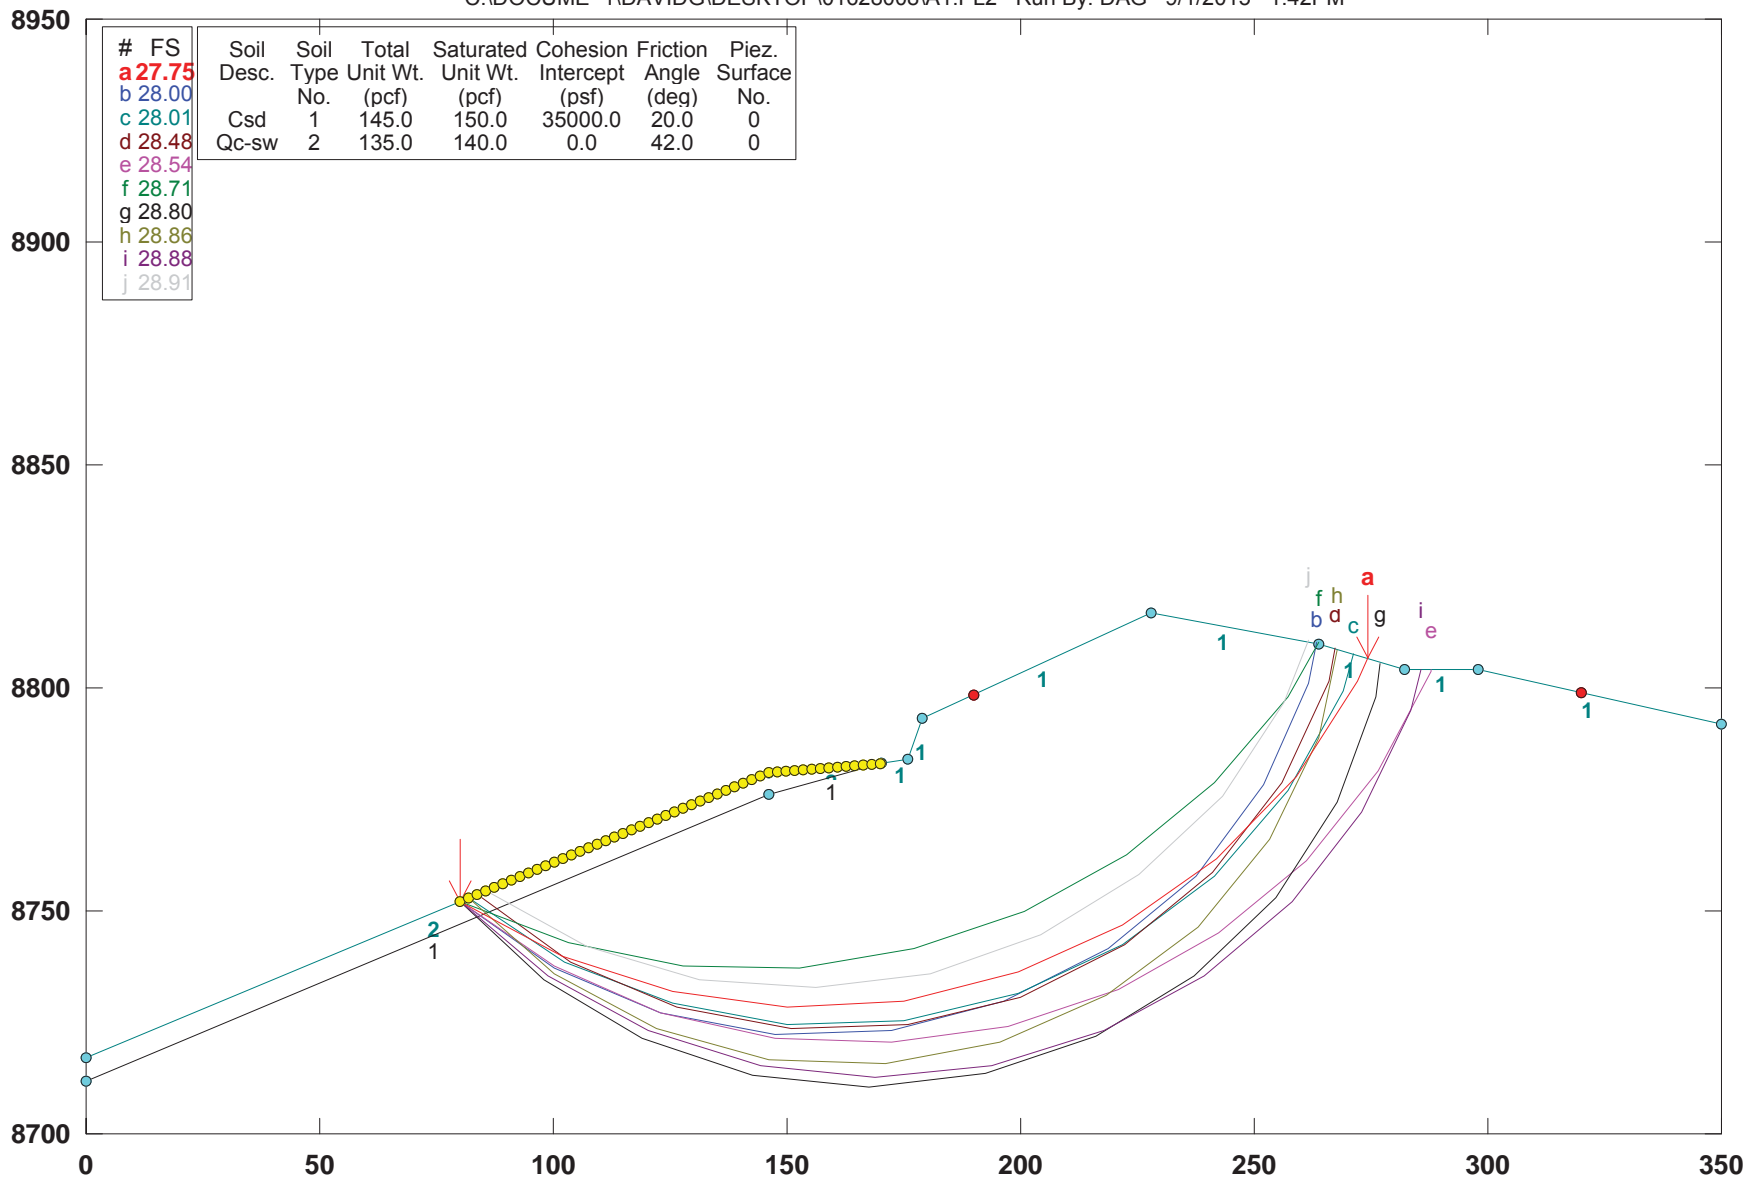
Summit/Ridge Nests; A-A'; Static

#	FS	Soil Desc.	Soil Type	Total Unit Wt. (pcf)	Saturated Unit Wt. (pcf)	Cohesion Intercept (psf)	Friction Angle (deg)	Piez. Surface No.
a	27.75							
b	28.00							
c	28.01	Csd	1	145.0	150.0	35000.0	20.0	0
d	28.48	Qc-sw	2	135.0	140.0	0.0	42.0	0
e	28.54							
f	28.71							
g	28.80							
h	28.86							
i	28.88							
j	28.91

GSTABL7 v.2 FSmin=27.75

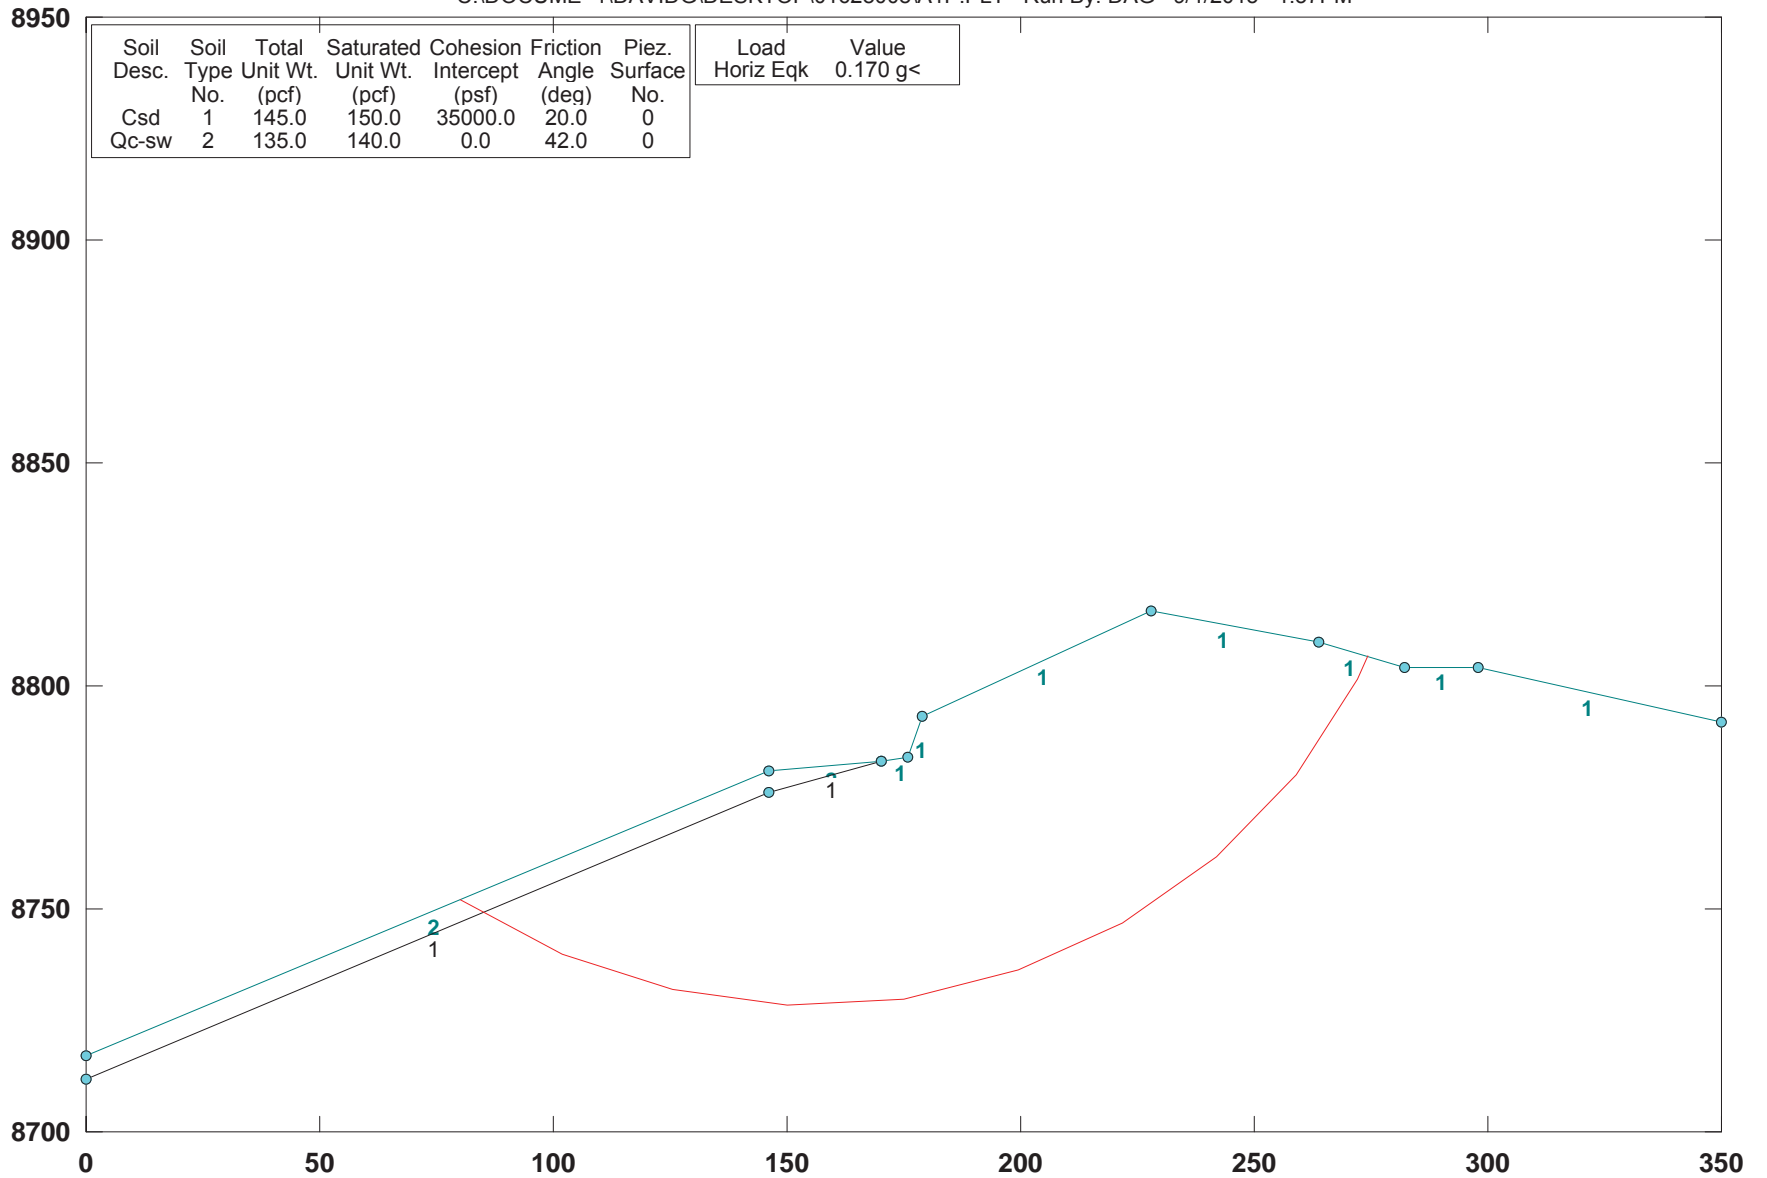
Summit/Ridge Nests; A-A'; Pseudo-Static

GSTABL7 v.2 FSmin=18.49

Factor Of Safety Is Calculated By The Modified Bishop Method

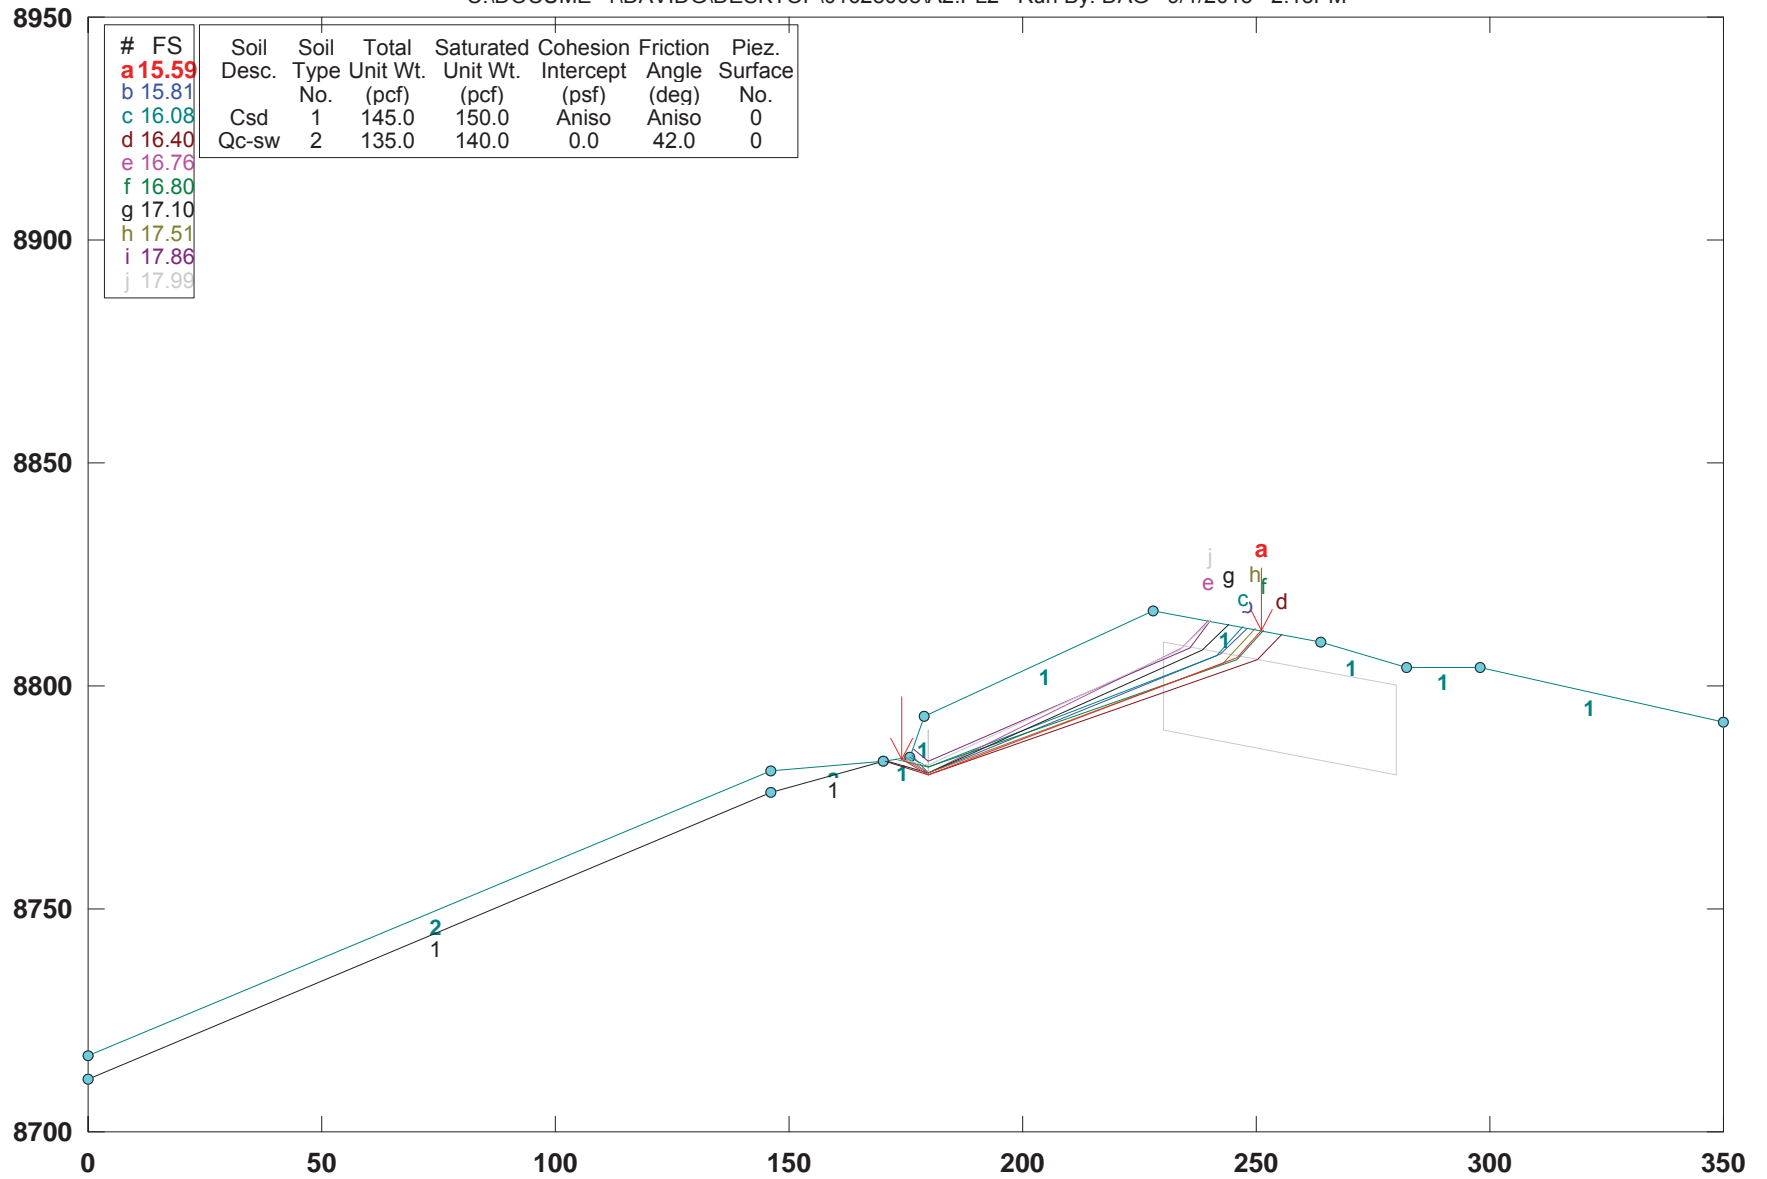
Summit/Ridge Nests; A-A'; Static; bedding 24 deg apparent dip

GSTABL7 v.2 FSmin=15.59

Safety Factors Are Calculated By The Simplified Janbu Method for the case of c & phi both > 0

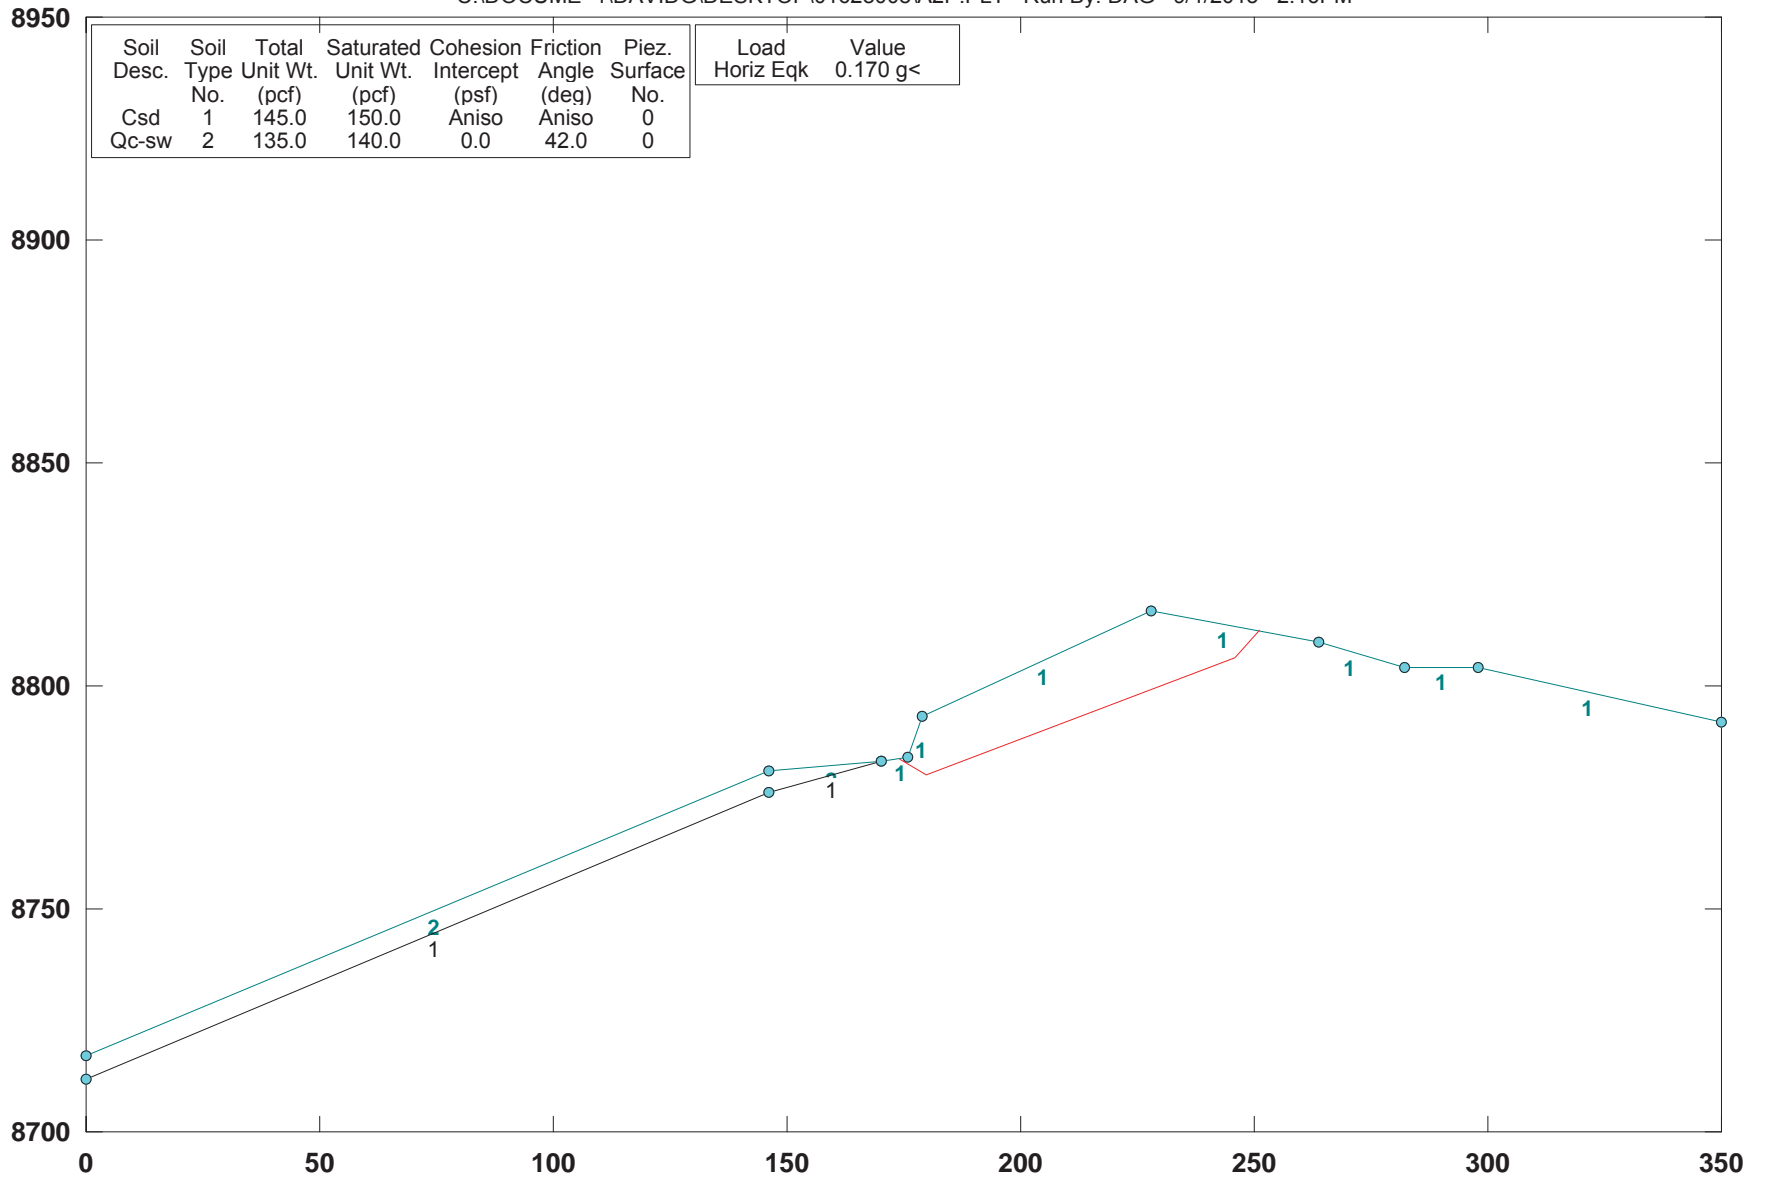
Summit/Ridge Nests; A-A'; Pseudo-Static; bedding 24 deg apparent dip

GSTABL7 v.2 FSmin=10.70

Factor Of Safety Is Calculated By The Simplified Janbu Method

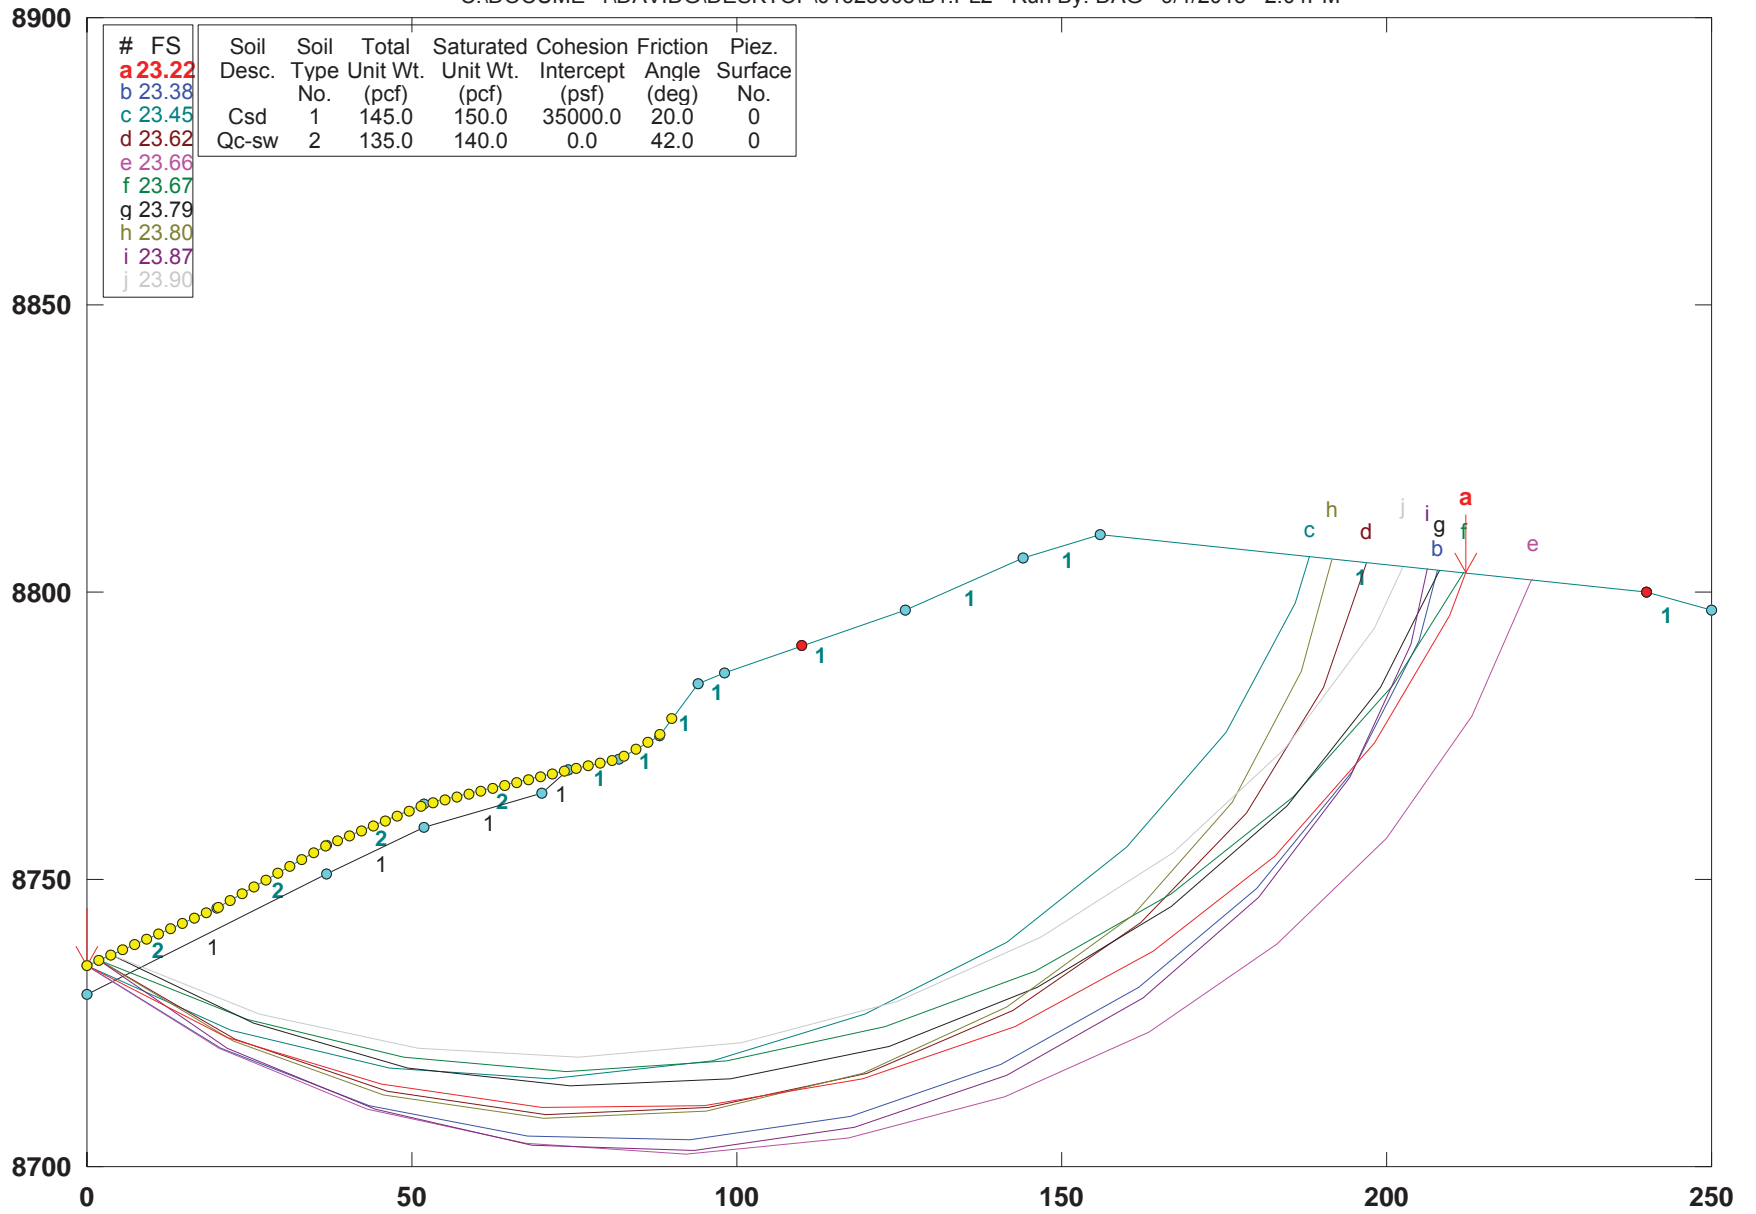
Summit/Ridge Nests; B-B'; Static

#	FS	Soil Desc.	Soil Type	Total Unit Wt. (pcf)	Saturated Unit Wt. (pcf)	Cohesion Intercept (psf)	Friction Angle (deg)	Piez. Surface No.
a	23.22							
b	23.38							
c	23.45							
d	23.62	Csd	1	145.0	150.0	35000.0	20.0	0
e	23.66	Qc-sw	2	135.0	140.0	0.0	42.0	0
f	23.67							
g	23.79							
h	23.80							
i	23.87							
j	23.90

GSTABL7 v.2 FSmin=23.22

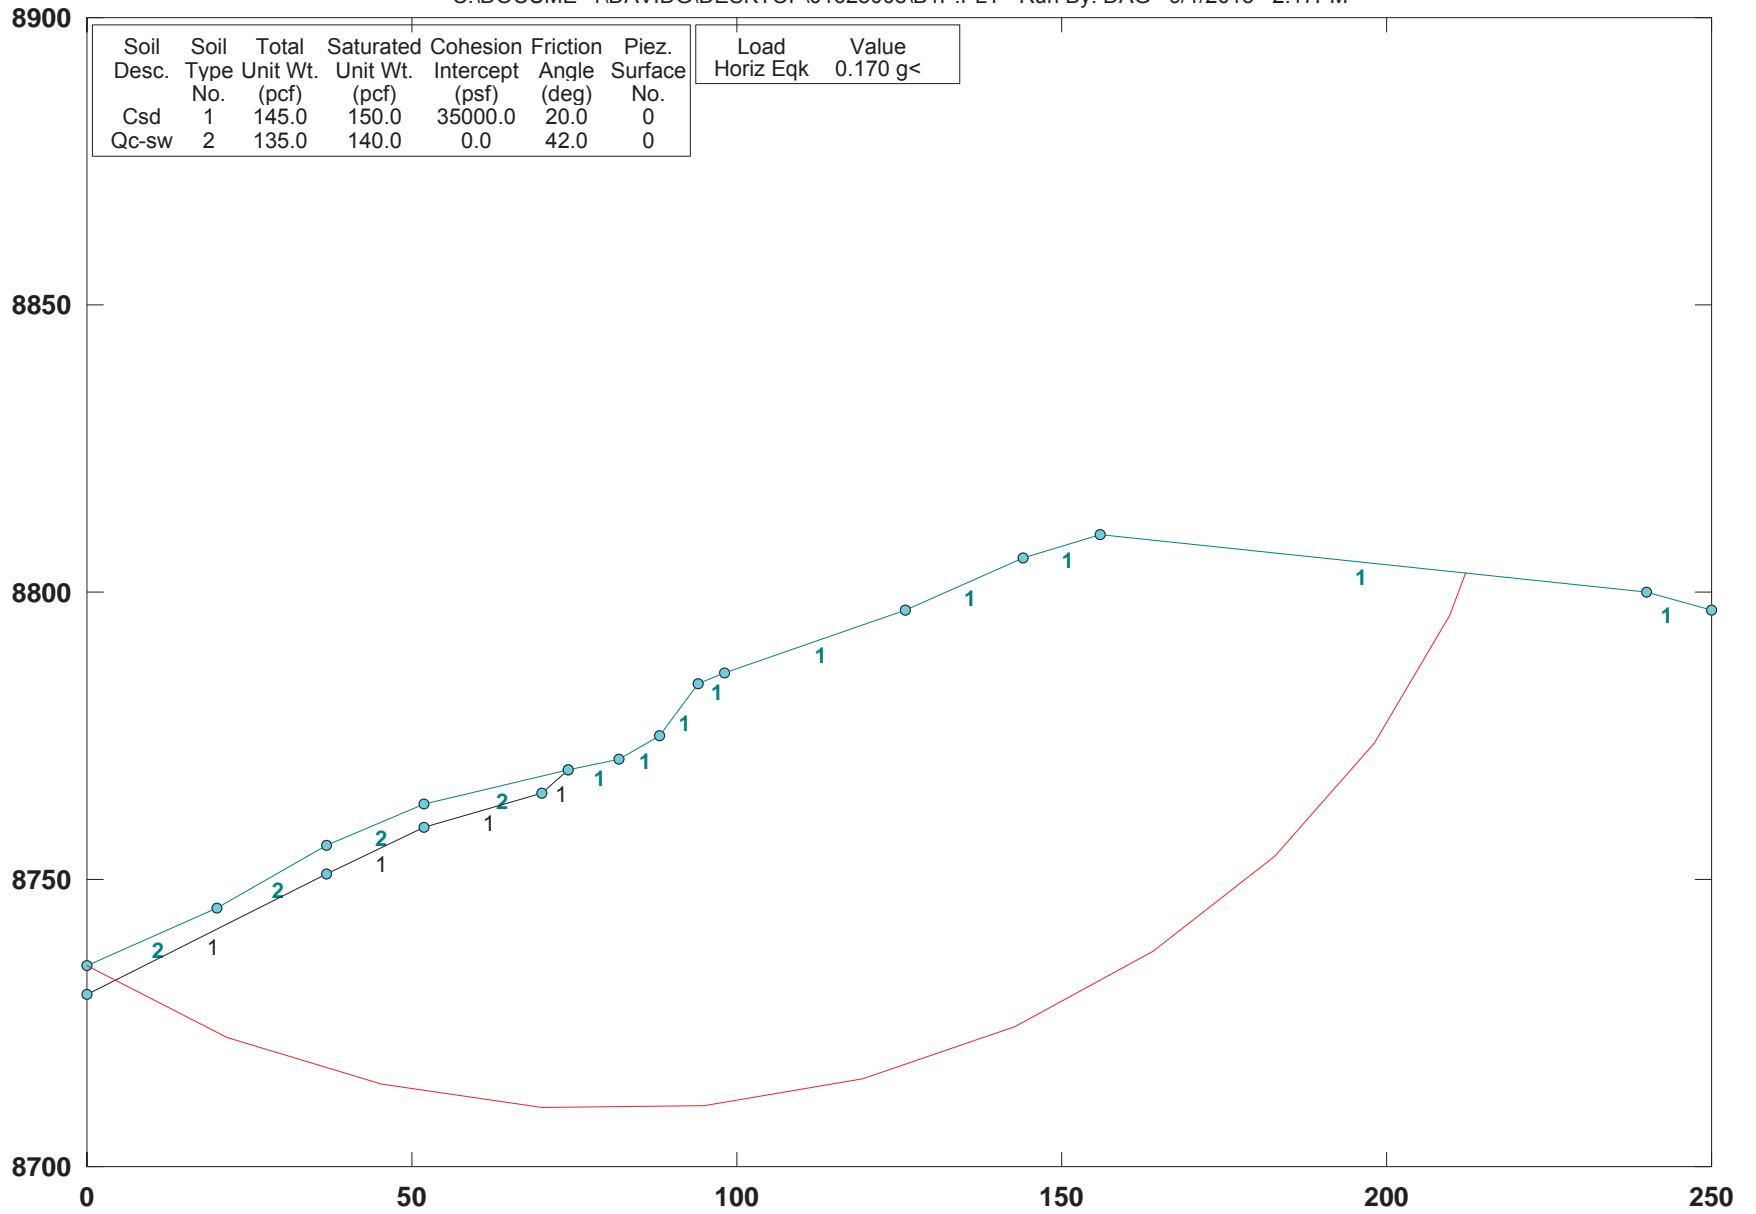
Summit/Ridge Nests; B-B'; Pseudo-Static

GSTABL7 v.2 FSmin=15.85

Factor Of Safety Is Calculated By The Modified Bishop Method

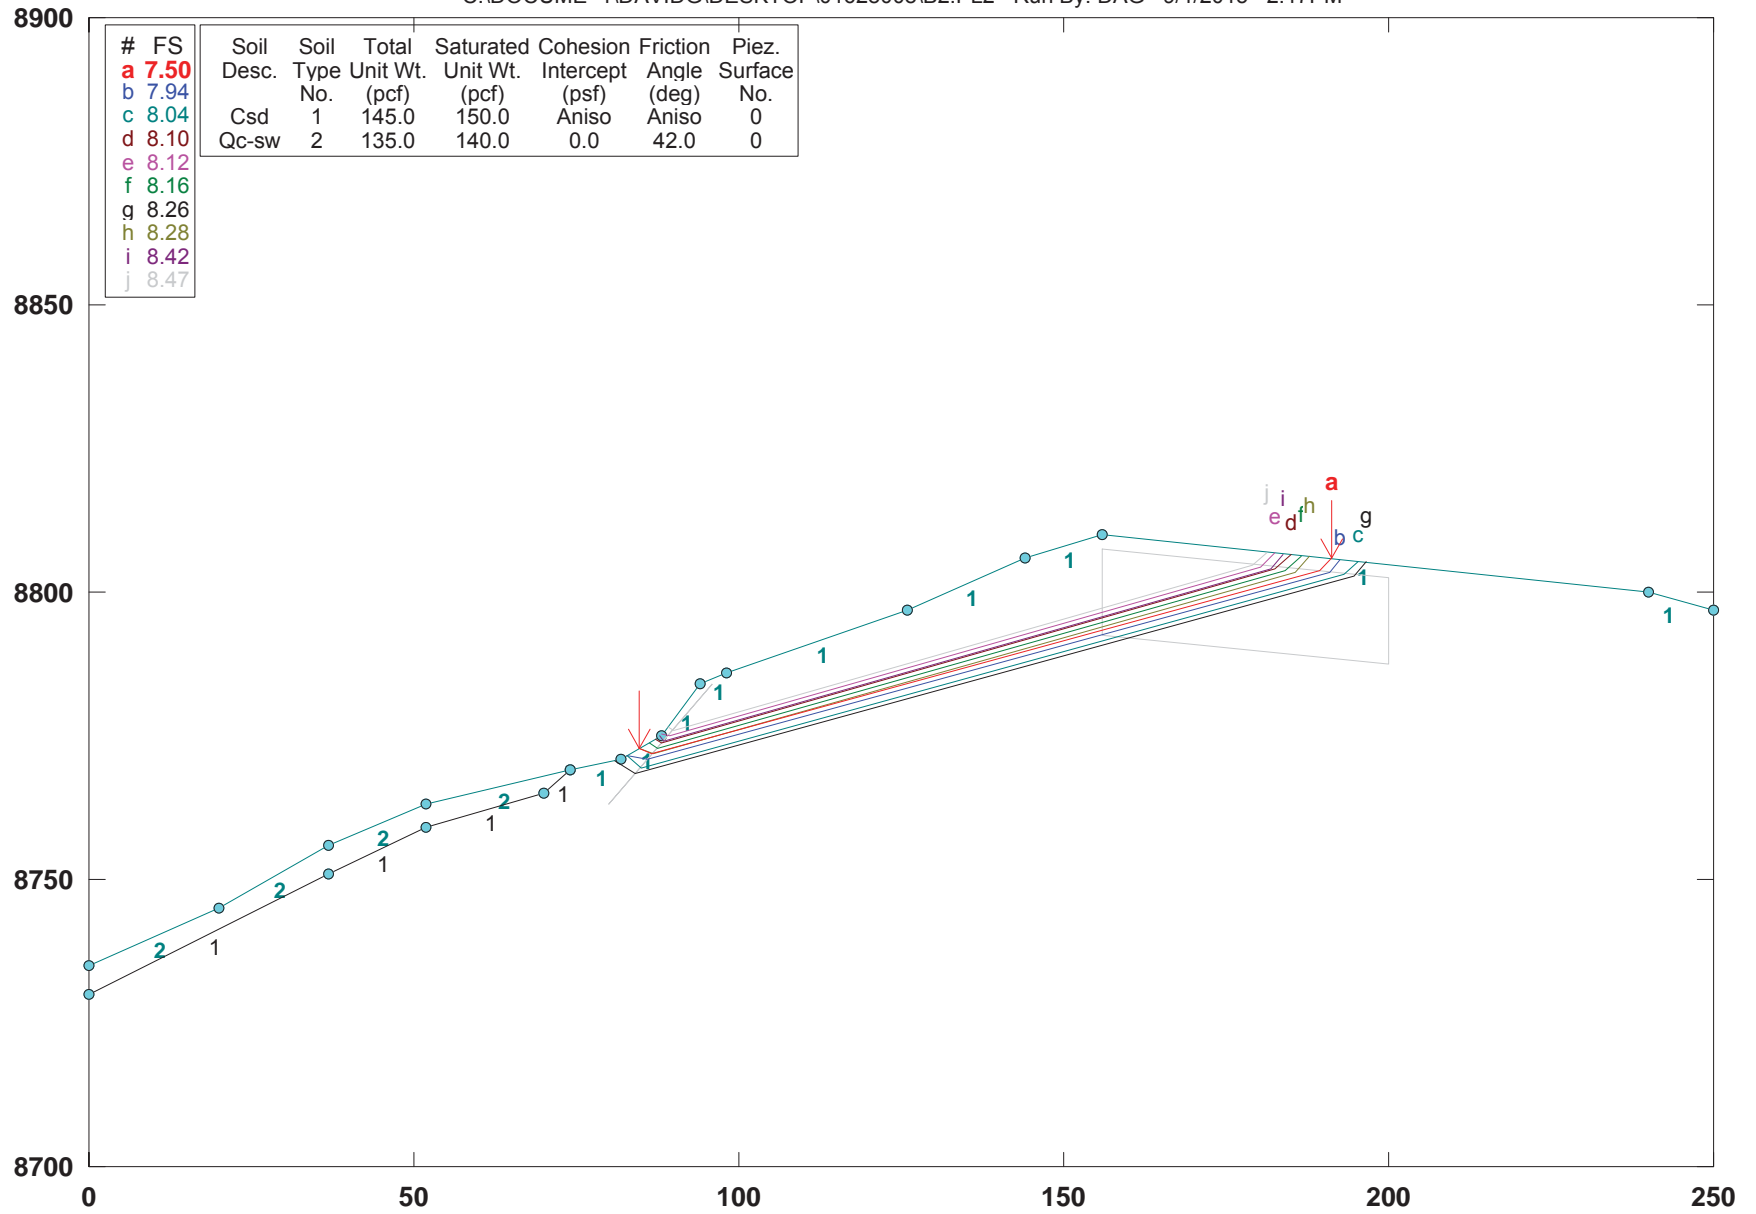
Summit/Ridge Nests; B-B'; Static; bedding 17 deg apparent dip

GSTABL7 v.2 FSmin=7.50

Safety Factors Are Calculated By The Simplified Janbu Method for the case of c & phi both > 0

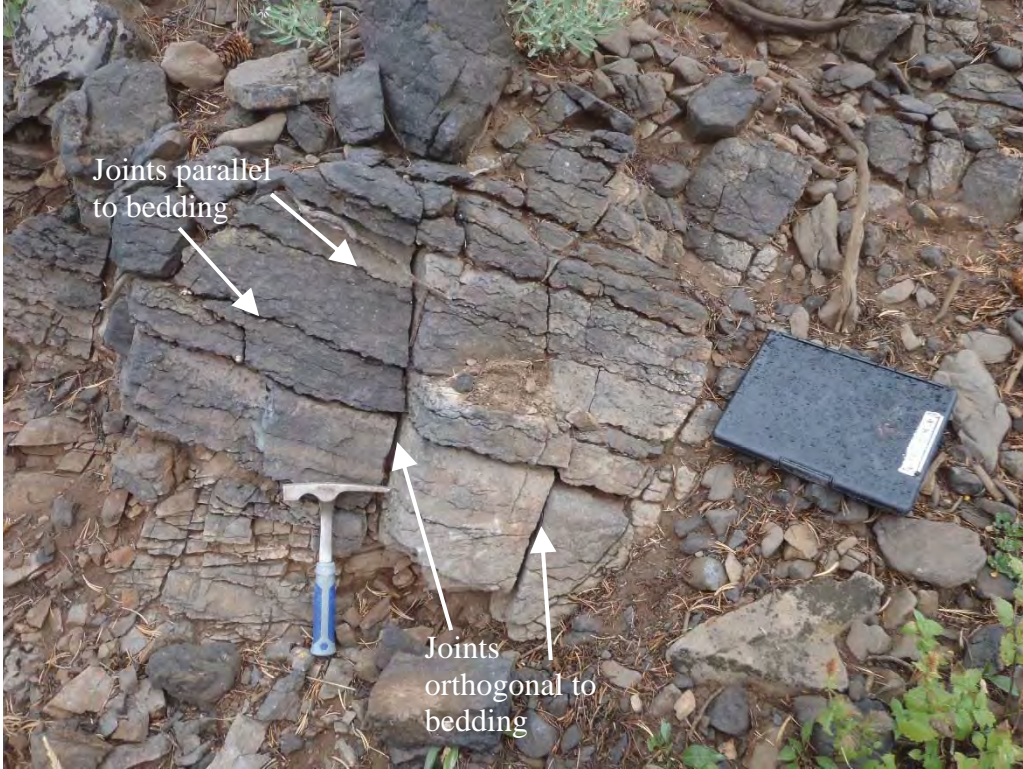
Photo 1. Finer-grained dolomite lithology, exhibiting thinner beds and blocky jointing.

In response to the comment, the following additional details are provided: bedrock was found to be largely moderately fractured (distance between fractures ~0.5-1.0 feet) to little fractured (distance between fractures ~1.0-4.0 feet), with localized areas of intense fracturing (distance between fractures ~0.05-0.1 feet). Joint spacing was largely found to be a product of the lithology. The finer-grained dolomite lithologies were more thinly bedded, and therefore had a smaller distance (approximately 1 to 4 inches) between bedding plane joints. These lithologies also tended to fracture into rectangular blocks generally between 4 and 18 inches in length and width, and contained both bedding-confined and through-going fractures (Photo 1). Coarser-grained dolomite lithologies were more thickly bedded to massive, with bedding plane joints separated by between 6 inches to as much as several feet. These lithologies tended to fracture into rectangular blocks with highly variable dimensions, ranging in width and length from between a couple inches to several feet, though larger blocks (with dimensions of several feet x several feet x several feet) were most common (Photo 2). Most fracturing associated with the coarser-grained dolomite lithologies consisted of large through-going fractures.

Nearly all of the joints encountered in the field investigation were open, had slightly rough to rough surfaces, and did not contain a secondary mineralization, except rare calcite infilling in places. No slickensides were observed on any joint surface. Joint apertures varied from between a few millimeters to a couple inches in width. Joints with smaller apertures tended to be devoid of any sort of fill, while the larger aperture joints were often filled with soil. In the cases of the two identified faults, reddish gray silty gouge was found to be the fill material.

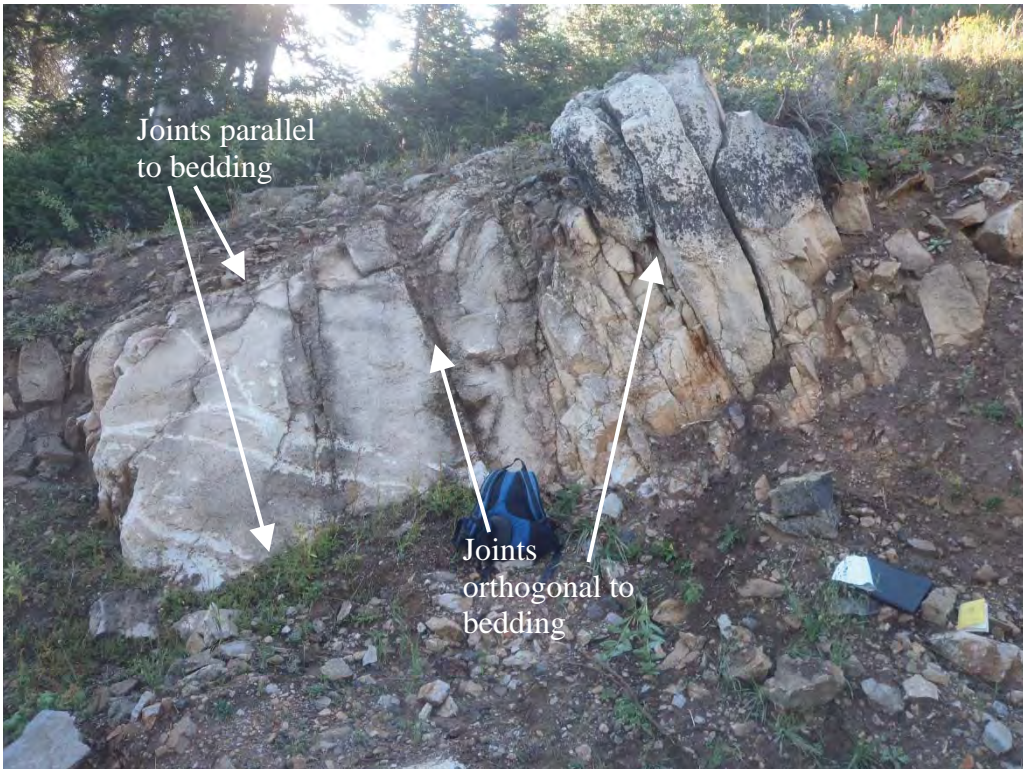
Photo 2. Coarser-grained dolomite lithology, exhibiting thicker beds and wider jointing.
