**GEOTECHNICAL AND GEOLOGIC HAZARD INVESTIGATION**  
**The Ridge Nests Development**  
**Powder Mountain Resort**  
**Weber and Cache Counties, Utah**

IGES Project No. 01628-008

July 15, 2016

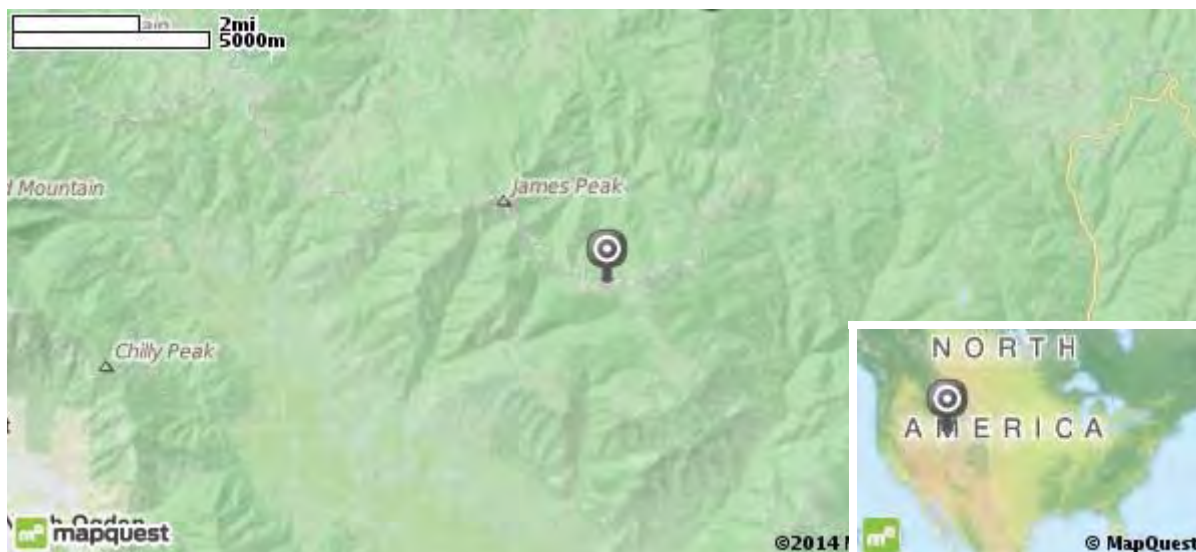
## USGS-Provided Output

$$\begin{array}{lll}
 S_s = 0.826 \text{ g} & S_{MS} = 0.826 \text{ g} & S_{DS} = 0.551 \text{ g} \\
 S_1 = 0.274 \text{ g} & S_{M1} = 0.274 \text{ g} & S_{D1} = 0.183 \text{ g}
 \end{array}$$

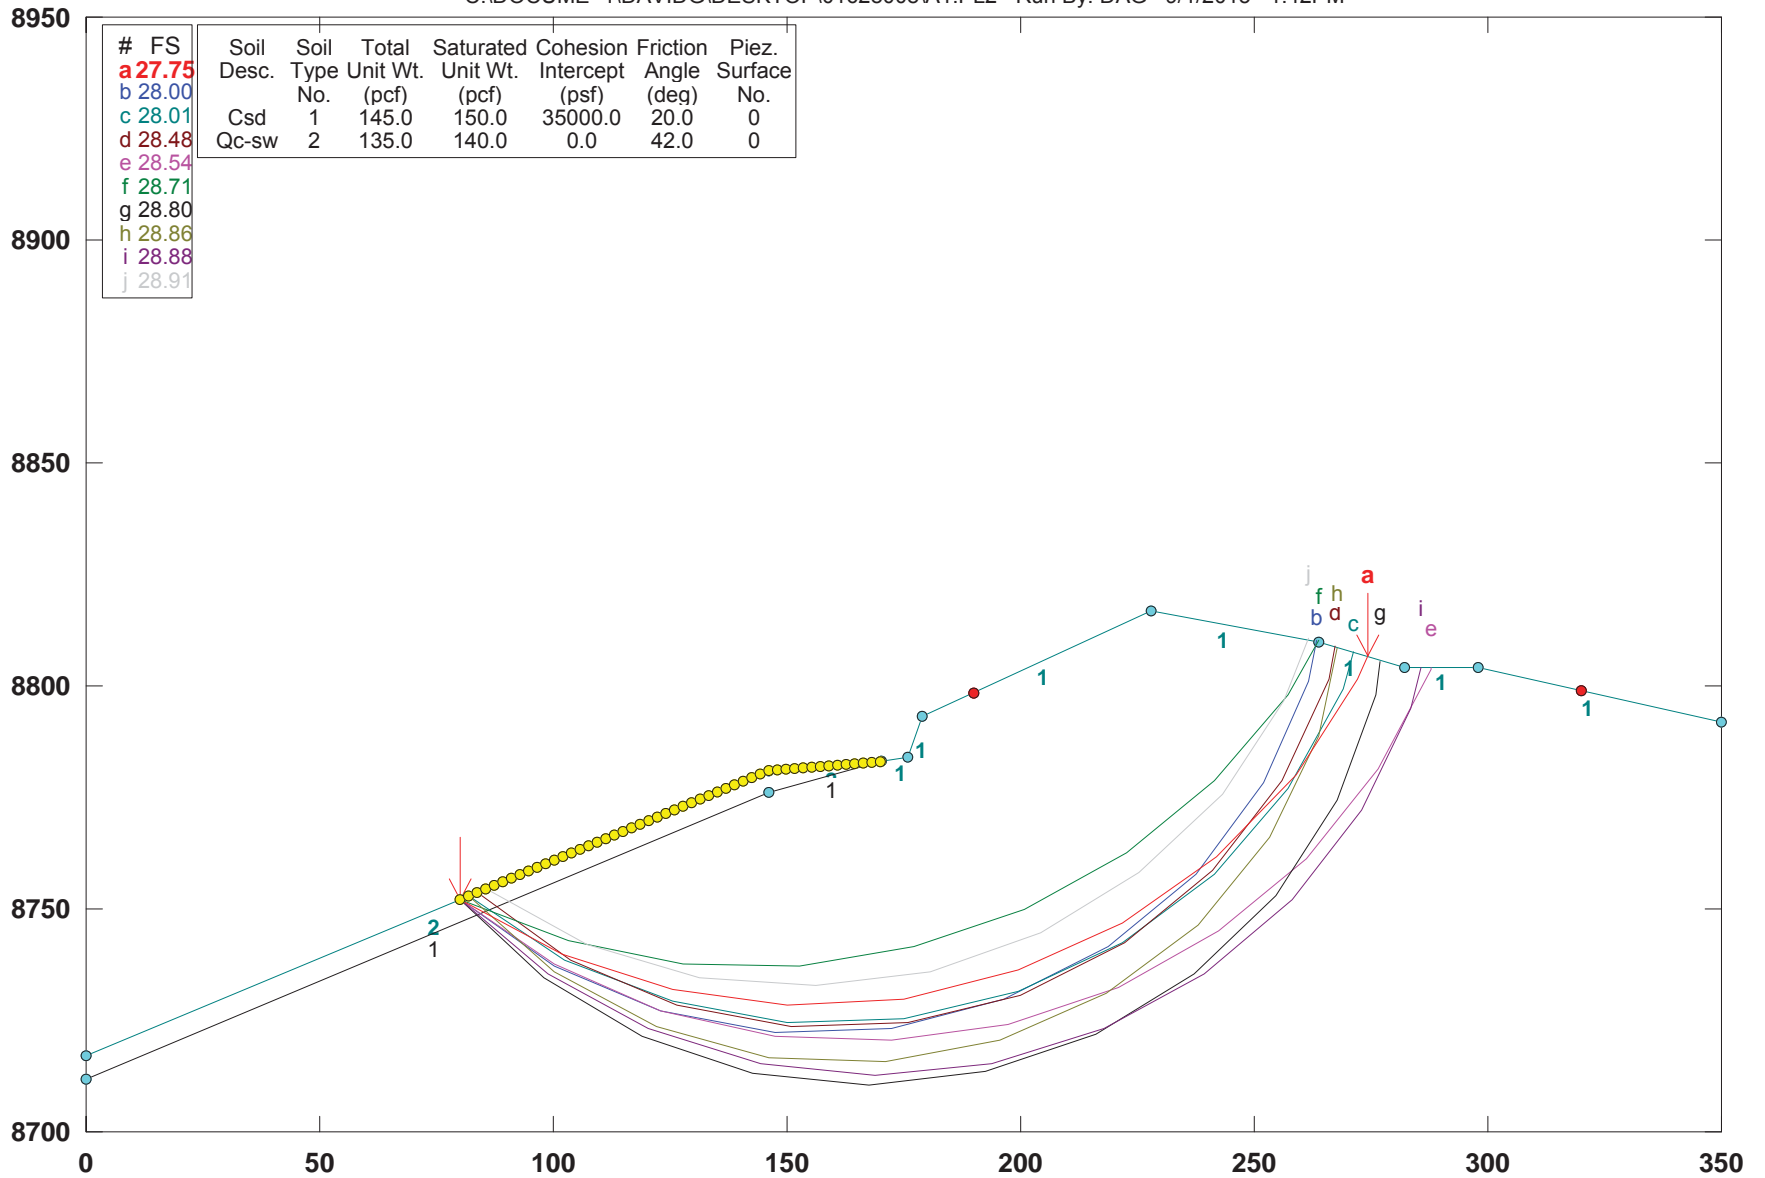
# Summit/Ridge Nests; A-A'; Static

GSTABL7 v.2 FSmin=27.75

Safety Factors Are Calculated By The Modified Bishop Method

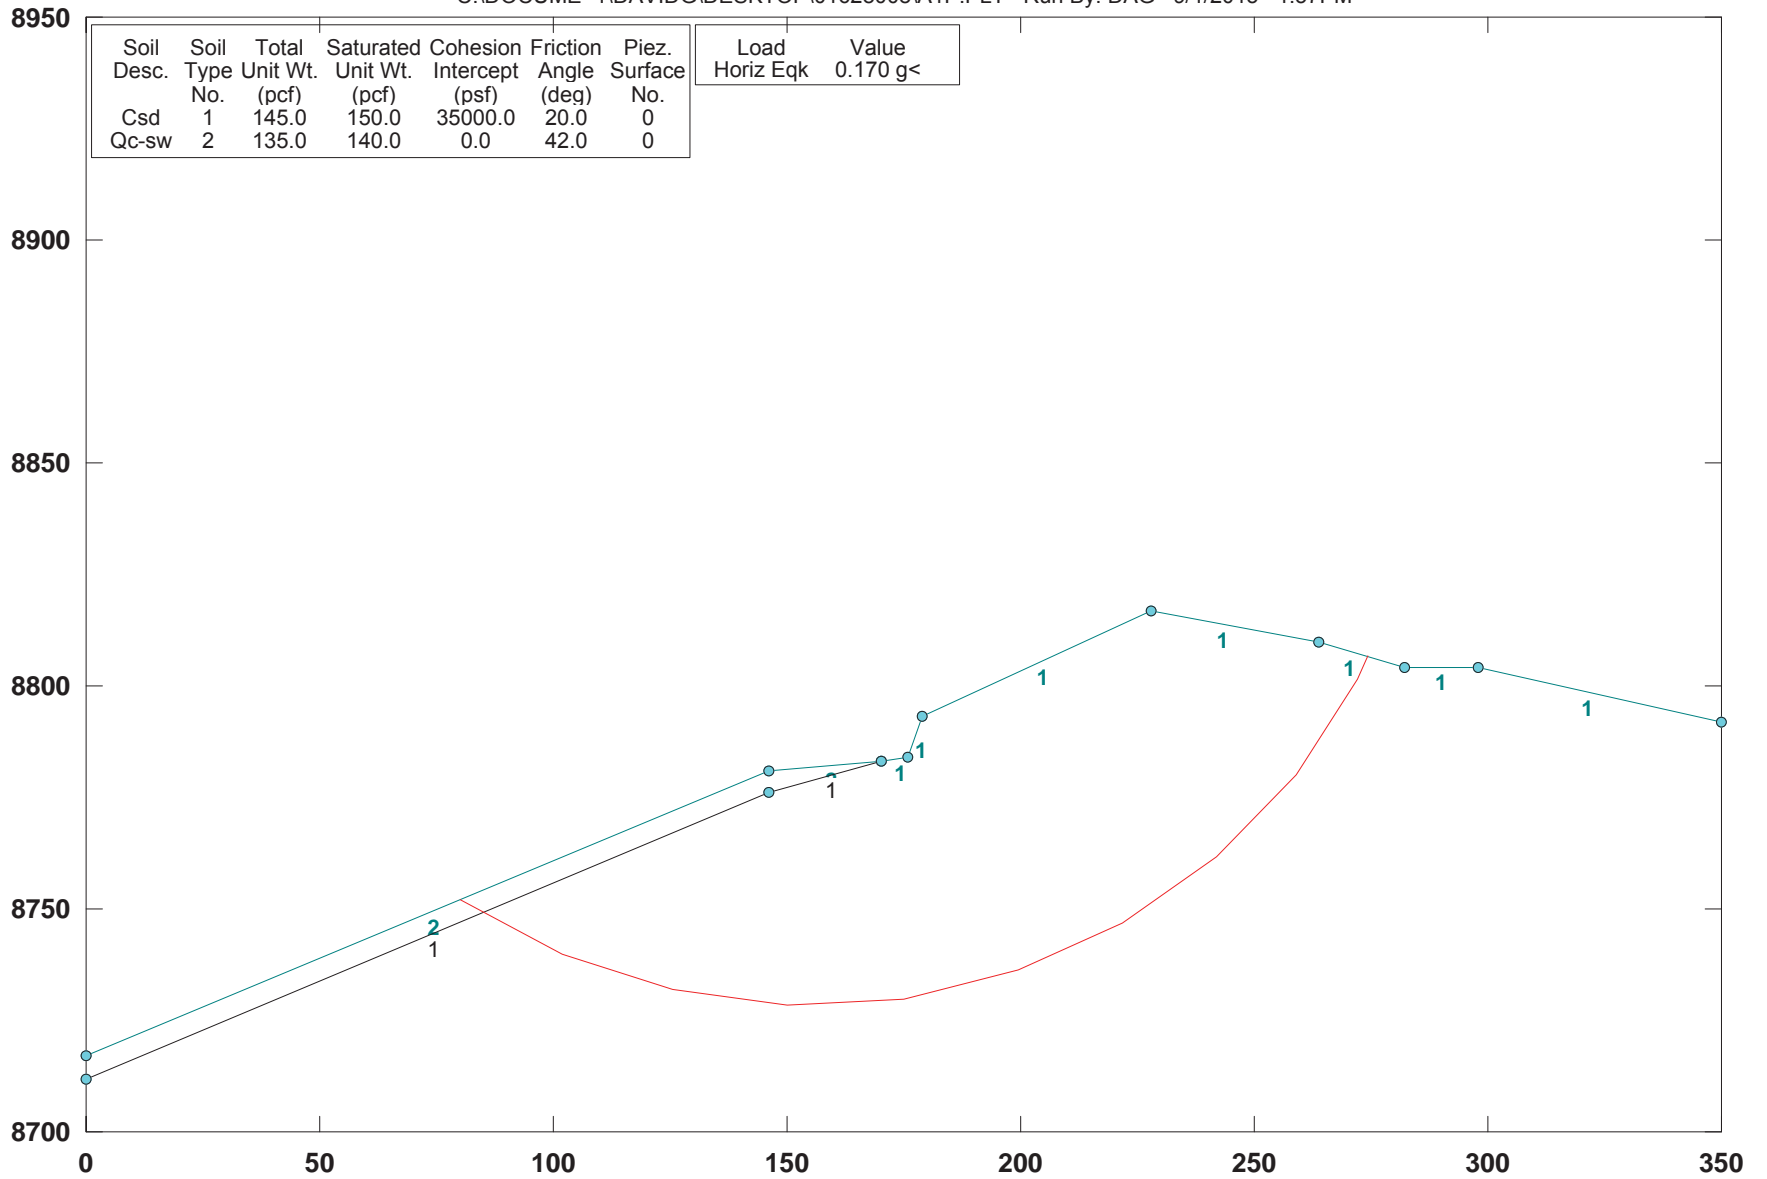
# Summit/Ridge Nests; A-A'; Pseudo-Static

GSTABL7 v.2 FSmin=18.49

Factor Of Safety Is Calculated By The Modified Bishop Method

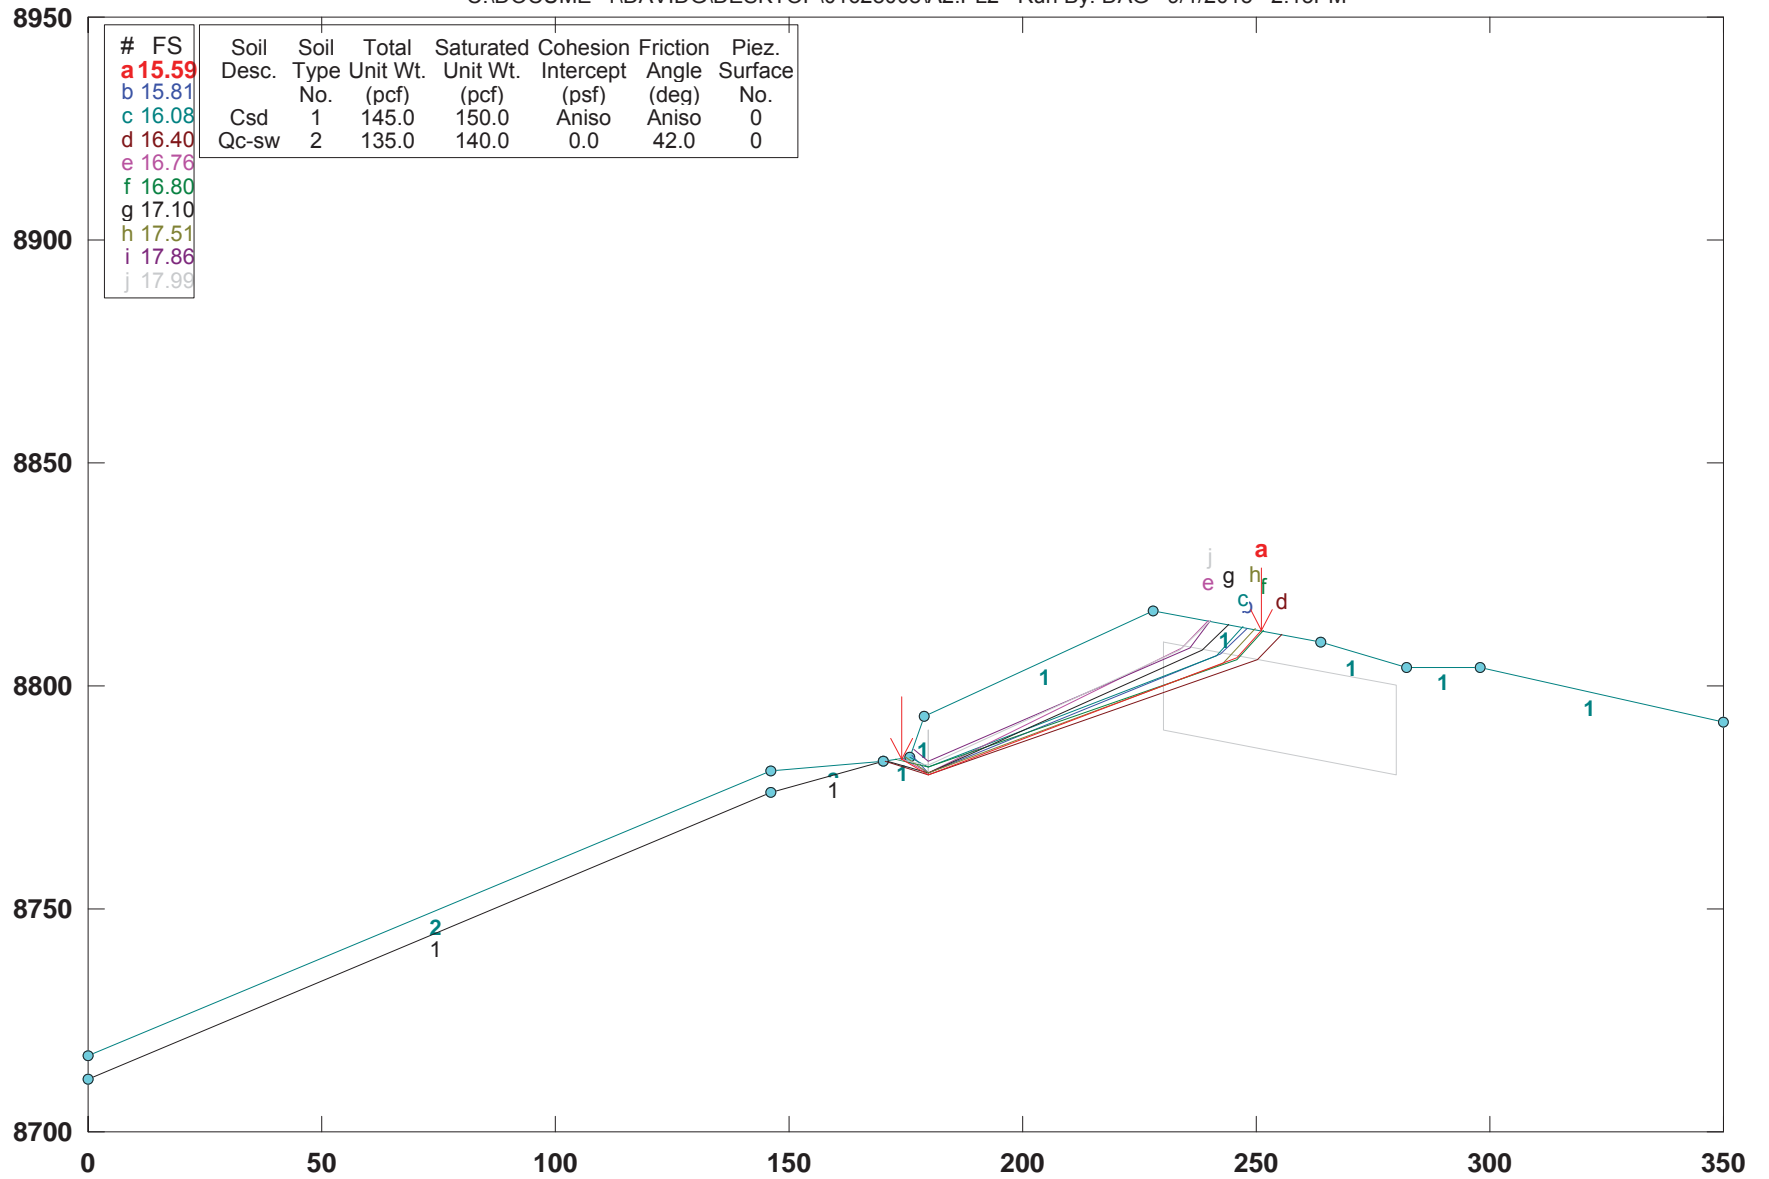
# Summit/Ridge Nests; A-A'; Static; bedding 24 deg apparent dip

GSTABL7 v.2 FSmin=15.59

Safety Factors Are Calculated By The Simplified Janbu Method for the case of c & phi both > 0

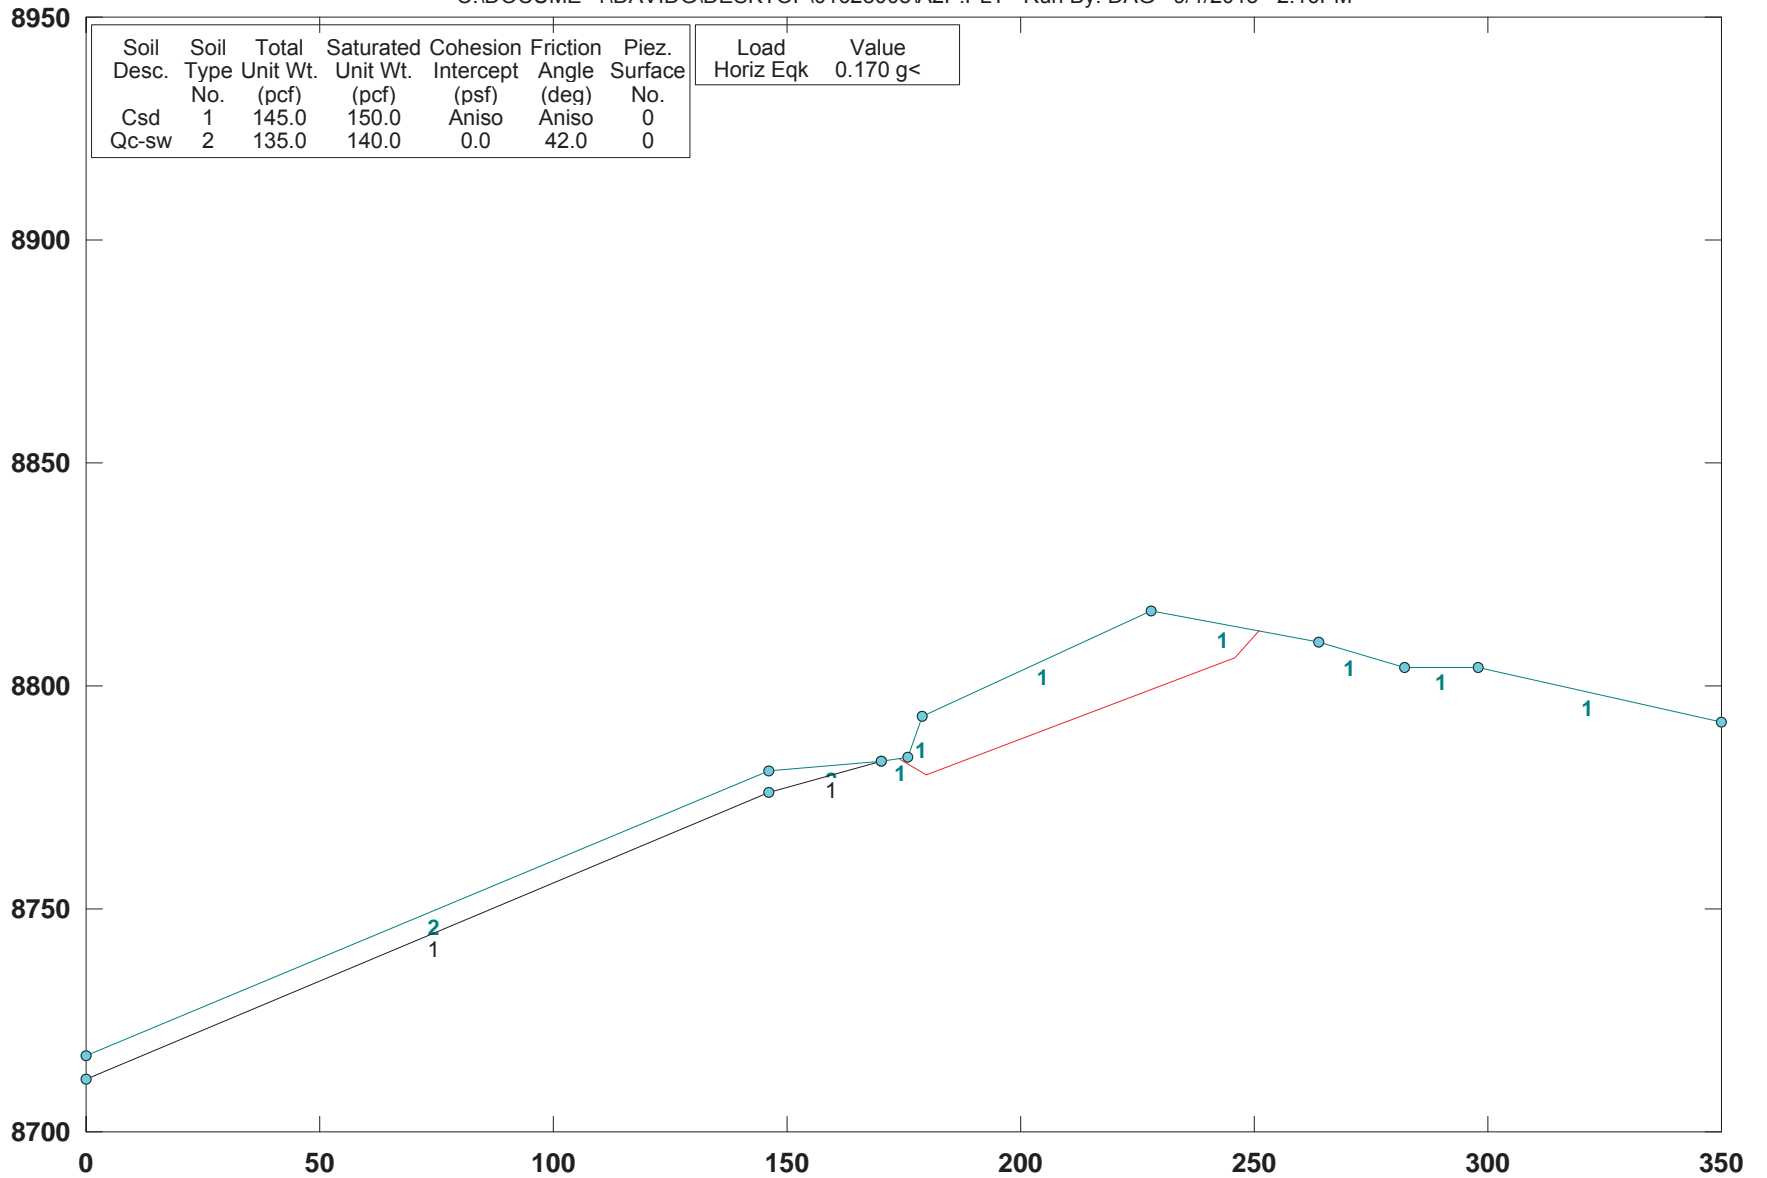
# Summit/Ridge Nests; A-A'; Pseudo-Static; bedding 24 deg apparent dip

GSTABL7 v.2 FSmin=10.70

Factor Of Safety Is Calculated By The Simplified Janbu Method

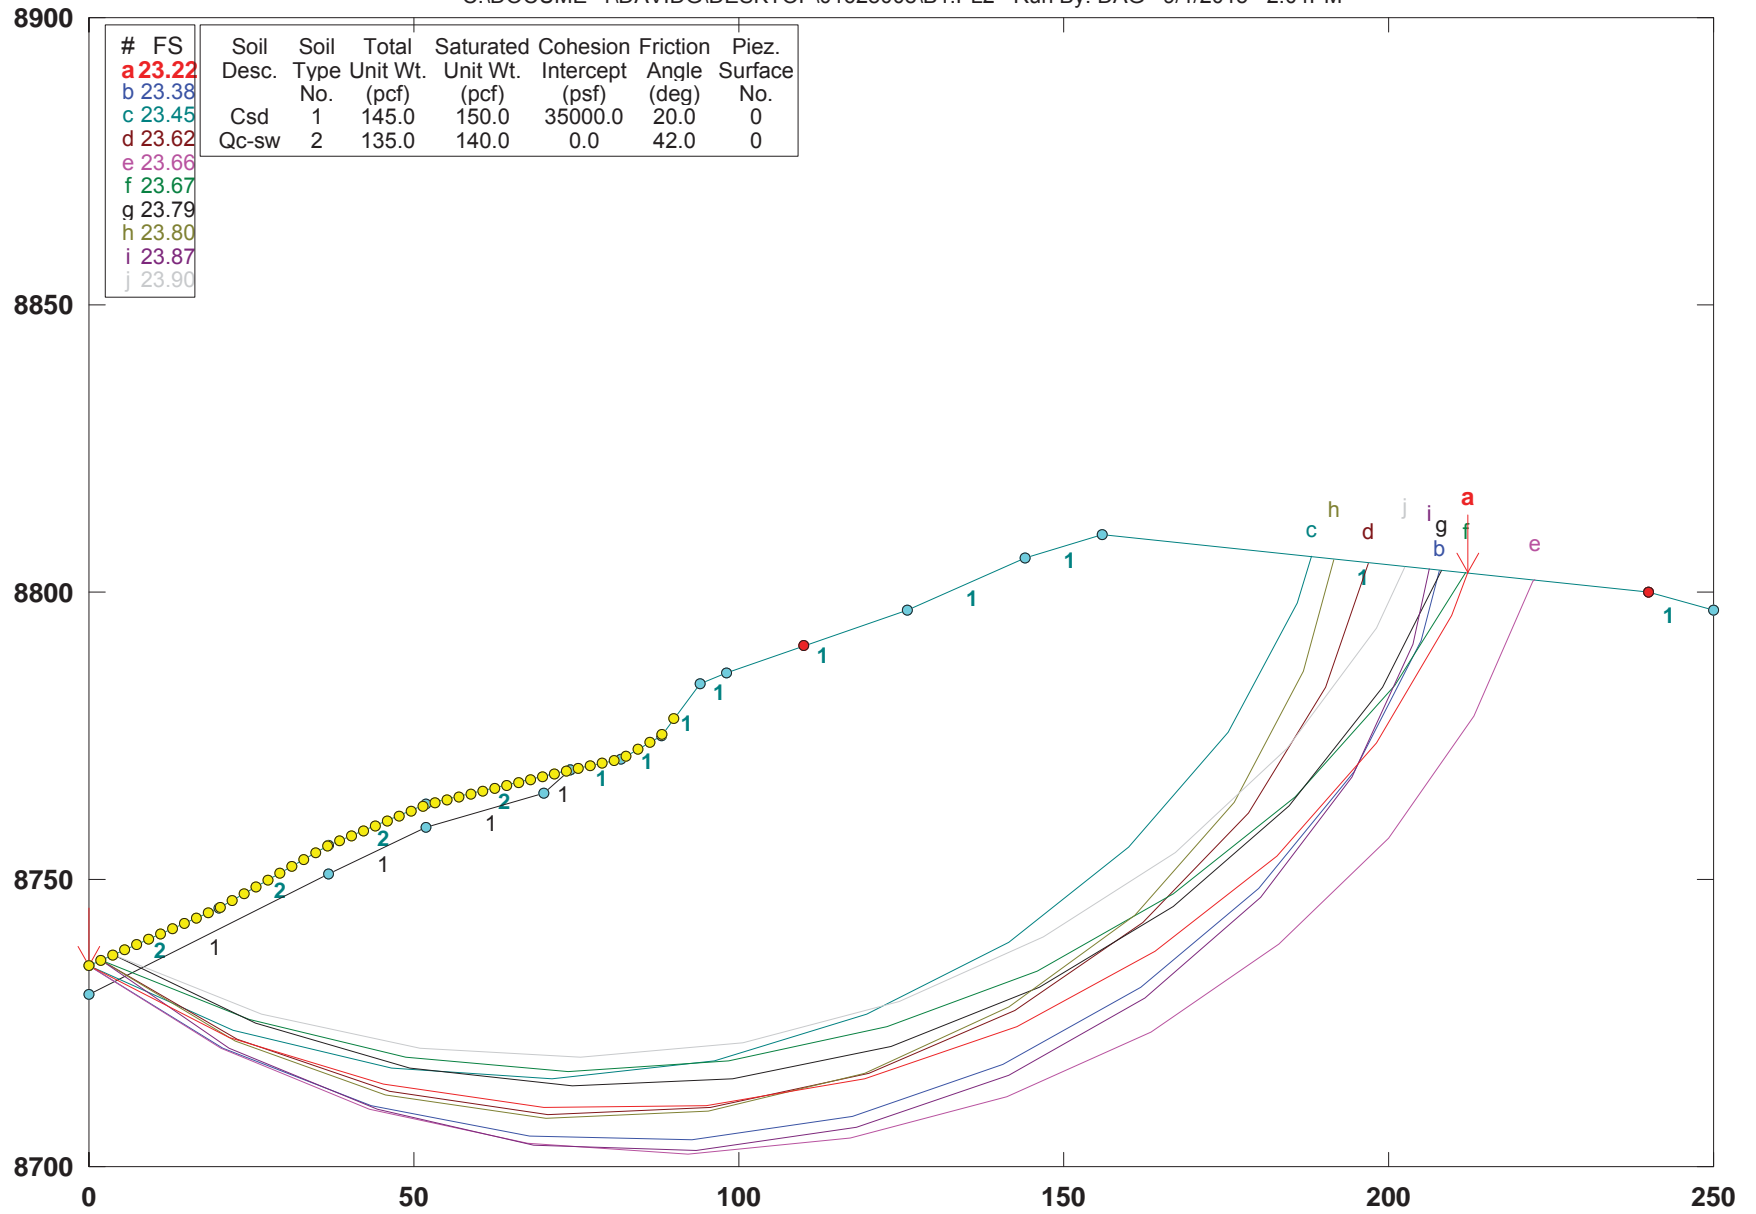
# Summit/Ridge Nests; B-B'; Static

GSTABL7 v.2 FSmin=23.22

Safety Factors Are Calculated By The Modified Bishop Method

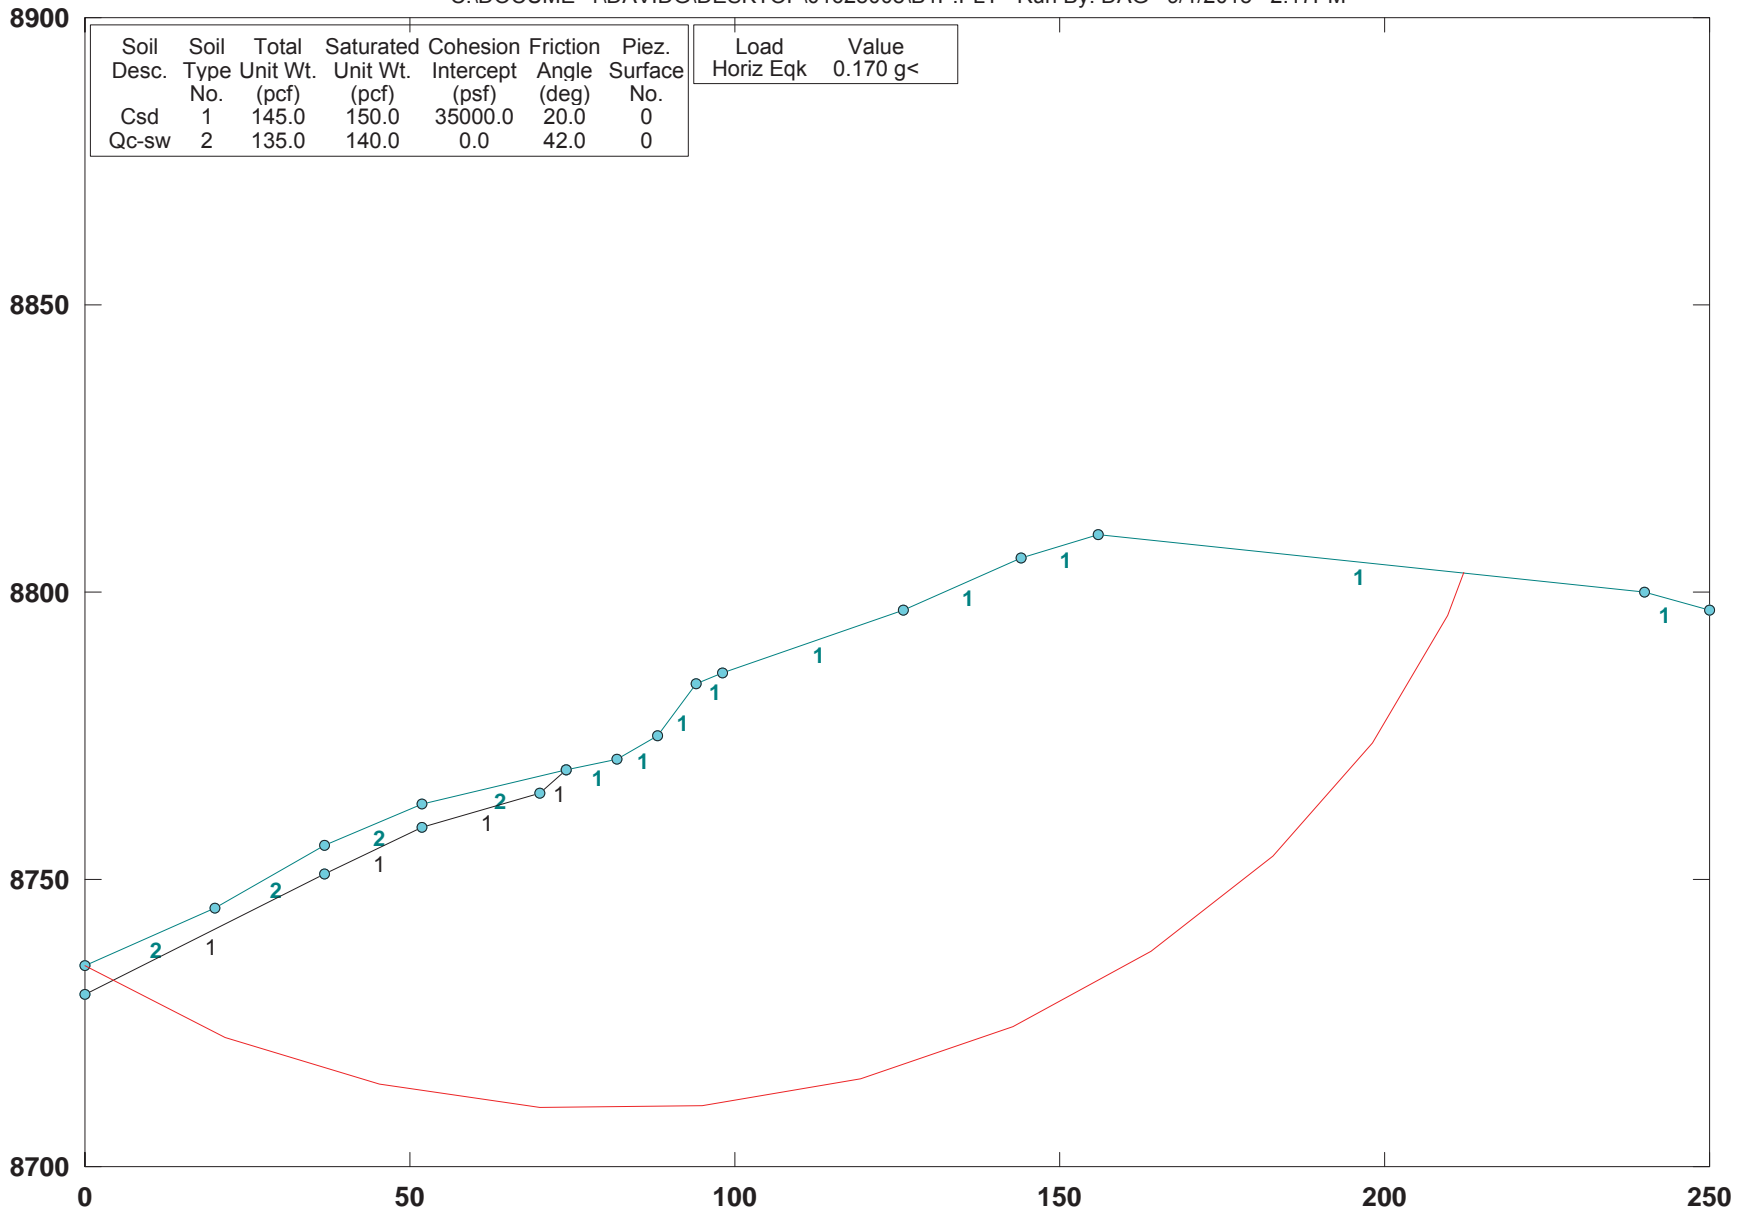
# Summit/Ridge Nests; B-B'; Pseudo-Static

GSTABL7 v.2 FSmin=15.85

Factor Of Safety Is Calculated By The Modified Bishop Method

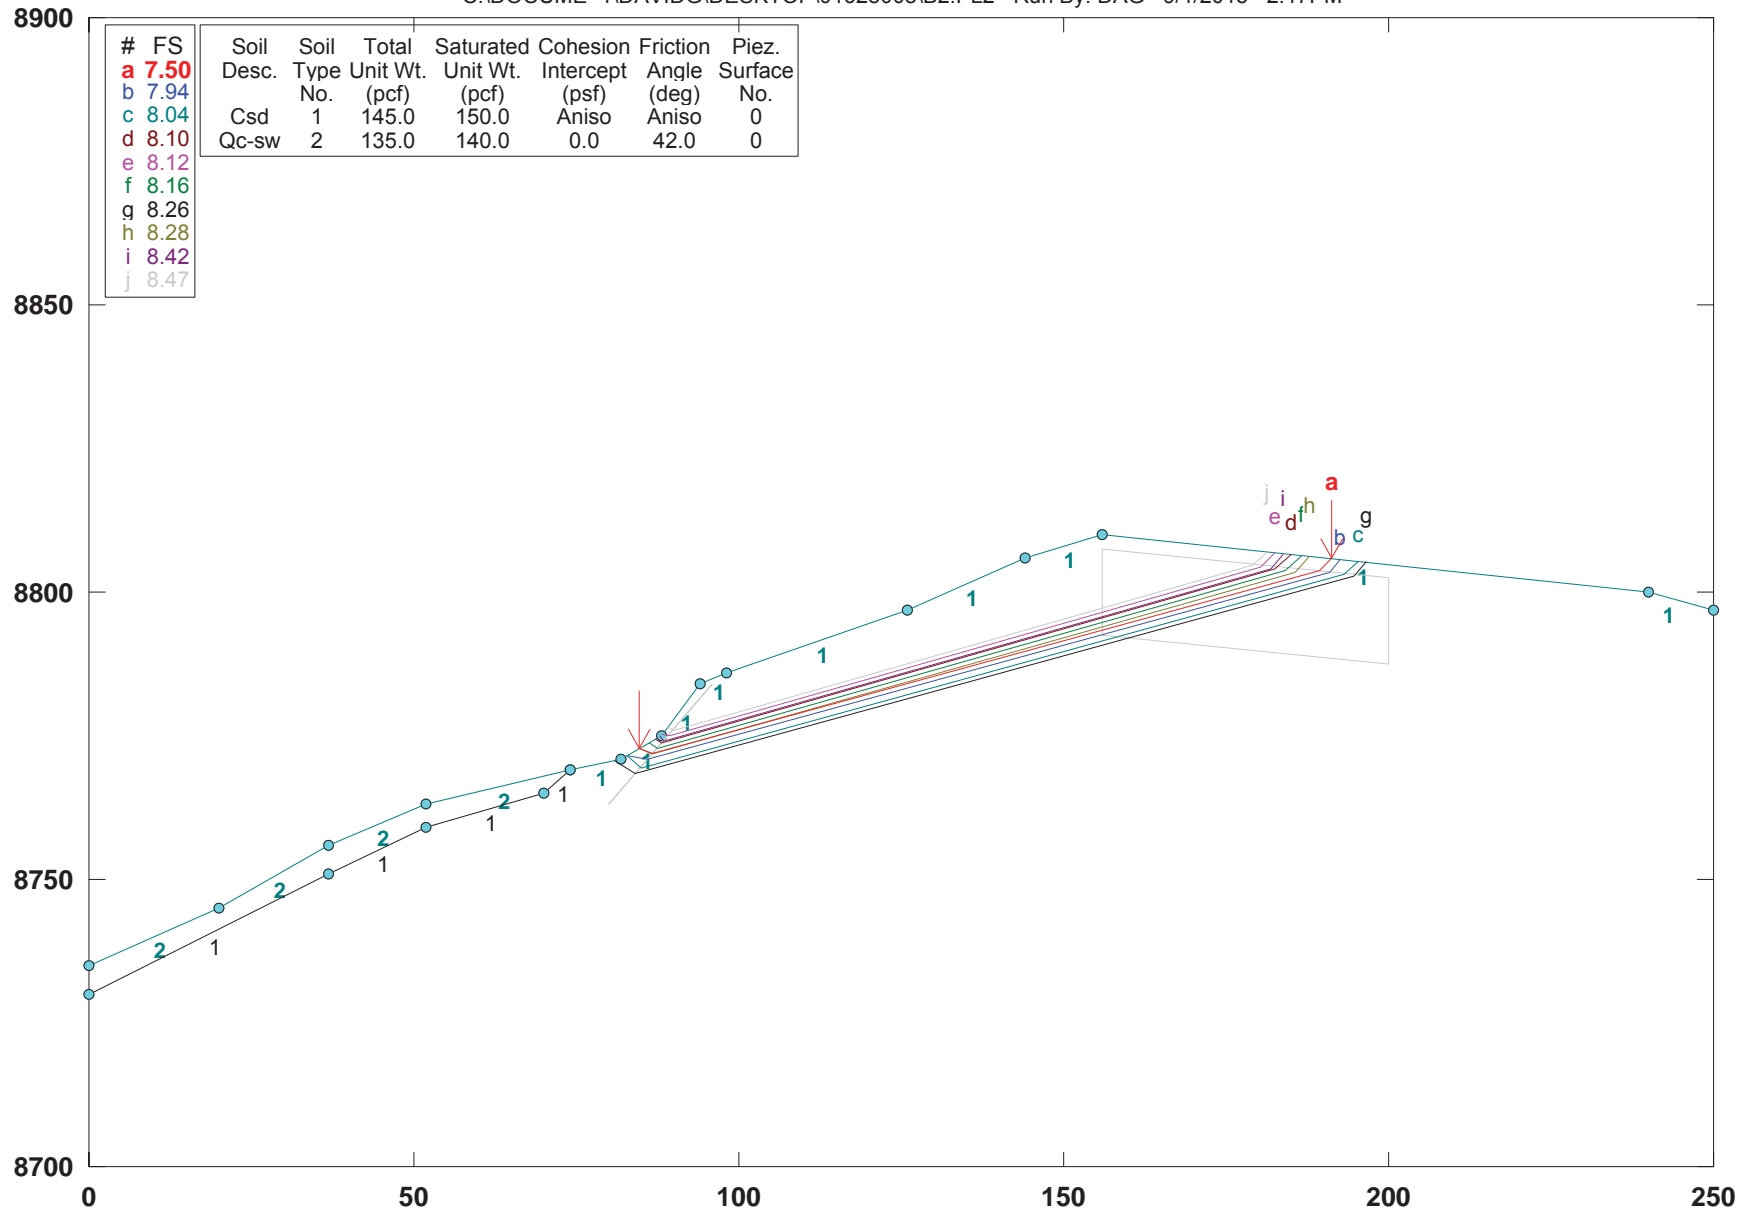
# Summit/Ridge Nests; B-B'; Static; bedding 17 deg apparent dip

GSTABL7 v.2 FSmin=7.50

Safety Factors Are Calculated By The Simplified Janbu Method for the case of c & phi both > 0

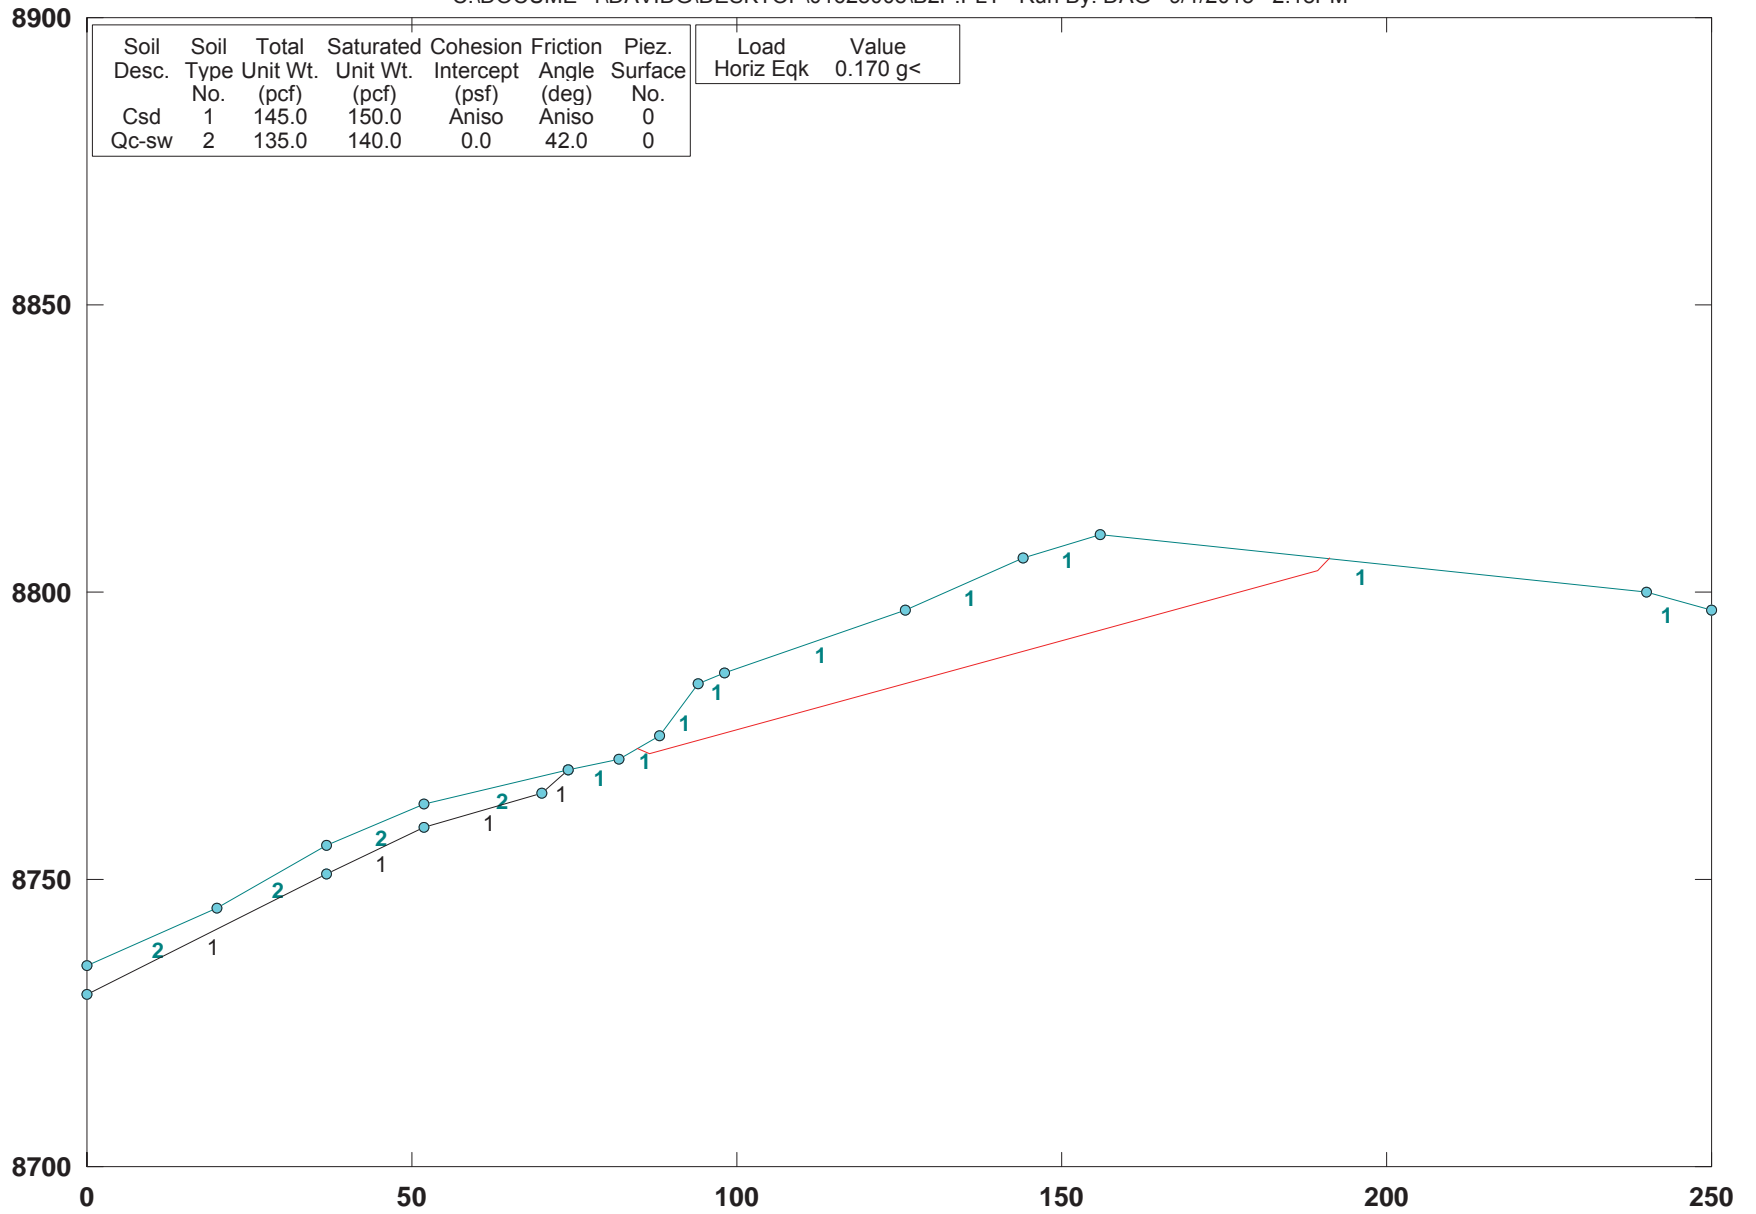
# Summit/Ridge Nests; B-B'; Pseudo-Static; bedding 17 deg apparent dip

Soil Desc.	Soil Type No.	Total Unit Wt. (pcf)	Saturated Unit Wt. (pcf)	Cohesion Intercept (psf)	Friction Angle (deg)	Piez. Surface No.
Csd	1	145.0	150.0	Aniso	Aniso	0
Qc-sw	2	135.0	140.0	0.0	42.0	0

Load Horiz Eqk	Value
	0.170 g<

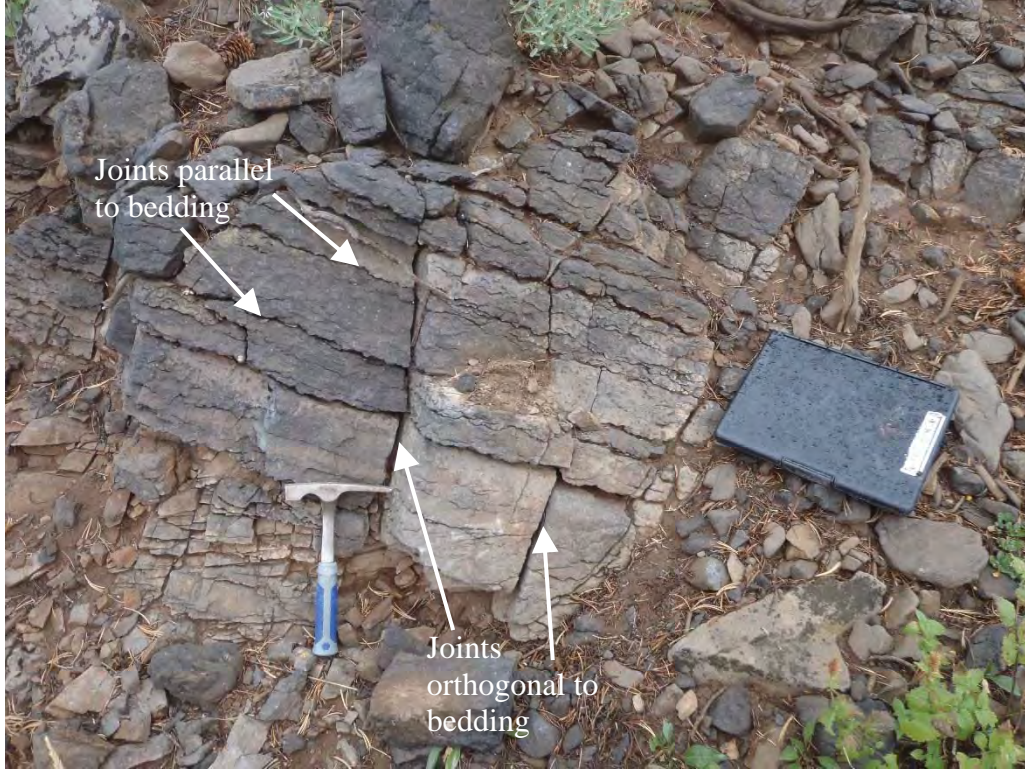
**Photo 1. Finer-grained dolomite lithology, exhibiting thinner beds and blocky jointing.**

In response to the comment, the following additional details are provided: bedrock was found to be largely moderately fractured (distance between fractures ~0.5-1.0 feet) to little fractured (distance between fractures ~1.0-4.0 feet), with localized areas of intense fracturing (distance between fractures ~0.05-0.1 feet). Joint spacing was largely found to be a product of the lithology. The finer-grained dolomite lithologies were more thinly bedded, and therefore had a smaller distance (approximately 1 to 4 inches) between bedding plane joints. These lithologies also tended to fracture into rectangular blocks generally between 4 and 18 inches in length and width, and contained both bedding-confined and through-going fractures (Photo 1). Coarser-grained dolomite lithologies were more thickly bedded to massive, with bedding plane joints separated by between 6 inches to as much as several feet. These lithologies tended to fracture into rectangular blocks with highly variable dimensions, ranging in width and length from between a couple inches to several feet, though larger blocks (with dimensions of several feet x several feet x several feet) were most common (Photo 2). Most fracturing associated with the coarser-grained dolomite lithologies consisted of large through-going fractures.

Nearly all of the joints encountered in the field investigation were open, had slightly rough to rough surfaces, and did not contain a secondary mineralization, except rare calcite infilling in places. No slickensides were observed on any joint surface. Joint apertures varied from between a few millimeters to a couple inches in width. Joints with smaller apertures tended to be devoid of any sort of fill, while the larger aperture joints were often filled with soil. In the cases of the two identified faults, reddish gray silty gouge was found to be the fill material.

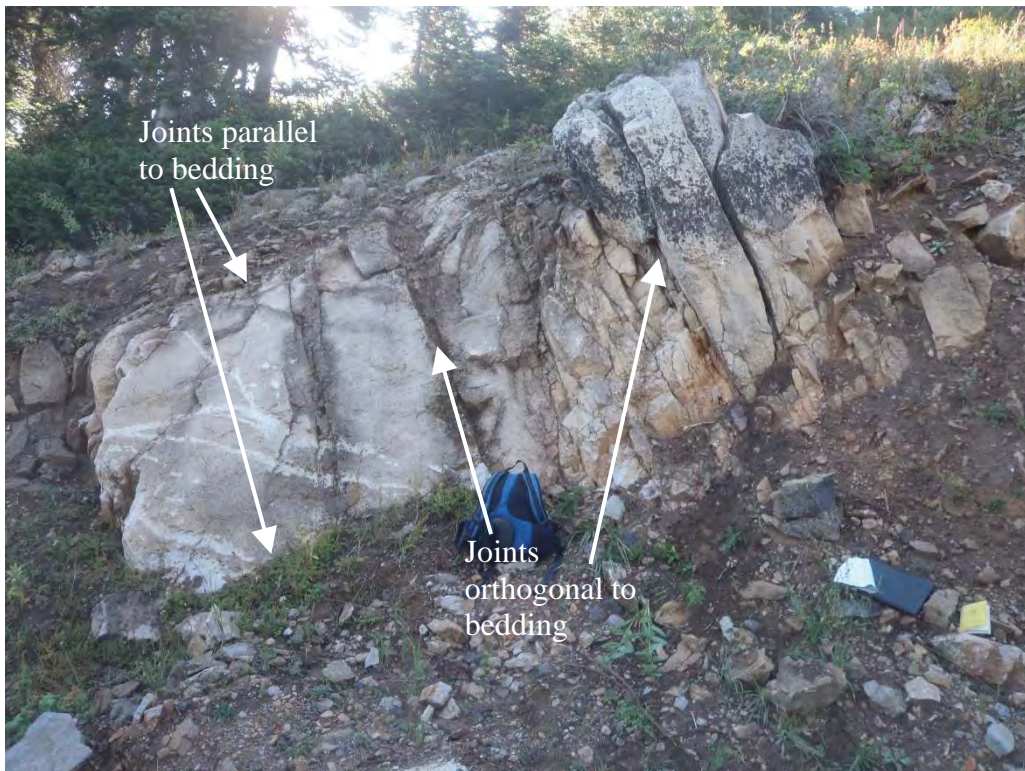
**Photo 2. Coarser-grained dolomite lithology, exhibiting thicker beds and wider jointing.**
