**GEOTECHNICAL AND GEOLOGIC HAZARD INVESTIGATION**  
**Proposed Hastings Residence**  
**Lot 14R of Summit Eden Phase 1A**  
**Summit Powder Mountain Resort**  
**Weber County, Utah**

IGES Project No. 02693-001

March 8, 2018

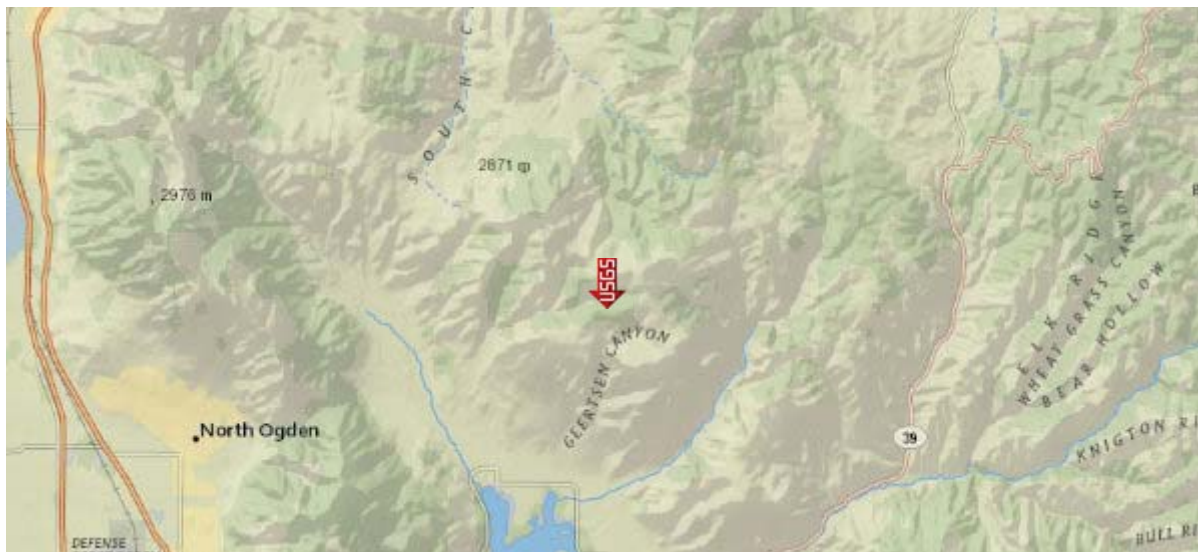
**Site Soil Classification** Site Class C – “Very Dense Soil and Soft Rock”

**Risk Category** I/II/III

$S_S = 0.831 \text{ g}$	$S_{MS} = 0.887 \text{ g}$	$S_{DS} = 0.592 \text{ g}$
$S_1 = 0.277 \text{ g}$	$S_{M1} = 0.421 \text{ g}$	$S_{D1} = 0.281 \text{ g}$
