GEOLOGIC AND GEOTECHNICAL STUDY

PROPOSED COOK RESIDENCE

LIBERTY, UTAH

PROJECT NO. 1170956

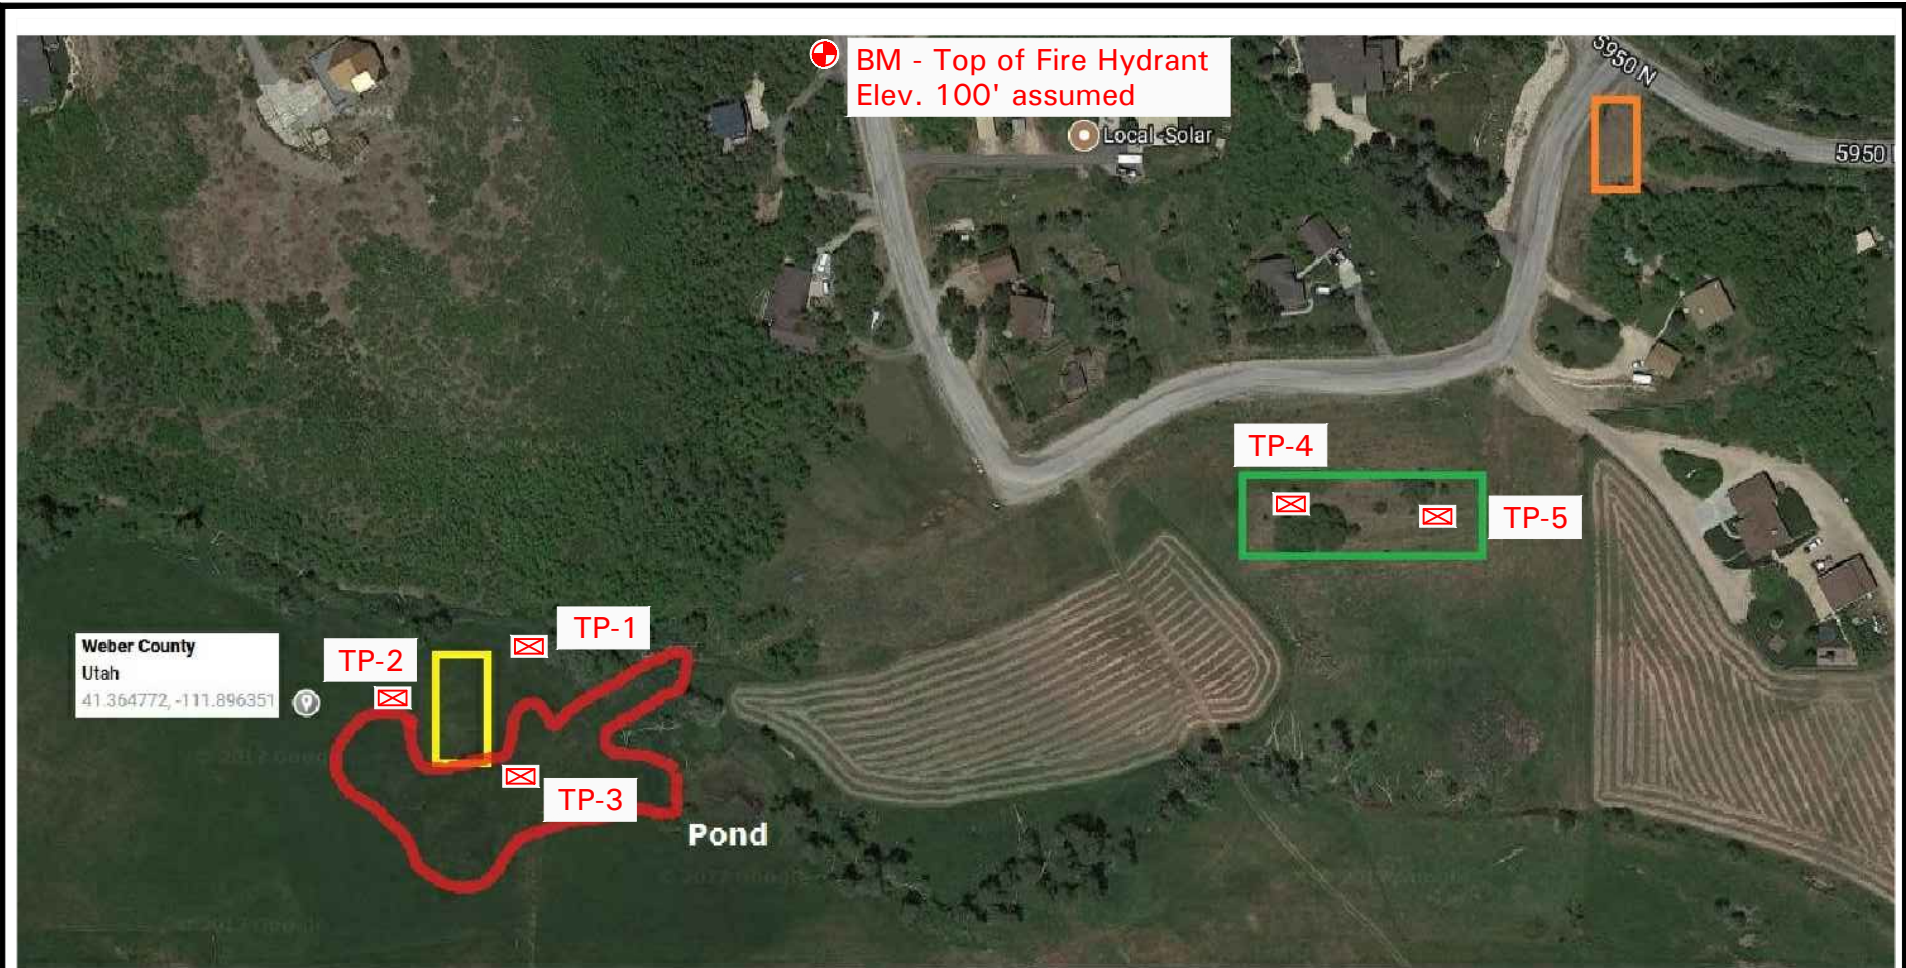
The field study was conducted on November 28, 2017. Five test pits were excavated at the approximate locations indicated on Figure 1 using a rubber-tired backhoe. The test pits were logged and soil samples obtained by an engineer from AGECE. Logs of the subsurface conditions encountered in the test pits are presented on Figure 2 with legend and notes on Figure 3.

Proposed Home Site

Fill Dirt Location

Wet Area

The geologic portion of the analysis and report findings are based on published geologic maps and reports, aerial photographs and Lidar data of the site, the test pits excavated at the approximate locations indicated on Figure 1 and our interpretation of geologic conditions at the site. Our conclusions are based on currently accepted geologic interpretation of this information.

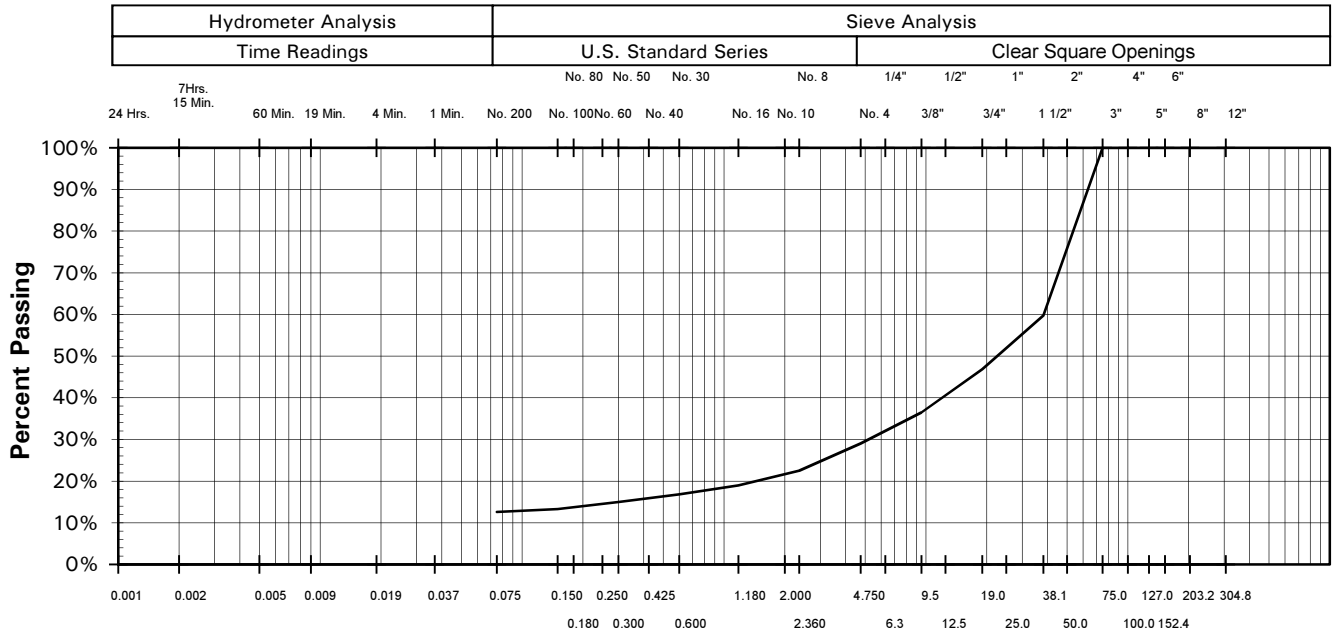
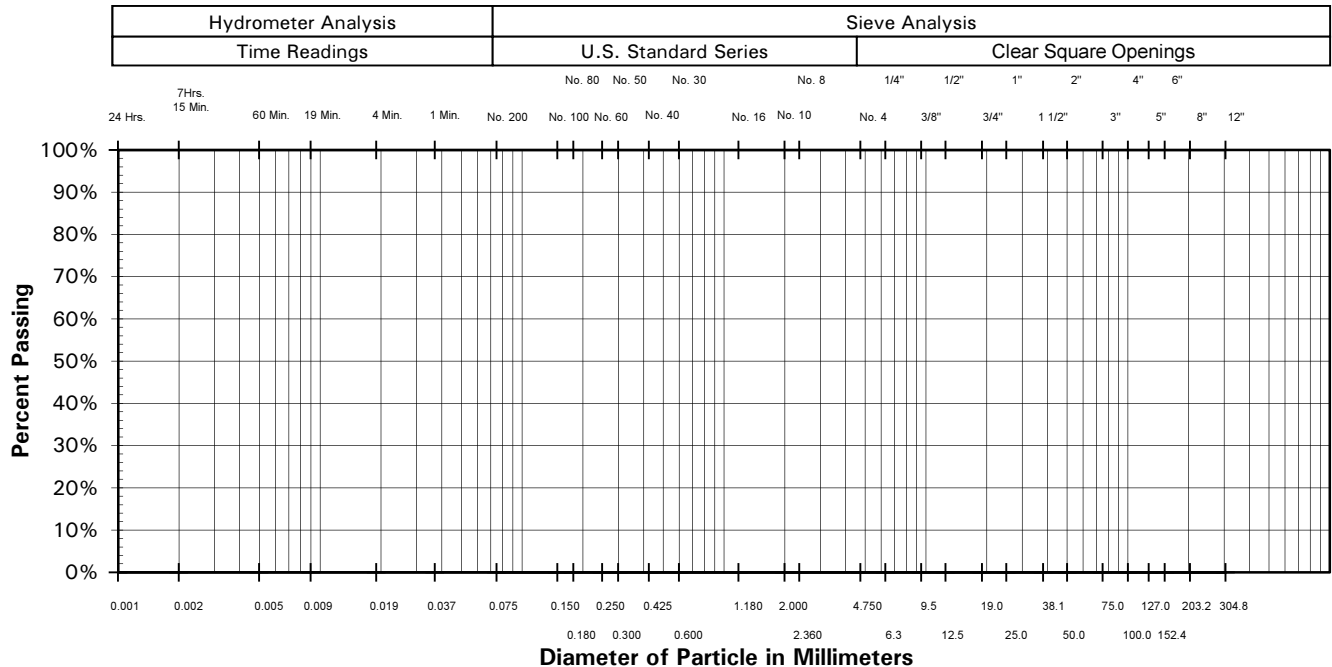
Results of a gradation test of the gravel are presented on Figure 5.

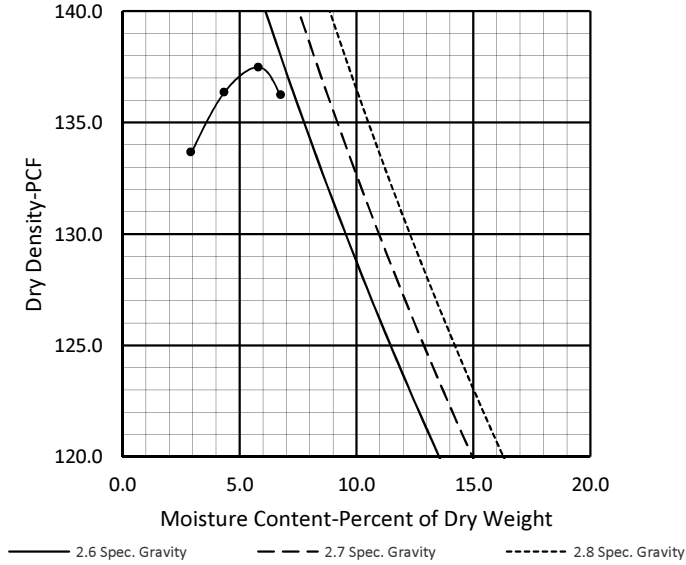
Figure 6

Results of gradation and moisture-density tests performed on the fill are presented on Figure 6.

Moisture - Density Relationship, Gradation, & Classification Results

Project Name: Cook
 Project No. 1170956
 Sample No. 15321
 Sample Location: TP-5 at 0' to 5'

Maximum Dry Density (Corrected) 137.5 pcf
 Optimum Moisture 5.8 %
 Rock Correction 10.2 pcf
 Final Based on Microwave Oven Moisture Contents

Clayey Gravel with Sand (GC)
 Contains 4-Inch Minus Cobble

Fill placed below areas of the proposed building should consist of granular soil as indicated above. The on-site sand and gravel and fill investigated at the proposed fill source area at Test Pits TP-4 and TP-5 are generally expected to meet these criteria if the organics, debris and oversized particles are removed. The clay is not recommended for use as fill below the building.
