**Report Professional Geologist Site
Reconnaissance and Review
Proposed 1500-foot Snowmaking Water Line Extension
Parcel #22-029-0008 Nordic Valley Ski Resort
Eden, Weber County, Utah**

October 19, 2018
GCS File No: 2018.33

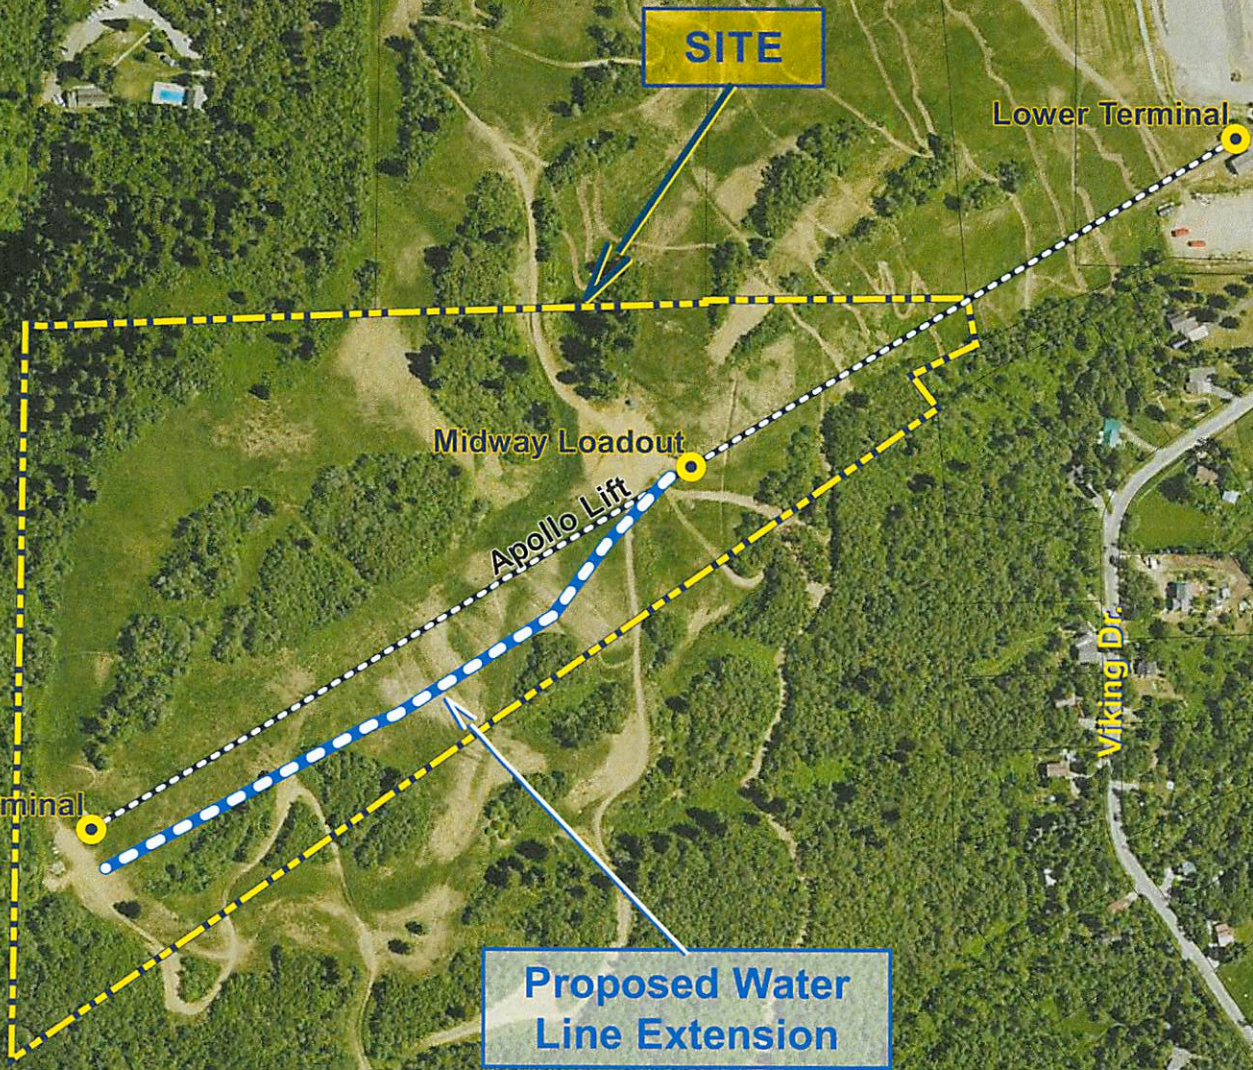
FIGURE 2
AERIAL COVERAGE
GCS Geoscience

It is our understanding that resort intends to extend existing snowmaking water supply to the upper Apollo Lift area, above the Midway Loadout, as shown on Figure 2. The proposed extension is to consist of an approximately 1500-foot long buried four-inch diameter water supply pipeline, with three interval-spaced hydrants for snow gun hook-up. The water supply pipeline excavation will be four feet in depth and 18-inches wide during construction
