**Report Professional Geologist Site  
Reconnaissance and Review  
Snowbasin Modular Structure  
Former Hill Haus Lodge Location, Snowbasin Resort  
Huntsville, Weber County, Utah**

October 23, 2019  
GCS File No: 2019.39

**Subject: Report**  
**Professional Geologist Site Reconnaissance and Review**  
**Snowbasin Modular Structure**  
**Former Hill Haus Lodge Location, Snowbasin Resort**  
**Huntsville, Weber County, Utah**

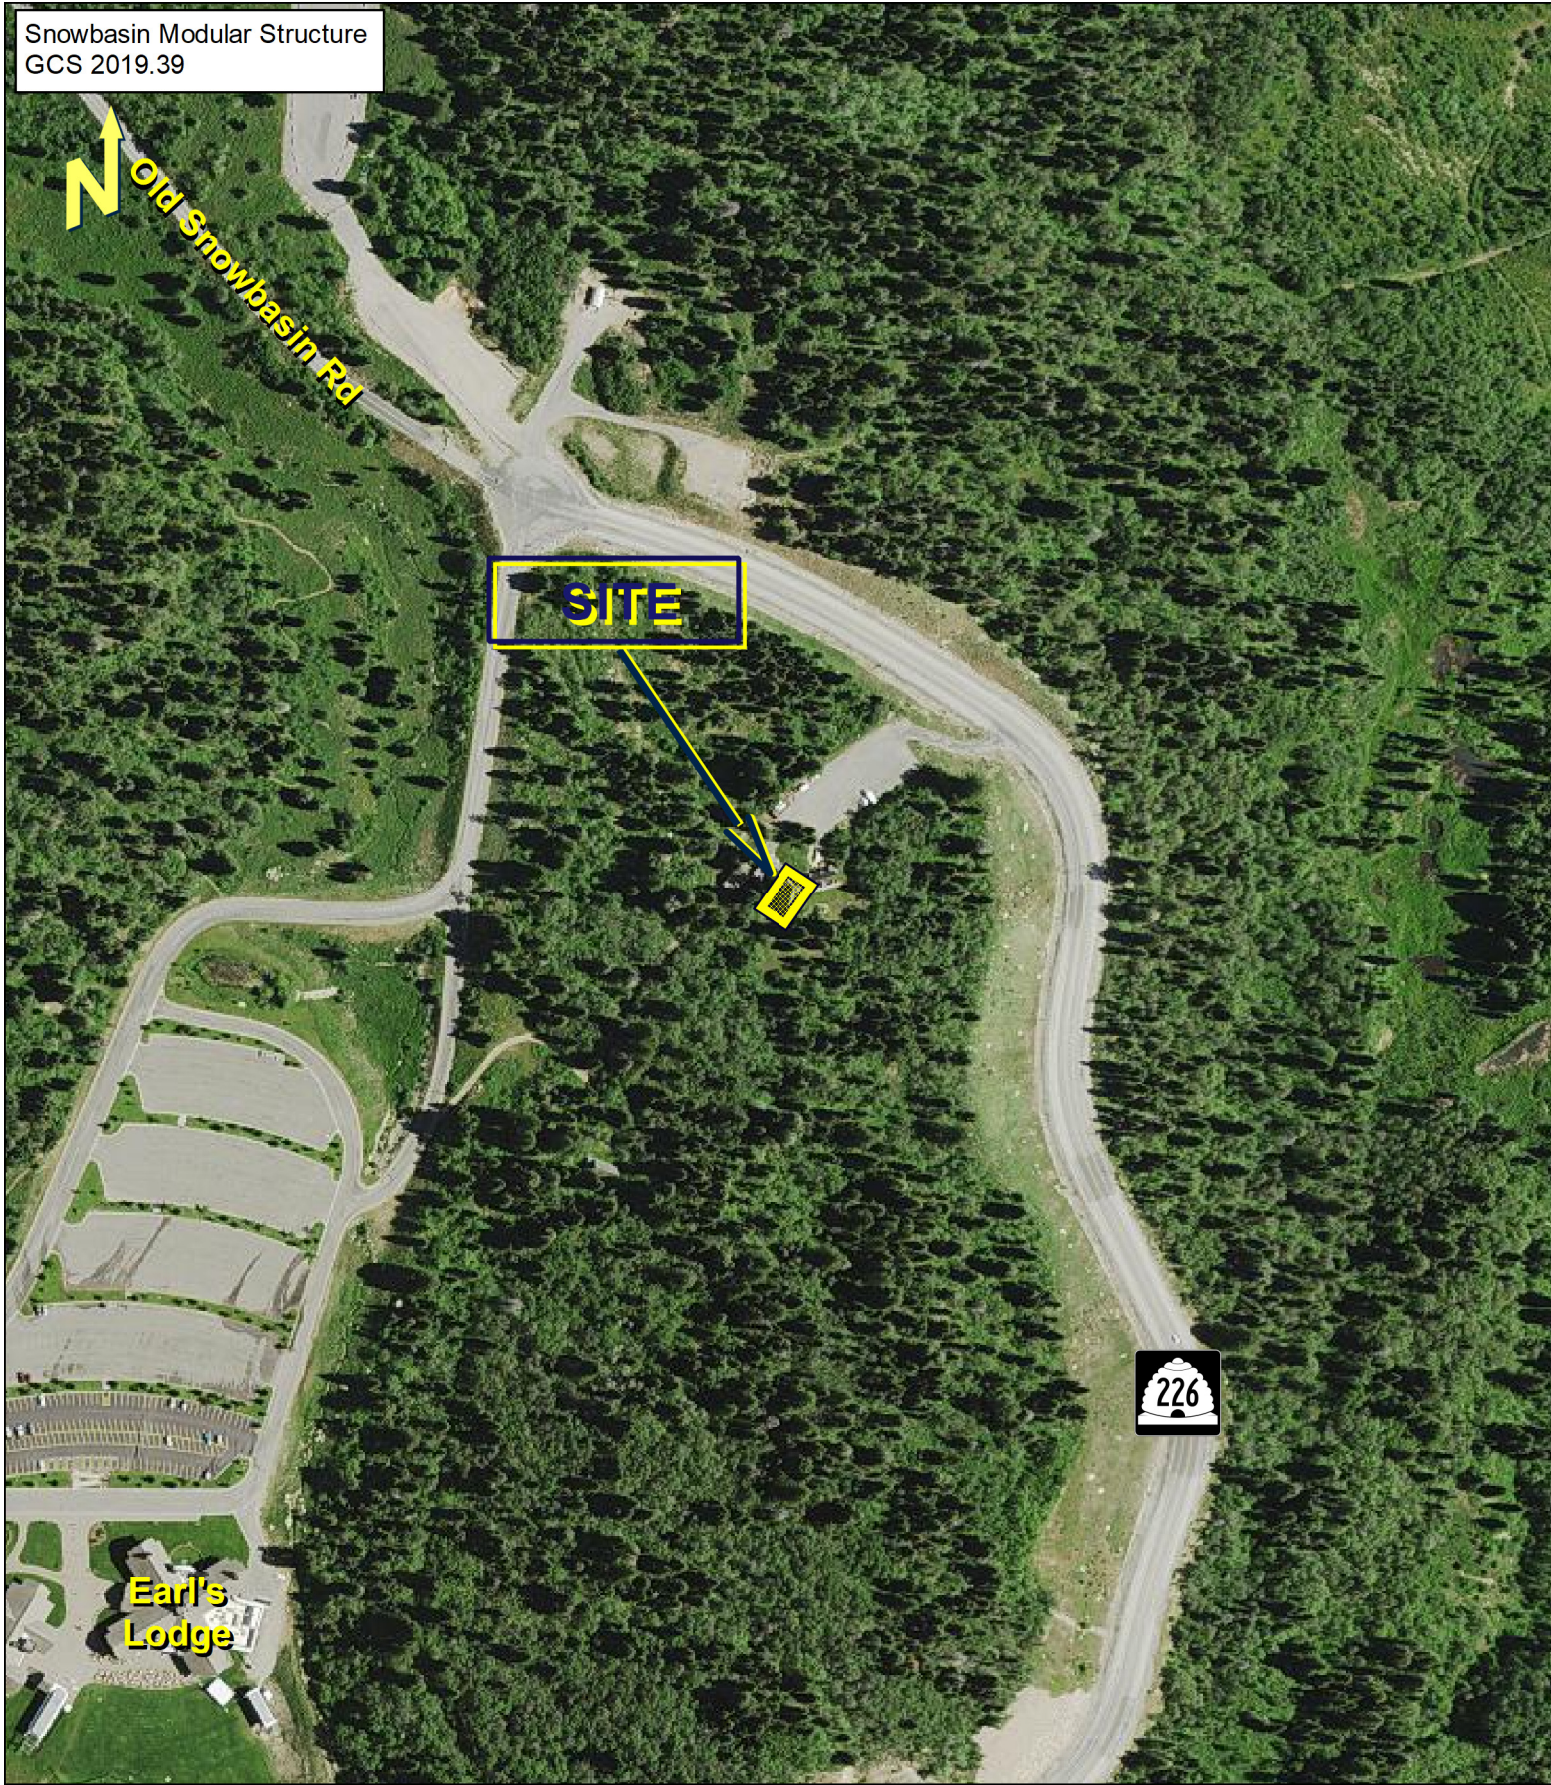
**FIGURE 2**  
**AERIAL COVERAGE**  
**GCS Geoscience**

Topographically the Site is located on base foothills on the east side of Mount Ogden, and overlooks Ogden Valley which is located to the northeast. As shown on Figure 2 the Site consists of an area of approximately 3000 square-feet in size that has currently been cleared and graded for development. The topography of the site vicinity consists of a foothill ridge with about 200 feet of total local vertical relief, with elevations locally ranging between 5212 feet and 5296 feet (msl). The Site, as shown on Figure 2, (2014 imagery) is surrounded by wooded undeveloped ground.

Haus Lodge facility. The former lodge building shown on Figure 2 has been razed and cleared from the site, and the construction pad location for the proposed modular structure appeared prepared for concrete placement. Surface vegetation on the site consisted of moderately to densely clustered wooded areas of scrub oak, maple, and fir trees, with a ground cover of Oregon grape and sparse grasses and weeds. Soils exposed by the grading for the pad appeared to consist of silty gravelly clays/silty gravels with angular- to sub-angular cobble and boulder sized particles.
