**Geotechnical Investigation  
Phase I – Mountainside and Parkside Communities  
The Bridges at Wolf Creek Development  
Eden, Utah**

GeoStrata Job No. 1311-002

February 15, 2018

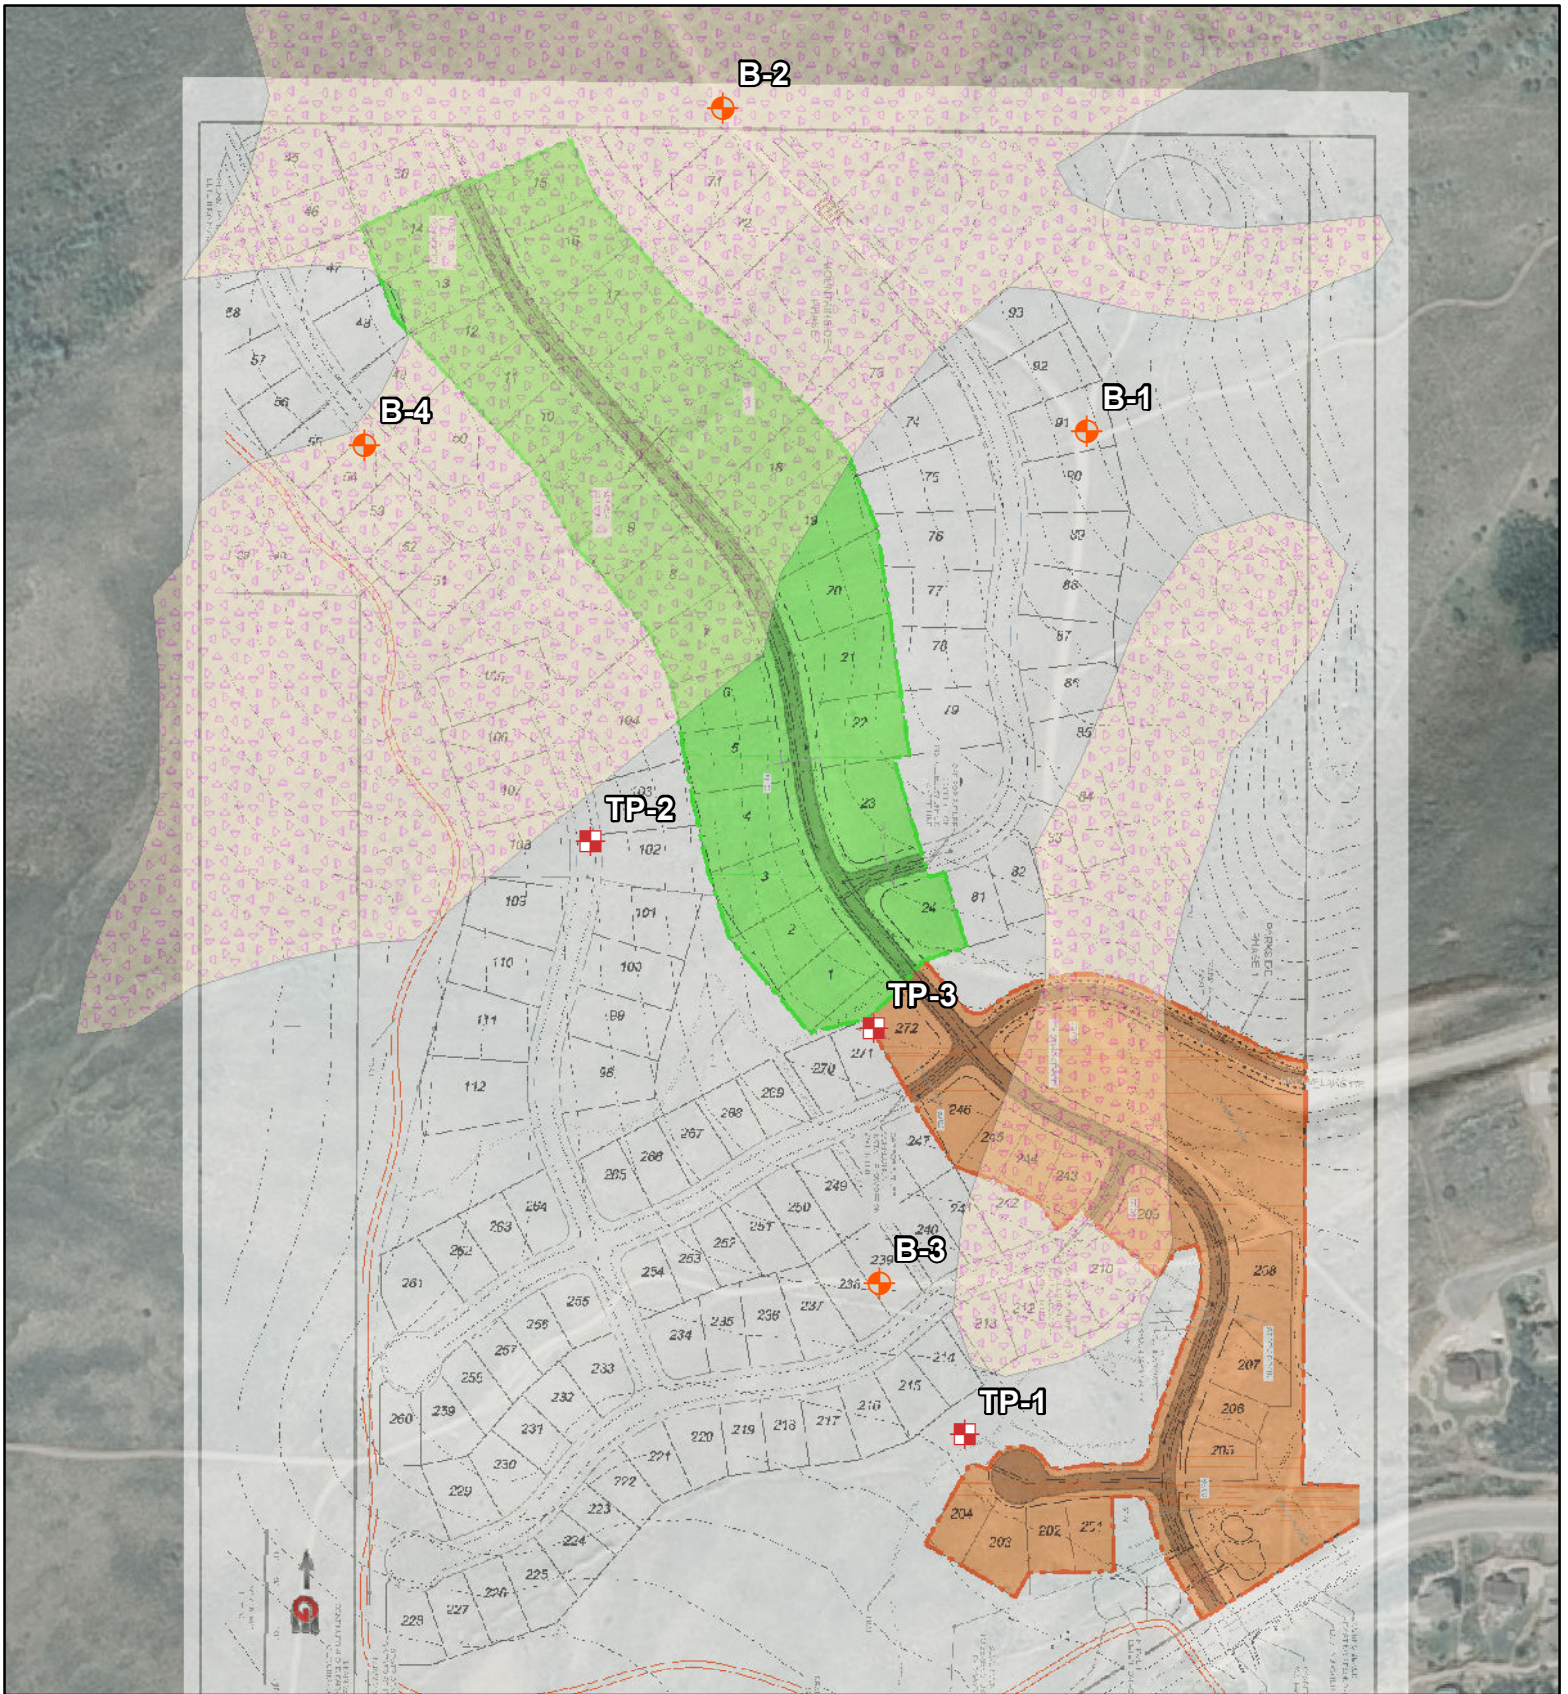
**Plate  
A-2**

- Legend**
- Approximate Boring Location
  - Approximate Test Pit Location
  - Landslide (Coogan and King)

Eric Householder  
The Bridges  
Eden, Utah  
Project Number: 1311-002  
**Exploration Location Map**

As a part of this investigation, subsurface soil conditions were explored by advancing 4 exploratory boreholes as well as excavating three test pits. The boreholes ranged from 31½ to 61½ feet below the site grade and were advanced using Mobile B-80 truck-mounted drill rig equipped with an ODEX drilling system. Both bulk and relatively undisturbed samples were obtained from each borehole location. A standard Split Spoon sampler and a 2.4-inch inside diameter California Sampler were utilized to collect bulk samples. Relatively undisturbed samples were obtained using Shelby tubes. The approximate locations of the borehole explorations are shown on the *Exploration Location Map*, Plate A-2 in Appendix A.

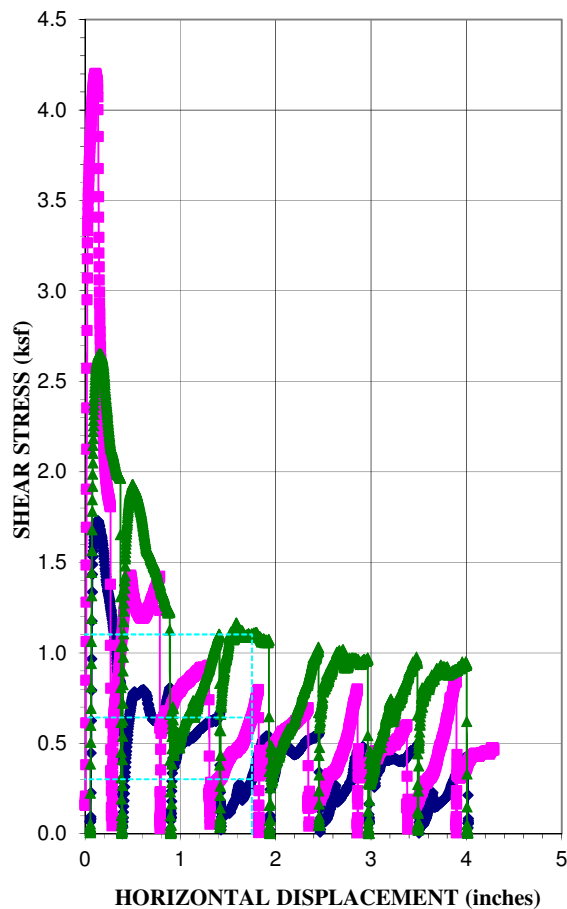
# DIRECT SHEAR TEST

<b>Source:</b>	B-2 @ 45
<b>Type of Test:</b>	Consolidated Drained/Saturated

Test No. (Symbol)	1 (◆)	2 (■)	3 (▲)
<b>Sample Type</b>	Remolded		
<b>Initial Height, in.</b>	1.063	1.12	1.056
<b>Diameter, in.</b>	2.5	2.5	2.5
<b>Dry Density Before, pcf</b>	85.3	87.0	87.9
<b>Dry Density After, pcf</b>	94.7	94.1	89.3
<b>Moisture % Before</b>	25.0	24.1	24.9
<b>Moisture % After</b>	30.3	30.2	31.8
<b>Saturation, % Before</b>	70.5	71.0	75.0
<b>Saturation, % After</b>	107.5	105.7	99.1
<b>Normal Load, ksf</b>	1.0	2.0	4.0
<b>Shear Stress, ksf</b>	0.30	0.64	1.10
<b>Strain Rate</b>	0.0033 IN/MIN

A value of 18 degrees and 0 psf cohesion for residual soil strength values were assigned for our engineering analysis. Results of our direct shear testing may be found in Appendix C of this report.

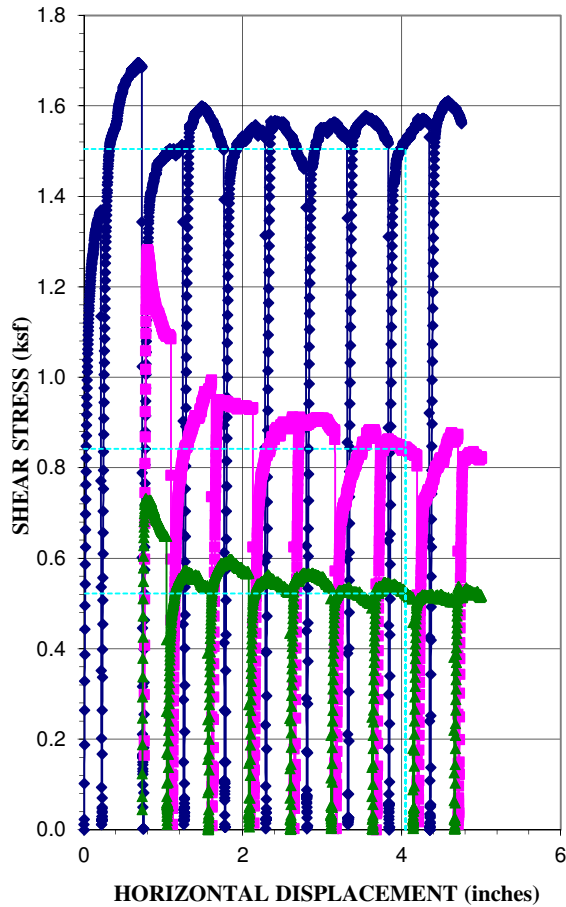
# DIRECT SHEAR TEST

<b>Source:</b>	B-3 @ 15 ft
<b>Type of Test:</b>	Consolidated Drained/Saturated

Test No. (Symbol)	1 (◆)	2 (■)	3 (▲)
Sample Type	Remolded		
Initial Height, in.	1.061	1.051	1.132
Diameter, in.	2.5	2.5	2.5
Dry Density Before, pcf	80.1	83.2	84.1
Dry Density After, pcf	81.7	84.8	85.6
Moisture % Before	39.6	37.7	35.2
Moisture % After	36.8	38.6	38.0
Saturation, % Before	98.6	101.1	96.6
Saturation, % After	95.2	107.6	108.1
Normal Load, ksf	4.0	2.0	1.0
Shear Stress, ksf	1.50	0.84	0.52
Strain Rate	0.0033 IN/MIN

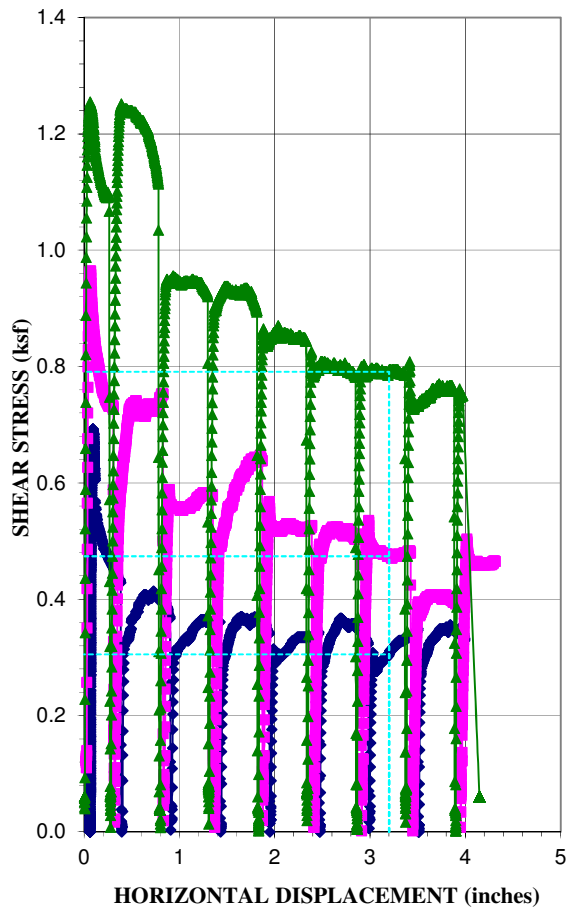
# DIRECT SHEAR TEST

Source:	TP-2 @ 10
Type of Test:	Consolidated Drained/Saturated

Test No. (Symbol)	1 (◆)	2 (■)	3 (▲)
Sample Type	Remolded		
Initial Height, in.	1.016	0.97	1.101
Diameter, in.	2.5	2.5	2.5
Dry Density Before, pcf	91.0	93.8	90.8
Dry Density After, pcf	92.7	92.9	95.2
Moisture % Before	28.2	28.6	27.2
Moisture % After	30.6	30.6	30.1
Saturation, % Before	91.4	99.2	87.7
Saturation, % After	103.3	104.1	108.2
Normal Load, ksf	0.5	1.0	2.0
Shear Stress, ksf	0.31	0.47	0.79
Strain Rate	0.0033 IN/MIN
