## **GEOLOGIC HAZARDS EVALUATION WHISPER RIDGE VILLAGE PHASE 1 SECTIONS 22 AND 23, TOWNSHIP 8 NORTH, RANGE 2 EAST UNINCORPORATED WEBER COUNTY, UTAH**

**Letter of Transmittal:** REPORT  
Geologic Hazards Evaluation  
Whisper Ridge Village Phase 1  
Sections 22 and 23, Township 8 North, Range 2 East  
Unincorporated Weber County, Utah

**WG&E Project No. 5428**

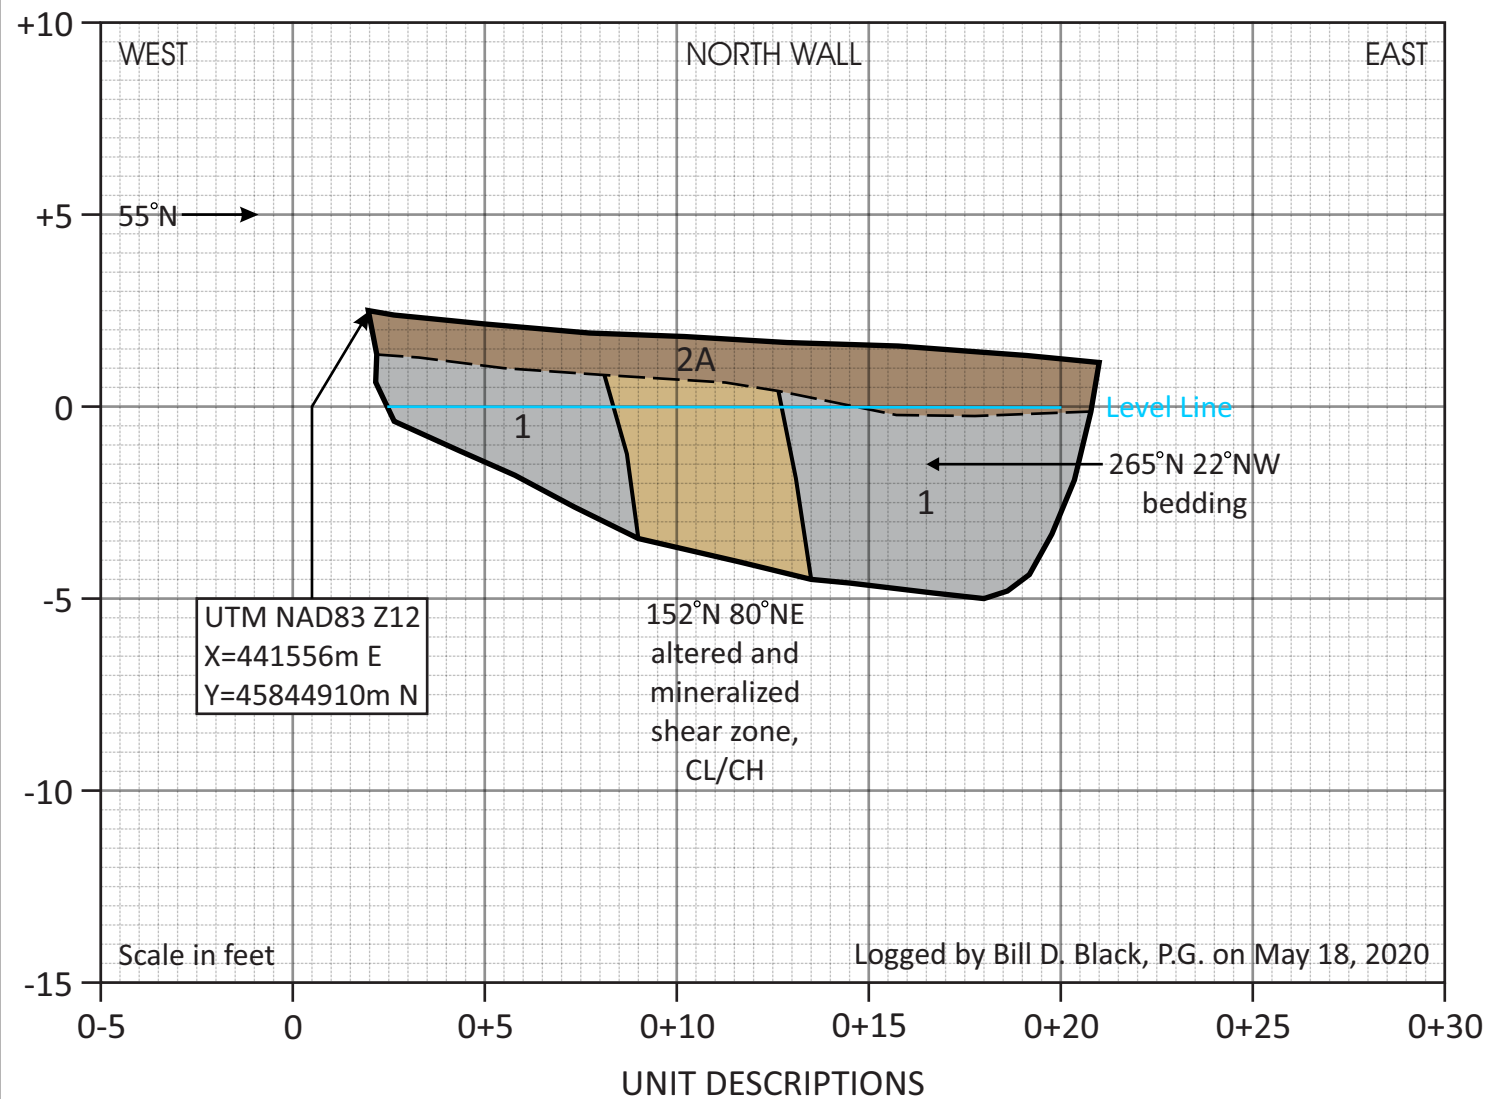
### TEST PIT 1

No evidence of active surface faulting is mapped or was evident at the site. A bedrock shear zone was observed in test pit TP-1 (Figure 4A) that showed no evidence for displacement of overlying Pleistocene- to Holocene-age alluvial and colluvial deposits. The shear zone appears to be on trend with where the bedrock fault mapped further southeast makes an abrupt 80-degree bend and continues to the west-southwest (Figure 2 and Figures 3A-B). This fault is mapped as being concealed where it crosses Quaternary-age sediments east-southeast of the Project on Figure 2. The nearest mapped active (Holocene-age) fault to the site is the Wellsville section of the West Cache fault zone 14.9 miles to the northwest (Black and others, 2003).

**Unit 1.** Cambrian Bloomington Formation, Hodges Shale Member - Weathered, blue-gray to gray, thinly bedded, fractured dolomitic shale, bedding 1/2" to 2" thick with fat clay between bedding planes.

**Unit 2A.** Pleistocene to Holocene alluvium and colluvium - Mixed alluvial and colluvial deposits comprised of brown (7.5 YR 4/4), loose to firm, massive, root-penetrated, sandy silt with clay (ML); modern A horizon formed in unit.

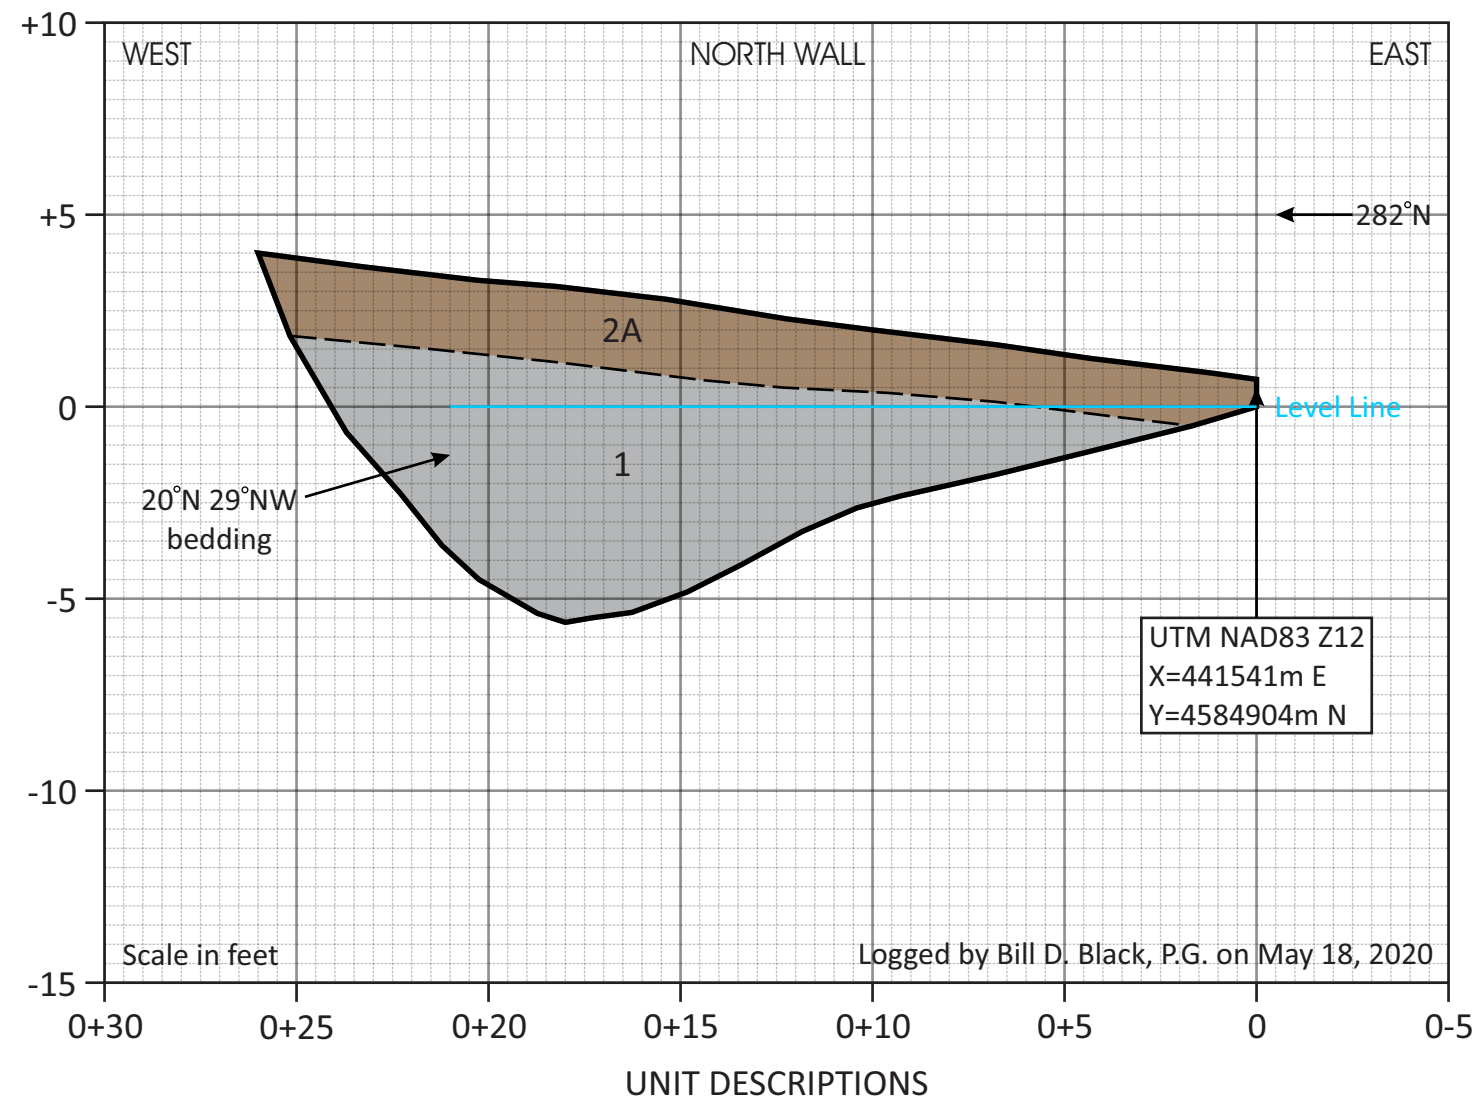
### TEST PIT 2

**Unit 1.** Cambrian Bloomington Formation, Hodges Shale Member - Weathered, blue-gray to gray, thinly bedded, fractured dolomitic shale, bedding 1/2" to 2" thick with fat clay between bedding planes.

**Unit 2A.** Pleistocene to Holocene alluvium and colluvium - Mixed alluvial and colluvial deposits comprised of brown (7.5 YR 4/4), loose to firm, massive, root-penetrated, sandy silt with clay (ML); modern A horizon formed in unit.

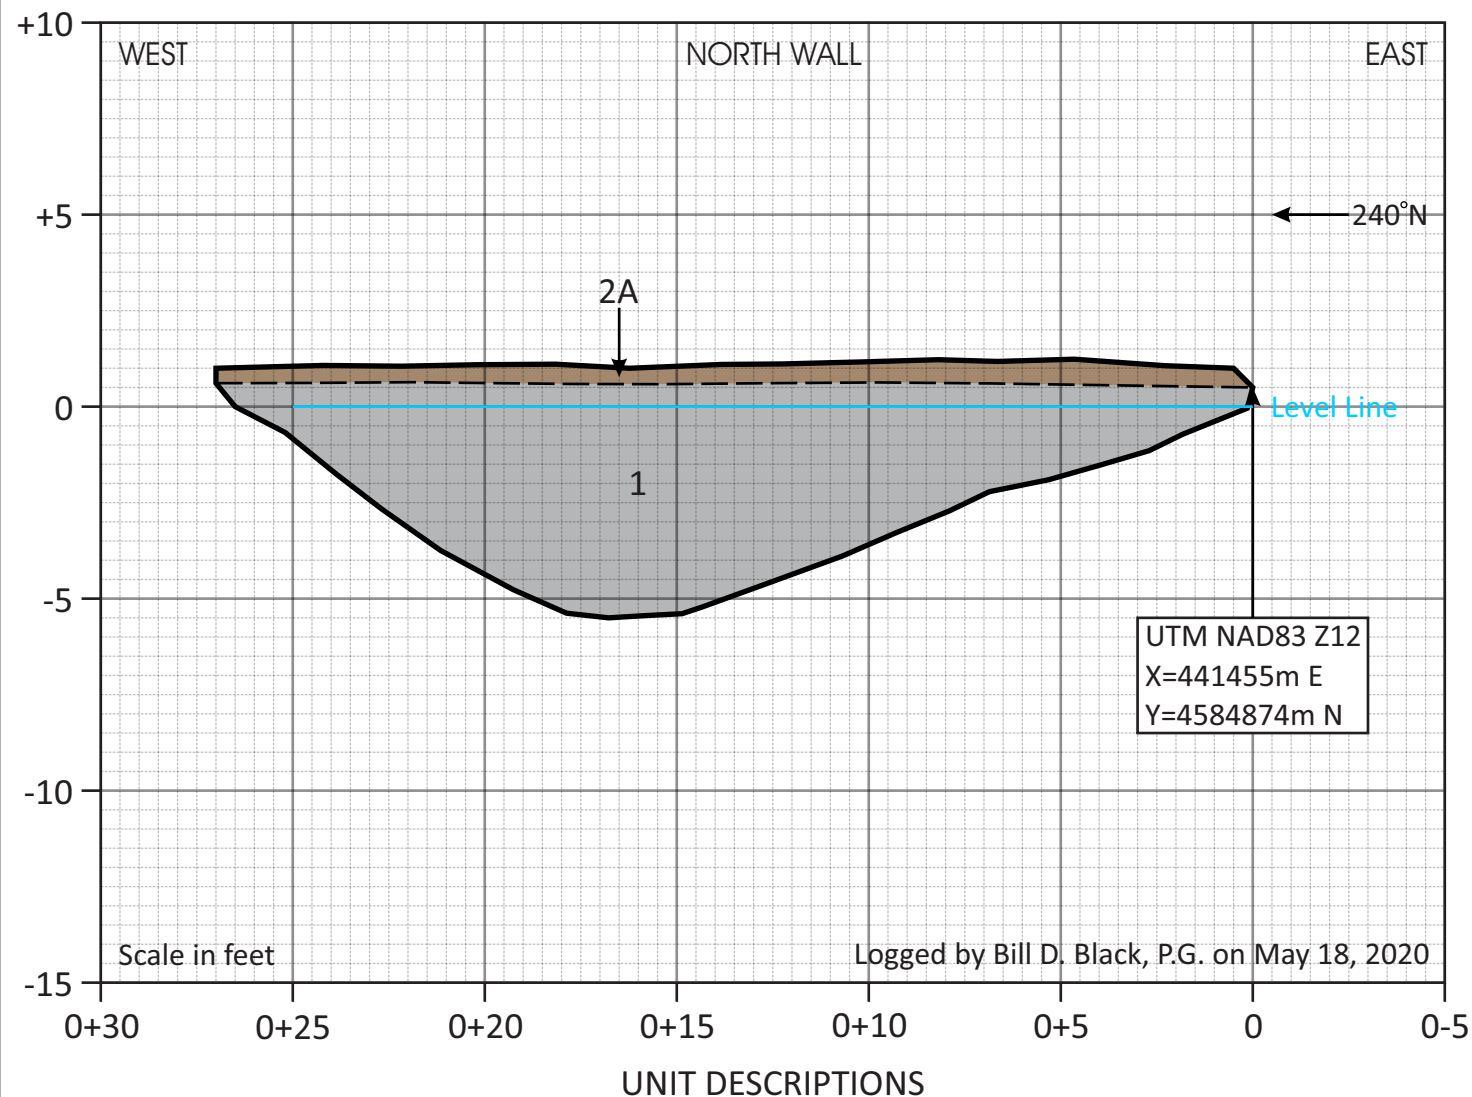
### TEST PIT 3

**Unit 1.** Cambrian Bloomington Formation, Middle Limestone Member - Weathered, olive- to brownish-gray, thinly bedded, dolomite to limestone.

**Unit 2A.** Pleistocene to Holocene alluvium and colluvium - Mixed alluvial and colluvial deposits comprised of brown (7.5 YR 4/4), loose to firm, massive, root-penetrated, sandy silt with clay (ML); modern A horizon formed in unit.

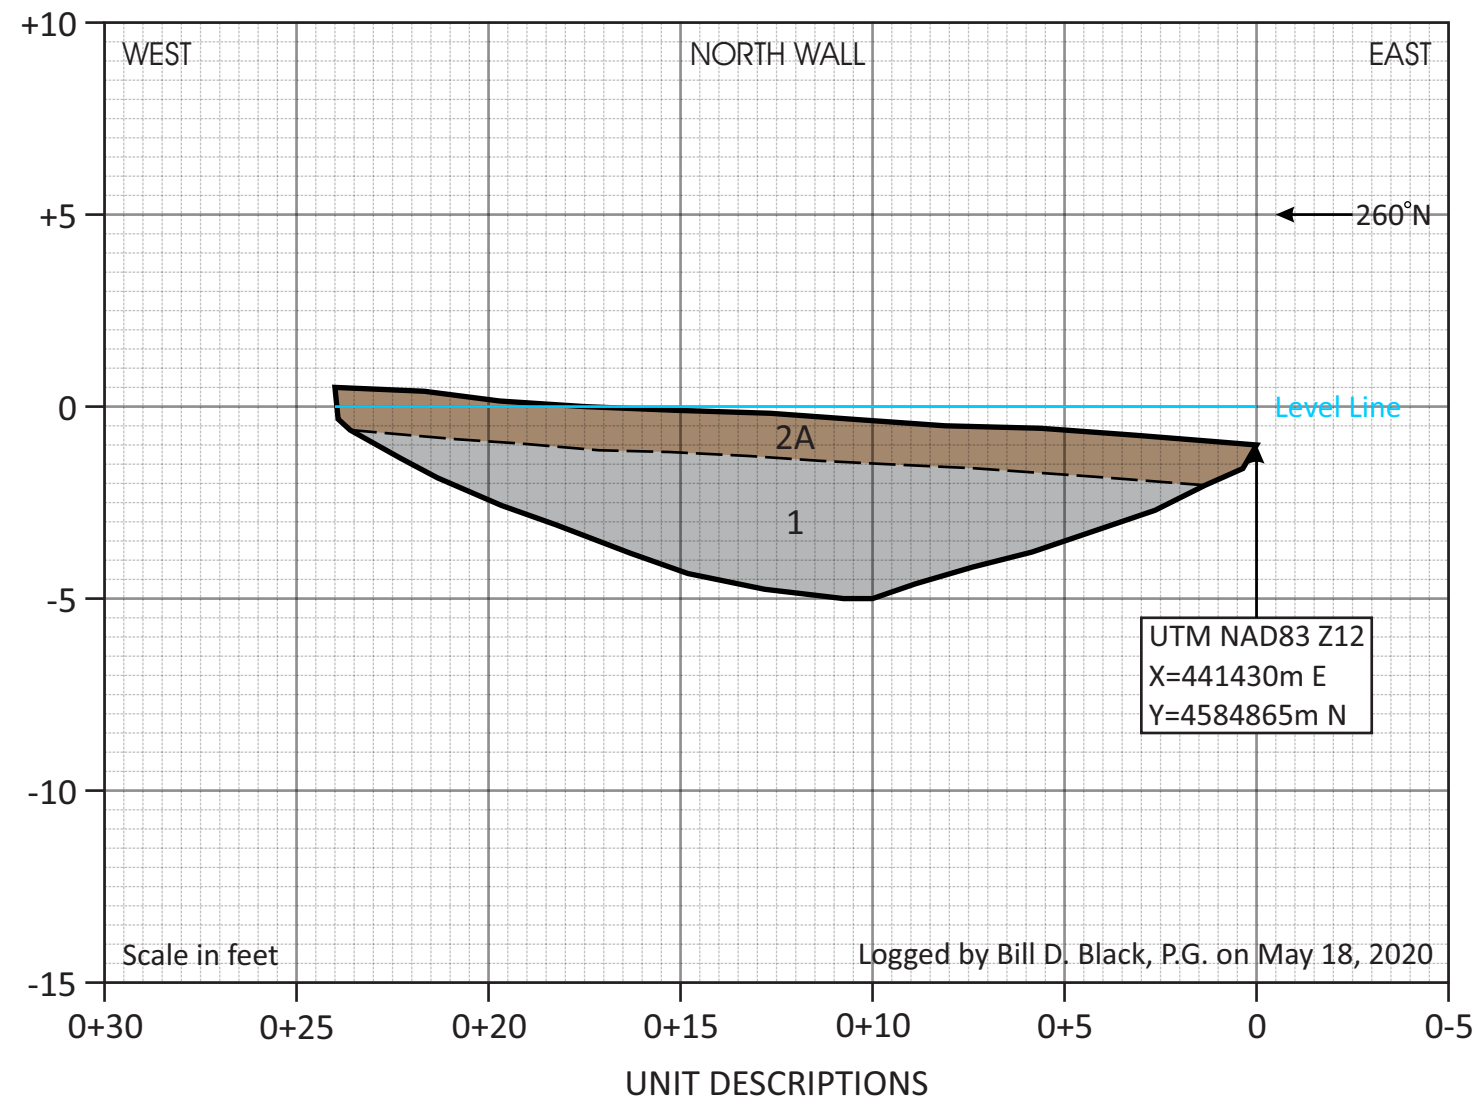
### TEST PIT 4

**Unit 1.** Cambrian Bloomington Formation, Middle Limestone Member - Dense to very dense, olive- to brownish-gray, thinly bedded, dolomite to limestone, refusal at 4.5'.

**Unit 2A.** Pleistocene to Holocene alluvium and colluvium - Mixed alluvial and colluvial deposits comprised of brown (7.5 YR 4/4), loose to firm, massive, root-penetrated, sandy silt with clay (ML); modern A horizon formed in unit.

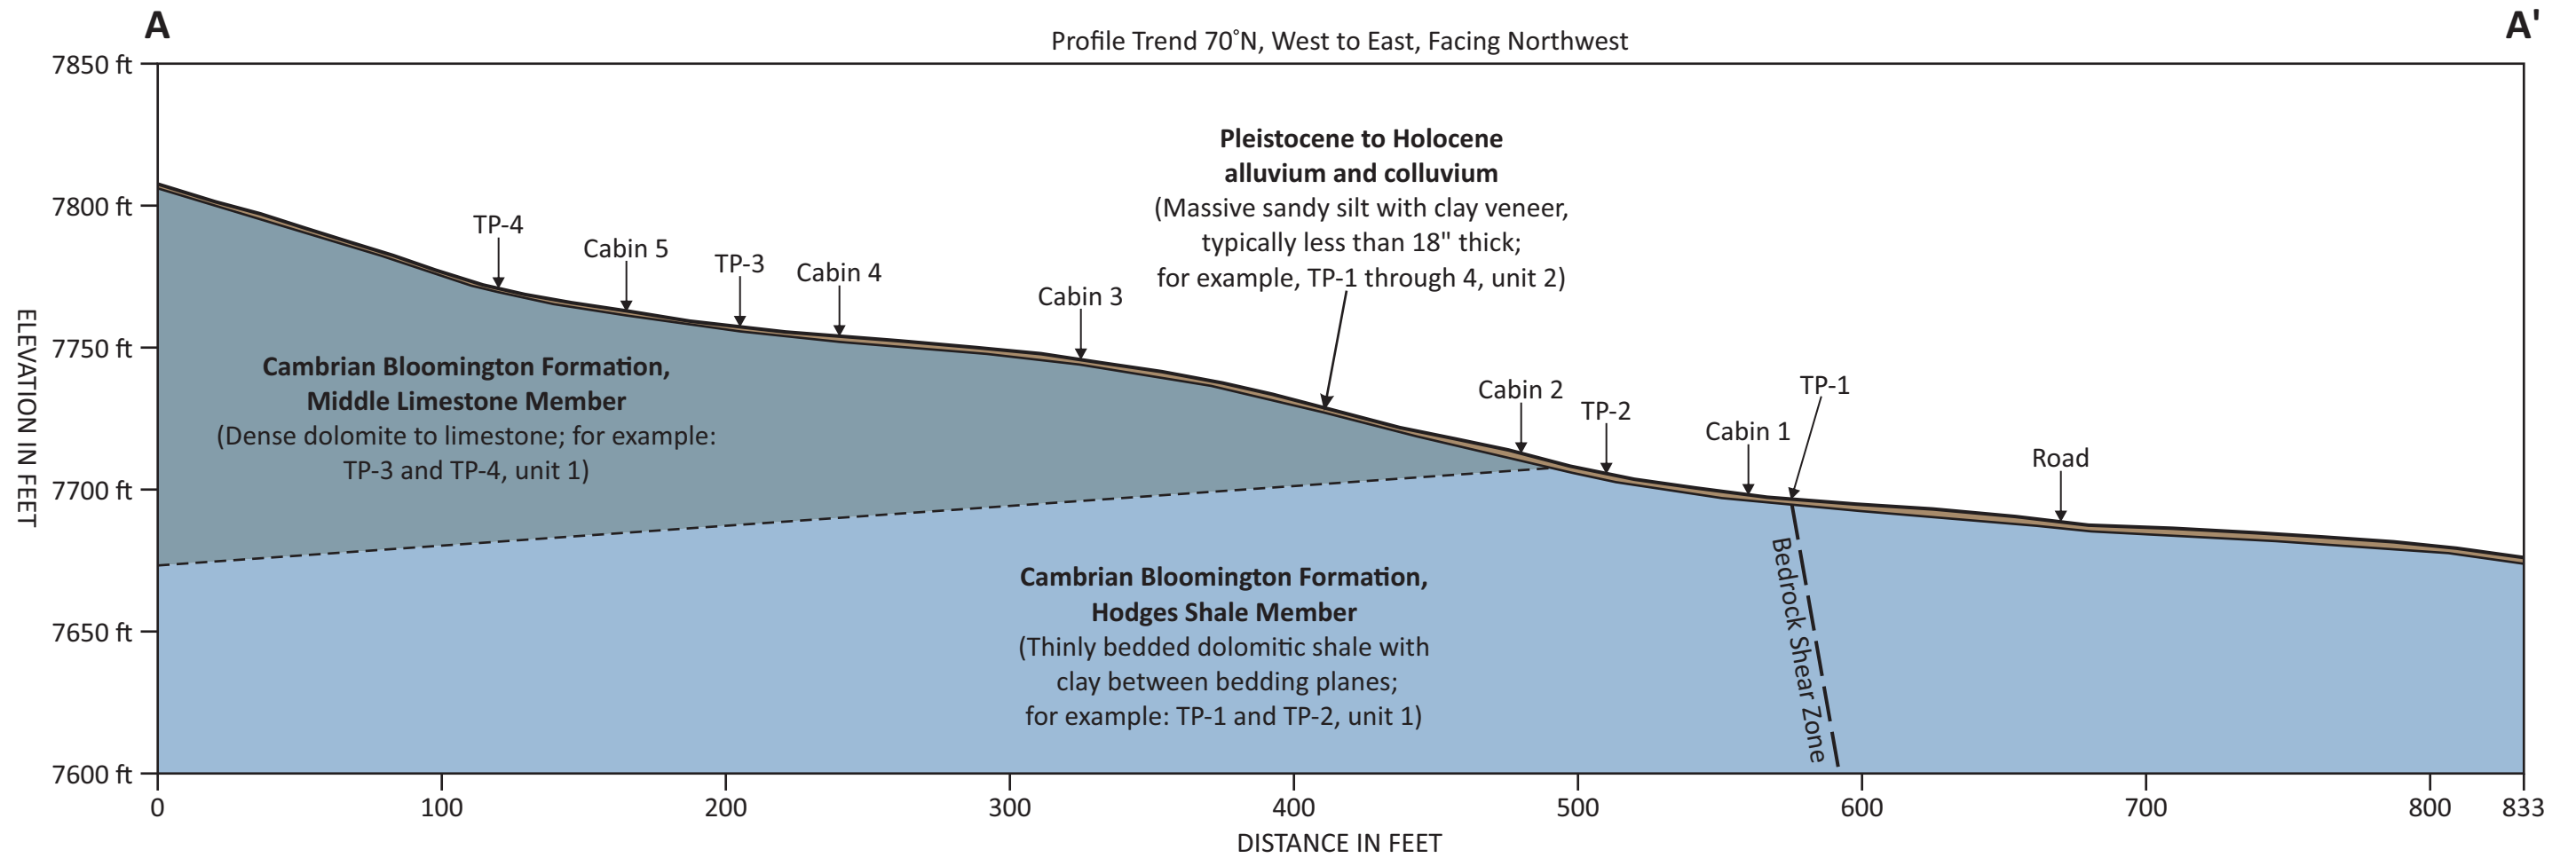
**FIGURE 5**

SCALE: 1 inch = 60 feet  
(no vertical exaggeration)  
Unit and subunit contacts are approximate and inferred; slope profile generated by Global Mapper from geoprocessed DEM data.

**CROSS SECTION A-A'**
