## UPDATED GEOTECHNICAL ENGINEERING AND GEOLOGICAL RECONNAISSANCE STUDY

# Proposed Jones Subdivision

About 2600 East North Ogden Canyon Road

**CMT PROJECT NO. 12290**

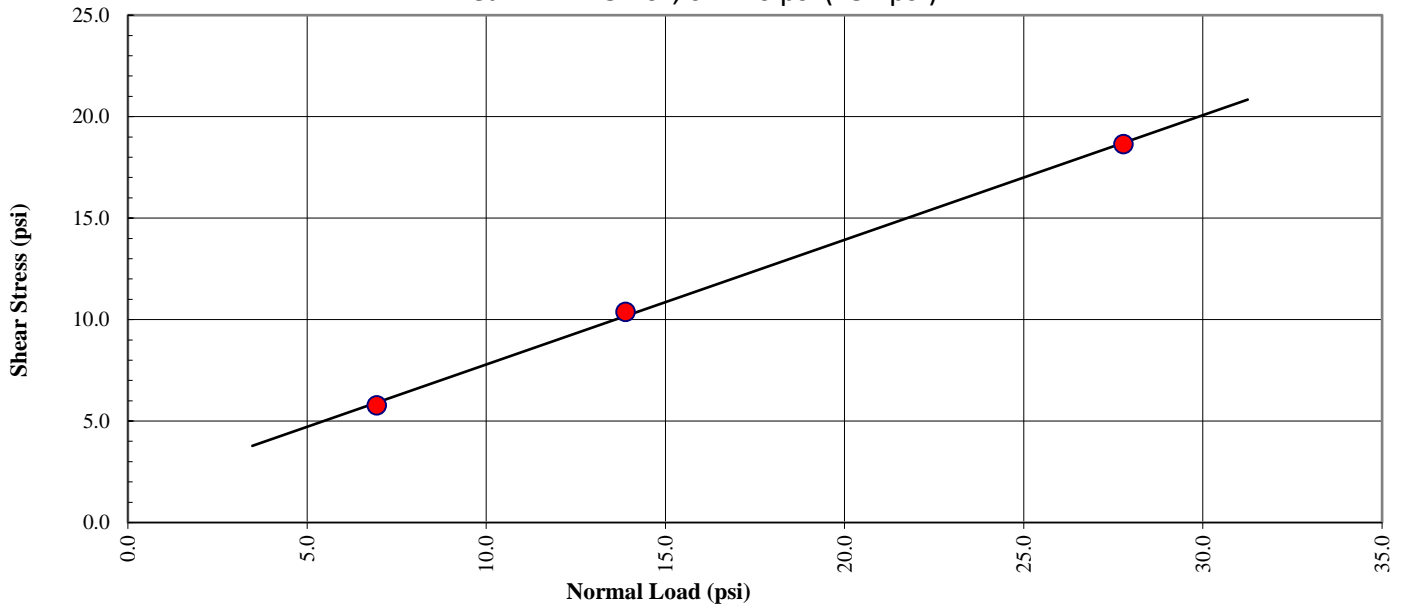
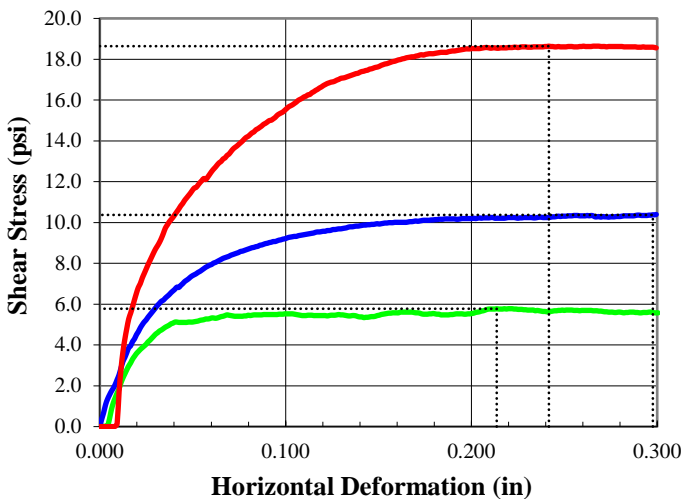
# Direct Shear Test (ASTM D3080)

Peak:  $\Phi = 31.6^\circ$ ,  $c = 1.6$  psi (237 psf)

Initial	Specimen		
	A	B	C
Moisture (%)	18.34	18.34	18.34
Dry Density (pcf)	103.23	99.42	99.03
Void Ratio	0.60	0.66	0.67
Saturation (%)	80.74	73.28	72.55
Diameter (in)	2.50	2.50	2.50
Height (in)	1.00	1.00	1.00

Final	A	B	C
Moisture (%)	22.62	22.62	22.62
Dry Density (pcf)	104.18	101.71	100.44
Void Ratio	0.59	0.63	0.65
Saturation (%)	100.0	95.8	92.8
Diameter (in)	2.50	2.50	2.50
Height (in)	0.98	0.97	0.90
Normal Stress (psi)	6.94	13.89	27.78
Shear Stress (psi)(@Peak)	5.78	10.38	18.64
Peak Strain (%)	8.54	11.89	9.66
Rate (in/min)	0.0033	0.0033	0.0033
Peak Deformation (in.)	0.213	0.297	0.241

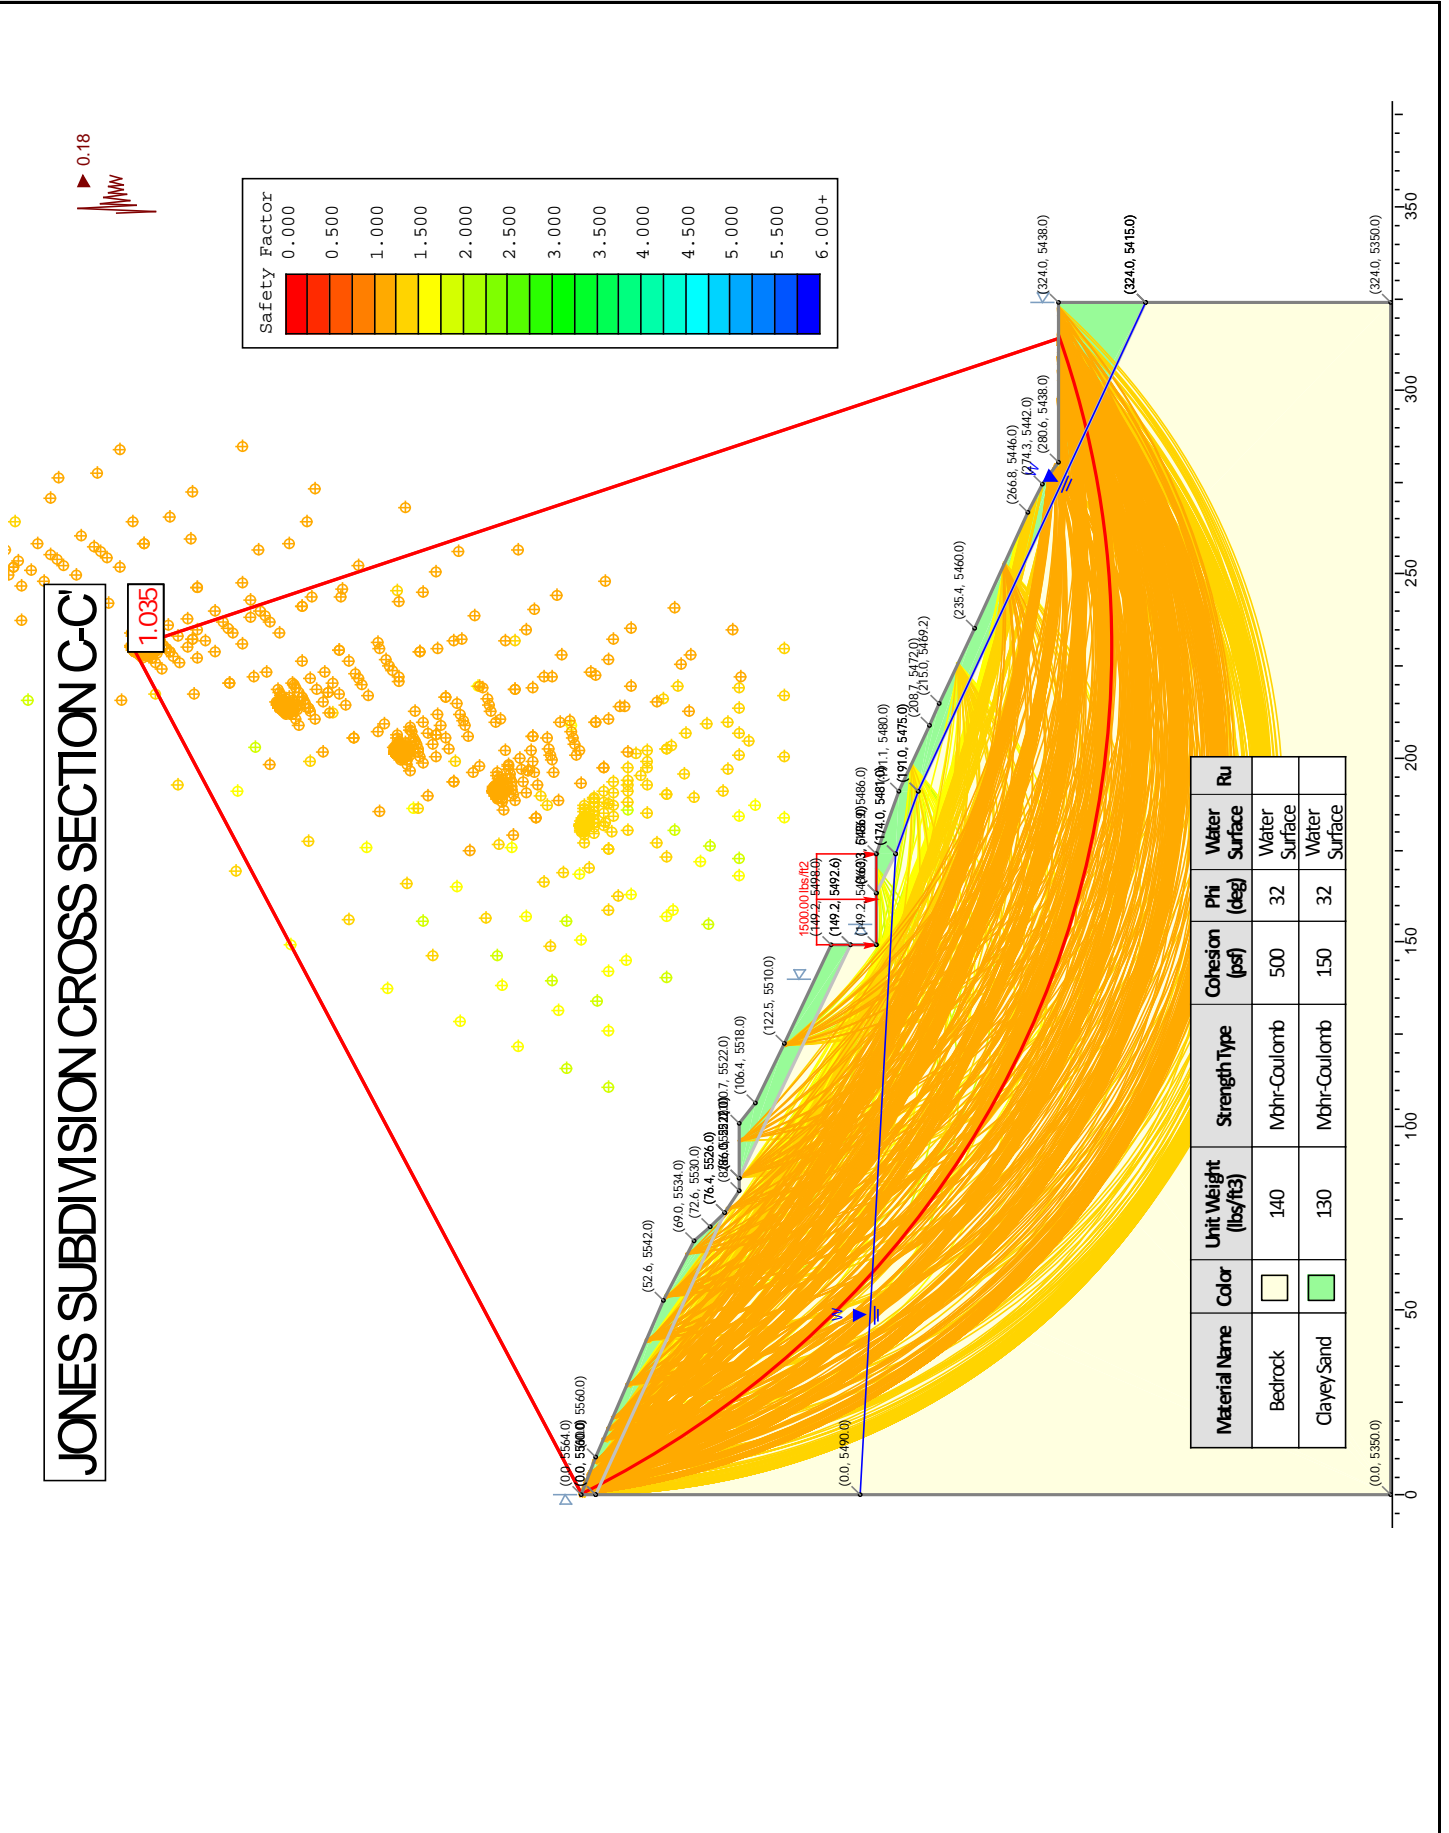
# Stability Results - Seismic

into the existing hillside. Typically, the required minimum factors of safety are 1.5 for static conditions and 1.0 for seismic (pseudostatic) conditions. The results of our analyses indicate that the slopes on the three lots will meet both these requirements, provided the structures are not placed on the Qms material shown in Figure 5. The analyses are graphically shown on **Figures 10 through 15, Stability Results**, provided in the Appendix, and are summarized in the following table.

CONDITION	SEISMIC COEFFICIENT	SLOPE CROSS-SECTION	SLIDE LOWEST FACTOR OF SAFETY	MINIMUM ALLOWABLE FACTOR OF SAFETY
Static	---	A-A'	1.51	1.5
Seismic	0.18	A-A'	1.04	1.0
Static	---	B-B'	1.44*	1.5
Seismic	0.18	B-B'	1.05	1.0
Static	---	C-C'	1.55	1.5
Seismic	0.18	C-C'	1.04	1.0
