GEOLOGIC HAZARDS EVALUATION PROPOSED LEGACY MOUNTAIN DEVELOPMENT SECTIONS 14 AND 23, TOWNSHIP 6 NORTH, RANGE 1 EAST HUNTSVILLE, WEBER COUNTY, UTAH

Letter of Transmittal: REPORT
Geologic Hazards Evaluation
Proposed Legacy Mountain Development
Sections 14 and 23, Township 6 North, Range 1 East
Huntsville, Weber County, Utah

WG&E Project No. 5515

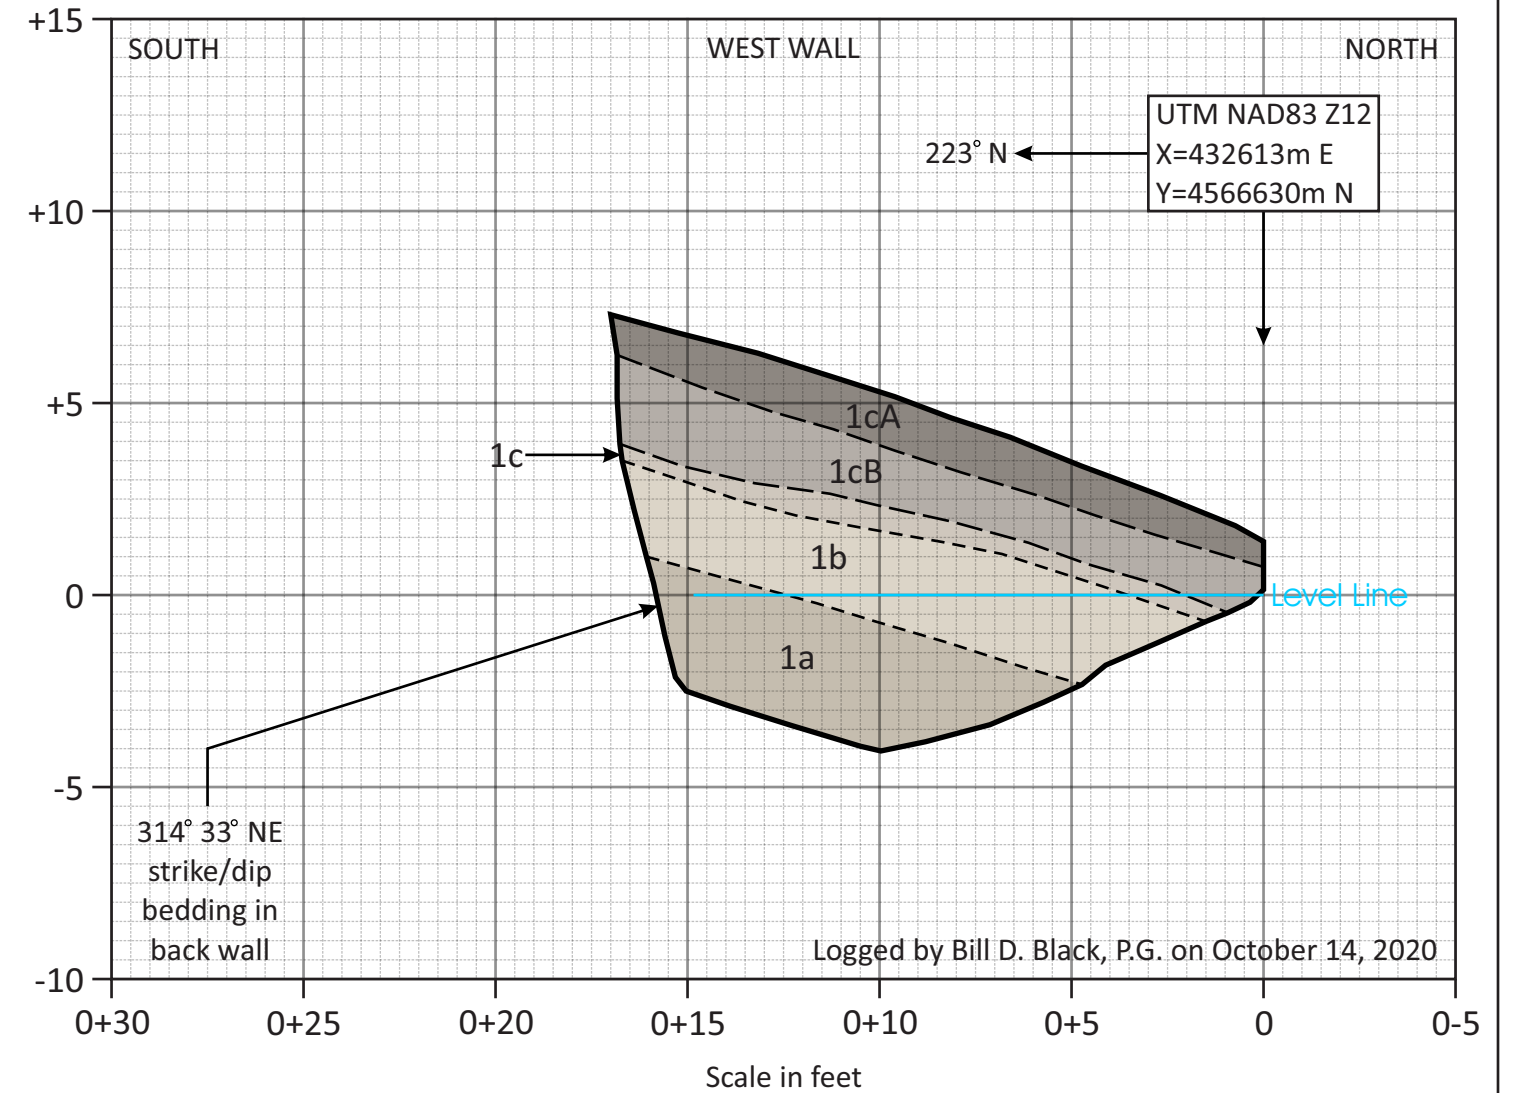
TEST PIT 2

Unit 1. *Tertiary Norwood Formation* - sequence comprised of a lower (1a) light-olive-brown, high density, poorly bedded, fine-grained tuffaceous sandstone; a middle (1b) pale-brownish-olive, high density, well bedded, fine-grained tuffaceous sandstone; and an upper (1c) pale-olive, moderate-high density, poorly bedded, sandy claystone; A and B soil horizons formed in unit 1c at surface (units 1cA and 1cB).

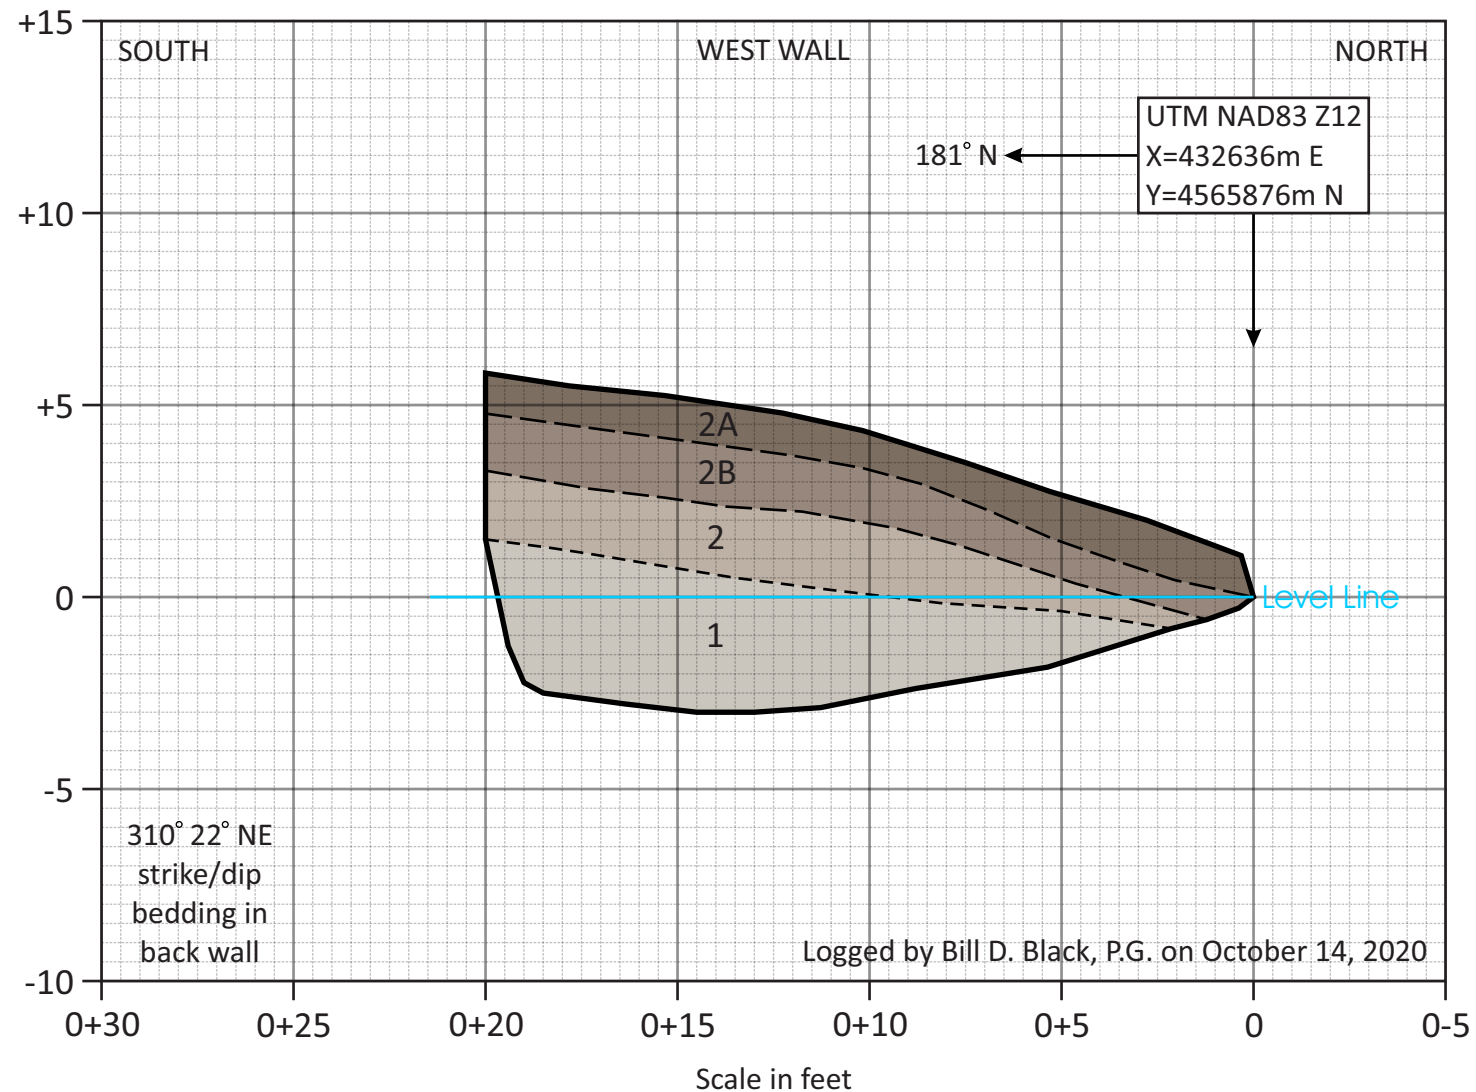
TEST PIT 22

Unit 1. Tertiary Norwood Formation - weathered, light olive-gray, high density, poorly to well bedded, tuffaceous sandstone.
