## **GEOLOGIC HAZARDS EVALUATION LEGACY MOUNTAIN DEVELOPMENT SECTIONS 23 AND 24, TOWNSHIP 6 NORTH, RANGE 1 EAST HUNTSVILLE, WEBER COUNTY, UTAH**

**Letter of Transmittal:** REPORT UPDATE  
Geologic Hazards Evaluation  
Legacy Mountain Development  
Sections 23 and 24, Township 6 North, Range 1 East  
Huntsville, Weber County, Utah

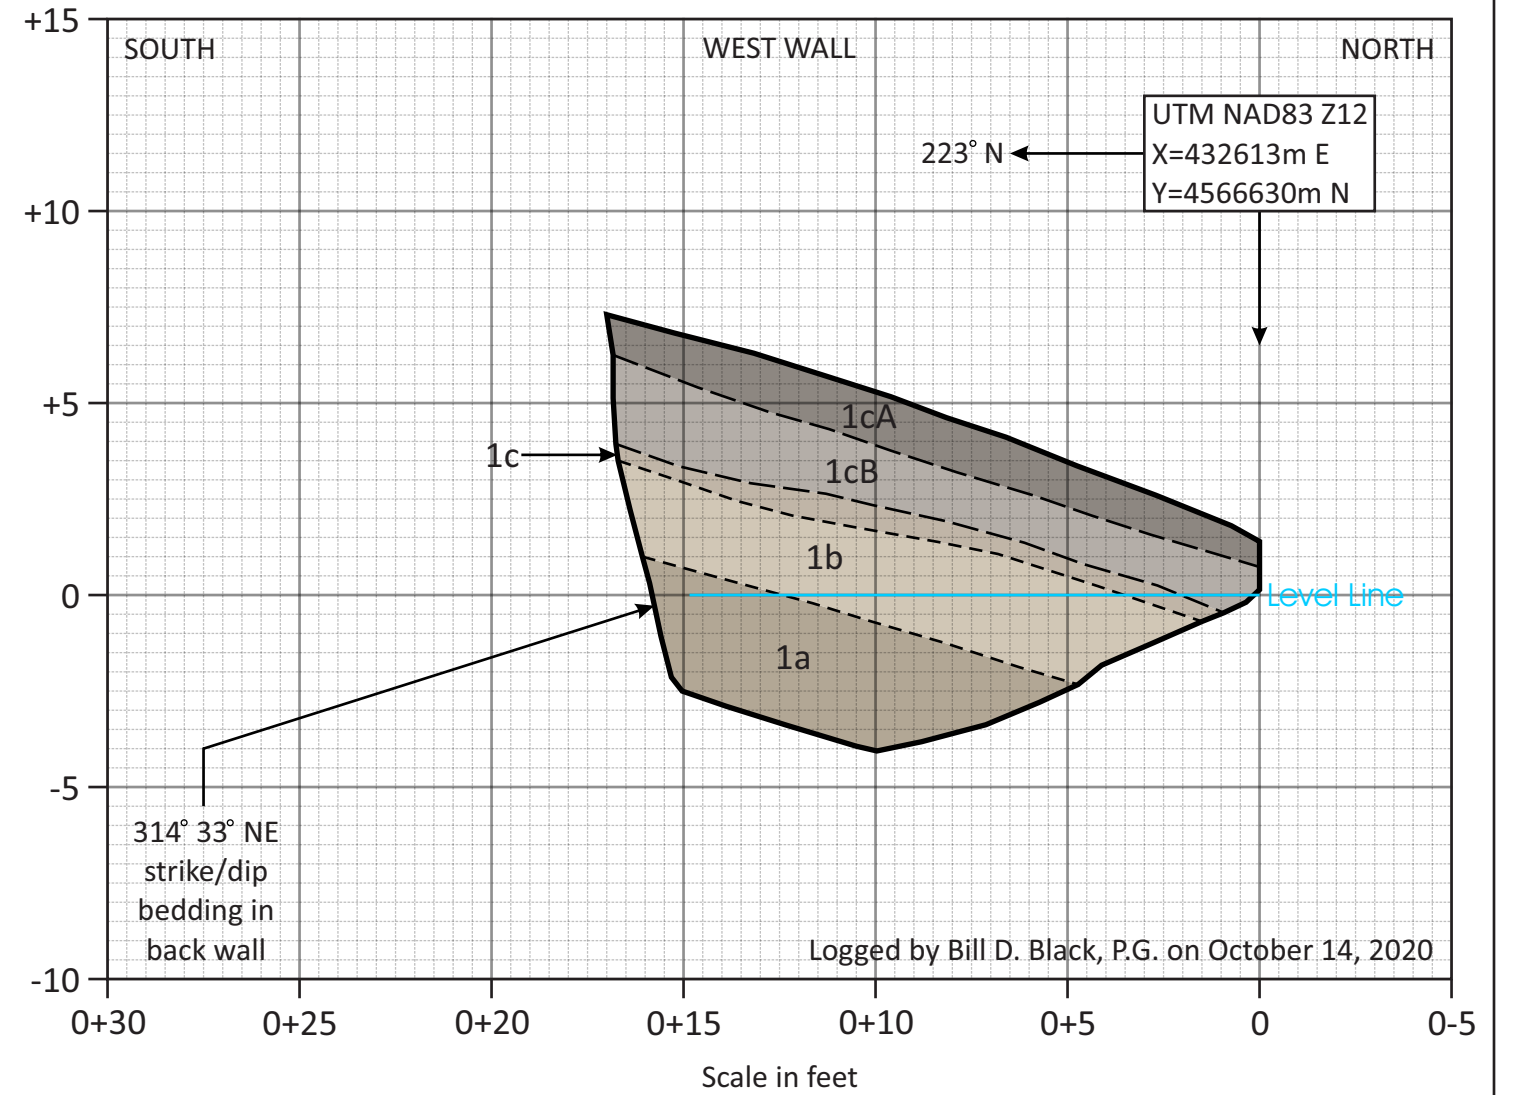
### TEST PIT 2

**Unit 1.** Tertiary Norwood Formation - sequence comprised of a lower (1a) light-olive-brown, high density, poorly bedded, fine-grained tuffaceous sandstone; a middle (1b) pale-brownish-olive, high density, well bedded, fine-grained tuffaceous sandstone; and an upper (1c) pale-olive, moderate-high density, poorly bedded, sandy claystone; A and B soil horizons formed in unit 1c at surface (units 1cA and 1cB).

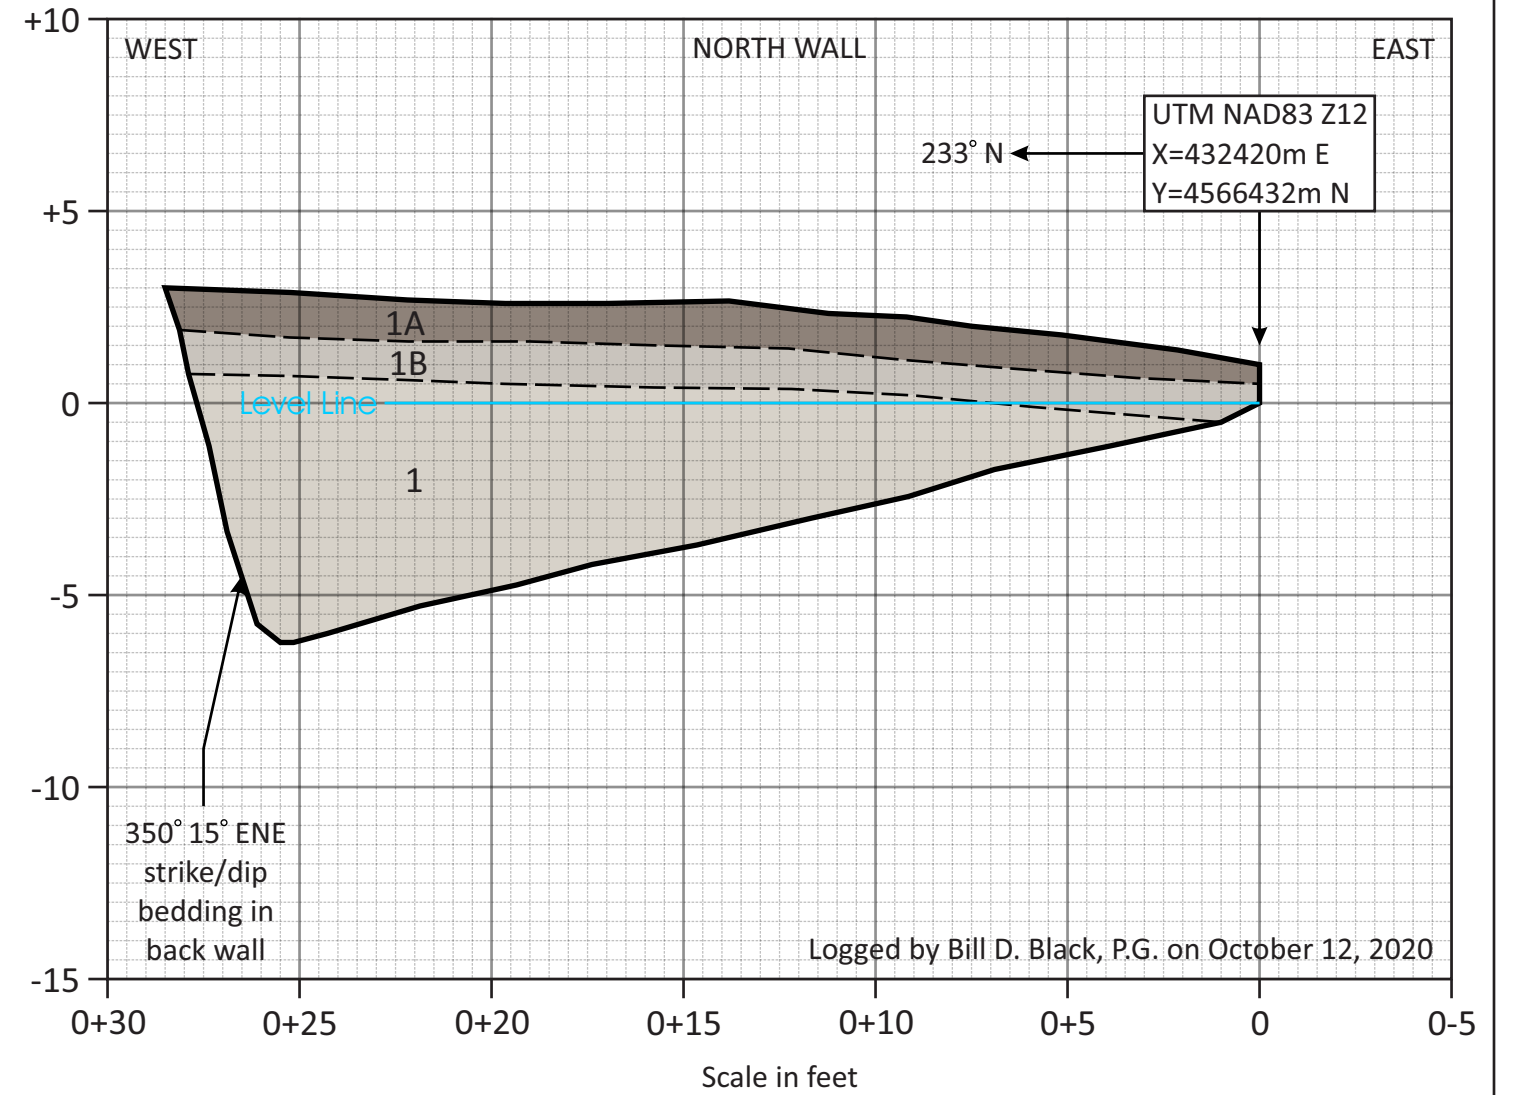
### TEST PIT 8

**Unit 1.** Tertiary Norwood Formation - weathered, pale-olive-gray, moderate-high density, thinly bedded, tuffaceous sandstone to siltstone; A and B soil horizons formed at surface (units 1A and 1B).

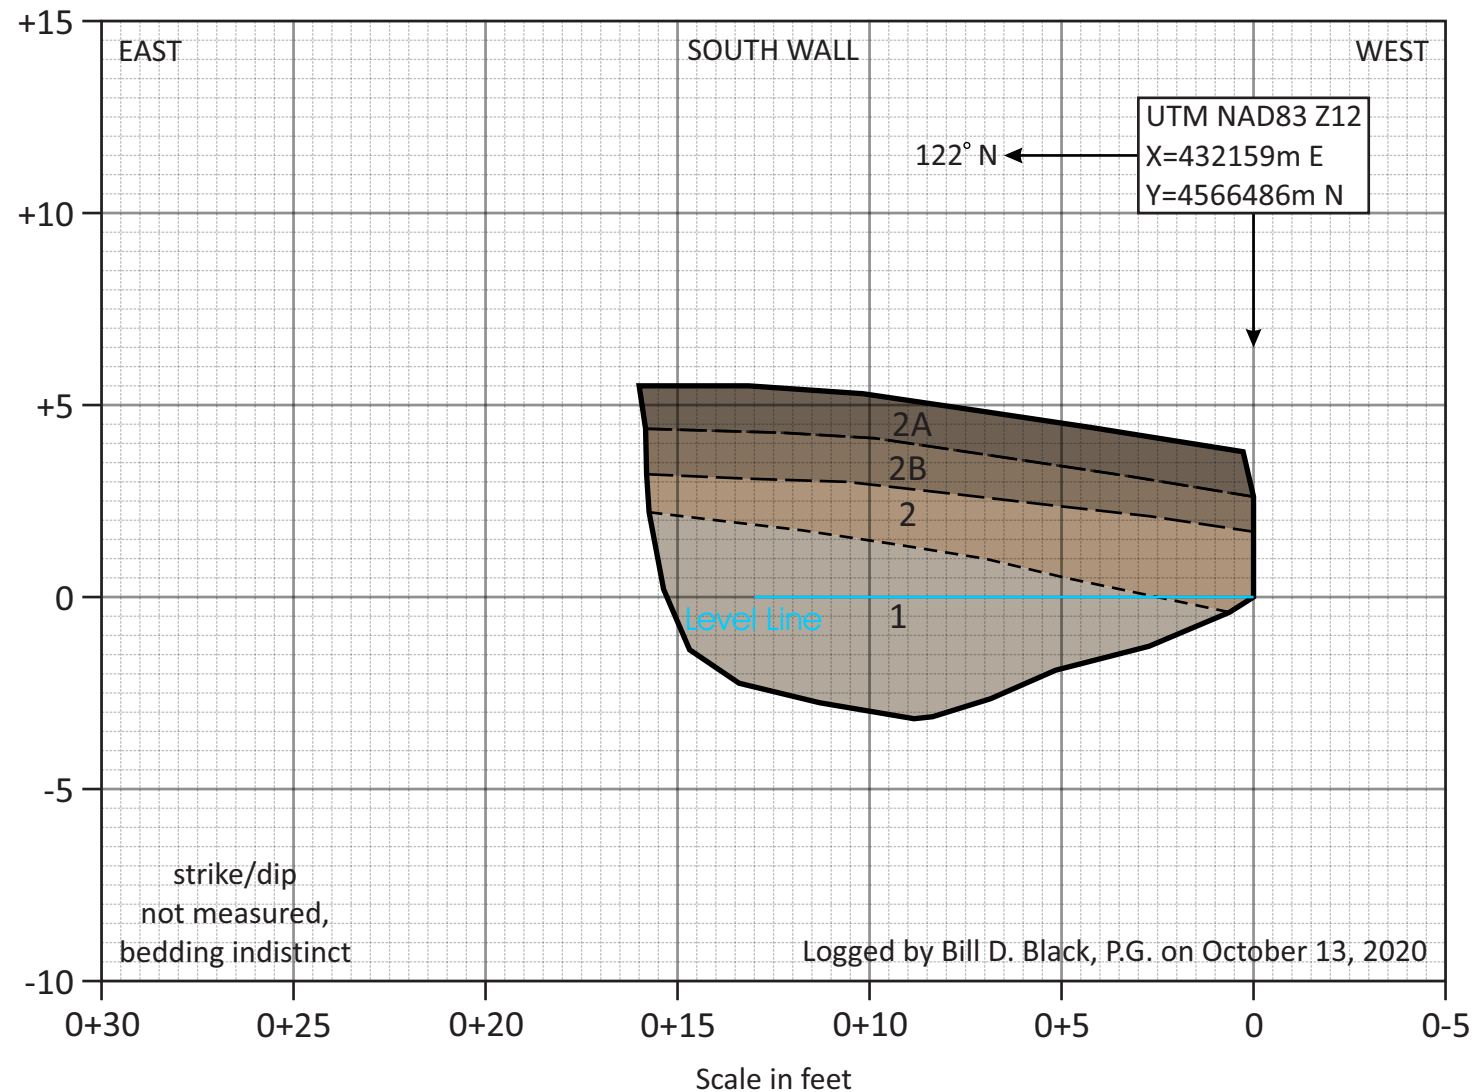
### TEST PIT 12

**Unit 1.** *Tertiary Norwood Formation* - highly weathered, light-olive-brown, high density, poorly bedded to massive, tuffaceous sandstone.

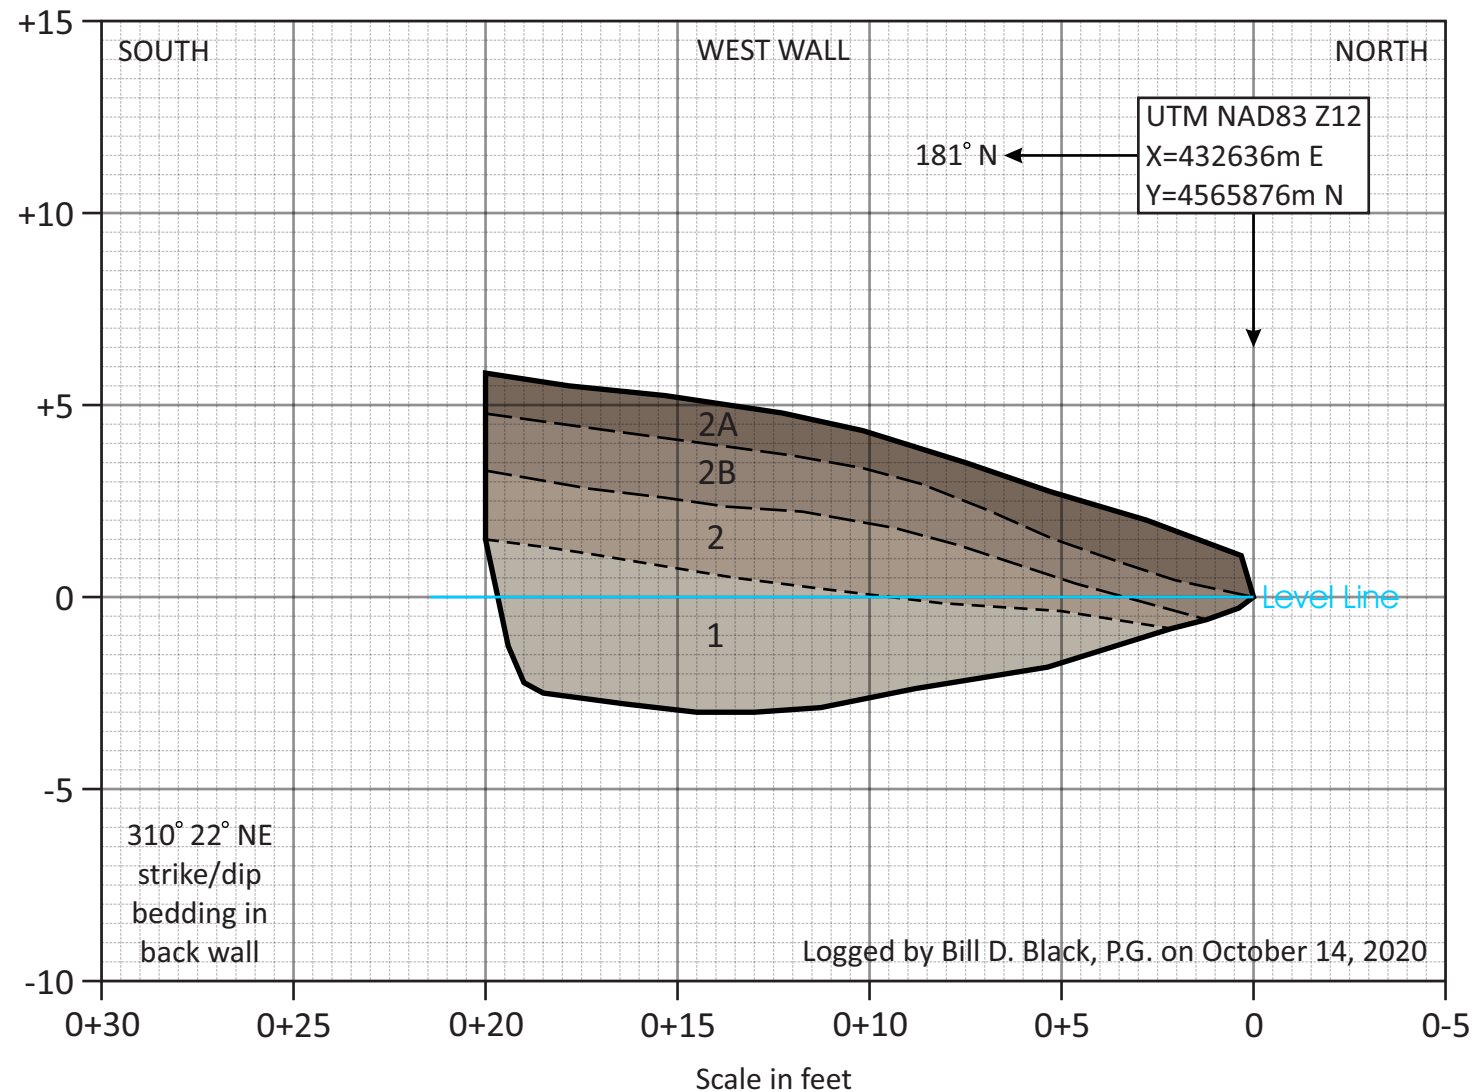
### TEST PIT 22

**Unit 1.** Tertiary Norwood Formation - weathered, light olive-gray, high density, poorly to well bedded, tuffaceous sandstone.

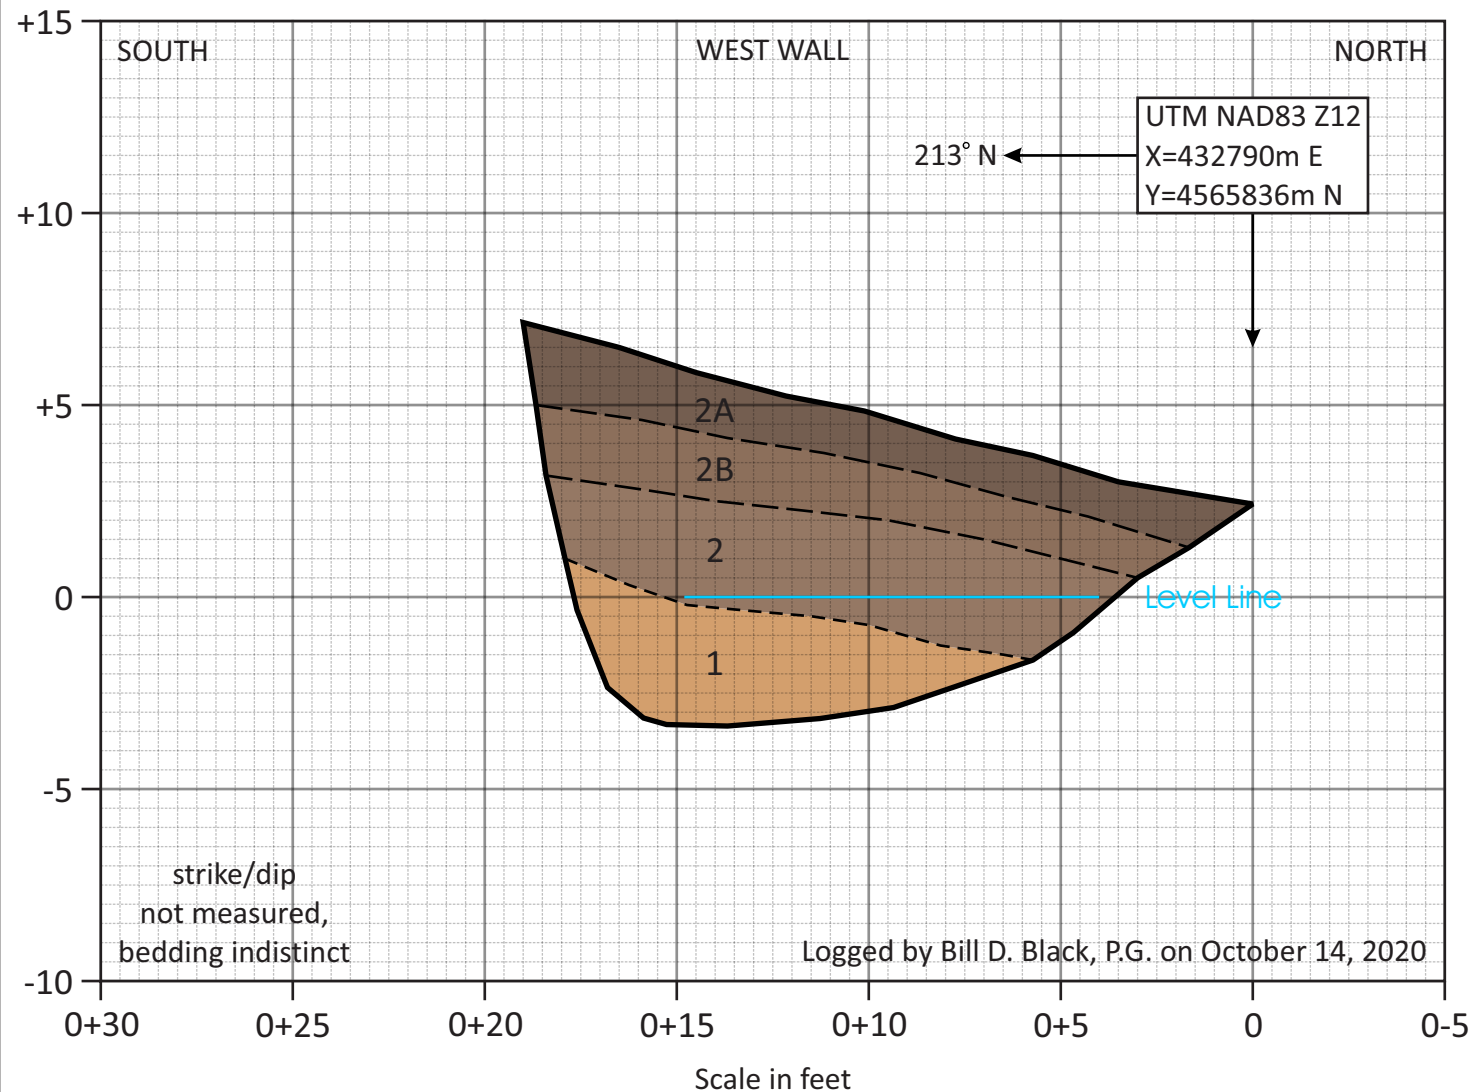
### TEST PIT 23

**Unit 1.** Pleistocene landslide colluvium - yellowish-brown, high density, massive, lean to fat clay (CL/CH) with gravel.

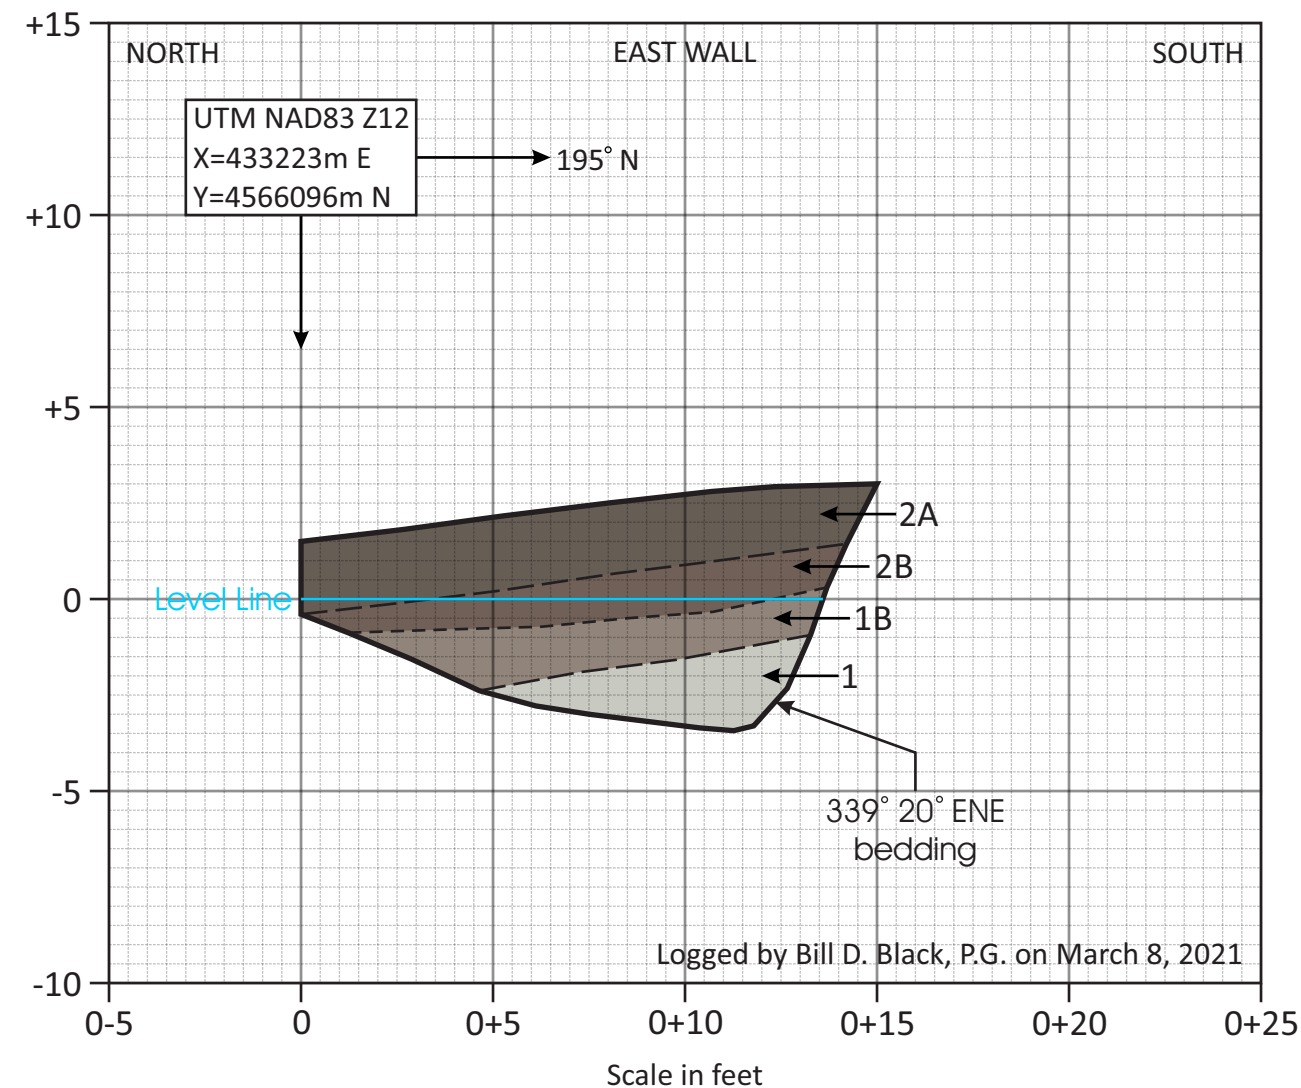
### TEST PIT 30

**Unit 1.** *Tertiary Norwood Formation* - weathered olive-brown to light-grayish-olive, thinly bedded, dense, tuffaceous sandstone with carbonate; Bt horizon formed in unit 1b (1B).

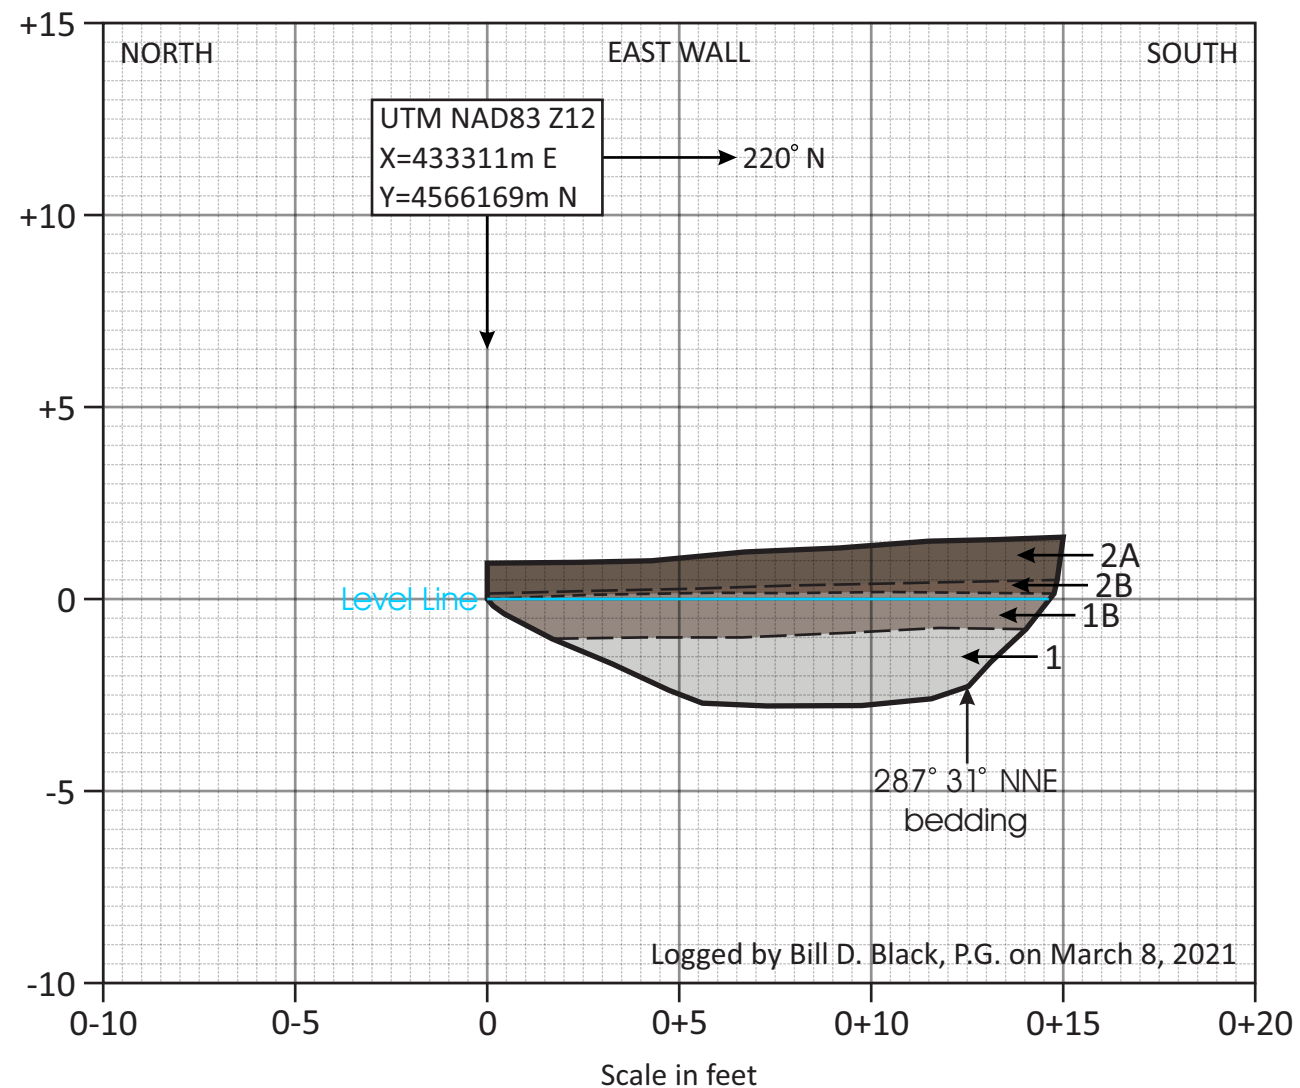
### TEST PIT 31

**Unit 1.** *Tertiary Norwood Formation* - pale to gray olive-brown, thinly bedded, dense, tuffaceous sandstone; carbonate-enriched, refusal at 4 feet; Bt horizon formed in unit (1B).

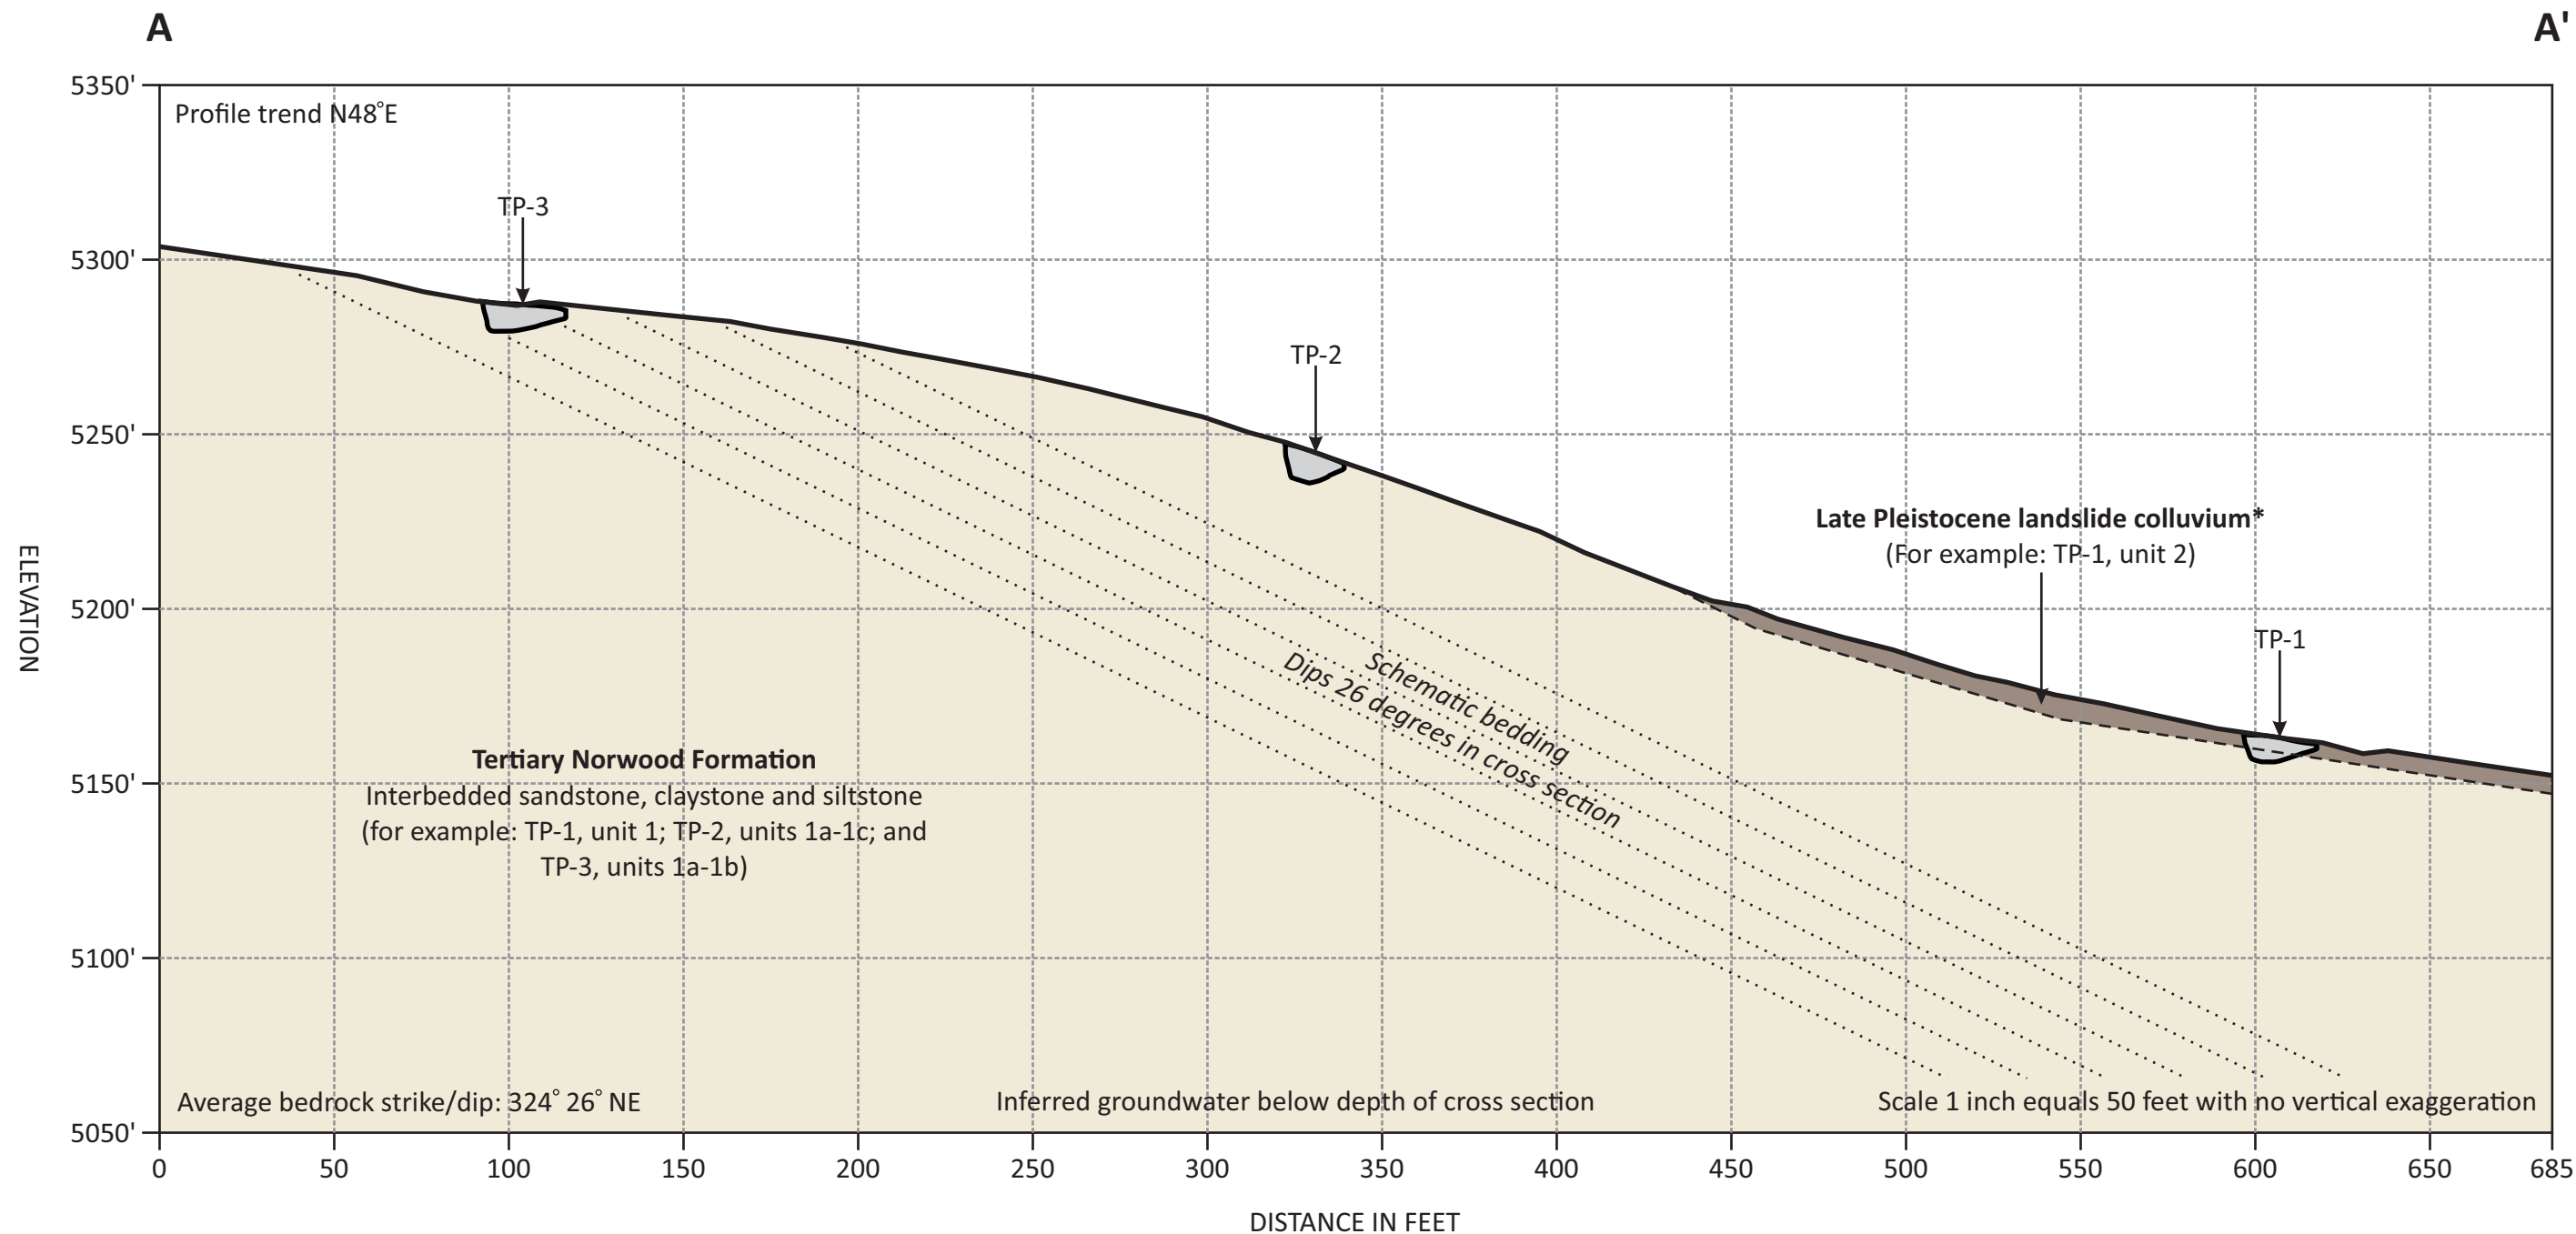
**FIGURE 5A**

Contacts are based on subsurface data and the surficial geologic mapping on Plate 1.  
 Topographic profile determined by Global Mapper using 2016 LIDAR data. Inferred groundwater is based on reported depths in nearby wells. All contacts and groundwater (if shown) are approximate and may vary. Schematic bedding is based on average strike/dip, profile trend, and dips determined using <http://app.visiblegeology.com/apparentDip.html>.

**CROSS SECTION A-A'**

Figures 5A-J show the geologic cross sections across critical slopes at the site. The scales vary between 1 inch equals 50 feet to 1 inch equals 100 feet, depending on the profile length and space constraints, with no vertical exaggeration. Locations of the cross sections are shown on Plate 1. Units and contacts are based on subsurface data from the test pits (Figures 4A-Q) and/or inferred from the geologic mapping on Plate 1. The topographic profile is based on geoprocessed 2016 LIDAR data. The LIDAR data provides a snapshot of topographic conditions at the time it was acquired; past, present and future surficial topography may vary. Units and contacts should be considered approximate and inferred, and variations should be expected at depth and laterally. We caution that some portions of the cross sections have limited or no subsurface data, particularly at depth. Schematic bedding dips were defined by <http://app.visiblegeology.com/apparentDip.html> based on the profile trend and average strike and dips measured in test pits along the profile or nearby. We conservatively recommend residual strengths be used in slope stability analyses for colluvial units shown with an asterisk on the cross sections, although these units may not be landslide deposits in all cases.

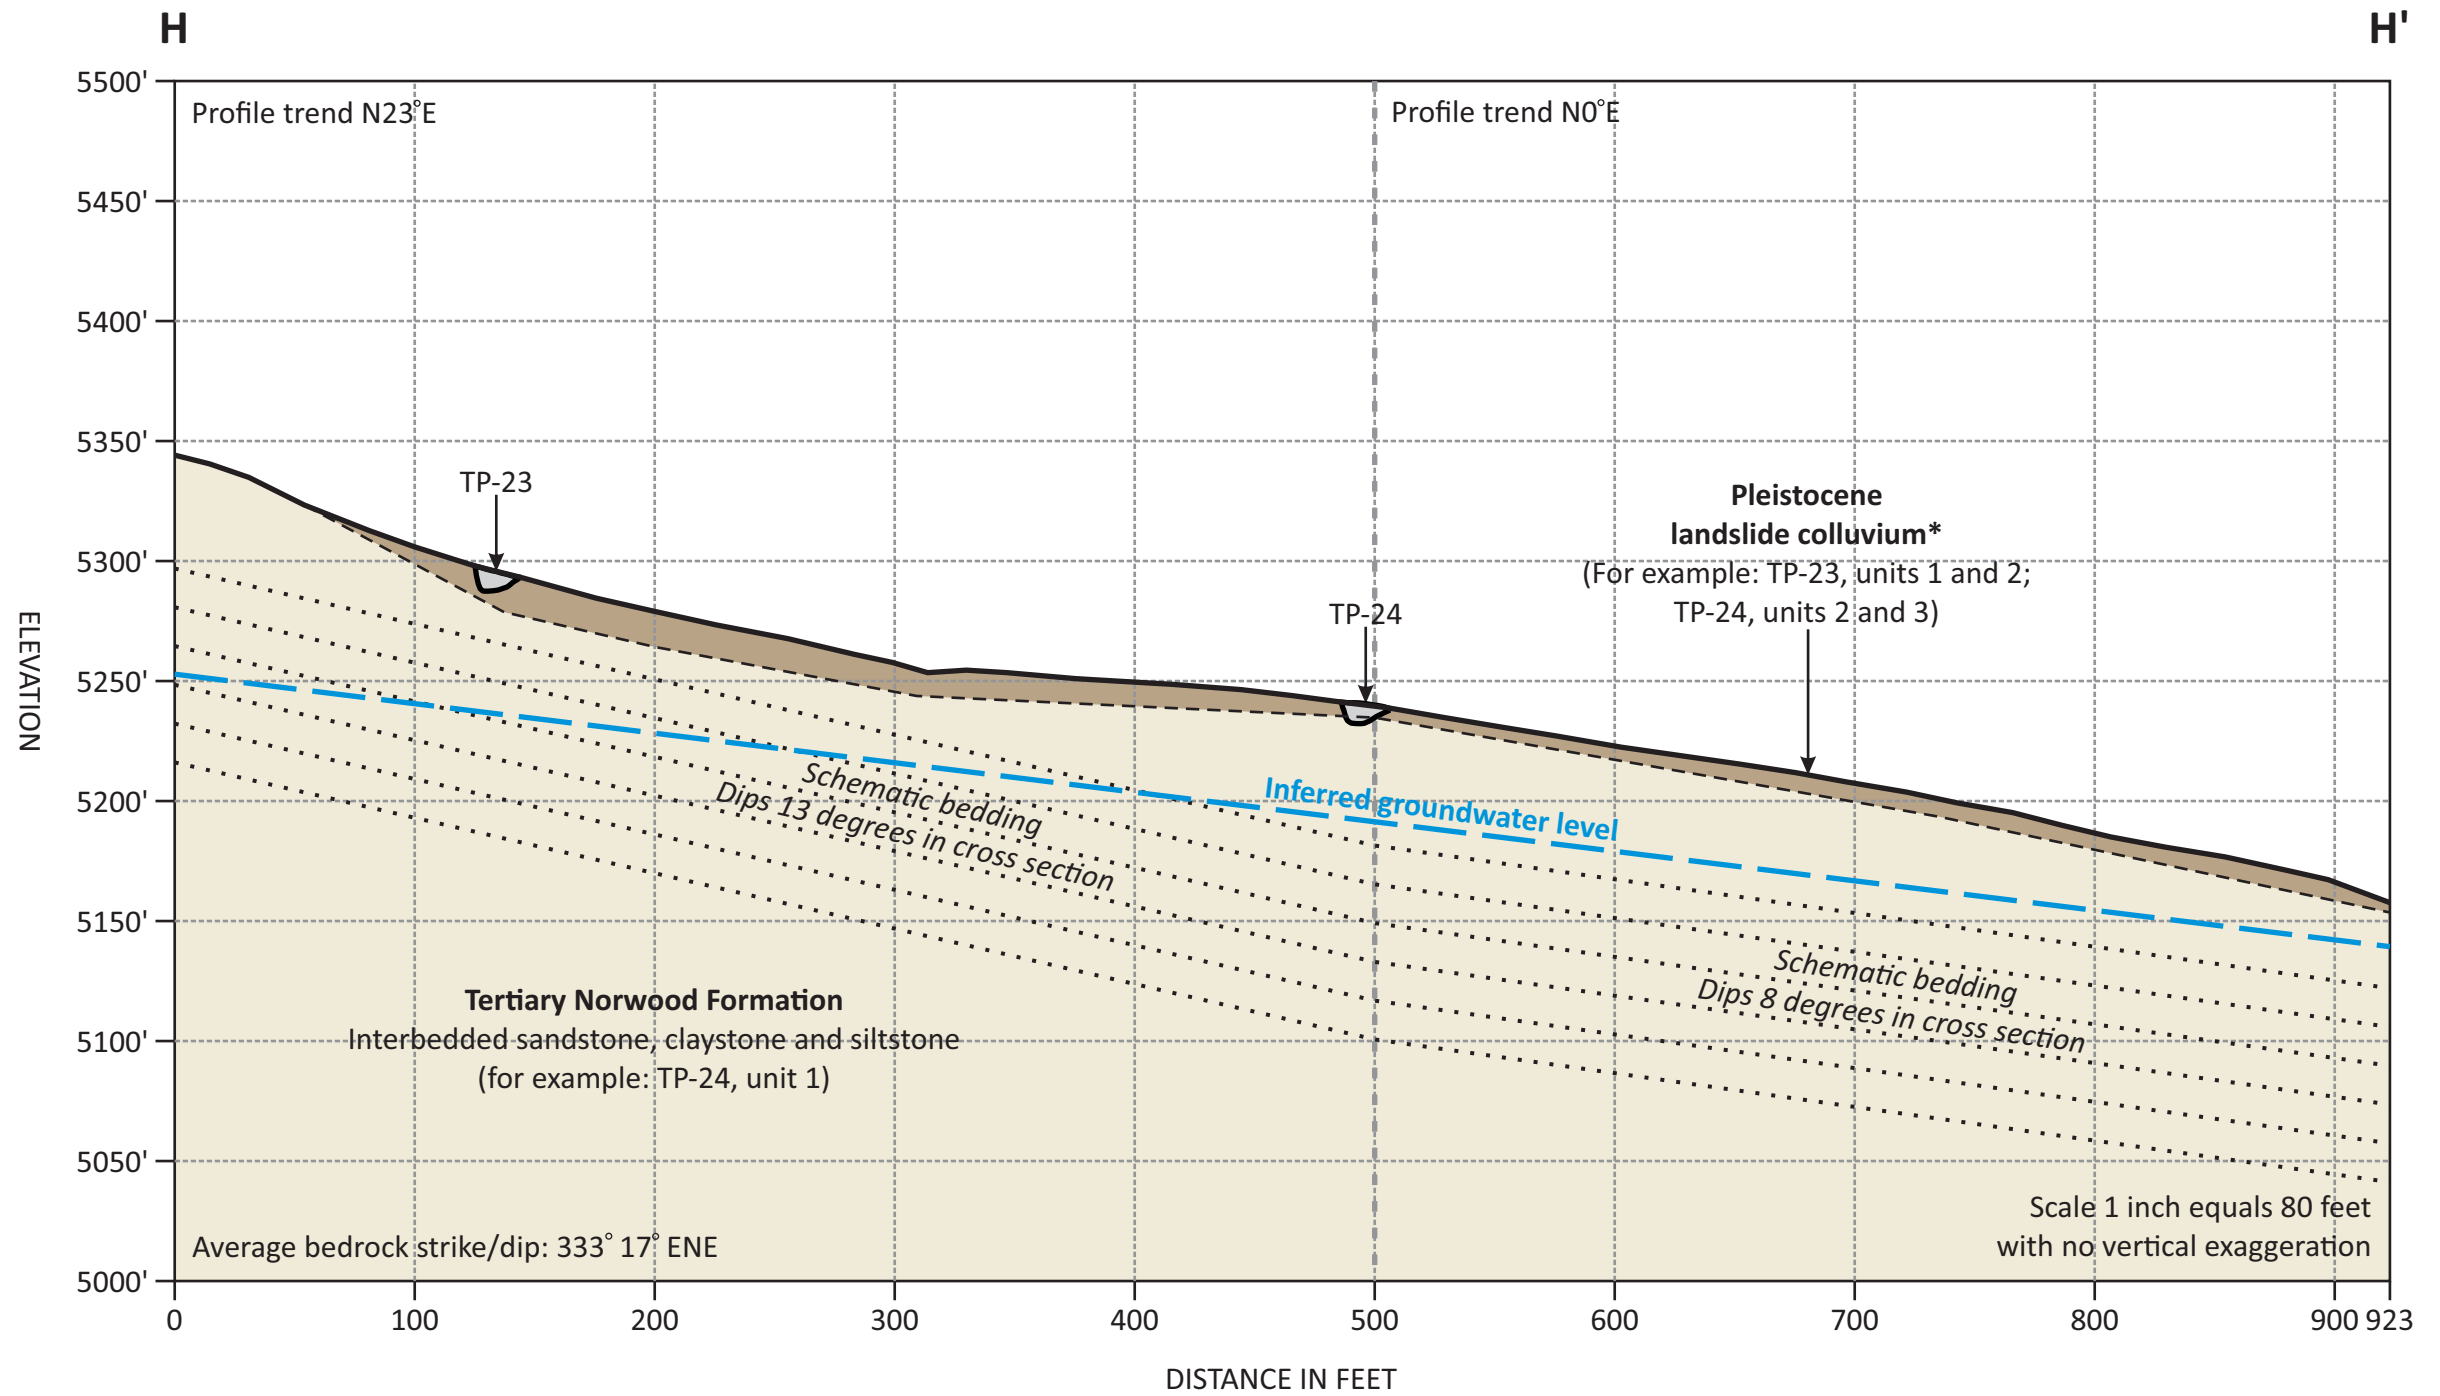
**CROSS SECTION H-H'**

Contacts are based on subsurface data and the surficial geologic mapping on Plate 1.  
Topographic profile determined by Global Mapper using 2016 LIDAR data. Inferred groundwater is based on reported depths in nearby wells. All contacts and groundwater (if shown) are approximate and may vary. Schematic bedding is based on average strike/dip, profile trend, and dips determined using <http://app.visiblegeology.com/apparentDip.html>.
