Staff Report for Administrative Hillside Review Approval

Application Request: Consideration and action on a Hillside Review Application for 8448 E. Copper Crest Rd., Eden.
Type of Decision: Administrative
Applicant: Jim and Penny Lacy
File Number: HSR 2021-02

A New Residence:
PENNY AND JIM LACY
Summit Powder Mountain, Lot # 147
- Copper Crest, Utah

GEOTECHNICAL AND GEOLOGIC HAZARD INVESTIGATION
West Village Sliver
Summit Powder Mountain Resort
Weber County, Utah

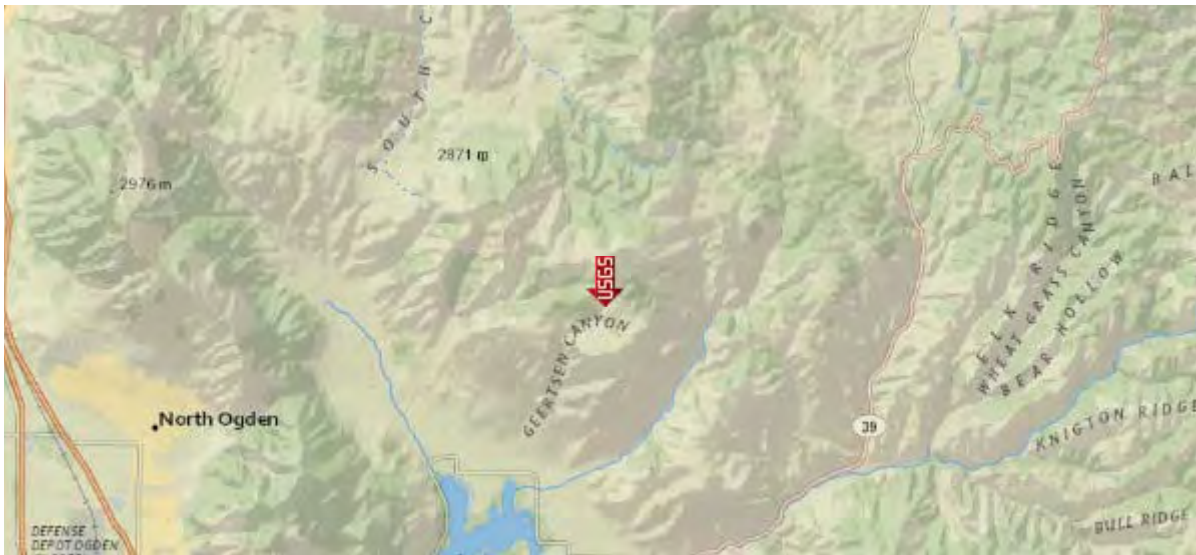
USGS-Provided Output

$S_s = 0.810 \text{ g}$	$S_{MS} = 0.872 \text{ g}$	$S_{DS} = 0.581 \text{ g}$
$S_1 = 0.269 \text{ g}$	$S_{M1} = 0.411 \text{ g}$	$S_{D1} = 0.274 \text{ g}$
