Geotechnical Investigation Smart Acres Development Ogden, Utah

December 2, 2021

**Geotechnical Investigation
Smart Acres Development
2575 West 1200 South
West Haven, Utah
CG Project No.: 145-014**

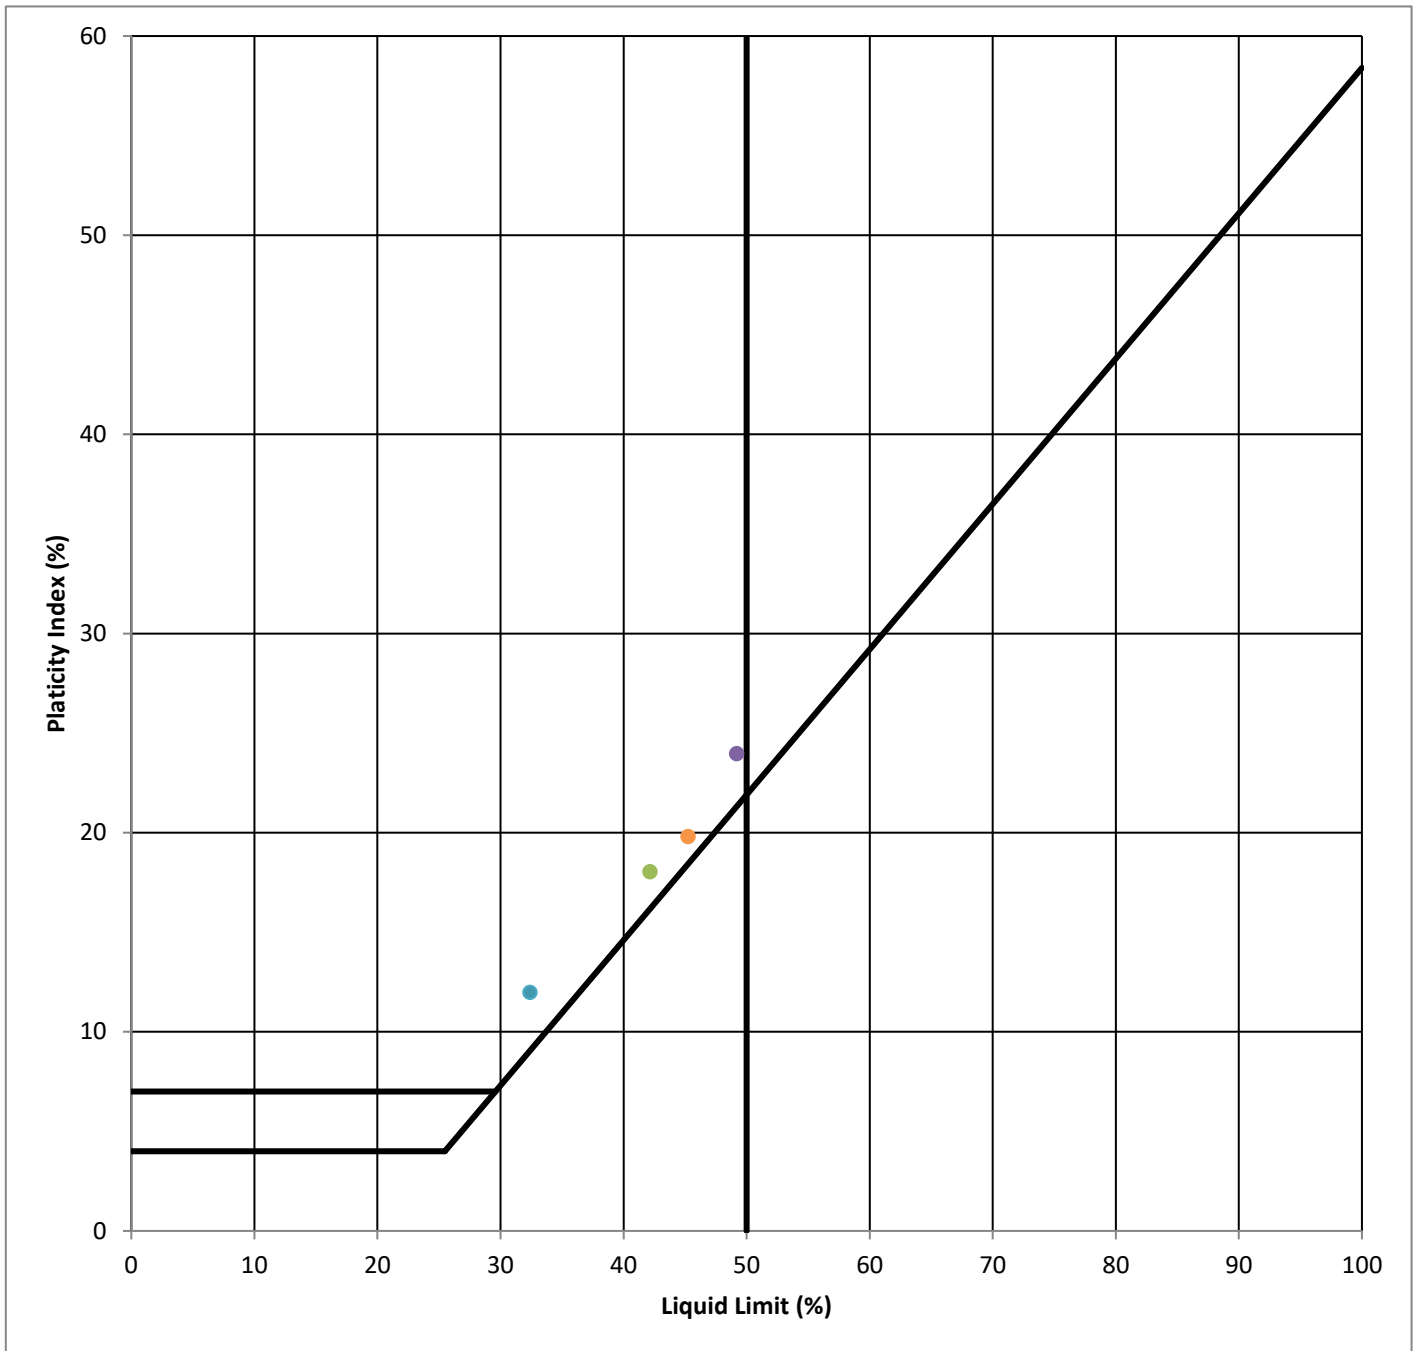
Atterberg Limits

Location	Depth (ft)		Classification	Liquid Limit	PI
TP-12	2	●	Lean CLAY with sand	32	12
TP-13	6	●	Lean CLAY with sand	45	20
B-1	25	●	Lean CLAY	42	18
B-1	40	●	Lean CLAY	49	24

The results of our laboratory tests are also presented on the Test Pit Logs and the Boring Log, Plates 3 through 19, and more detailed laboratory results are presented on the laboratory testing plates, Plates 21 through 24.

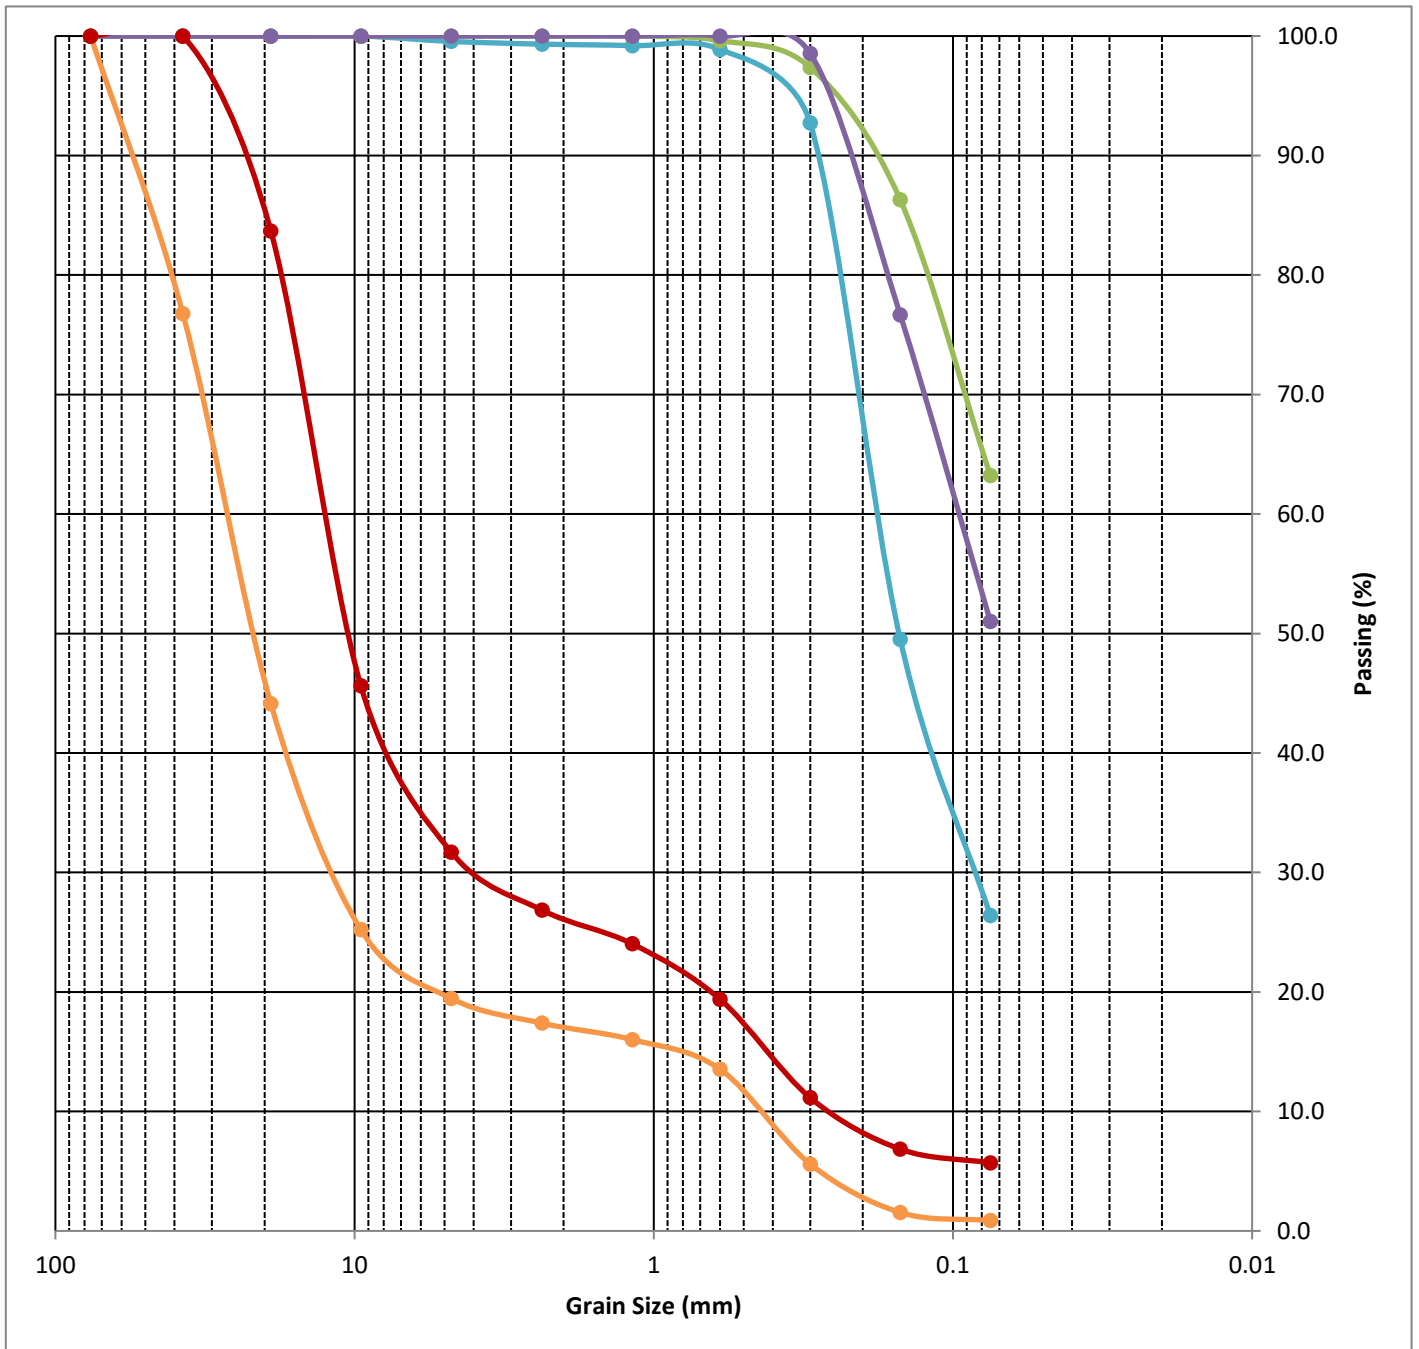
Grain Size Distribution

Location	Depth		Classification	% Gravel	% Sand	% Silt and Clay
TP-1	2	●	Silty SAND	0.5	73.2	26.4
TP-2	7	●	Poorly Graded GRAVEL with sand	80.5	18.6	0.9
TP-3	2	●	Sandy SILT	0.0	36.8	63.2
TP-4	2	●	Sandy SILT	0.0	49.0	51.0
TP-5	3	●	Poorly Graded GRAVEL with silt and sand	68.3	26.0	5.7
