**Geotechnical Investigation  
Grove Cabin PRUD Phase 1 & Future Lots  
Eden, Utah**

**Geotechnical Investigation  
Grove Cabins PRUD Phase 1 & Future Lots  
Approximately 4650 North Seven Bridges Road  
Eden, Utah  
CG Project No.: 133-019**

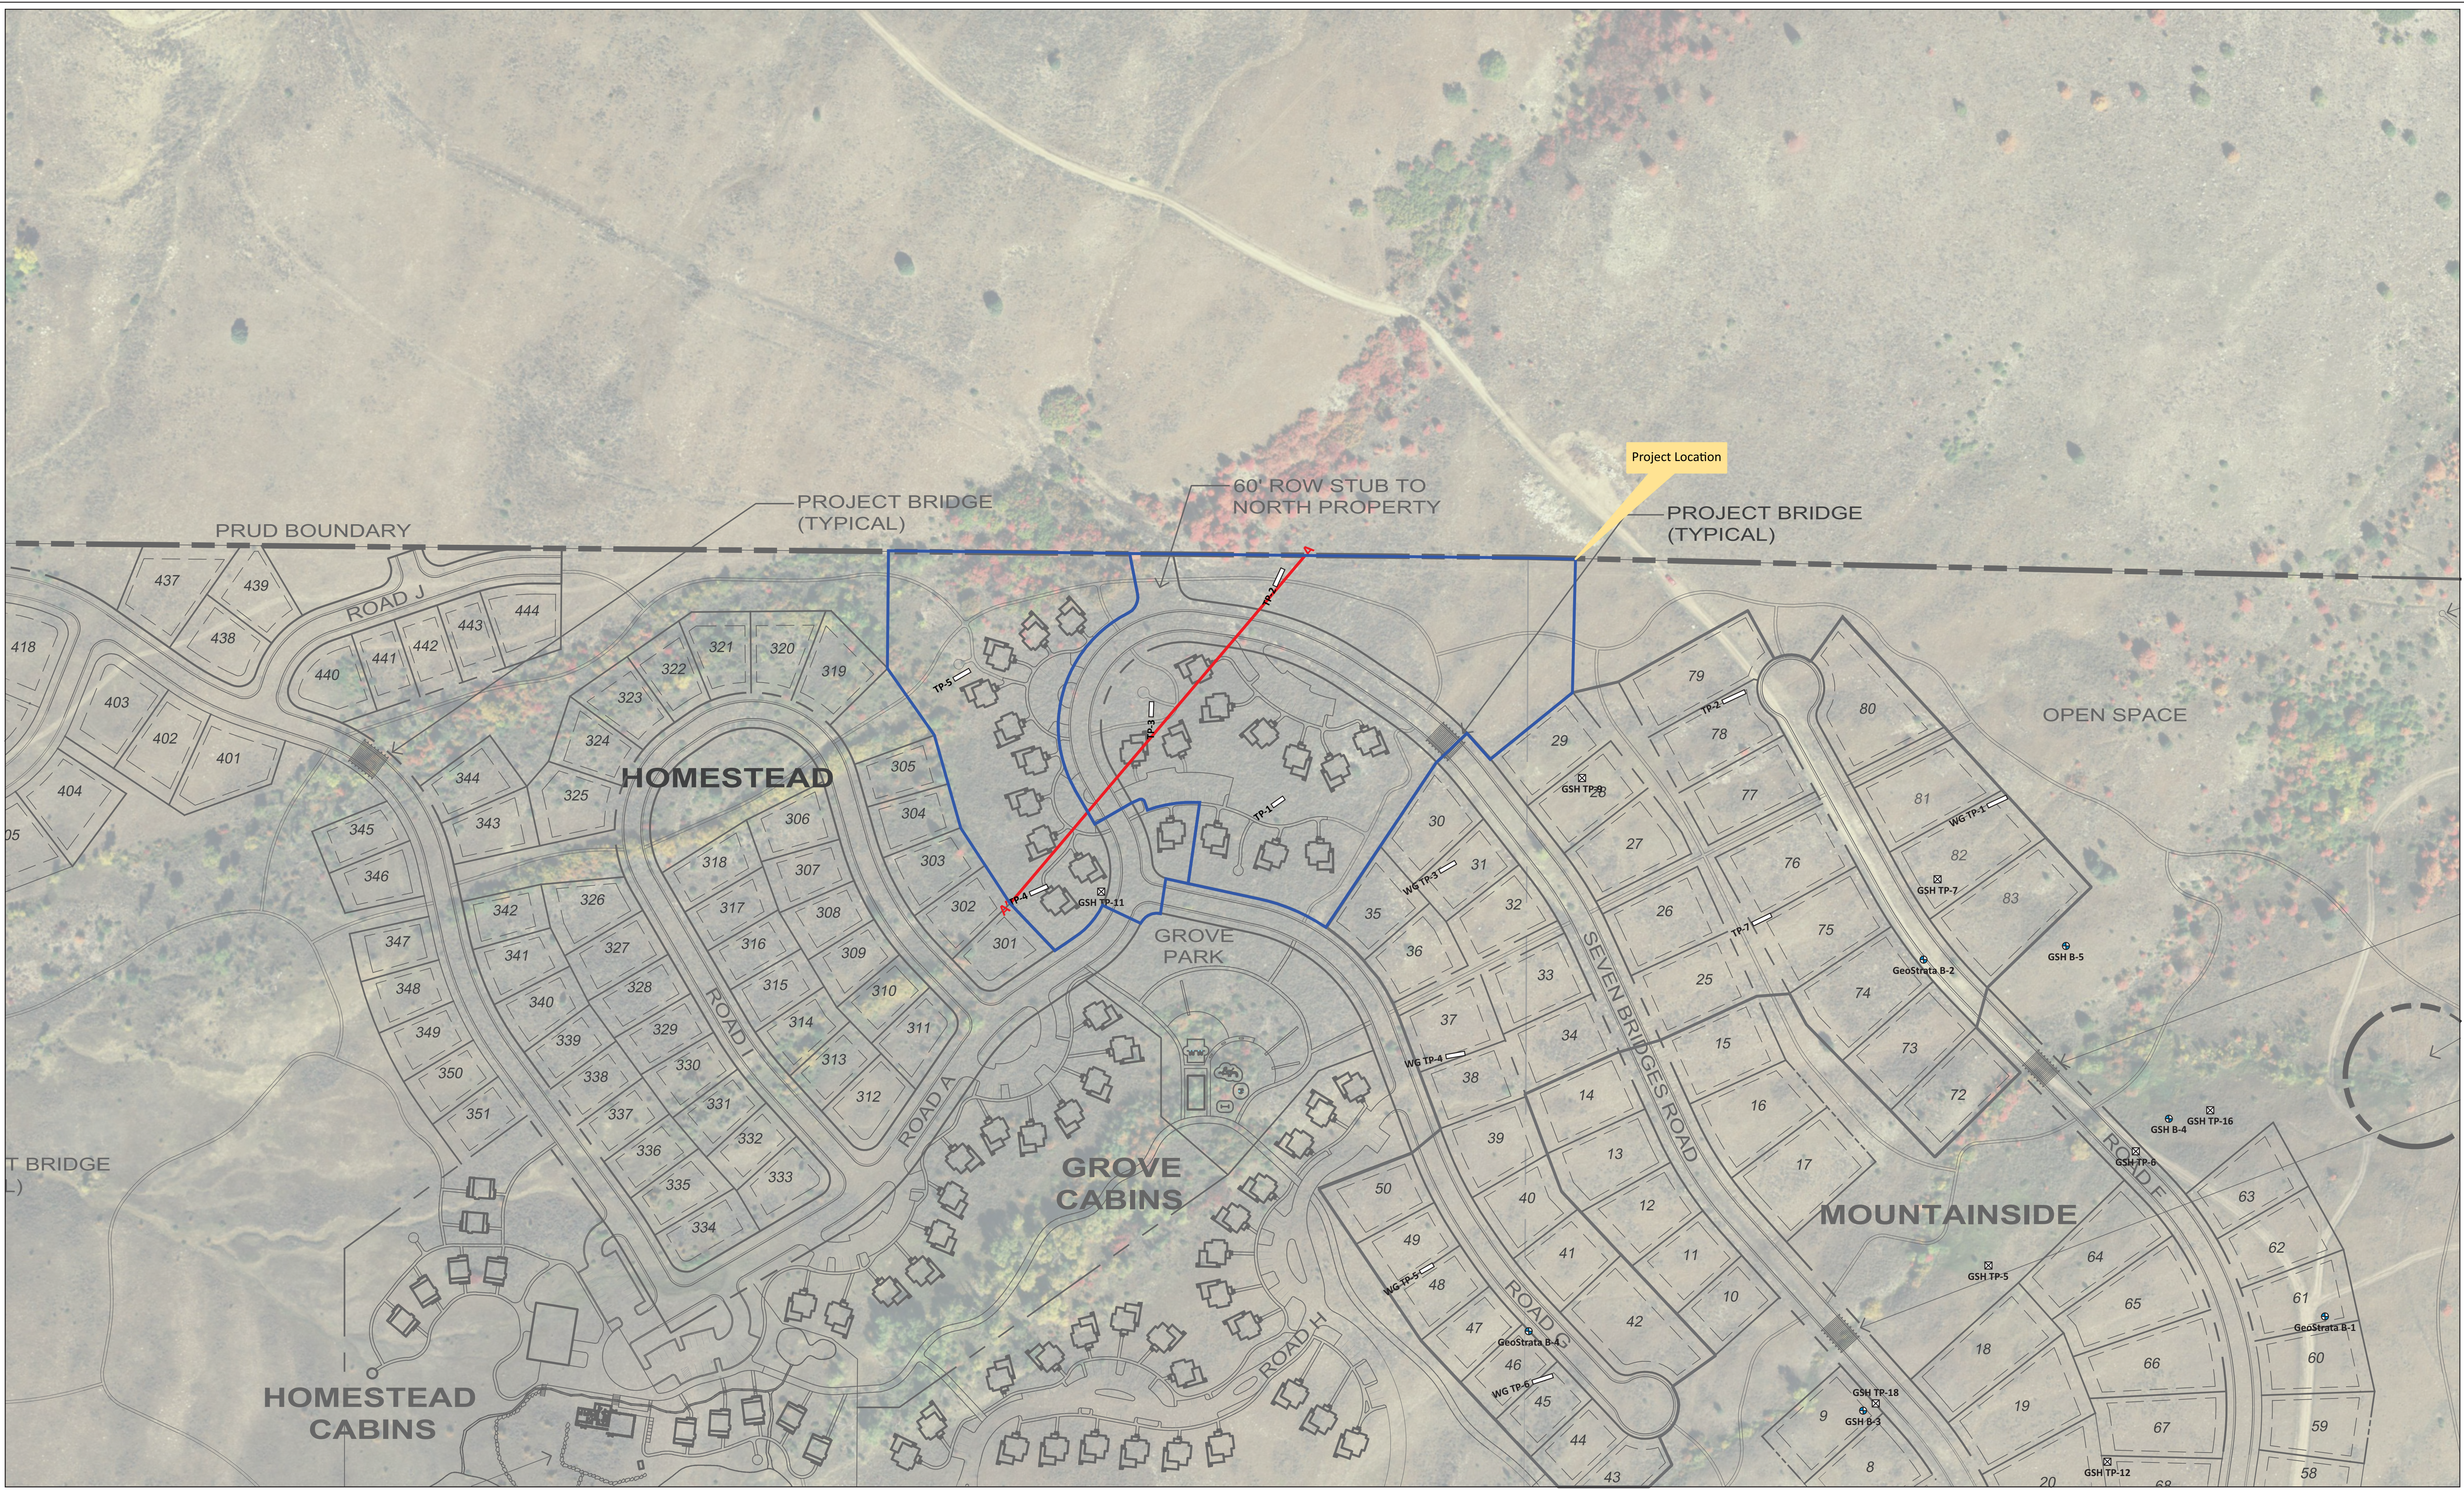
Lewis Homes  
 Grove Cabins PRUD Phase 1 and Future Lots  
 Eden, Weber County, Utah,  
 Project No. 133-019  
**Exploration Locations**

Base: Utah Geospatial Resource Center high resolution orthophoto. Site plan modified from Langvardt Design Group overall site plan sheet P1.2 dated June 2019.

The subsurface conditions at the site were explored by excavating five test pits to depths of 5½ to 8 feet below the existing site grade. The approximate test pit locations are shown on the Exploration Location Map, Plate 2. The subsurface conditions as encountered in the test pits were recorded at the time of excavation and are presented on the attached Test Pit Logs, Plates 3 to 7. A key to the symbols and terms used on the Test Pit Logs may be found on Plate 8.

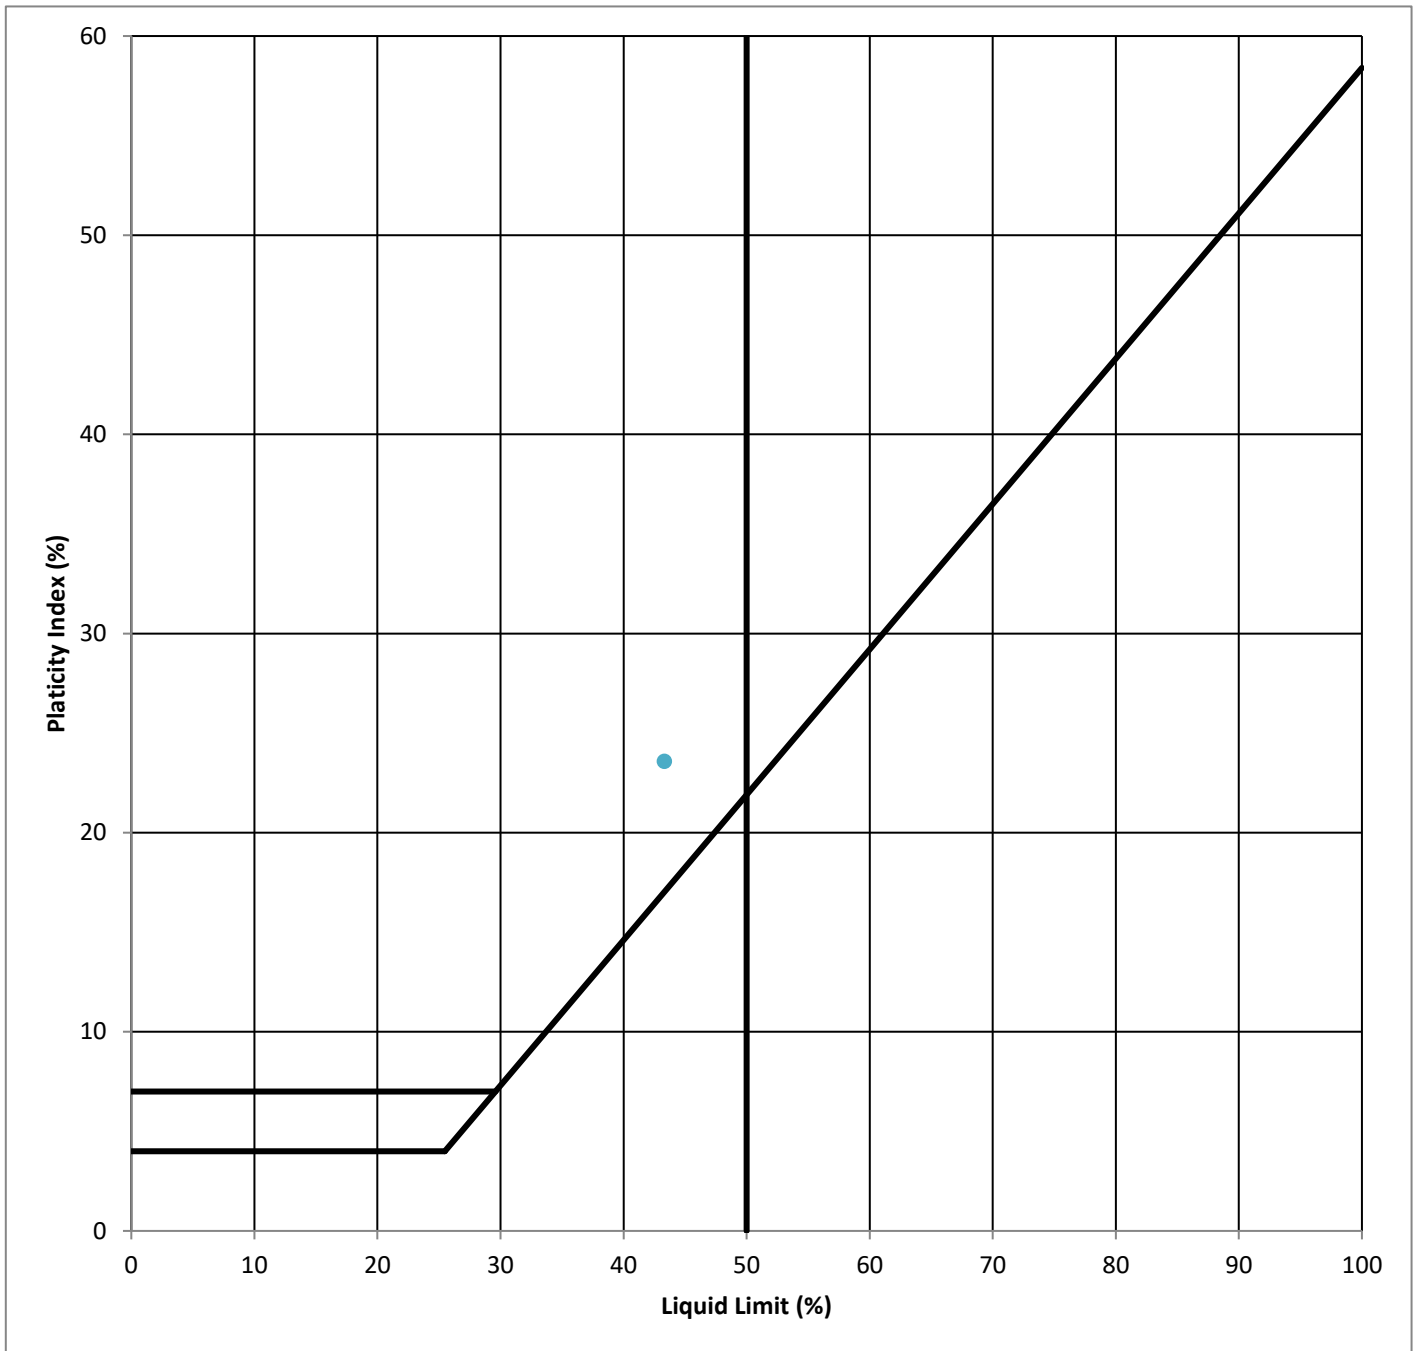
<p>Lewis Homes Grove Cabins Phase 1 &amp; Future Lots Eden, Utah Project No.: 133-019</p>	<p>Plate <b>9</b></p>
---	---	---------------------------

# Atterberg Limits

Location	Depth (ft)		Classification	Liquid Limit	PI
TP-4	4	●	Sandy Lean CLAY with gravel	43	24

The results of our laboratory tests are also presented on the Test Pit Logs, Plates 3 through 7, and more detailed laboratory results are presented on the laboratory testing plates, Plates 9 and 10.

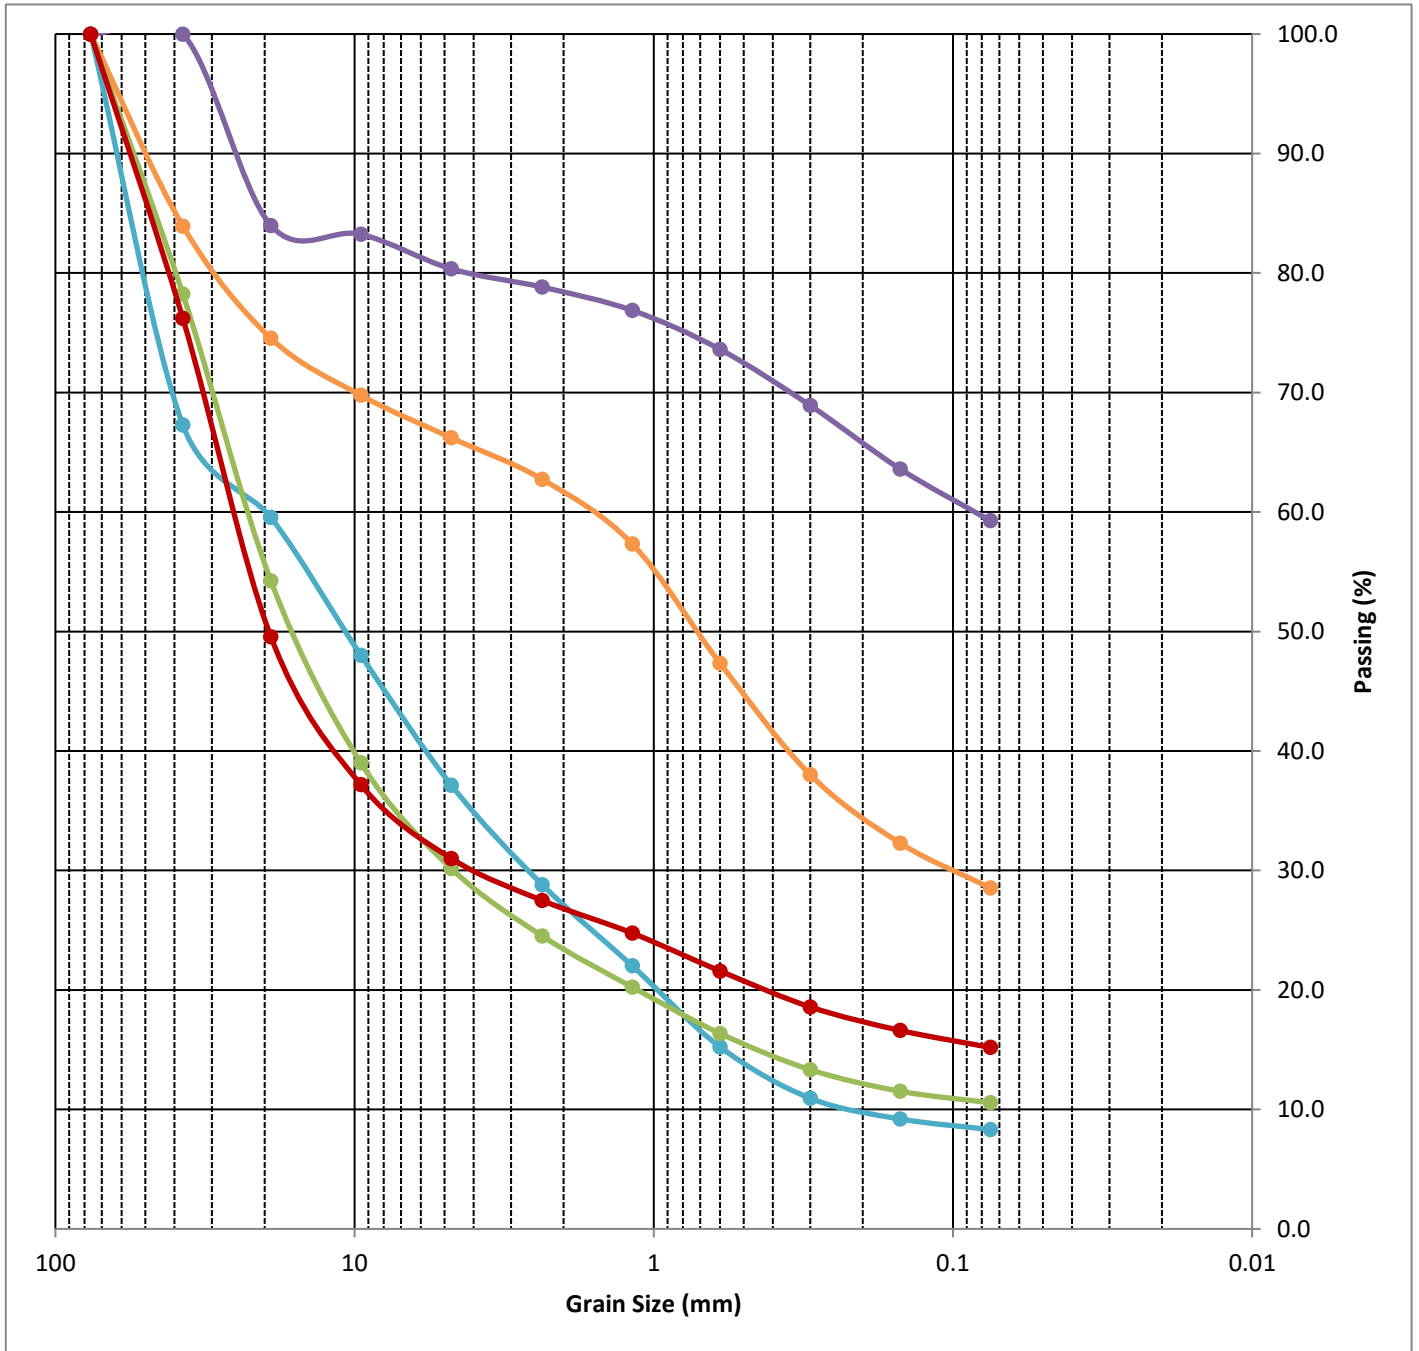
<p><b>Lewis Homes</b>  <b>Grove Cabins Phase 1 &amp; Future Lots</b>  <b>Eden, Utah</b>  <b>Project No.: 133-019</b></p>	<p><b>Plate</b>   <b>10</b></p>
---	--	---

# Grain Size Distribution

Location	Depth		Classification	% Gravel	% Sand	% Silt and Clay
TP-1	6	●	Poorly Graded GRAVEL with clay & sand	62.9	28.8	8.3
TP-2	3	●	Clayey GRAVEL with sand	33.8	37.7	28.5
TP-3	3	●	Poorly Graded GRAVEL with clay & sand	69.8	19.6	10.6
TP-4	4	●	Sandy Lean CLAY with gravel	19.7	21.1	59.3
TP-5	6	●	Clayey GRAVEL with sand	69.0	15.8	15.2

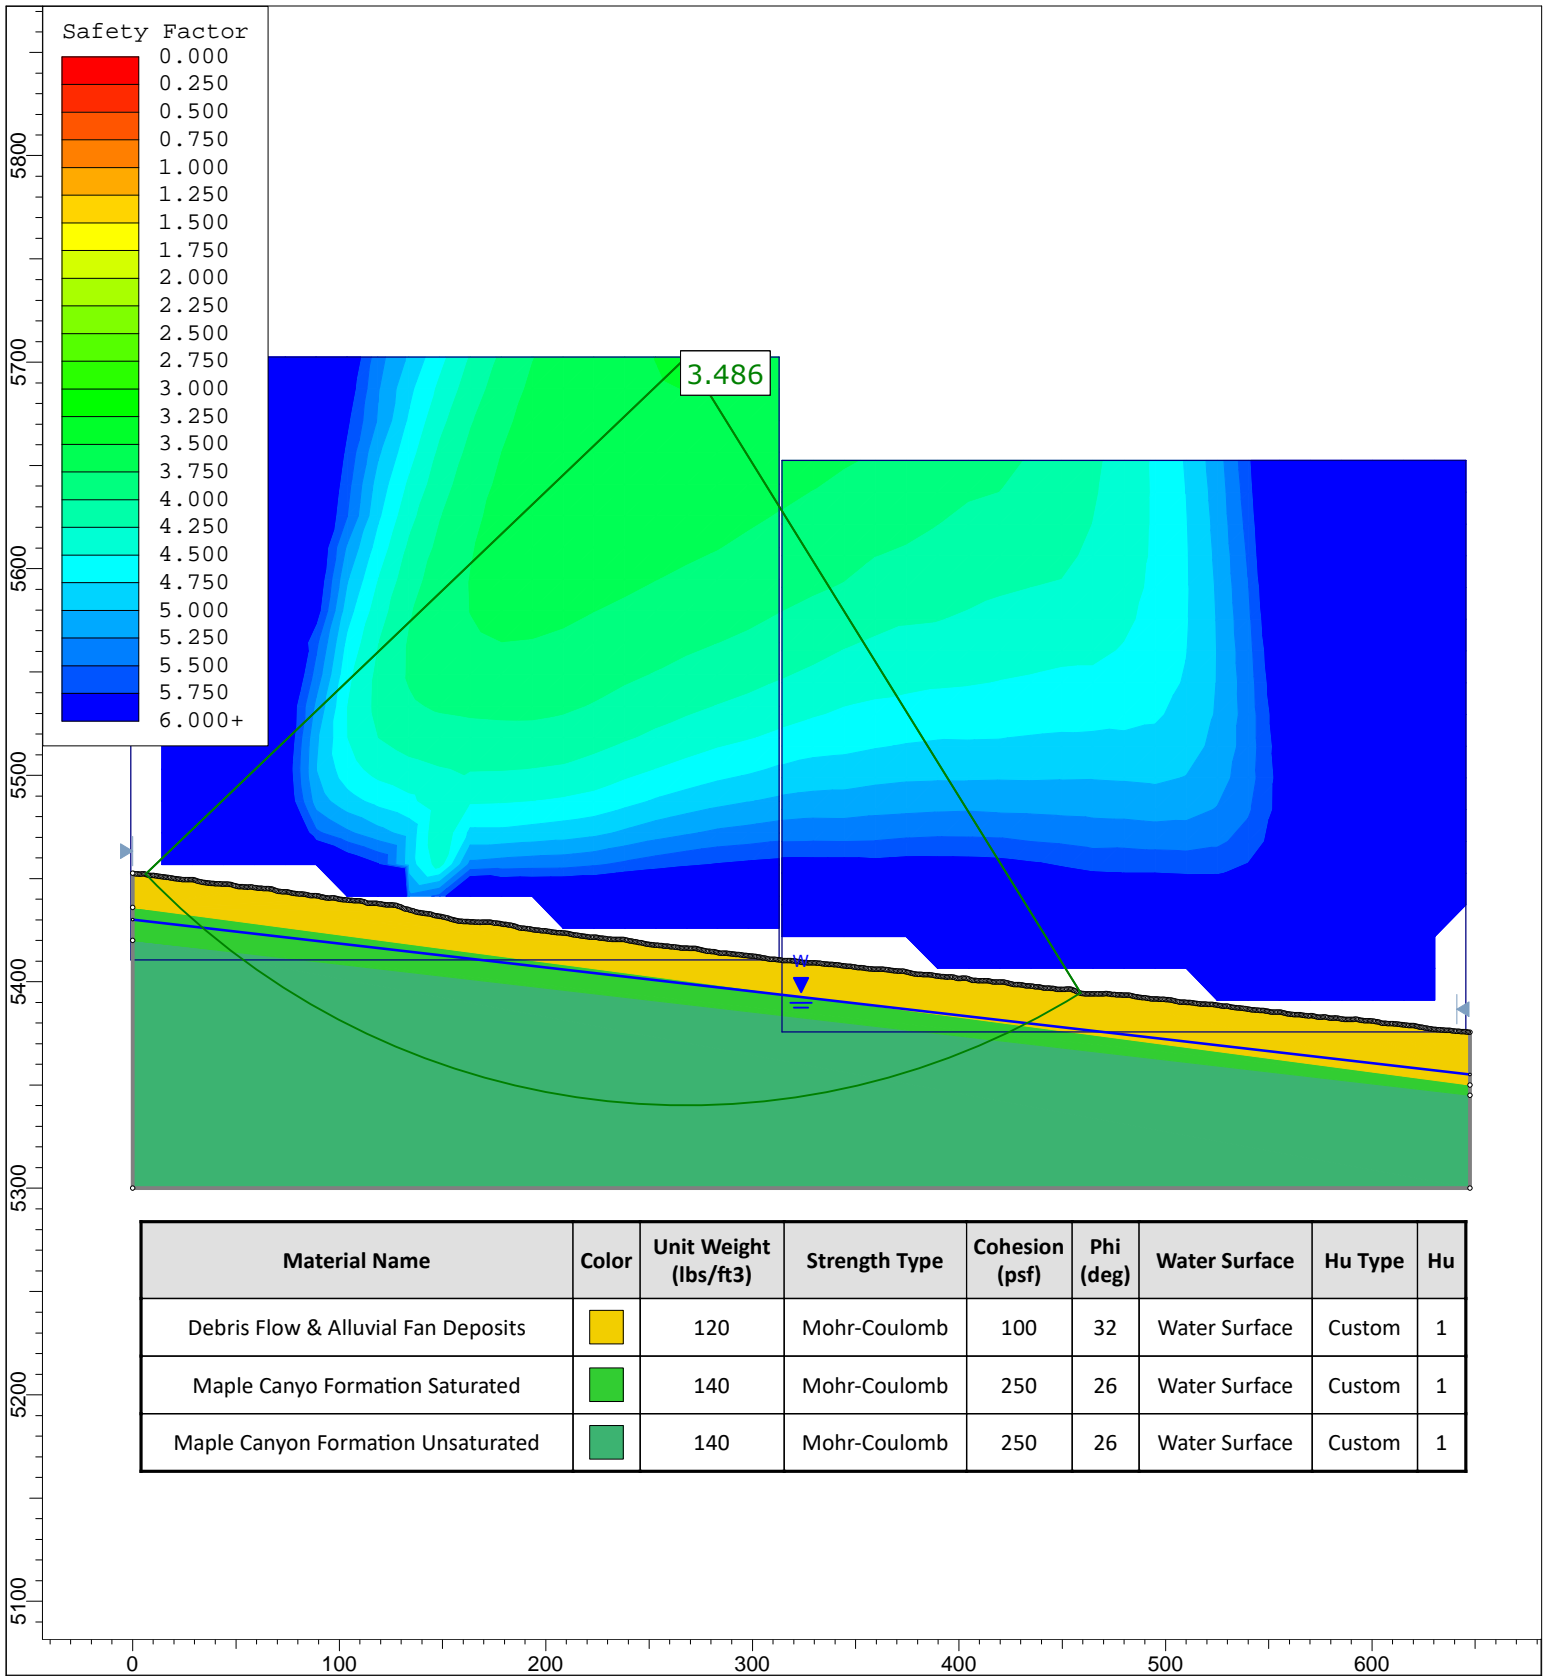
Plate  
**11**

### Global Stability - Static

As recommended in the Geologic Hazards Evaluation by Western Geologic, a slope stability assessment was performed using the Slide computer program and the modified Bishop's method of slices. The location of the profile assessed is shown on Plate 2 and is based on the cross section presented in The Western Geologic report for the development. The alluvial fan and debris flow deposits were assumed to have a strength consisting of an angle of internal friction of 32 degrees and a cohesion of 100 psf. The Maple Canyon Formation bedrock strength was based on the 2018 GeoStrata report and consisted of an angle of internal friction of 26 degrees and 250 psf cohesion.

The profile was assessed under static and pseudo static conditions. The pseudo static condition is used to assess the slope during a seismic event. As indicated in Section 4.1, the peak ground acceleration at this site is estimated to be 0.503g. As is common practice, half of this value was used in our pseudo static assessments. Minimum factors of safety of 1.5 and 1.0 for static and seismic conditions, respectively, were considered acceptable. Our analyses indicate that the profile has safety factors greater than 1.5 and 1.0 for the static and pseudo static conditions and is therefore considered suitable for residential construction.

The slope stability analysis presented above is based on the assumption that no significant cuts or fills will occur during the development of the site. Significant changes to the site grade, such as the steepening of slopes with cuts or fills, may adversely affect the stability of the slopes and increase the risk of slope failures. If cuts or fills over 15 feet are planned, additional slope stability assessments may be necessary and Christensen Geotechnical should be contacted to provide the additional assessments. The results of our slope stability assessments may be found on Plates 11 through 12.

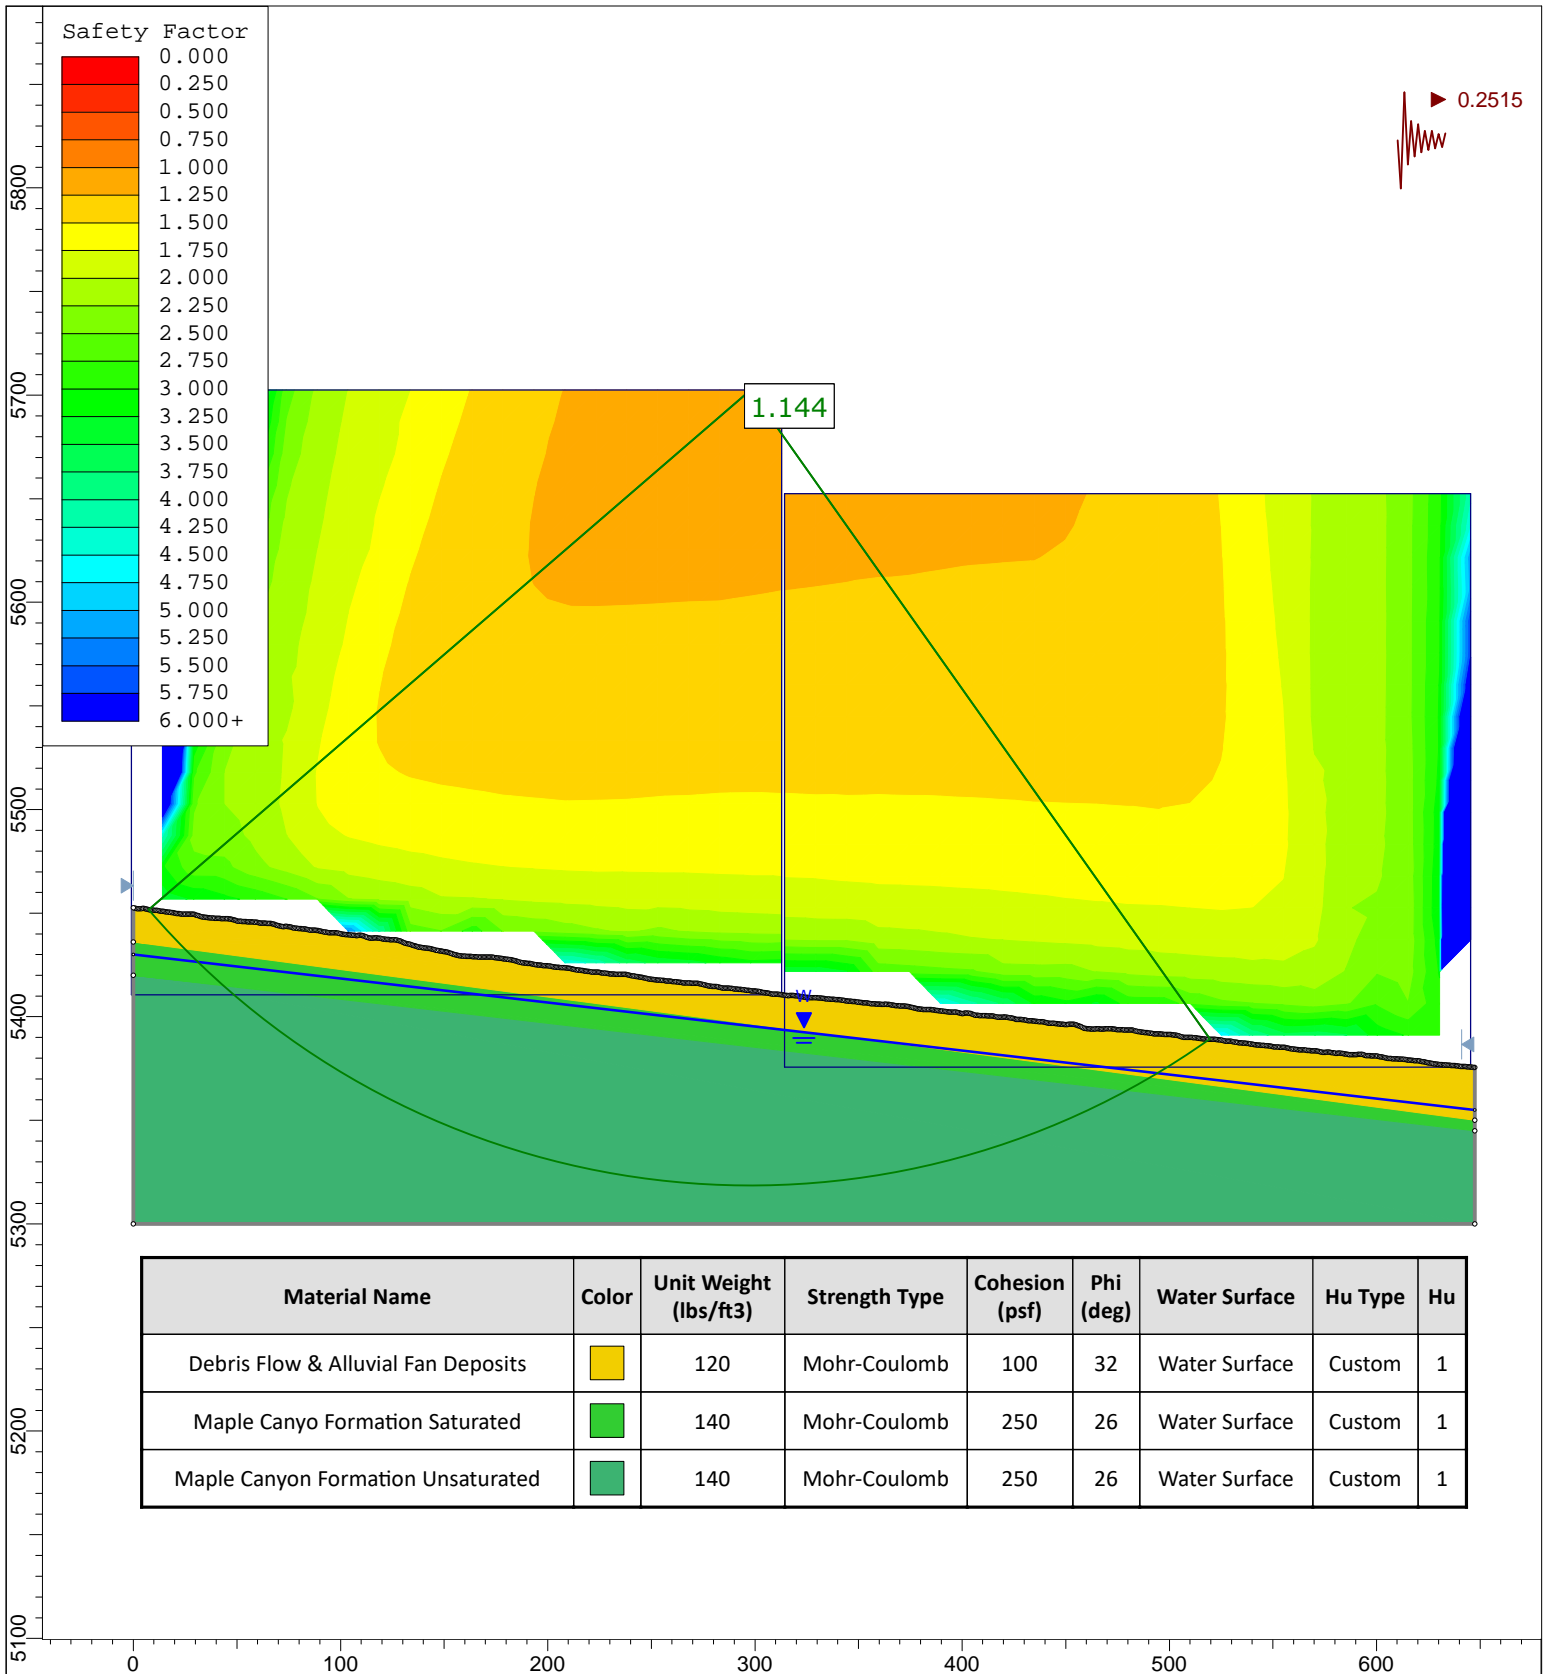
### Global Stability - Pseudo Static
