**MEMORANDUM****To: Matt Rasmussen****From: Timothy J. Thompson, P.G.  
Hiram Alba P.E., P.G.  
Daniel J. Brown, E.I.T.****Date: September 4, 2015****Subject: Review Response for Third Geological Review Matt Rasmussen Hillside Review  
6472 South Bybee Drive, Ogden, Utah, 84403 SA Project No. 15-140**

**Site Geologic Setback Map**

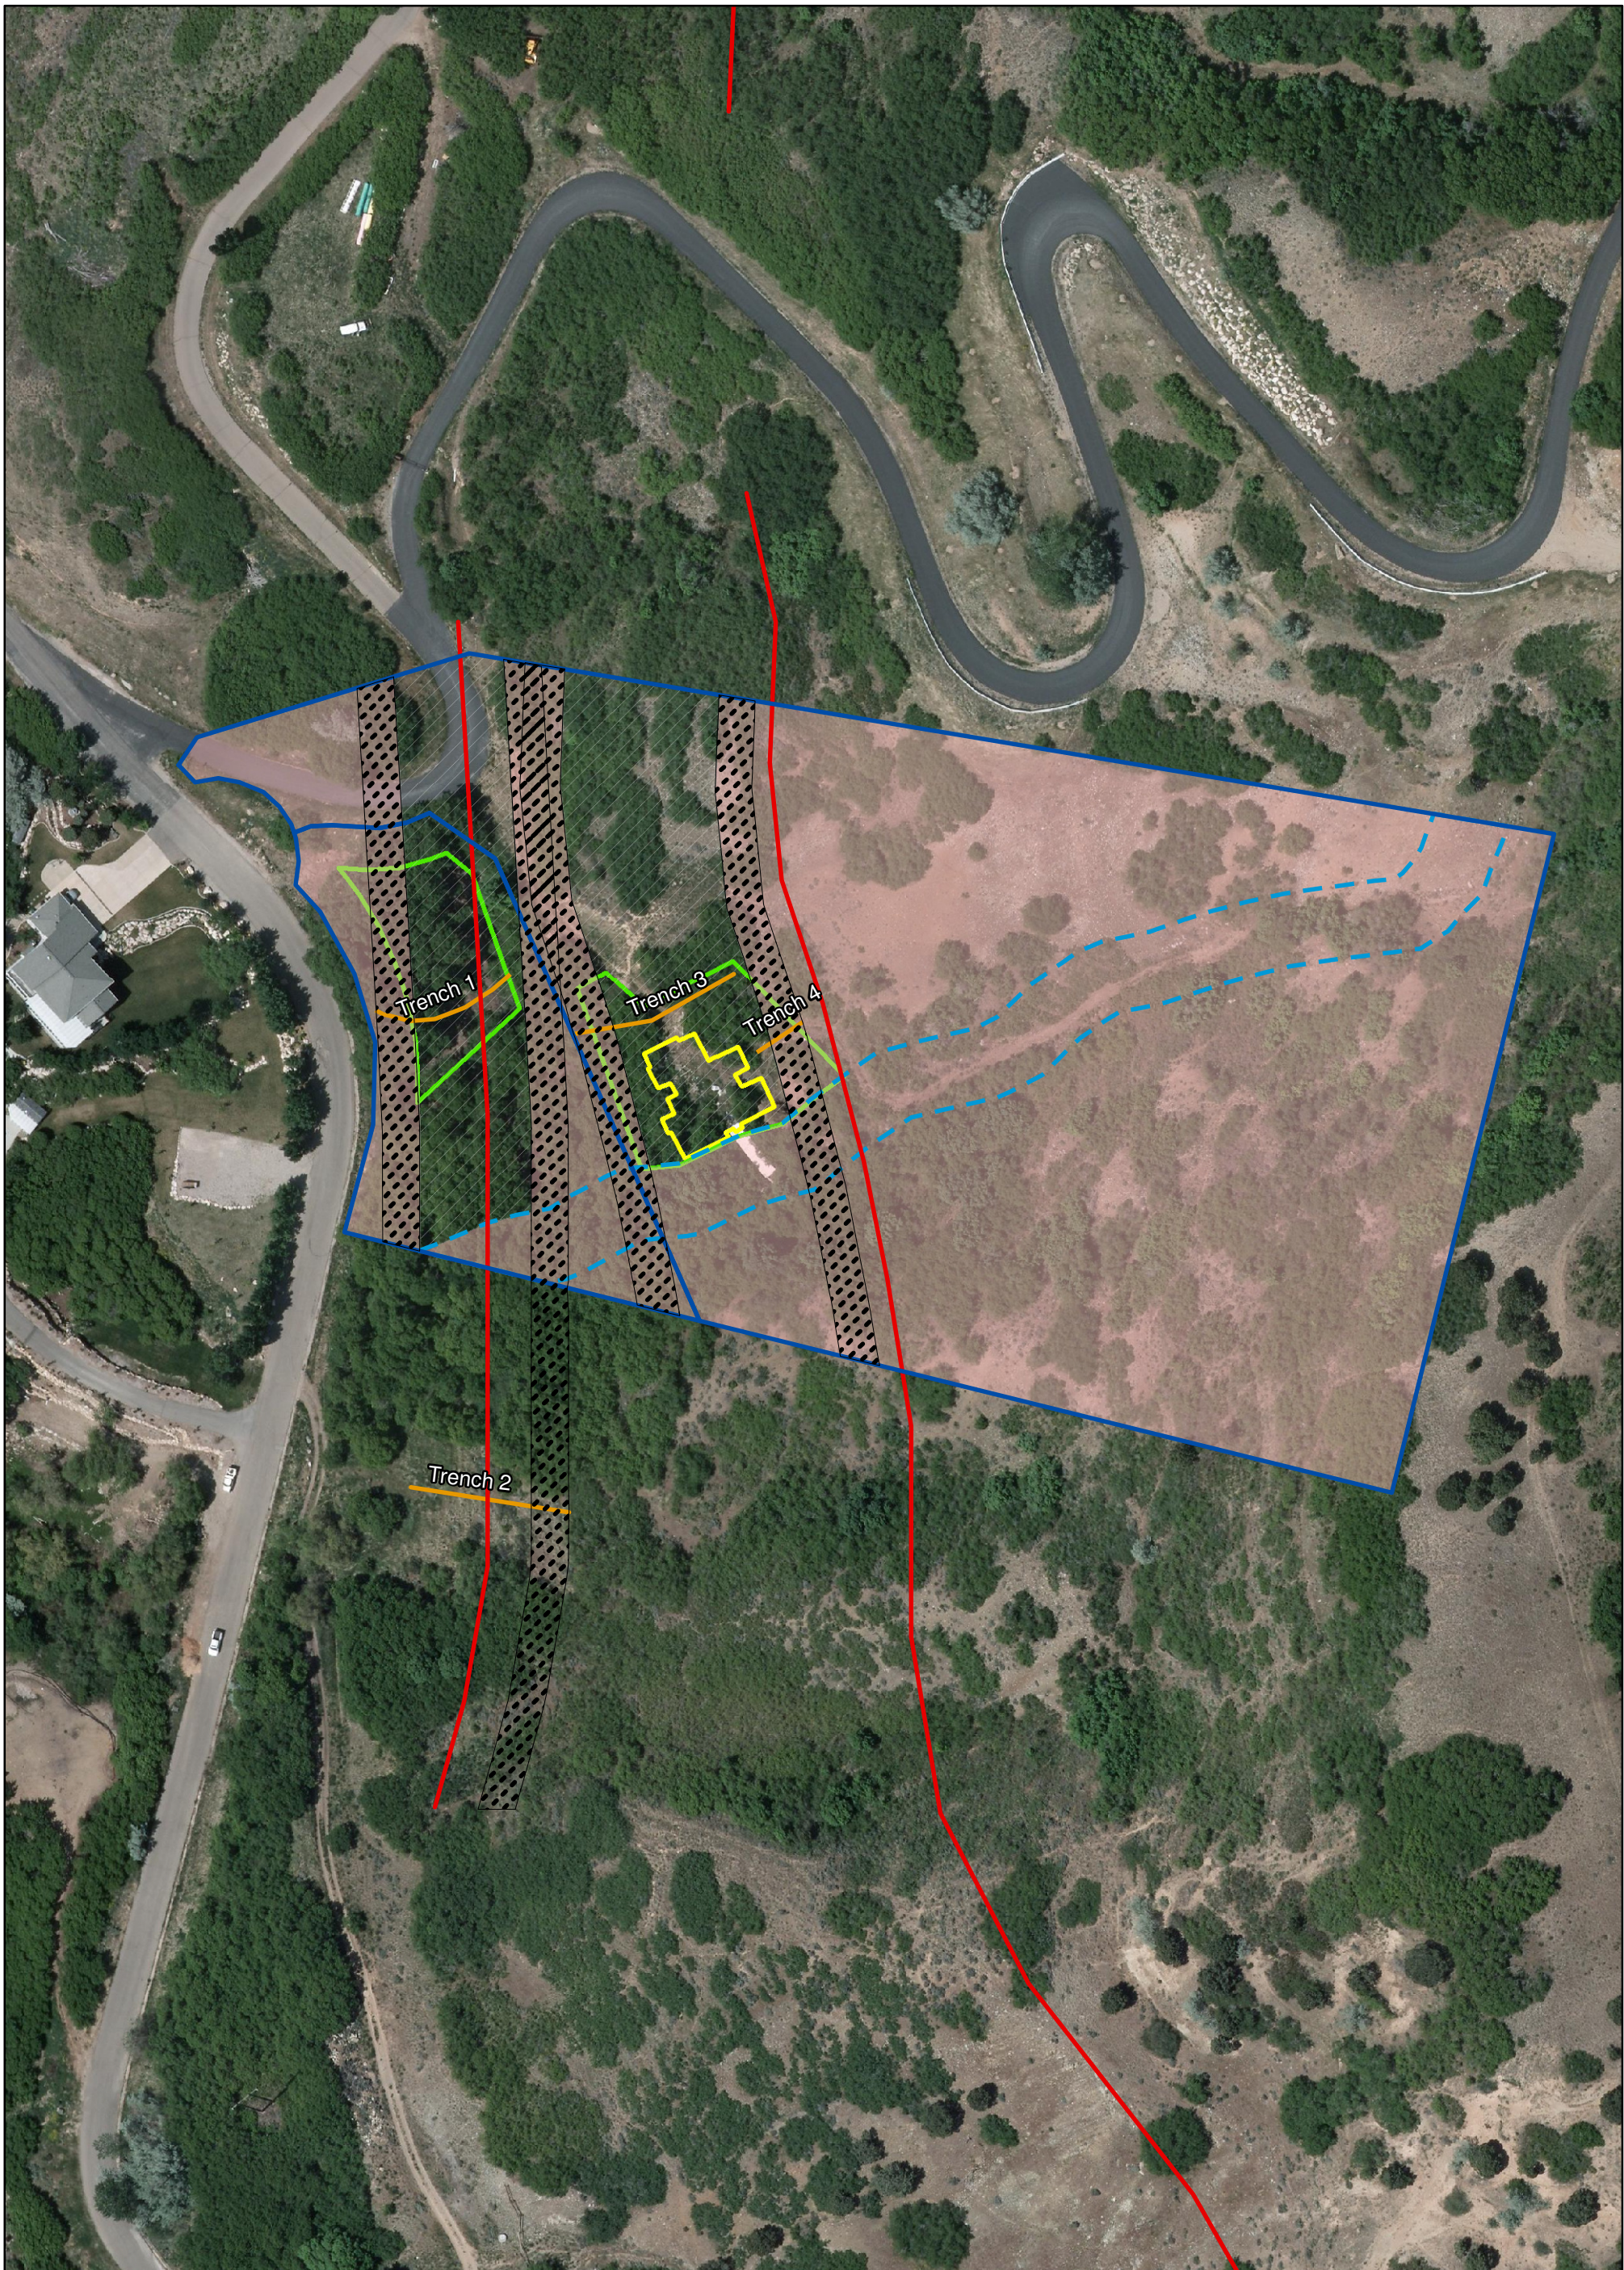
**Plate  
1**

GeoStrata has revised the Site Geologic Setback Map to more accurately reflect the location of the drainage easement delineated in the Grading/Drainage Plan prepared by Silverpeak Engineering. The updated map is attached as Plate 1.

*There appears to be an inconsistency between the calculated drainage setback as shown on GeoStrata Plate A-6, Site Geologic Setback Map (attached), and site geologic conditions as shown on GeoStrata Plate A-5, Site Geologic Map (attached). Plate A-6 depicts the drainage setback coinciding with the proposed building foot print, northwest of the drainage setback line. SA recommends Weber County request GeoStrata clarify the apparent discrepancy.*

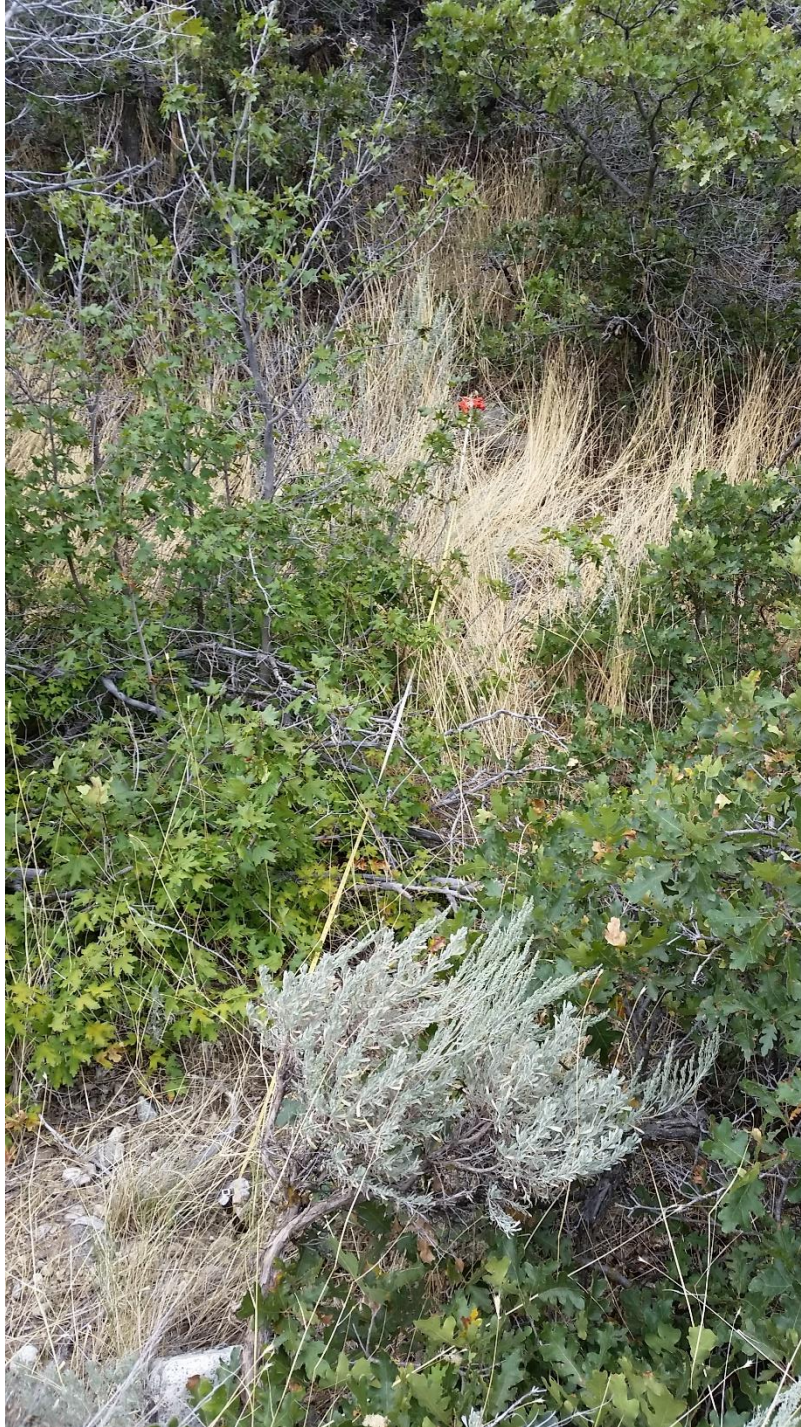
**Plate  
5**

**Cross Section 1 – Cross-Stream View**

A field investigation was conducted to observe the conditions of the existing channel and to measure cross sections of the channel bottom at selected representative points along the length of the channel. Photographs from various points along the length of the channel, including the locations of the measured cross sections, are included as Plate 4 to Plate 10. Cross sections of the channel were measured in the field at 3 representative points along the length of the channel. A map showing the locations of each of the cross sections is included as Plate 11. During our field investigation, we observed that the channel is heavily vegetated with scrub oak, grasses, and some small cacti. Soils observed consisted mainly of a silty gravel with sand. The high fines content of the observed soil suggests that erosion of the existing stream channel is occurring at a very slow rate, which is a function of the presence of heavy vegetation.

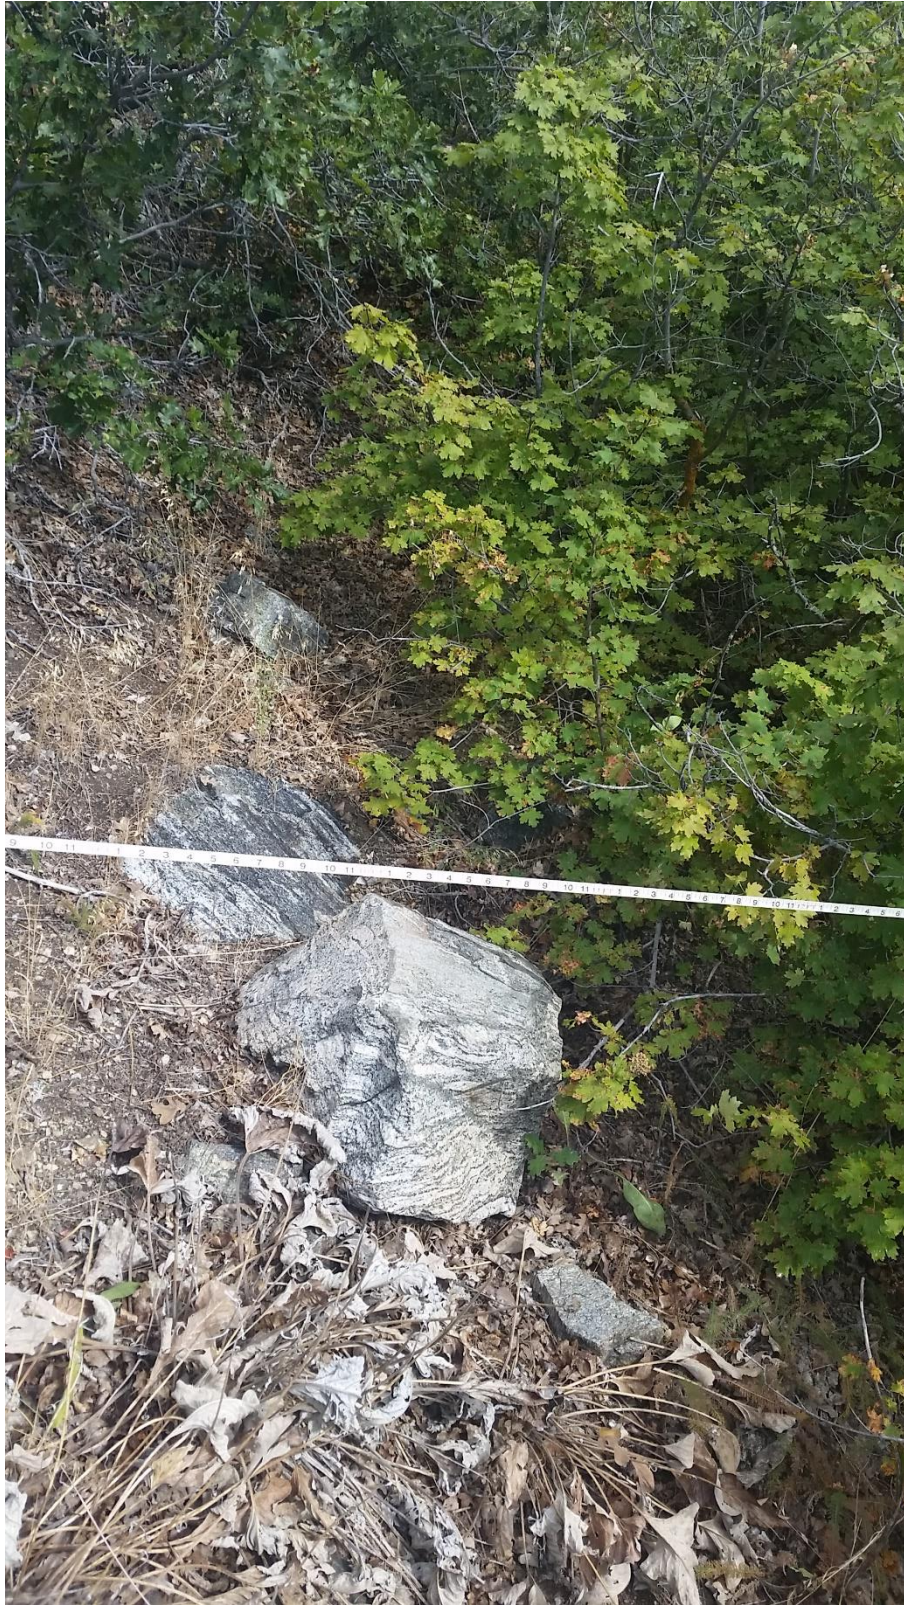
**Cross Section 3 – Upstream View**

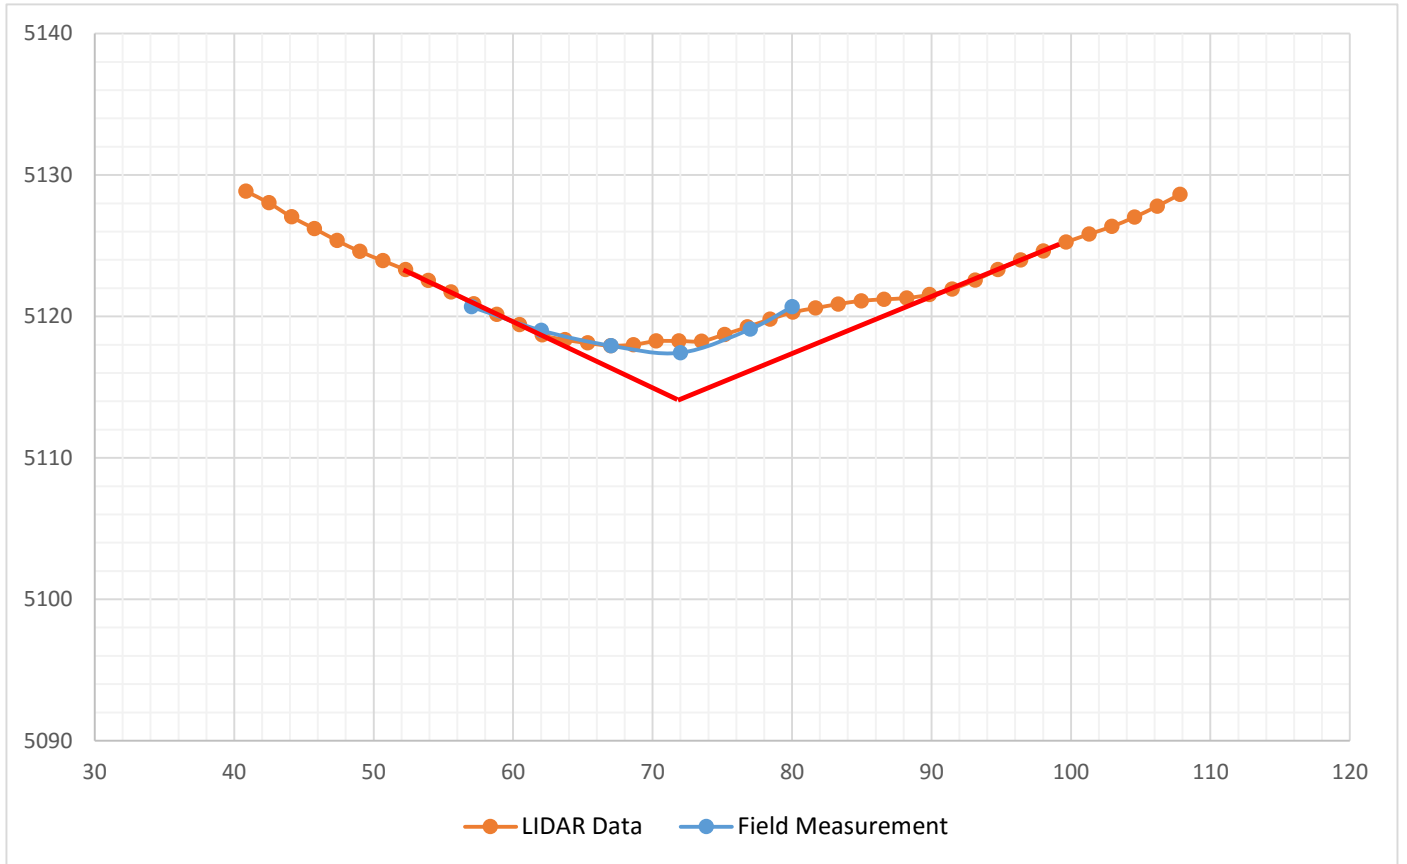
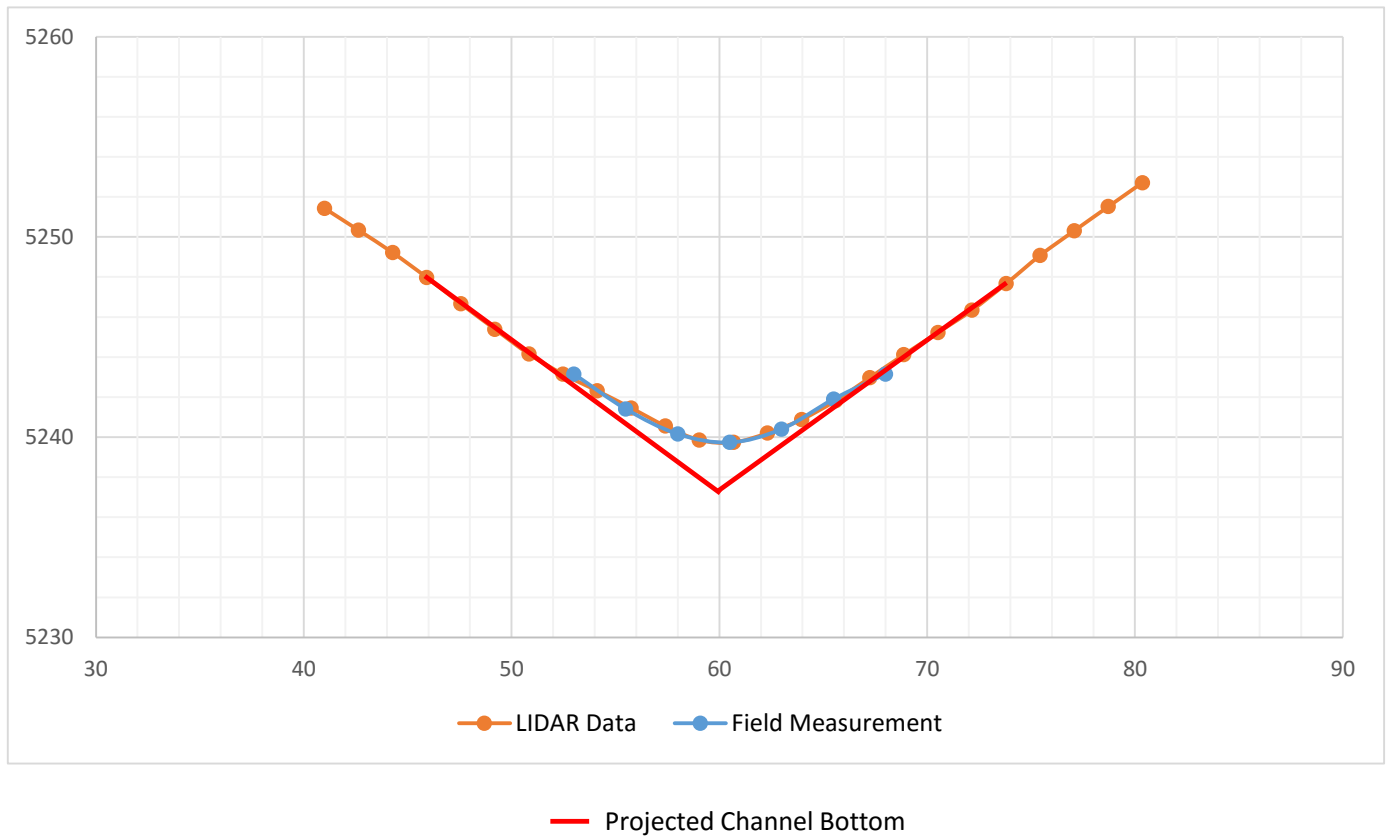
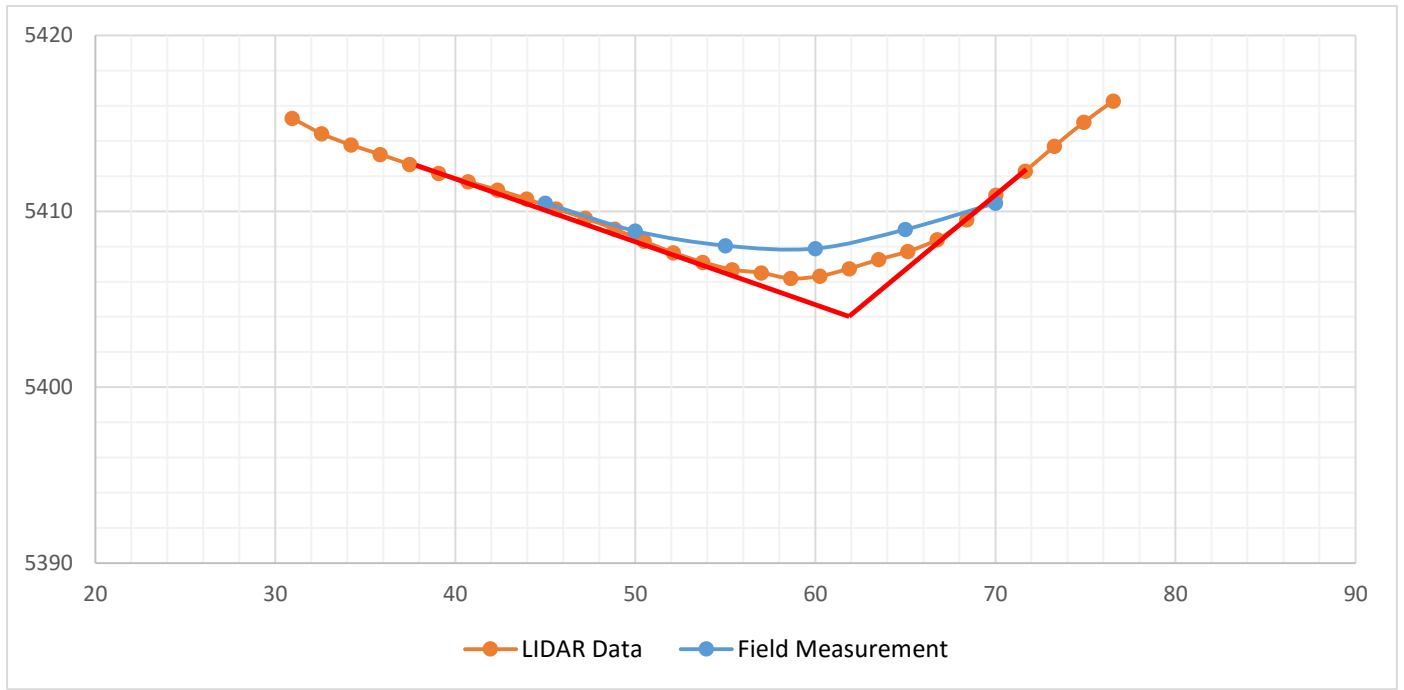
Plots of each of the cross sections that were analyzed for this investigation are included as Plate 14 through Plate 17. Total stored sediment was estimated using the geometry of each of the cross sections. The table below summarizes the results of our investigation.

— Projected Channel Bottom

Cross Section	Channel Segment Length (ft)	Stored Sediment (ft <sup>3</sup> /ft)	Stored Sediment (ft <sup>3</sup> )	Debris Flow Volume (ac-ft)
1	882.4	28	24707.2	0.6
2	614.5	8	4916	0.1
3	1010.1	18	18181.8	0.4
4	1558.0	86	133988	3.1
				4.2

In order to be conservative, we have elected to estimate the total stored sediment for the entire length of the channel to be 86 ft<sup>3</sup>/ft, the maximum observed stored sediment, and that 100% of the stored sediment is mobilized in a debris flow event with a 50% bulking rate (debris flows consisting of 50% sediment and 50% water). Using these assumptions, the maximum potential debris flow event is estimated to be 16.1 ac-ft.
