REPORT
GEOTECHNICAL STUDY
LOT 44 BIG SKY ESTATES
4075 BLUEBELL DRIVE
NEAR LIBERTY, WEBER COUNTY, UTAH

July 8, 2016

Job No. 1041-04N-16

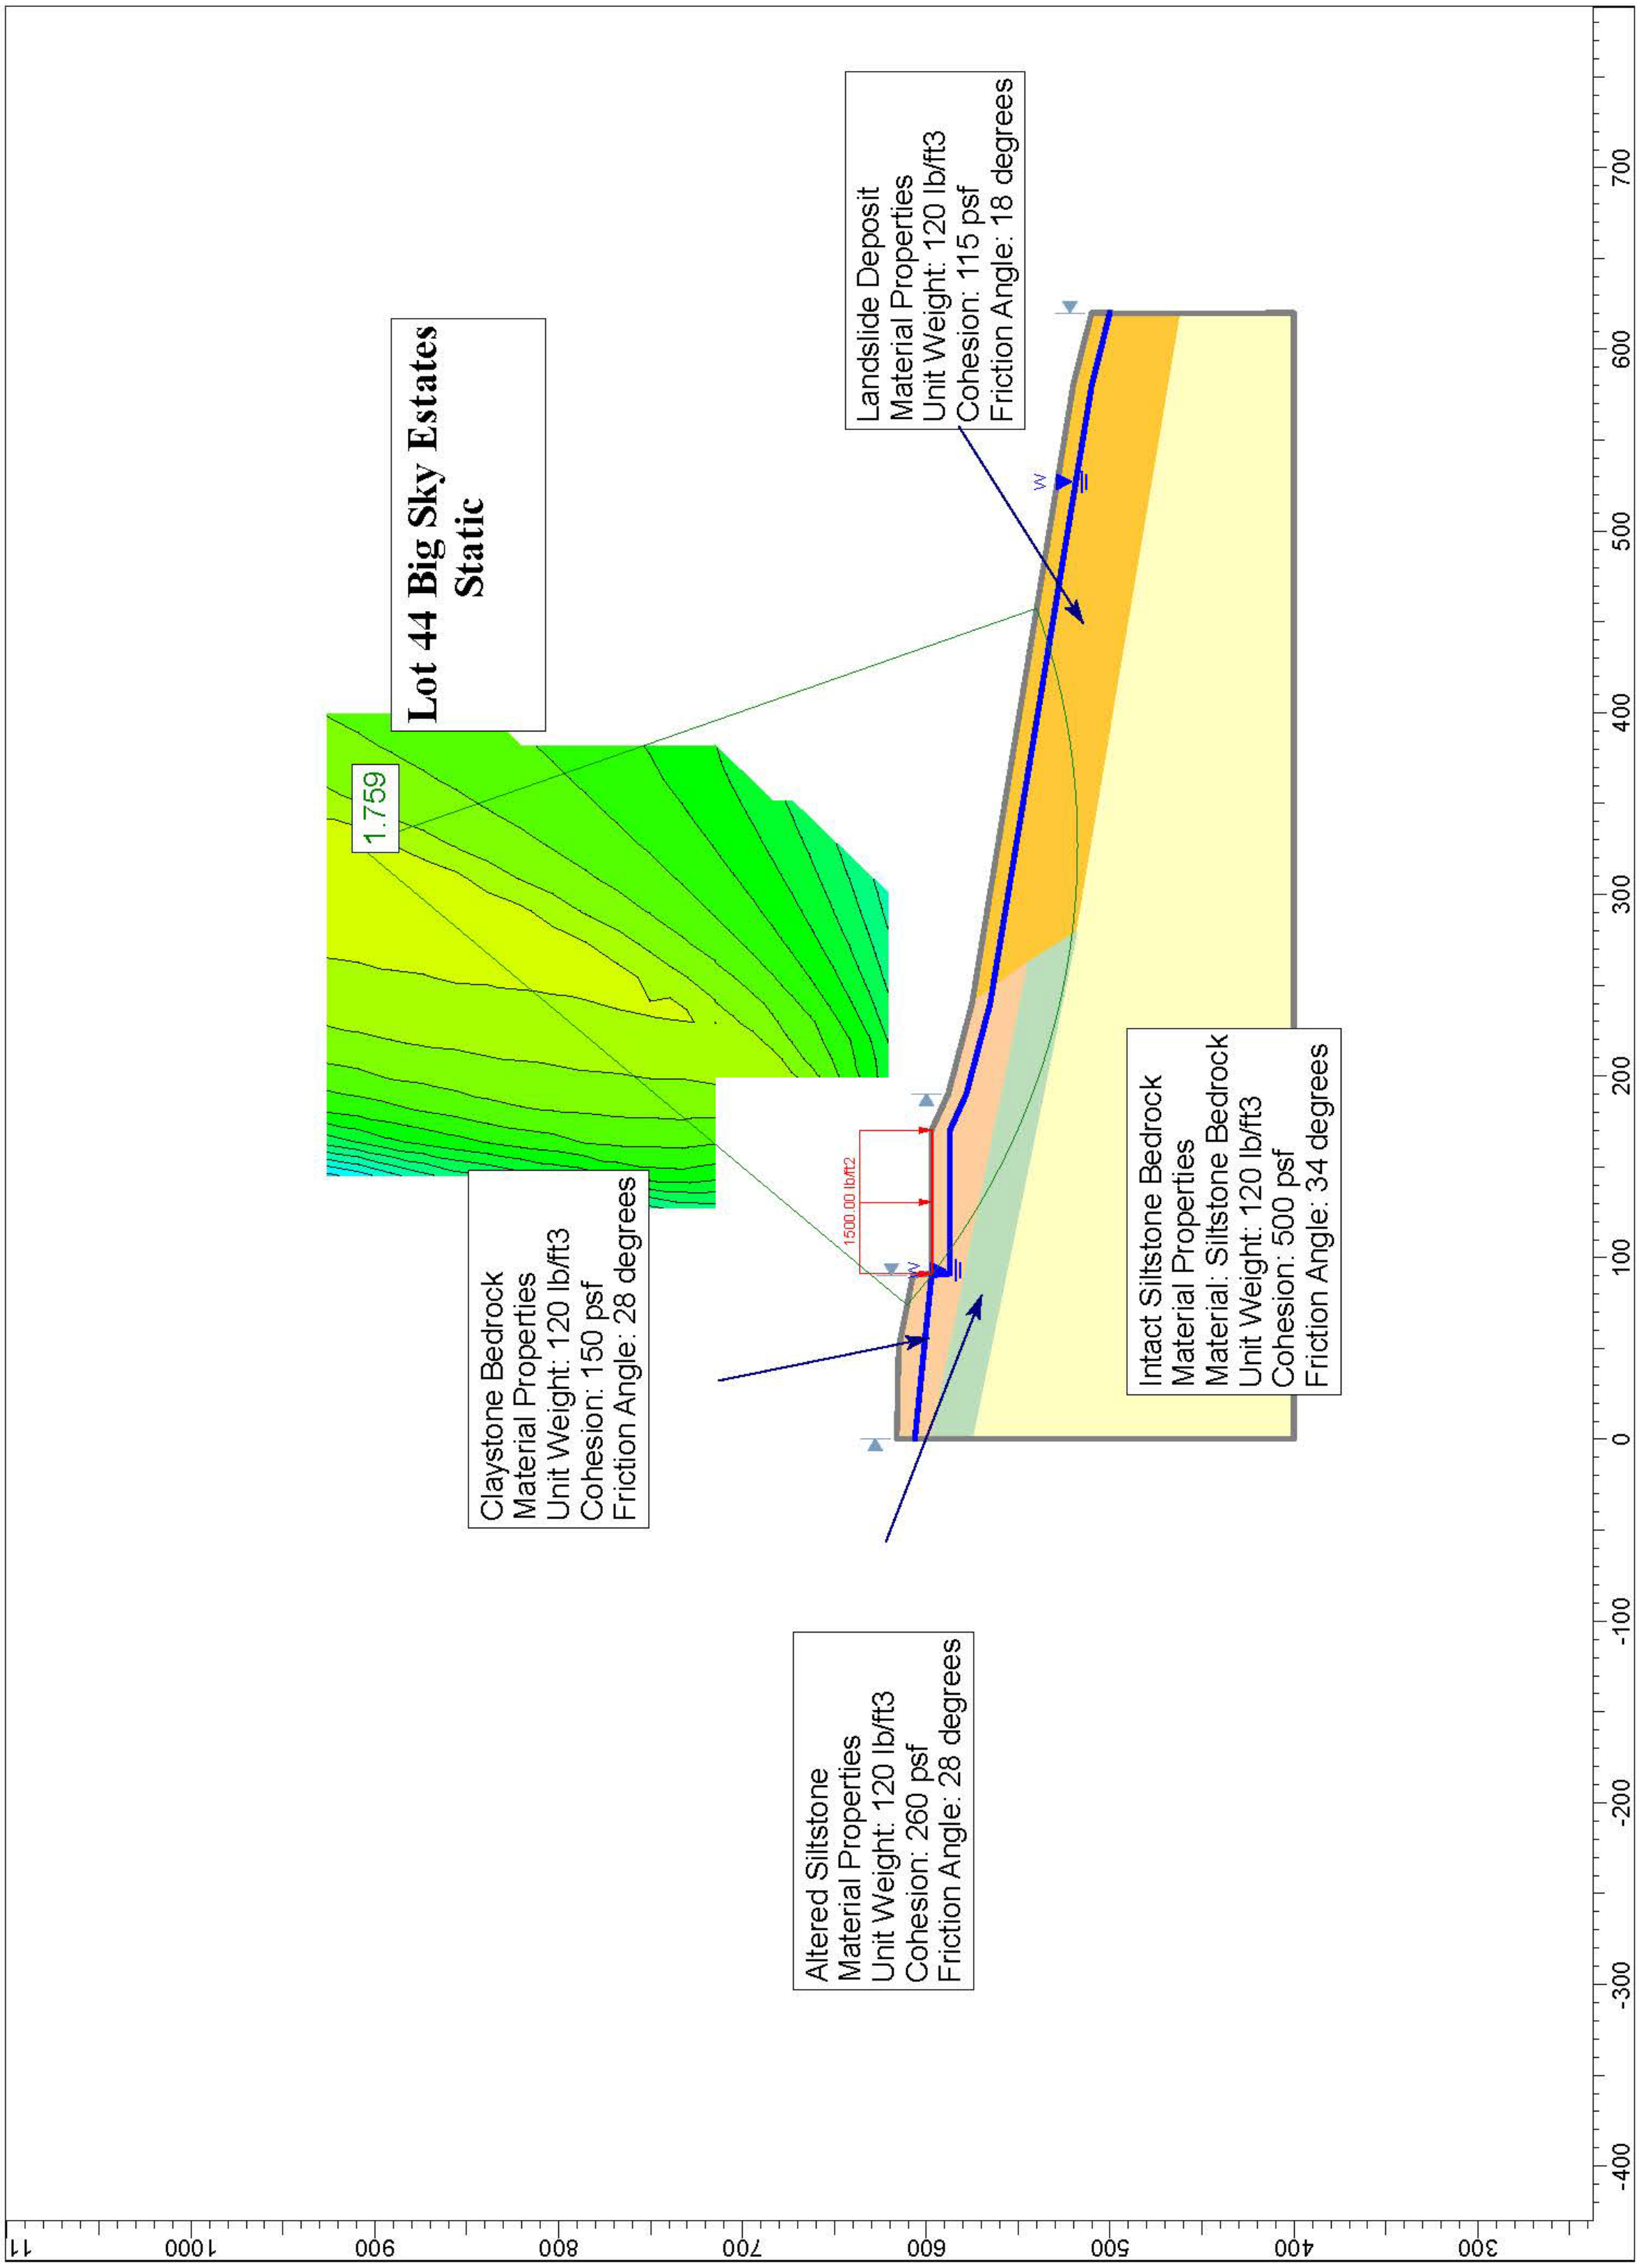
PROJECT NO.: 1041-04N-16	GSH	**FIGURE NO.:** 7

Typically, the required minimum factors of safety are 1.5 for static conditions and 1.0 for seismic (pseudostatic) conditions. The results of our analyses indicate that the existing slope configurations analyzed will meet both these requirements provided our recommendations are followed (see Figures 7 and 8).
