Report Professional Geologist Site Reconnaissance and Review
Approximately 4.0-Acre Homesite
North Part of Parcel # 22-007-0013, Montgomery Acres
4461 North 3300 East Street
Liberty, Weber County, Utah

January 29, 2019
GCS File No: 2019.02

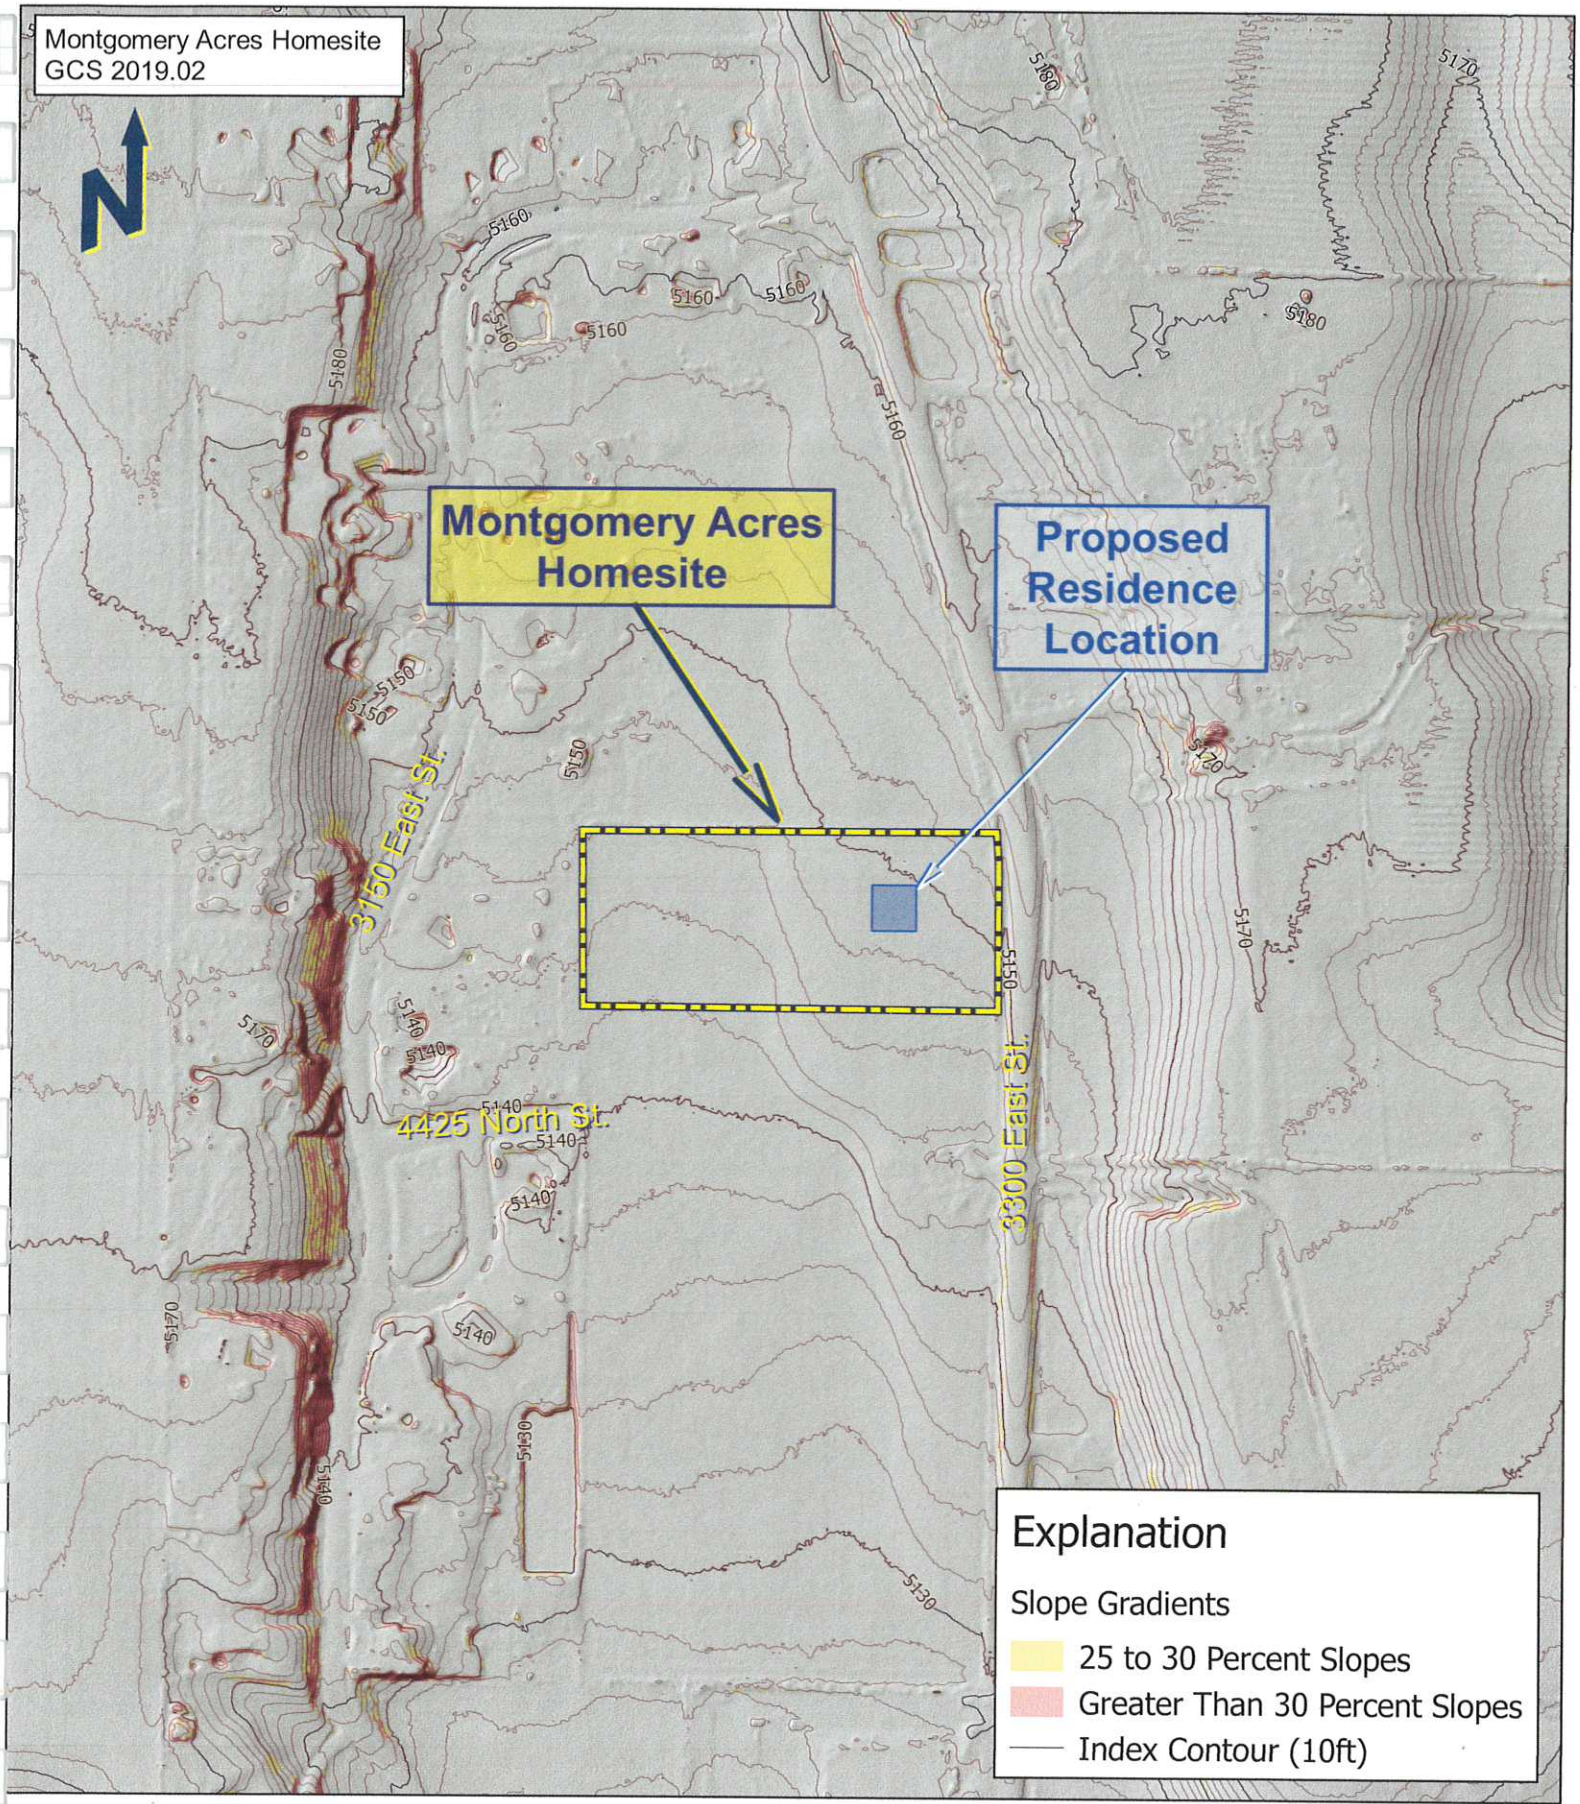
FIGURE 4
LiDAR ANALYSIS

6. **Sloping surfaces:** The site vicinity slope gradients developed from our LiDAR analysis range from level to well over 50-percent as shown on Figure 4. Within the homesite area slope gradients are relatively gentle. On Figure 4, the property slopes are shown to slope very gently to the southwest. The calculated average slope for homesite area is 2.5 percent.

The threshold gradient for site slope development considerations and hillside review according to the Weber County Section 108-14-3 includes slopes greater that 25-percent (Weber County Code, 2019).

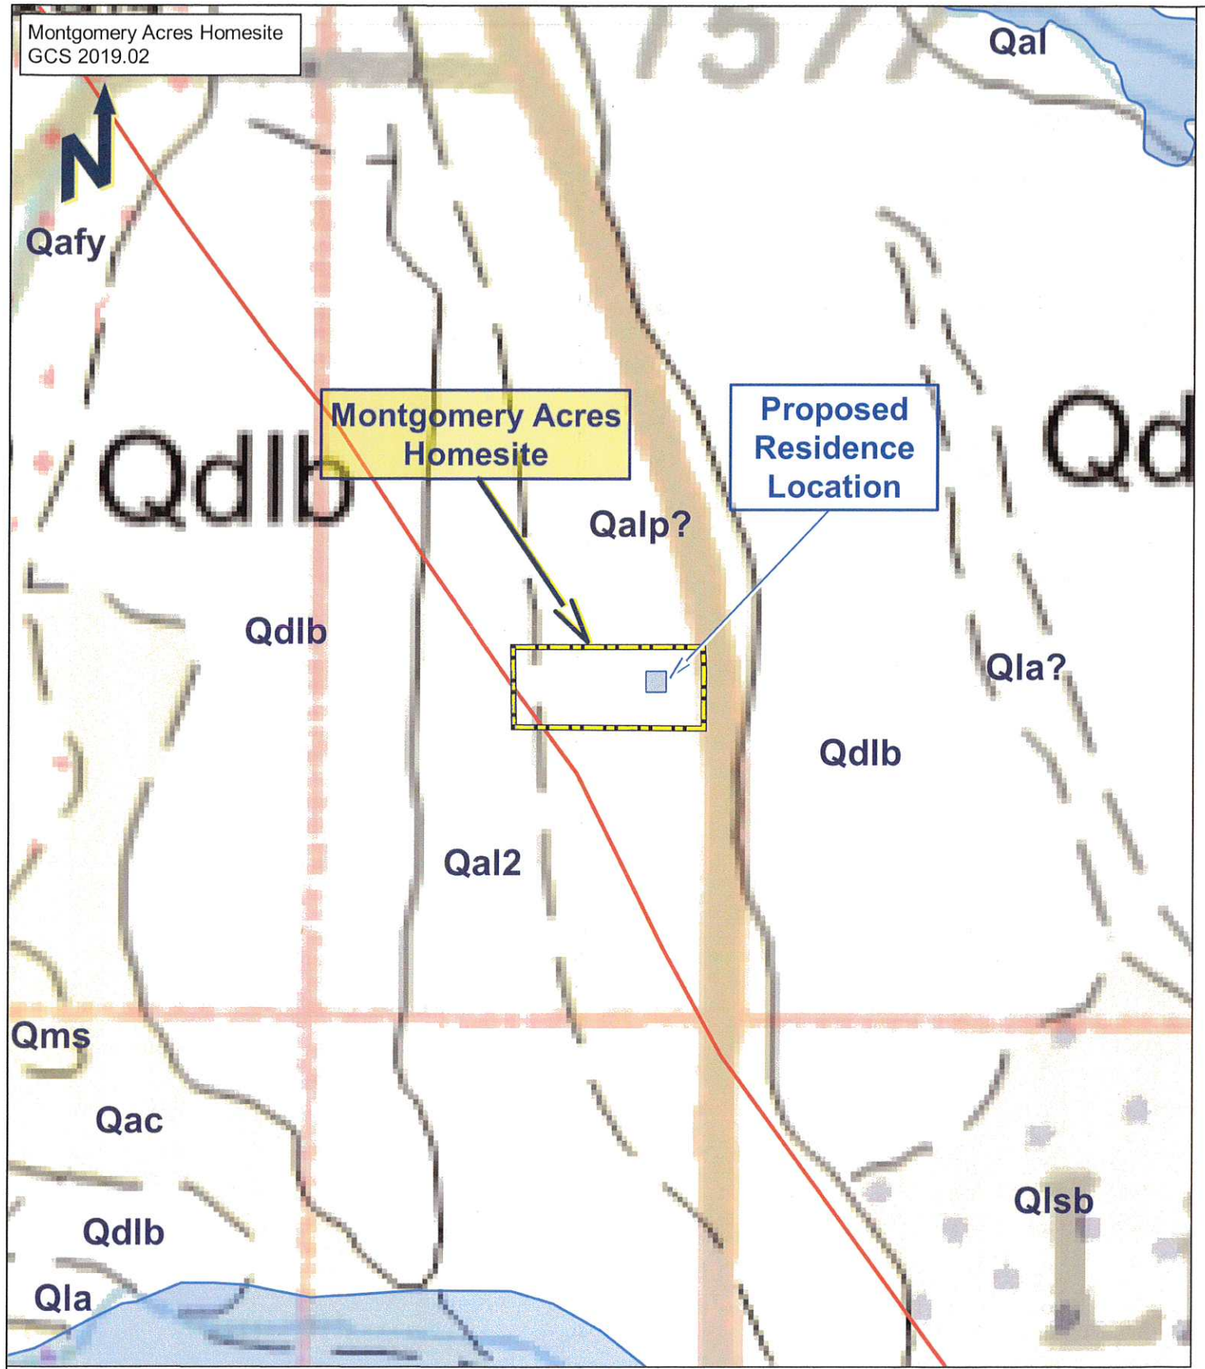
FIGURE 3
GEOLOGIC AND FLOOD HAZARD MAP
GCS Geoscience

Geological Mapping: Figure 3 shows the location of the site relative to GIS overlays including geological mapping drawn from Coogan and King (2016). A summary of the geological mapping of the site vicinity, as paraphrased from Coogan and King (2016), is provided as follows:

1. **Landsliding:** The nearest active landslide units are mapped as **Qms** deposits by Coogan and King (2016), and are located approximately 2275 feet to the west of the site, as shown on Figure 3. These deposits should not impact the proposed homesite.

2. **Alluvial fan debris flow processes** including flash flooding and debris flow hazard: The nearest potential debris flow process deposits to the site are mapped as **Qmdf** by Coogan and King (2016), and occur approximately 1800 feet to the west side of the site, and these deposits should not impact the proposed homesite.

5. **Flooding:** Mapping by Federal Emergency Management Agency (FEMA, 2015) is shown on Figure 3. The Zone AE shown on Figure 3, includes the 100-year flood hazard zone as delimited by recent FEMA (2015) studies conducted in the Ogden Valley area. On the basis of the FEMA determination *...mandatory flood insurance purchase requirements and floodplain management standards apply...*for improvements made in the Zone AE area shown on Figure 3. The entirety of the proposed subdivision is shown to be outside the flood zone areas shown on Figure 3.
