Project: 002703.C | Green Hills WTF
Equipment/Material/Spec: GeoHazard Assessment

**Reconnaissance- Level Geologic Hazards Assessment
Green Hills Sewer and Water - Maple Hills WTP
922 N. Maple Street Huntsville, Utah 84317**

GeoStrata Job No. 1929-001

September 13, 2024

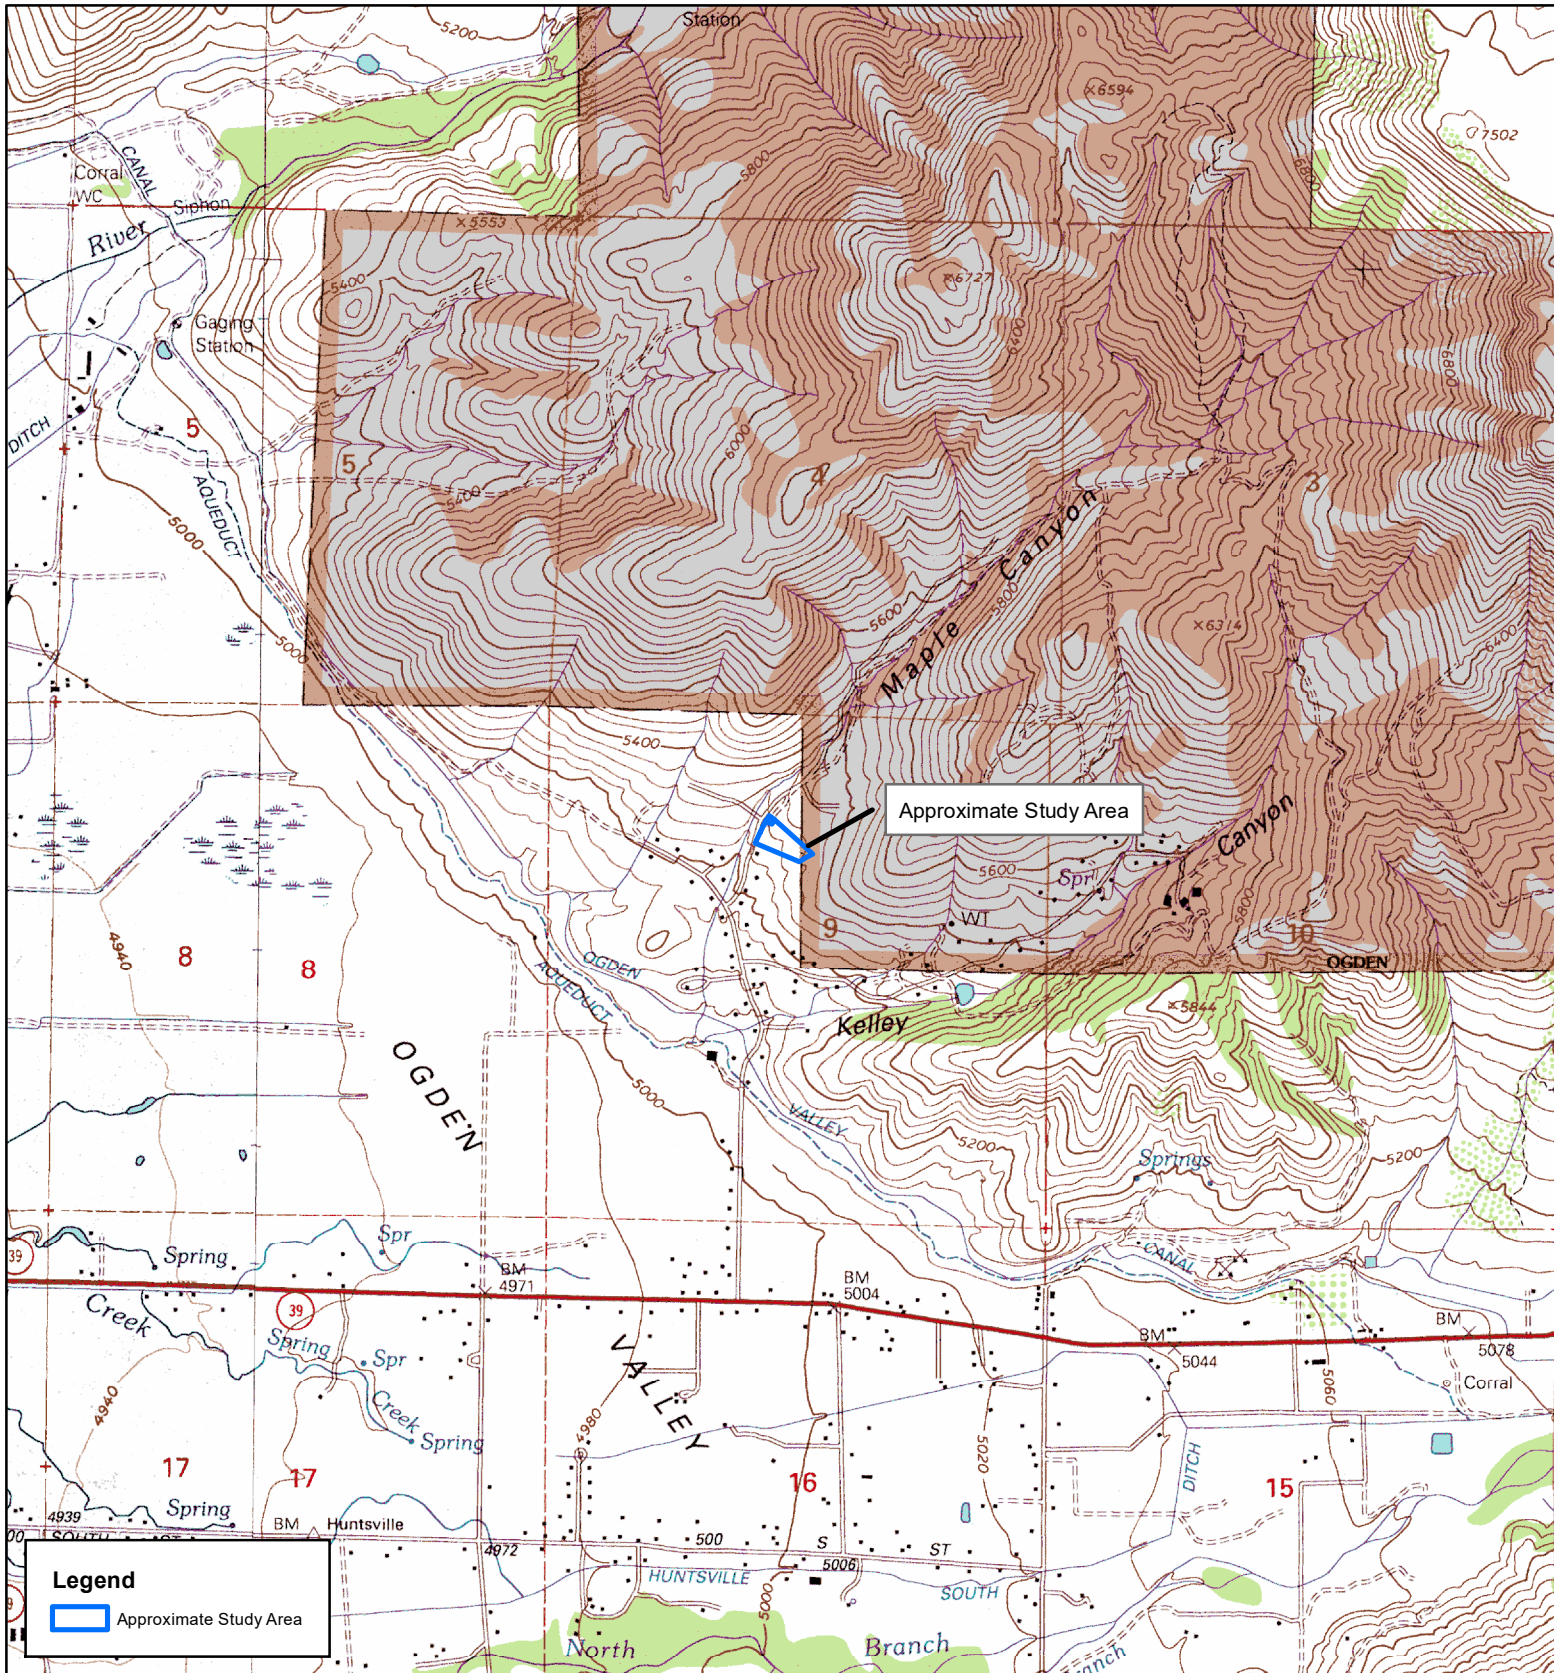
**Plate
1**

Based on our review of .6-meter 2021 aerial imagery (Plate 1 *Site Vicinity Aerial Imagery Map*), and our review of hillshade and slope imagery derived from 2016 .5-meter lidar elevation data, no bedrock outcroppings that could be a rockfall and topple source were identified in the vicinity of the subject property and no rockfall talus was observed within or adjacent to the subject property. It is the opinion of GeoStrata that rockfall and topple hazard within the subject site is considered low and should not preclude development of the proposed water treatment facility.
