July 13, 2015

**Re: Engineering Geology Assessment
Lot 15, Ski Lake Estates No. 3
6640 East 1100 South
Huntsville, Utah
Job No. 145150**

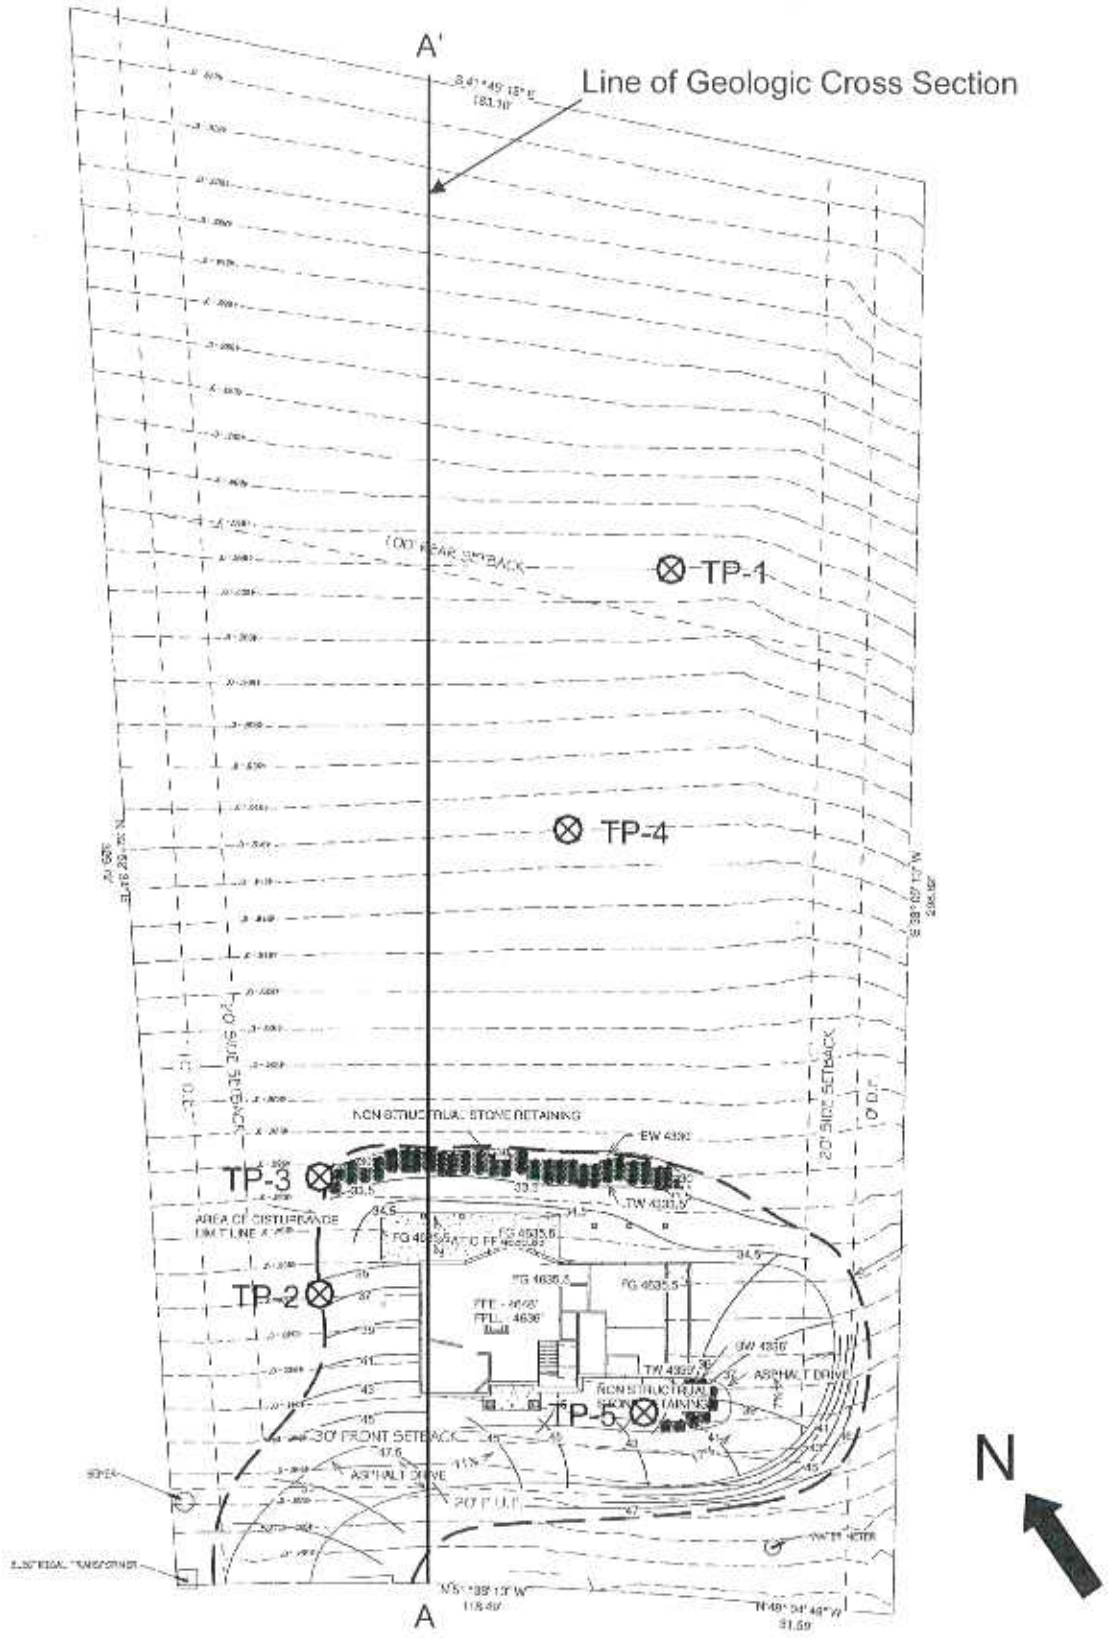
LOT 15, SKI LAKE ESTATES NO. 3

At the time of the original geotechnical report for the subject lot, two test pits were excavated on the lot and logged by a geotechnical engineer with Earthtec Engineering. The original test pits were designated as TP-1 and TP-2 in the referenced geotechnical report and the approximate locations of the test pits were shown on a aerial photograph of the lot included in the report. On June 19, 2015, two additional test pits were excavated on the subject lot using a track-mounted excavator. These additional test pits were designated as TP-3 and TP-4. The approximate locations of the original test pits and the additional test pits on the lot are shown on Figure No. 3, *Site Plan and Locations of Test Pits*, at the end of this report. The additional test pits (TP-3 and TP-4) were logged by an experienced engineering geologist from Earthtec Engineering. As previously discussed, a representative from the Weber County Engineering Department as well as the third-party geotechnical engineer and engineering geologist, retained by the County, were present on-site on the afternoon of June 19th to observe the test pits and review the logs. On June 22, 2015, a geotechnical engineer from Earthtec Engineering returned to the lot with the excavator and oversaw the excavation of an addition test pit (TP-5) in the area of the proposed house on the lot as well as extending TP-3 down slope to the elevation of TP-4. This was done to provide additional subsurface observation in order to better understand the shallow subsurface geology at the site. Test Pit TP-5 and the extension of TP-3 were not logged but were photographed by the engineer. In addition to observing and logging the test pits, additional samples were obtained from TP-3 and TP-4 for the purpose of providing additional lab testing data to aid in additional slope stability modeling for the subject lot. All of the test pits on the lot were back-filled following the completion of our field work on June 22nd.
