October 9, 2015

**Re: Engineering Geology Assessment-Revised  
Lot 15, Ski Lake Estates No. 3  
6640 East 1100 South  
Huntsville, Utah  
Job No. 145150**

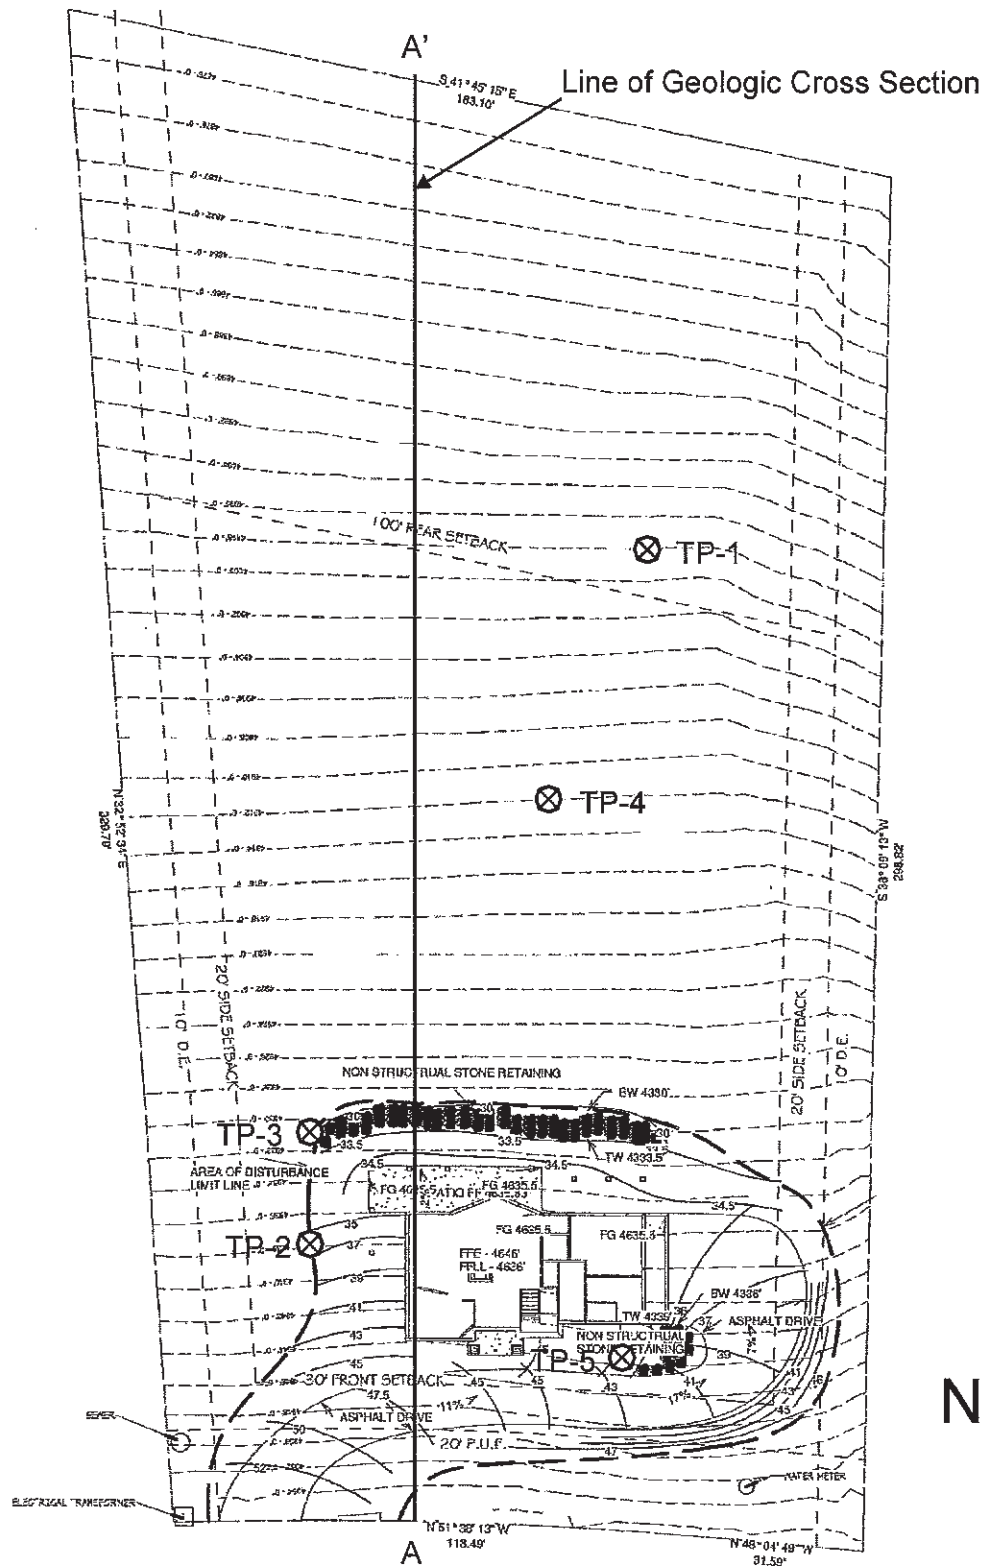
At the time of the original geotechnical report for the subject lot, two test pits were excavated on the lot and logged by a geotechnical engineer with Earthtec Engineering. The original test pits were designated as TP-1 and TP-2 in the referenced geotechnical report and the approximate locations of the test pits were shown on a aerial photograph of the lot included in the report. On June 19, 2015, two additional test pits were excavated on the subject lot using a track-mounted excavator. These additional test pits were designated as TP-3 and TP-4. The approximate locations of the original test pits and the additional test pits on the lot are shown on Figure No. 3, *Site Plan and Locations of Test Pits*, at the end of this report. The additional test pits (TP-3 and TP-4) were logged by an experienced engineering geologist from Earthtec Engineering. As previously discussed, a representative from the Weber County Engineering Department as well as the third-party geotechnical engineer and engineering geologist, retained by the County, were present on-site on the afternoon of June 19<sup>th</sup> to observe the test pits and review the logs. On June 22, 2015, a geotechnical engineer from Earthtec Engineering returned to the lot with the excavator and oversaw the excavation of an addition test pit (TP-5) in the area of the proposed house on the lot as well as extending TP-3 down slope to the elevation of TP-4. This was done to provide additional subsurface observation in order to better understand the shallow subsurface geology at the site. Test Pit TP-5 and the extension of TP-3 were not logged but extension of TP-3 was photographed by the engineer. Photographs of TP-5 were not recovered. In addition to observing and logging the test pits, additional samples were obtained from TP-3 and TP-4 for the purpose of providing additional lab testing data to aid in additional slope stability modeling for the subject lot. All of the test pits on the lot were back-filled following the completion of our field work on June 22<sup>nd</sup>.
