November 23, 2016

IGES Project No. 02348-001

Subject: Geologic Hazards Assessment (Revision 1)
The Ridge Subdivision Phases 3, 4, and 5
Eden, Utah

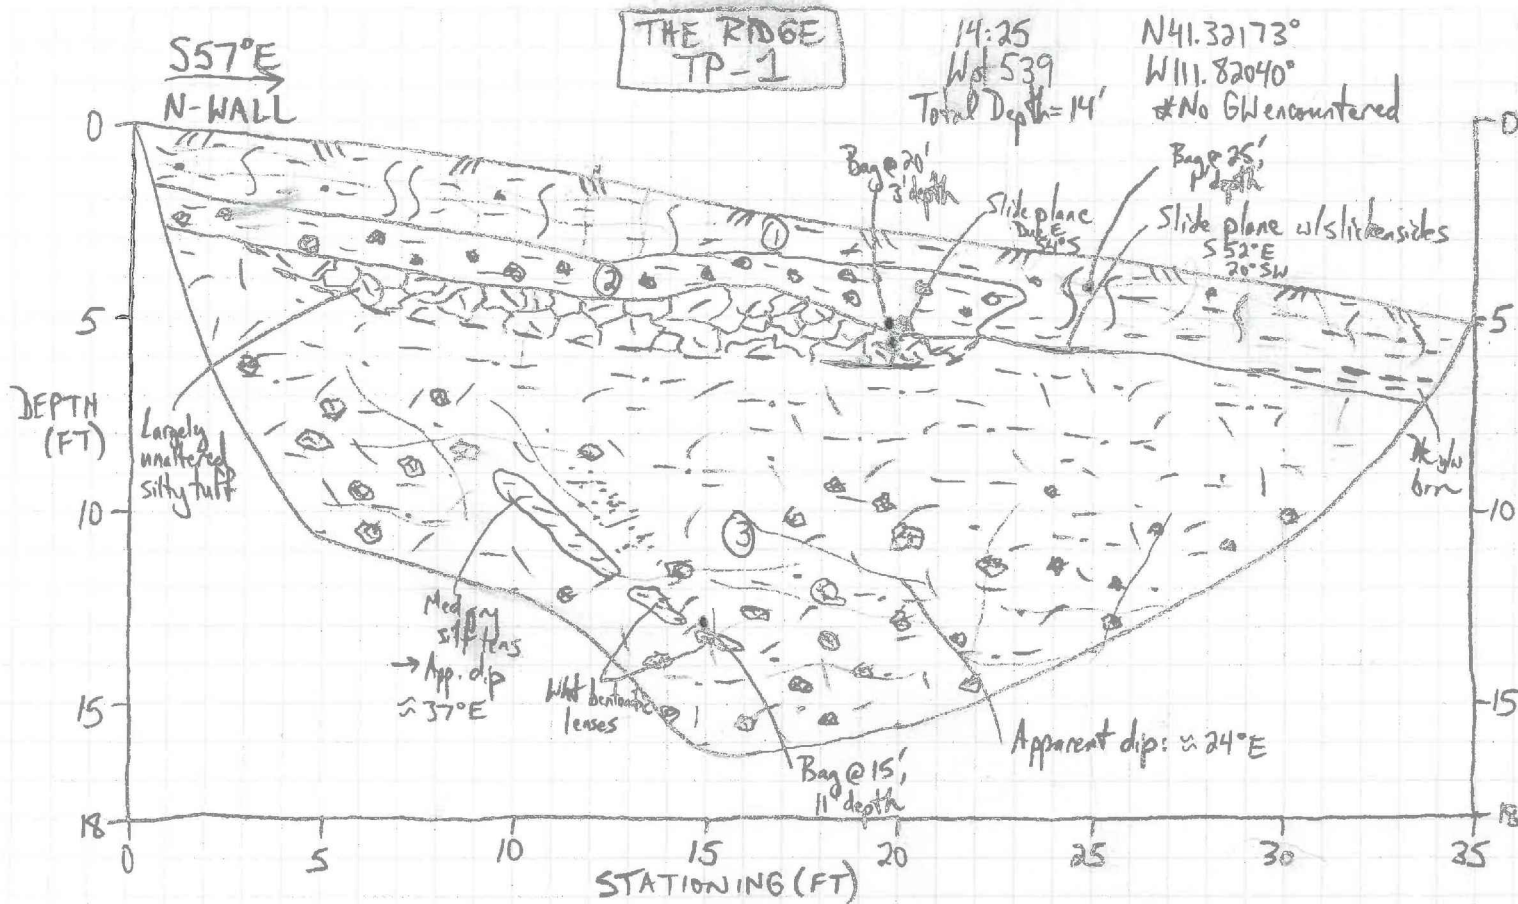
1. A/B Soil Horizon: ~1-3' thick; brownish black (5YR 2/1) fat CLAY, very stiff, slightly moist, moderate to high plasticity, massive, though blocky appearance due to abundant desiccation cracks; very similar to A/B horizon seen in TP-3, except slightly moist and therefore does not exhibit as large, wide, and prevalent desiccation cracks as seen in other test pits; subrounded quartzite clasts up to 2" diameter; abundant plant and tree roots, especially uppermost ~6"; irregular, sharp basal contact exhibits slickensides in places.

2. Highly Weathered Norwood Tuff Bedrock: ~1-2' thick; mottled grayish brown (5Y 3/2) and white (N9) mix of topsoil (Unit 1) and abundant small, angular Norwood Tuff clasts; gradational between gravelly fat CLAY and clayey GRAVEL, dense to very stiff, slightly moist, moderate plasticity, massive; common plant roots; irregular, gradational basal contact; basal contact largely characterized by thin brown shear plane, though slickensides not well defined; likely represents a shallow landslide deposit.

3. Norwood Tuff: >10' thick; light gray (N7) to medium light gray (N6) tuff partially to largely weathered to various masses of silt, sand, and clay; uppermost ~1.5' is lens of largely competent silty tuff, the top of which is a slide plane upon which the overlying material passes; contains common calcite-filled fractures, both along bedding planes and subvertical; basal ~6" exposed in pit exhibits highly irregular, possibly chaotic structure with hard and soft areas scattered throughout; calcium carbonate and manganese oxide dendrites and nodules commonly found scattered through basal ~6"; occasional white (N9) lenses largely decomposed to bentonite; uppermost ~4' of unit is predominantly silty tuff largely decomposed to silt; no quartzite observed.

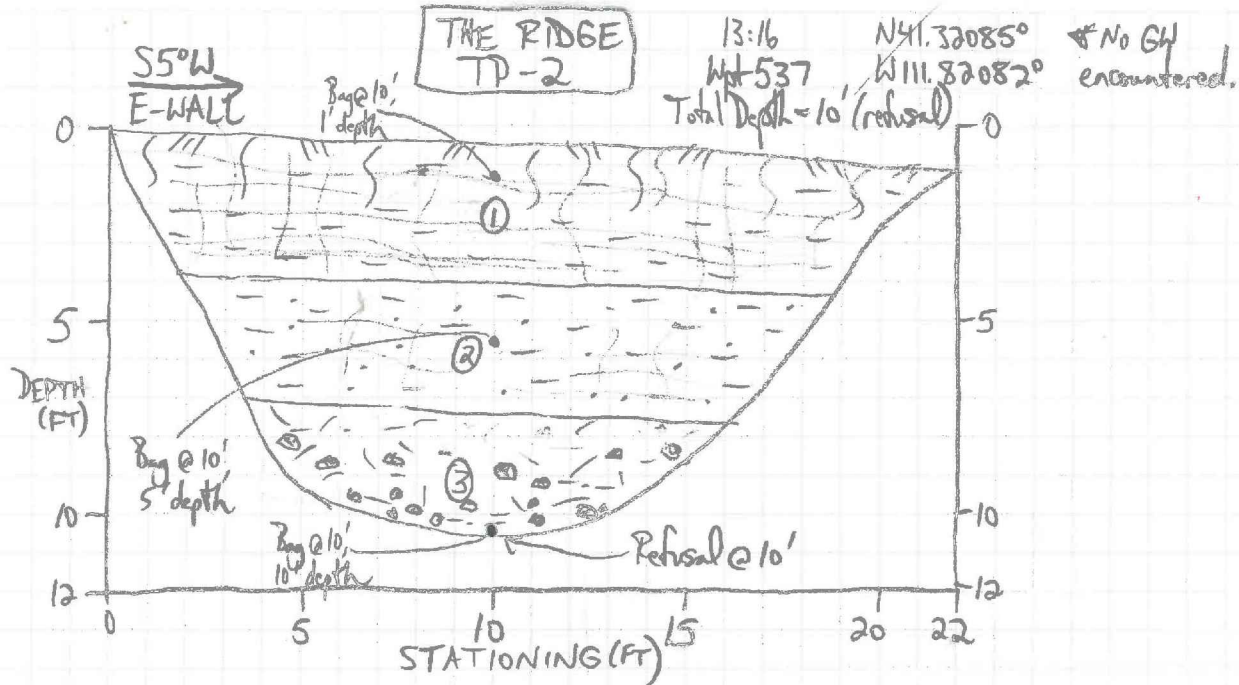
1. A/B Soil Horizon: ~3.5' thick; brownish black (5YR 2/1) to grayish brown (5Y 3/2) fat CLAY, very stiff, dry, moderate to high plasticity, massive, though blocky appearance due to abundant desiccation cracks; very similar to as seen in TP-3, except unit is thicker, contains fewer clasts (~1%), and displays wider desiccation cracks (seen to extend to the base of unit at up to 1" wide); common small plant roots throughout, though abundant in uppermost ~6" of unit; sharp, planar basal contact.

2. Weathered Norwood Tuff Ash: ~3' thick; dark yellowish brown (10YR 4/2), mottled with white (N9) specks; fat CLAY, stiff to very stiff, slightly moist, moderate to high plasticity, massive; abundant small white CaCO₃ nodules scattered throughout unit, up to 1 cm in diameter; ash almost entirely decomposed to fat clay, though possibly a B-horizon; exhibits mechanically-induced slickensides, though no natural slickensides observed; minor desiccation cracking; sharp, planar basal contact.

3. Norwood Tuff Block-and-Ash: >3.5' thick; moderate yellowish brown (10YR 5/4) to dark yellowish brown (10YR 4/2) silty lean CLAY with gravel, very stiff to stiff, slightly moist, low to moderate plasticity, massive; gravel and larger sized clasts comprise ~30-40% of unit; clasts are ~60% very light gray (N8), subangular to subrounded, silty, soft tuff, and ~40% dark yellowish orange (10YR 6/6), very hard, subrounded to subangular quartzite clasts up to 4" in diameter, though mode size ~1"; uppermost ~1' is largely devoid of clasts and exhibits a blocky structure due to possible desiccation cracks; clast concentration increases with depth.

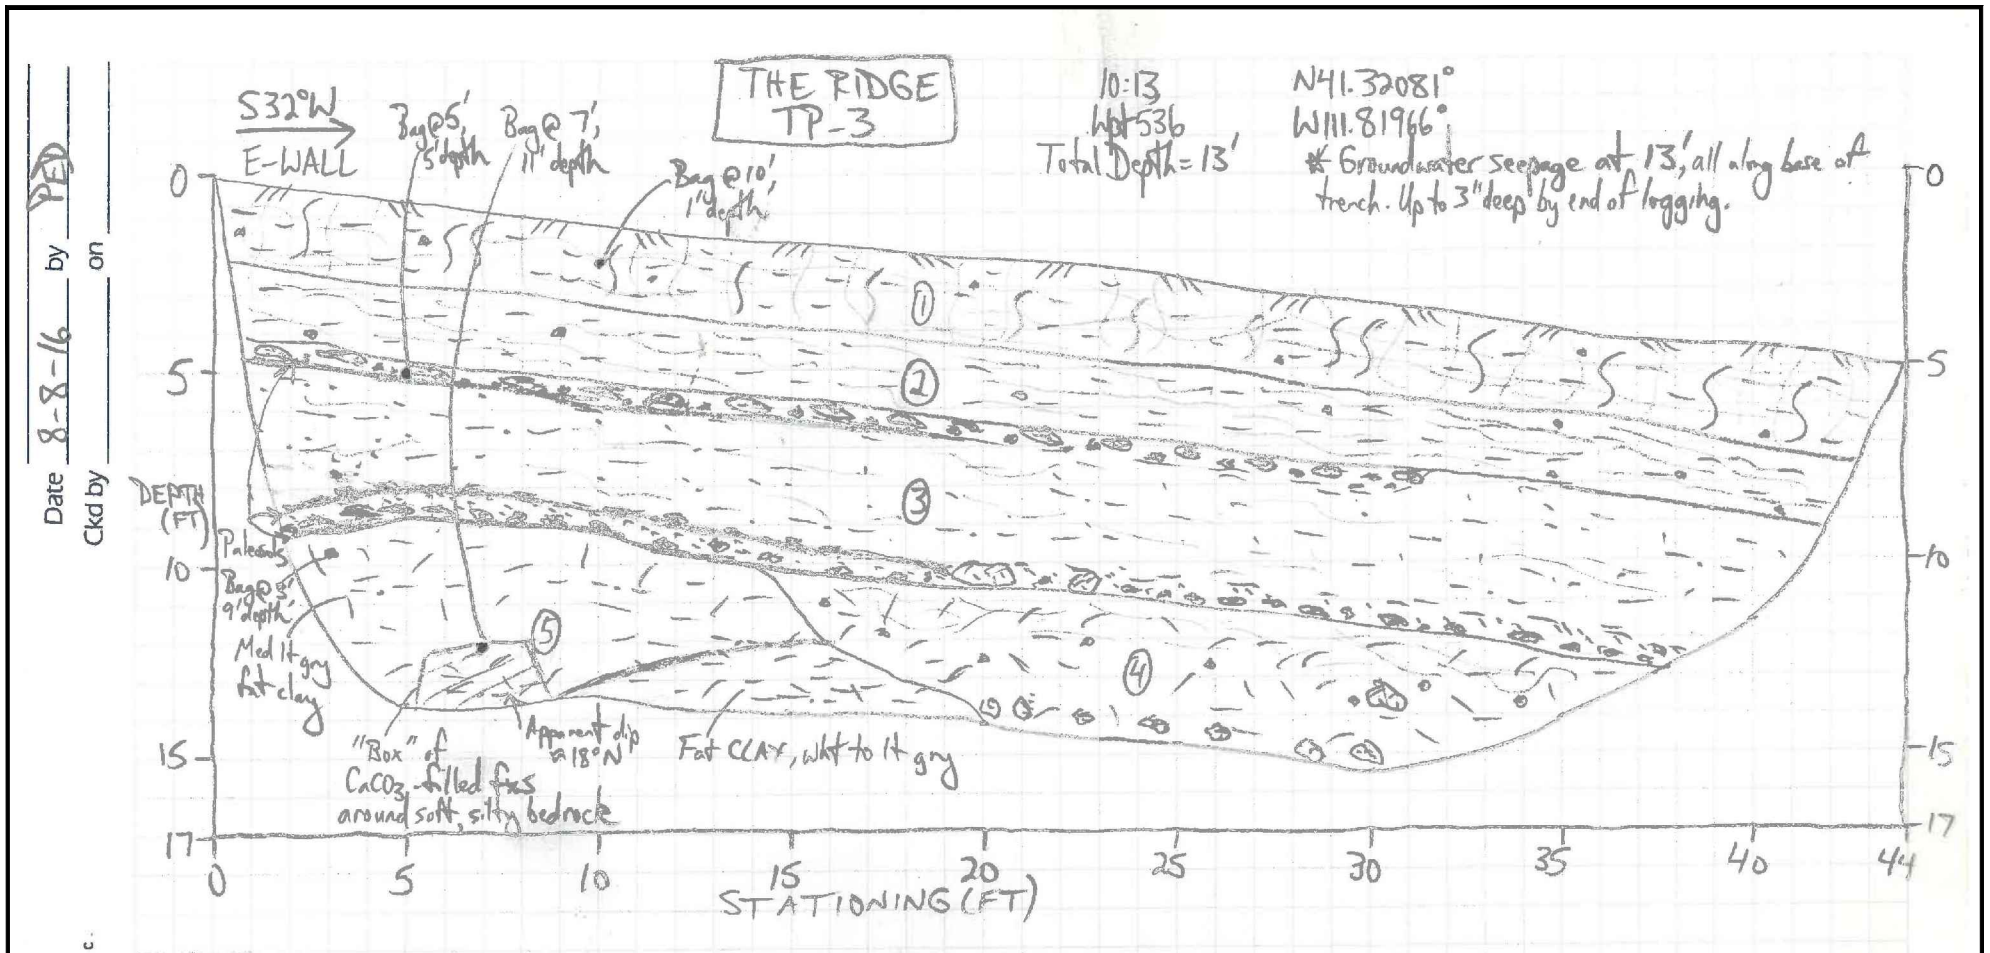
1. A/B Soil Horizon: ~2-2.5' thick; brownish black (5YR 2/1) to grayish brown (5Y 3/2) fat CLAY, very stiff, dry, moderate to high plasticity, massive, though blocky appearance due to abundant desiccation cracks; very well developed soil horizon; desiccation cracks are spaced between 1-2", and extend to base of unit; aperture of cracks seen to be 1" or greater on the surface in places, and generally 1-5 mm in subsurface; minor (<5%) gravel and larger sized clasts; clasts are entirely pink to dark yellowish orange (10YR 6/6) subrounded to subangular quartzite up to 1" in diameter; common plant and tree roots in uppermost 1', but decrease with depth; sharp, planar basal contact.

2. Alluvial?: ~2' thick; mottled very light gray (N8) and dark yellowish brown (10YR 4/2) lean CLAY with gravel; stiff, slightly moist, low plasticity, weakly thinly bedded (<1/2"); mottled due to abundant CaCO₃ stringers, flour, and bedding plane infilling throughout; uppermost ~1' is highly calcareous and CaCO₃ decreases with depth; gravel and larger sized clasts comprise ~5% of unit, ~80% of which is subrounded quartzite and ~20% is subrounded white (N9) Norwood Tuff; clasts up to 2.5" diameter; gradational, planar basal contact; possibly hyperconcentrated flow deposit.

3. Debris-Flow?: ~4' thick; dark yellowish brown (10YR 4/2) and mottled with white (N9) CaCO₃ stringers and flour in places; silty lean CLAY with gravel gradational to clayey GRAVEL in places; stiff to dense, moist, low to medium plasticity, thinly to moderately bedded (up to 3.5"), blocky in places; top and bottom of unit has ~6"-1' thick clayey, sandy gravel lenses with imbricated quartzite clasts and associated thin (~3 mm) paleosols; clasts predominantly ~80% subrounded quartzite, ~20% Norwood Tuff weathered to clay; common 1 mm pinholes; sharp, irregular basal contact.

4. Norwood Tuff Block-and-Ash: >4' thick; mottled dark yellowish brown (10YR 4/2) and white (N9); top 1-2' has abundant CaCO₃ stringers; silty fat CLAY with gravel; stiff, moist, moderate to high plasticity, massive; fat clay content and clast frequency increases with depth; gravel and larger sized clasts comprise ~5-10% of unit; clasts predominantly quartzite up to 5" in diameter.

5. Weathered Bedrock: >4' thick; medium light gray (N6) to light gray (N7); Norwood Tuff bedrock largely disaggregated to silty fat CLAY and clayey SILT; stiff to very stiff, moist, moderate to high plasticity, possibly thickly bedded; common organic or MnO₂ smear in fat clay, as seen in silty tuff; some CaCO₃ filled fractures; no natural slickensides observed.

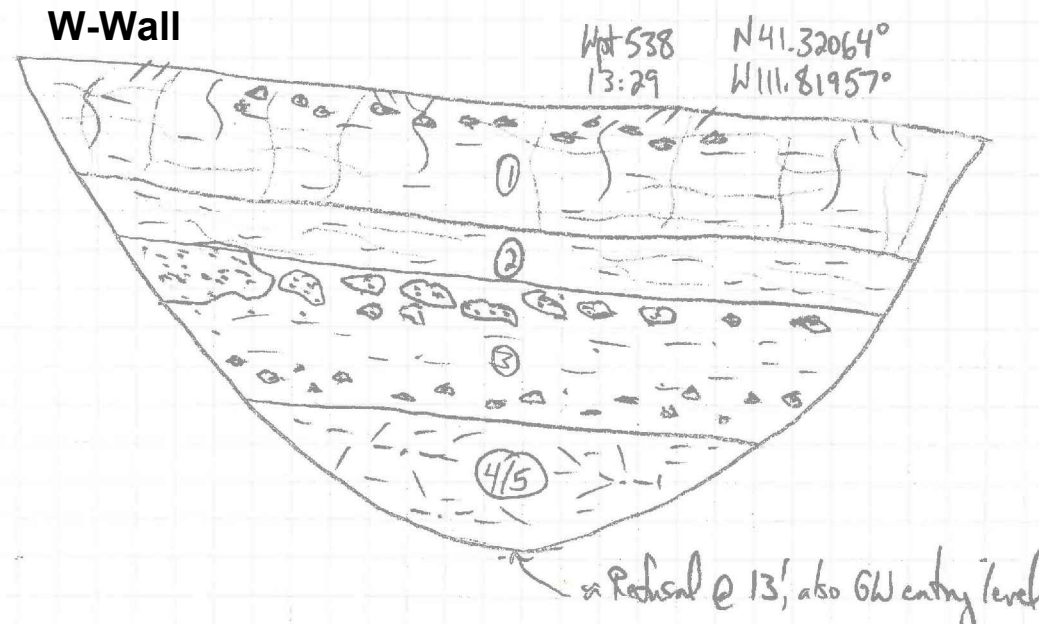
PH-1

8/8/16 02348-001 Pothole 1
 → Located \approx 60' E of TP-1, in an attempt to hit bedrock
 → GW present @ 13', water \approx 3" deep
 → Pothole TD = 13', \approx 25' long, oriented @ 538°W

All units same as seen in TP-3, except:

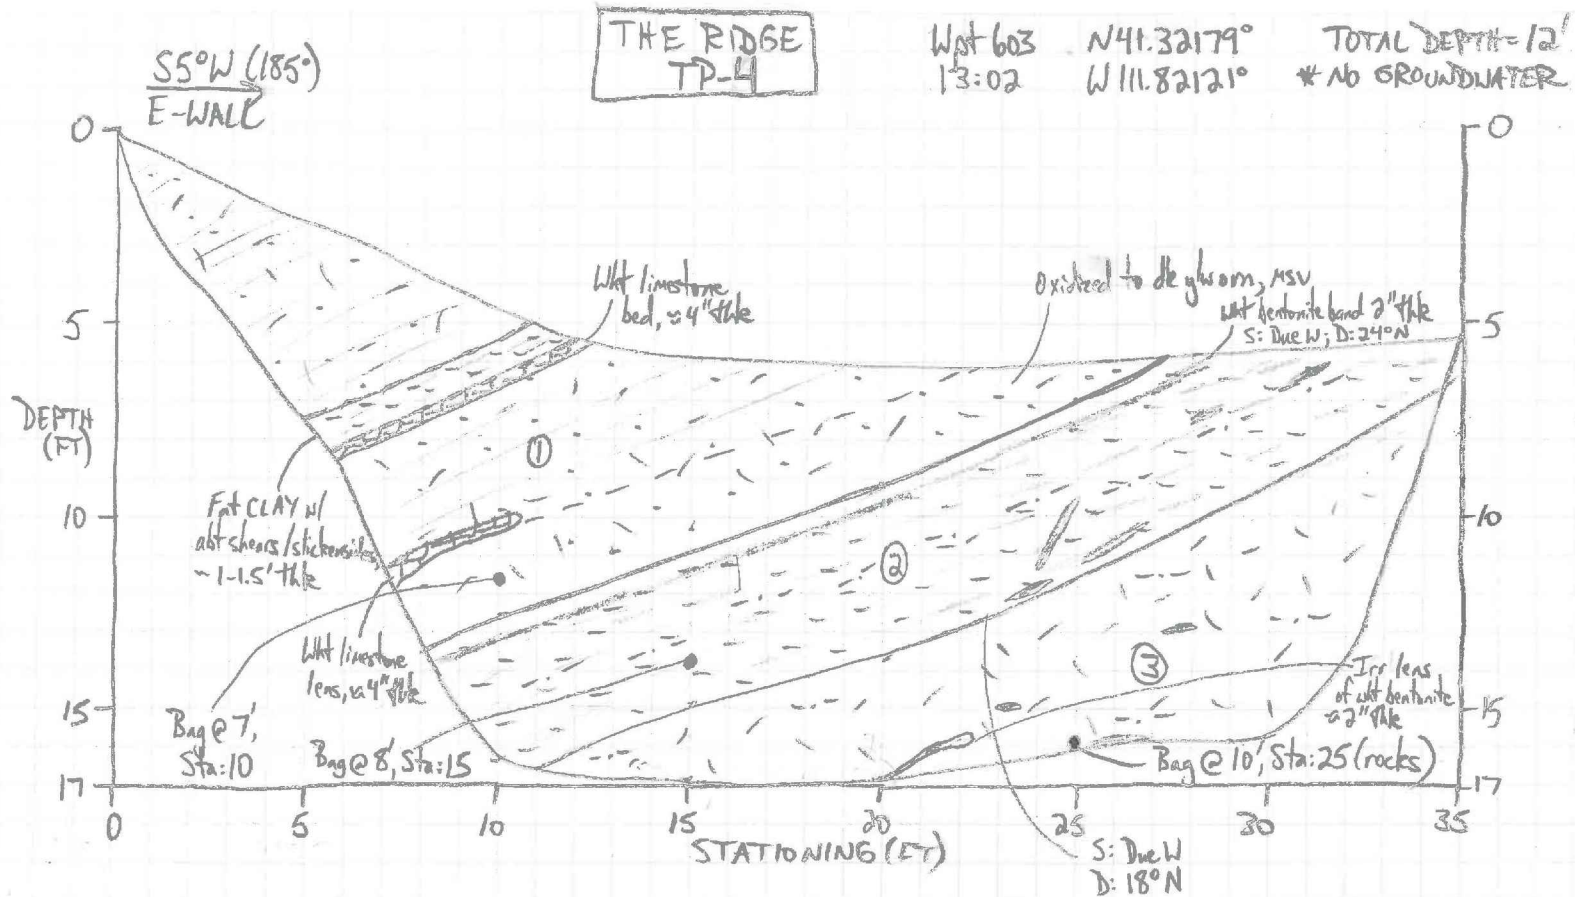
1. Norwood Tuff 1: At least ~12' thick; pale olive (10Y 6/2) to light brownish gray (5YR 6/1); Norwood Tuff bedrock consisting of sandy tuff gradational to tuffaceous sandstone, very fine-grained to fine-grained, calcite cement, subangular, well sorted, finely laminated; grains are predominantly quartz, though ~10% mafics; moderately hard, though gradational between soft and hard; commonly oxidized along laminae and basal ~2' of unit is oxidized to dark yellowish orange (10YR 6/6); contains a ~1-1.5' thick pale olive bed of heavily slickensided/sheared fat CLAY (CH), stiff to very stiff, moist, high plasticity, massive; unit contains some thin (<4") beds of white micritic limestone with caliche coating; sharp, planar basal contact.

2. Shear Zone: ~4' thick; brownish gray (5YR 4/1) to pale olive (10Y 6/2); fat CLAY (CH), stiff to very stiff, moist, high plasticity, massive; heavily sheared/slickensided throughout, with common glassy appearance; sheared/broken internal structure, though contains some white possibly bentonitic bands and nodules with caliche coating, and the bands are laterally continuous; some remnants of siltstone bedrock found in the middle of the unit; sharp, planar basal contact.

3. Norwood Tuff 2: >6' thick; pale olive (10Y 6/2) to light brownish gray (5YR 6/1); Norwood Tuff bedrock consisting of silty tuff gradational to tuffaceous siltstone, massive, weak calcite cement; moderately hard to soft, though hard in places; thinly bedded in places; grades to very fine-grained sandstone with depth; contains occasional plant roots along fractures, though fractures are largely unfilled; some white possibly bentonitic lenses and nodules with caliche coating.

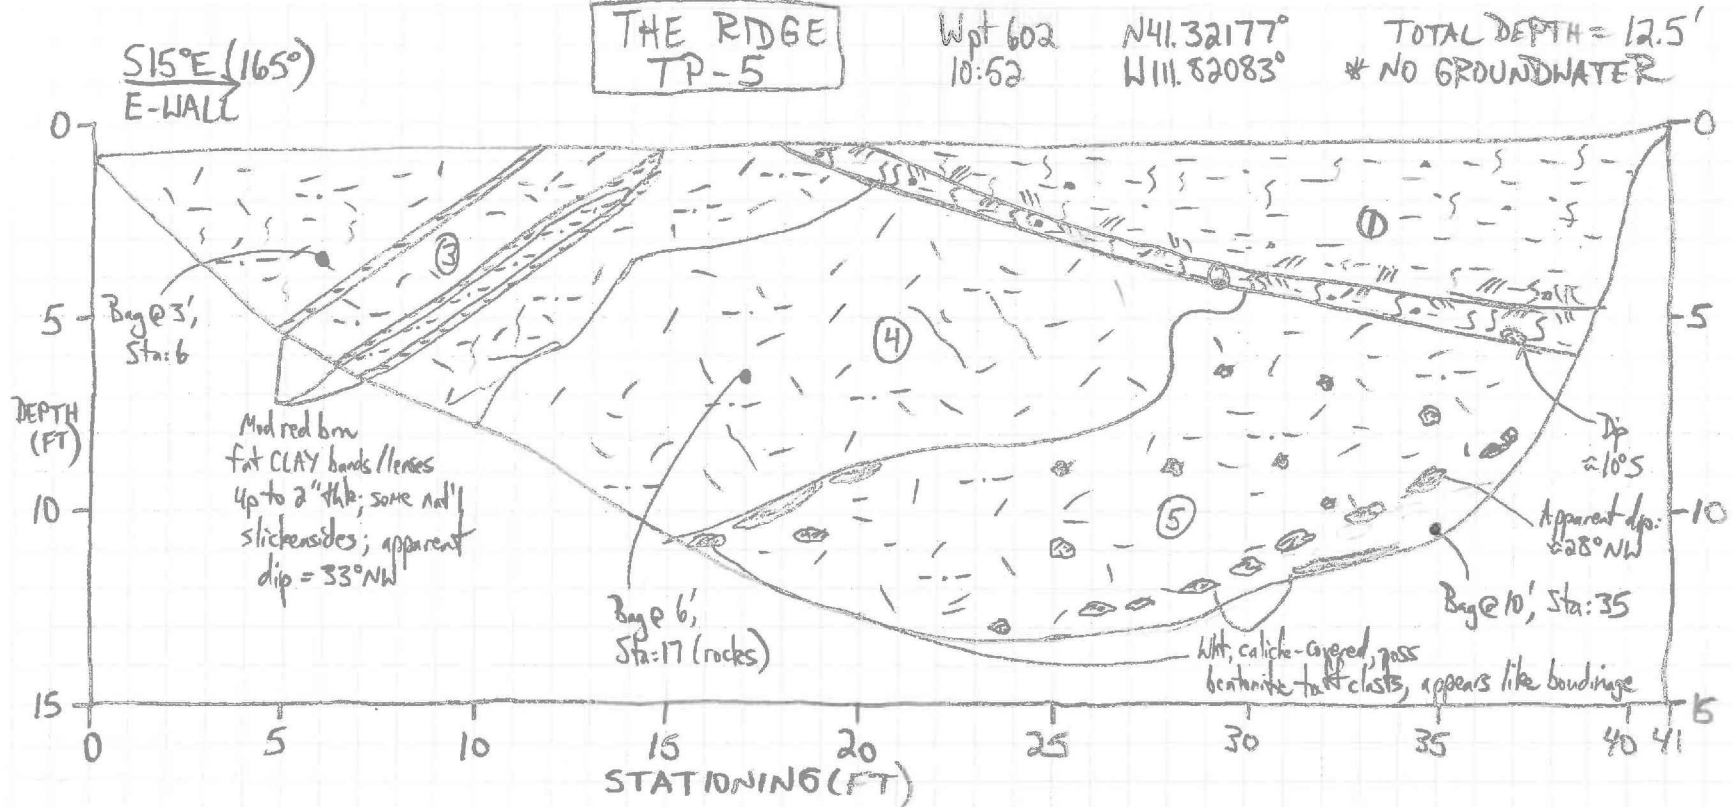
- 1. Fill:** Up to 4' thick; mix of topsoil and fat CLAY taken from hillslope cut; fat CLAY with gravel (CH), loose to medium stiff, slightly moist to moist, moderate plasticity, massive; contains abundant organic matter mixed in, especially in basal ~6"-1' of unit; gravel and larger-sized clasts comprise ~5-10% of unit; clasts are subangular and up to 4" diameter; clasts are comprised of predominantly white (N9) silty tuff and some medium gray (N5) quartzite; thickens to south; sharp, planar basal contact.

- 2. A/B Soil Horizon:** ~6" thick; brownish black (5YR 2/1) to black (N1); lean CLAY with gravel (CL), stiff, moist, low to moderate plasticity, massive; gravel and larger-sized clasts comprise ~5-10% of unit, and include roughly equal proportions of medium gray (N5) quartzite and light brownish gray (5YR 6/1) medium-grained lithic tuff; clasts are subangular to subrounded and up to 6" in diameter, though mode size is <1"; abundant plant/tree roots and very organic-rich; thickens slightly downslope to south; very sharp, planar basal contact.

- 3. Weathered Bedrock:** At least ~6" thick; pale reddish brown (10R 5/4) to pale olive (10Y 6/2); highly to partially weathered Norwood Tuff tuff/siltstone bedrock decomposed to elastic SILT (MH) and fat CLAY (CH), stiff to very stiff, slightly moist, moderate plasticity, massive to medium bedded (~1-4"); abundant small, thin, white caliche stringers; occasional caliche-filled fractures (subvertical and subhorizontal); contains several thin (~1-2") moderate reddish brown (10R 4/6) fat clay bands that exhibit natural slickensides, but dip into hillslope; occasional in situ blocks of silty tuff; sharp, irregular basal contact.

- 4. Norwood Tuff 1:** ~7" thick; light brown (5YR 6/4) to moderate yellowish brown (10YR 5/4); Norwood Tuff bedrock, silty and very fine-grained, massive; moderately hard to hard; quartz-rich, with angular to subangular grains; occasional calcite-filled fractures; fairly difficult to excavate; occasional plant roots along fractures; sharp, irregular basal contact.

- 5. Norwood Tuff 2:** >7" thick; light brown (5YR 6/4) to light brownish gray (5YR 6/1); block-and-ash deposit, largely decomposed to sandy fat CLAY (CH), stiff to very stiff, slightly moist, moderate plasticity, massive, though possibly weakly thinly bedded; gravel and larger-sized clasts comprise ~10-15% of unit; clasts are entirely angular white (N9) to medium light gray (N6) tuff and silty tuff, some partially oxidized and others possibly bentonitic; abundant white caliche flour, fracture infilling, and clast covering; clasts are up to 1' diameter, and some are gradational to very fine-grained to fine-grained sandstone.

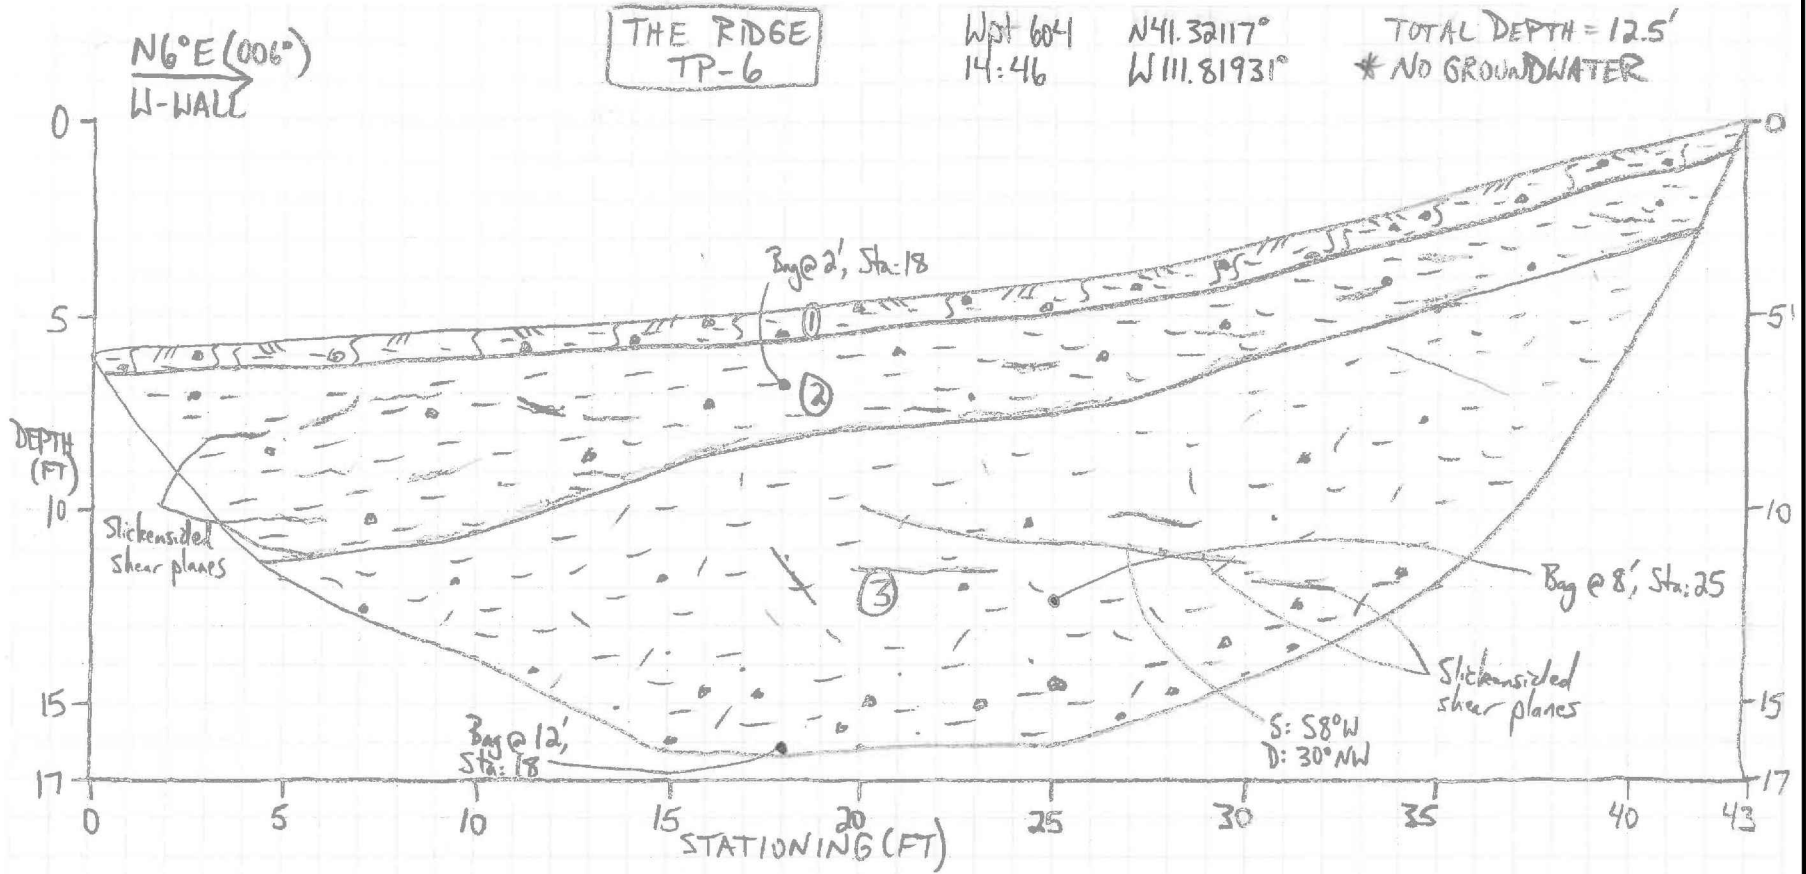
1. A/B Soil Horizon: ~6-8" thick; brownish black (5YR 2/1) to black (N1); fat CLAY with gravel (CH), medium stiff, moist, moderate to high plasticity, massive; gravel and larger-sized clasts comprise ~5-10% of unit; clasts are entirely pale yellowish orange (10YR 8/6) subrounded to subangular quartzite up to 4" in diameter; abundant plant and tree roots; largely planar, gradational basal contact.

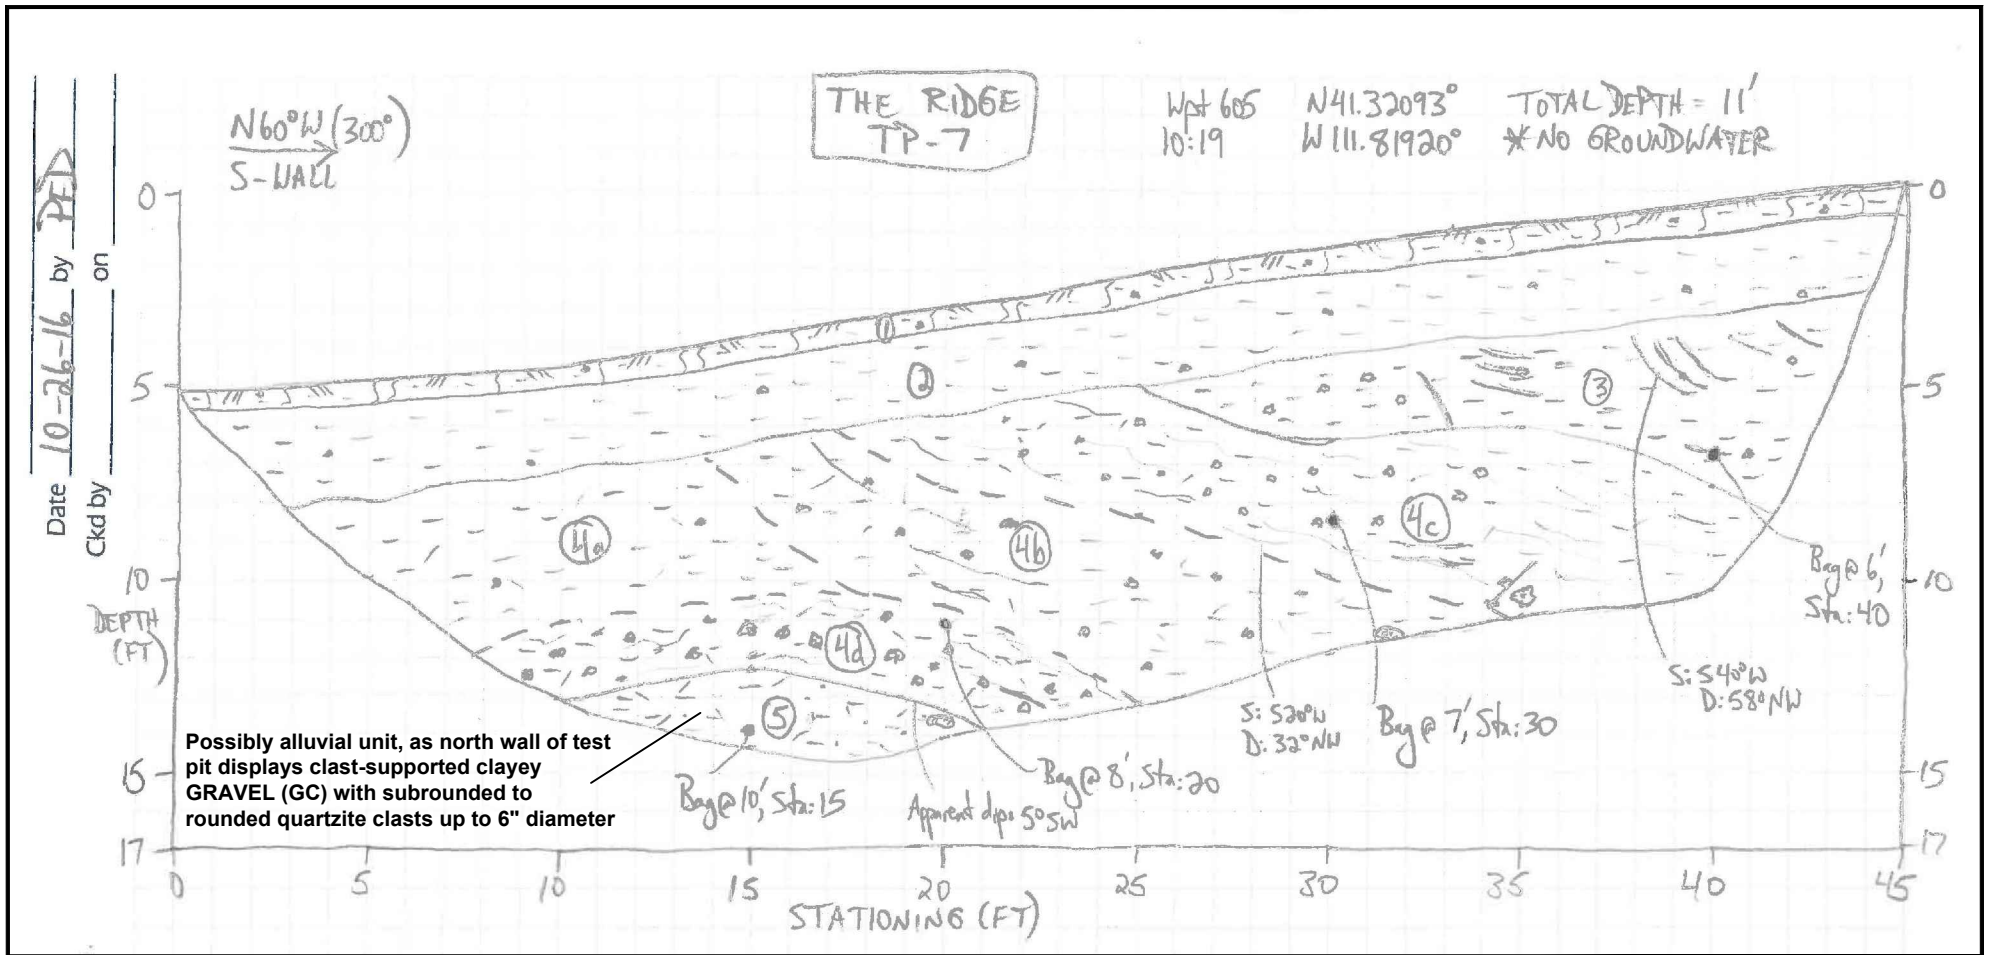
1. A/B Soil Horizon: ~6-8" thick; brownish black (5YR 2/1) to black (N1); fat CLAY with gravel (CH), medium stiff, moist, moderate to high plasticity, massive; gravel and larger-sized clasts comprise ~5% of unit; clasts are entirely pale yellowish orange (10YR 8/6) subrounded to subangular quartzite up to 4" in diameter; abundant plant and tree roots; largely planar, gradational basal contact.
