**GEOTECHNICAL AND GEOLOGIC HAZARD INVESTIGATION  
Lot 29 of Summit Eden Phase 1B  
Summit Powder Mountain Resort  
Weber County, Utah**

IGES Project No. 01496-004

September 13, 2017

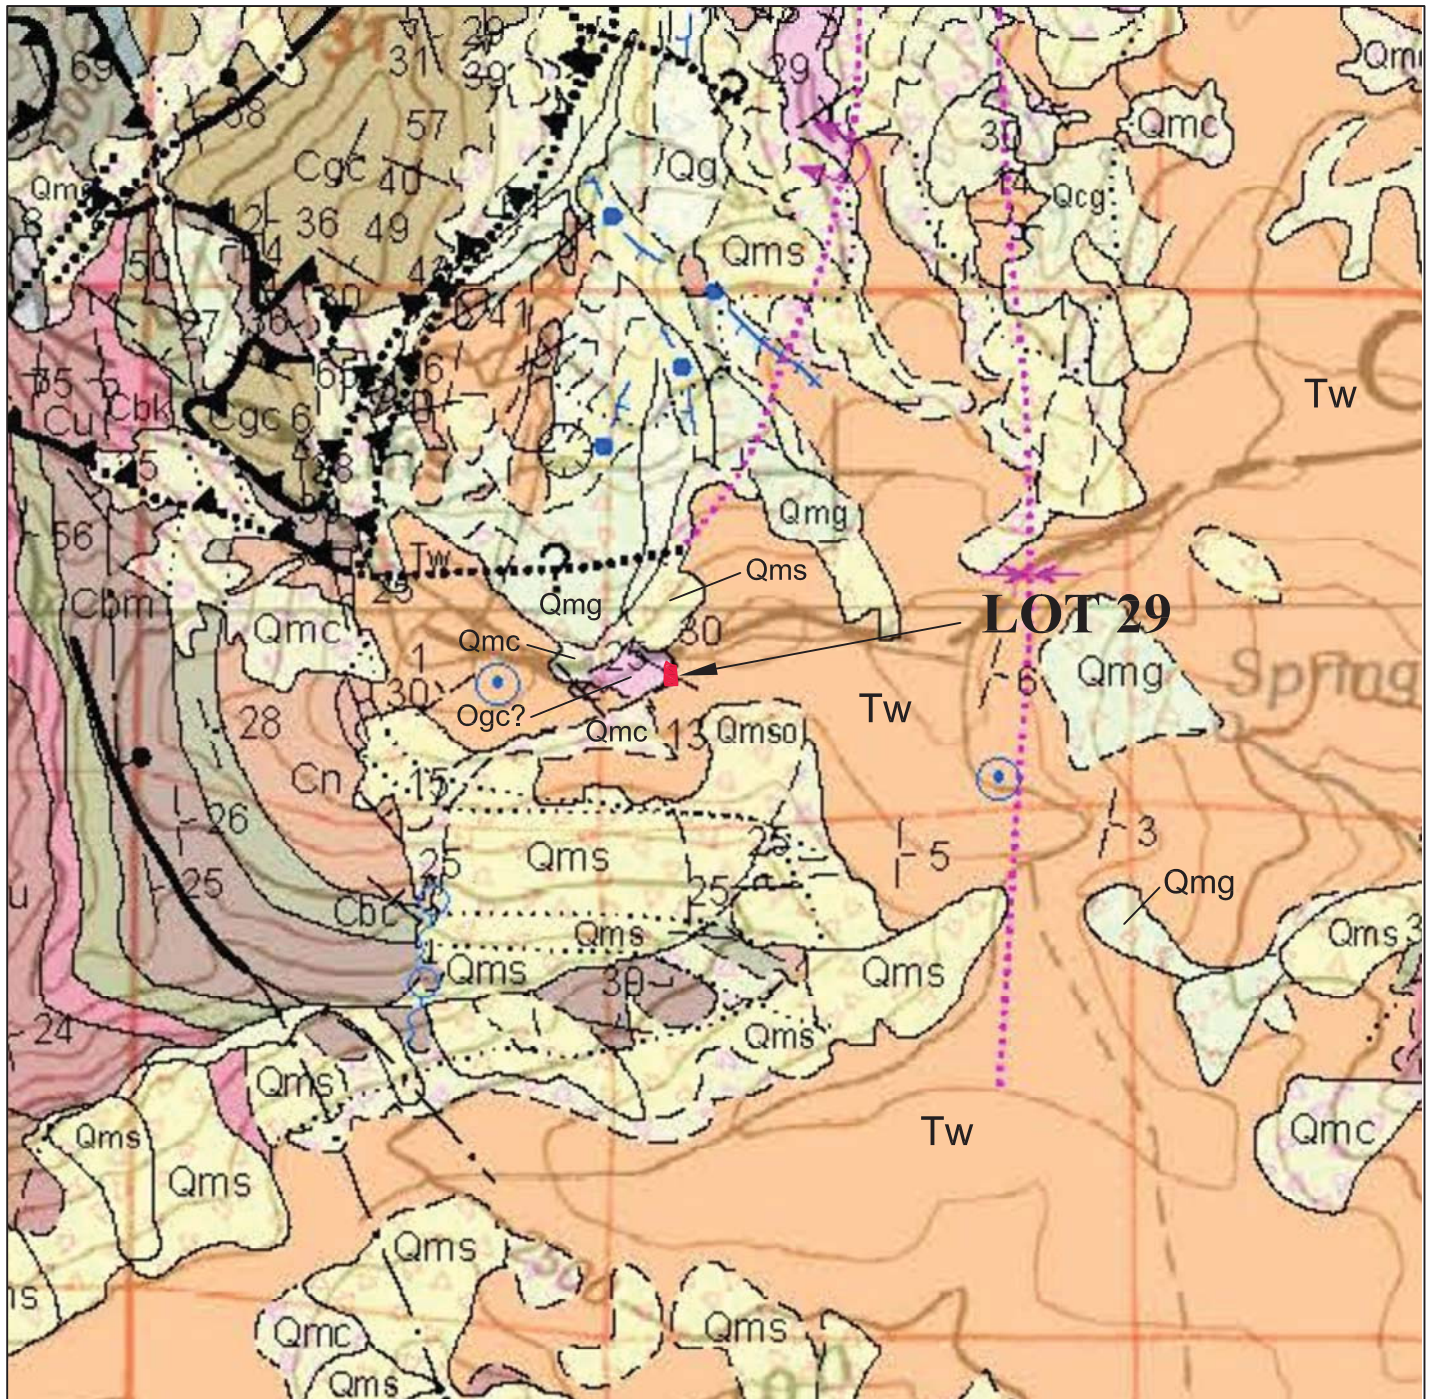
**A-7**

Geotechnical & Geologic Hazard Investigation  
 Lot 29 of Summit Eden Phase 1B  
 Summit Powder Mountain Resort  
 Weber County, Utah REGIONAL GEOLOGY MAP 2
