**Geologic Hazards Screening Assessment  
Approximately 4400 North 2900 East  
Eden, Utah 84310  
Parcel # 22-088-0076**

GeoStrata Job No. 1348-001

December 4, 2017

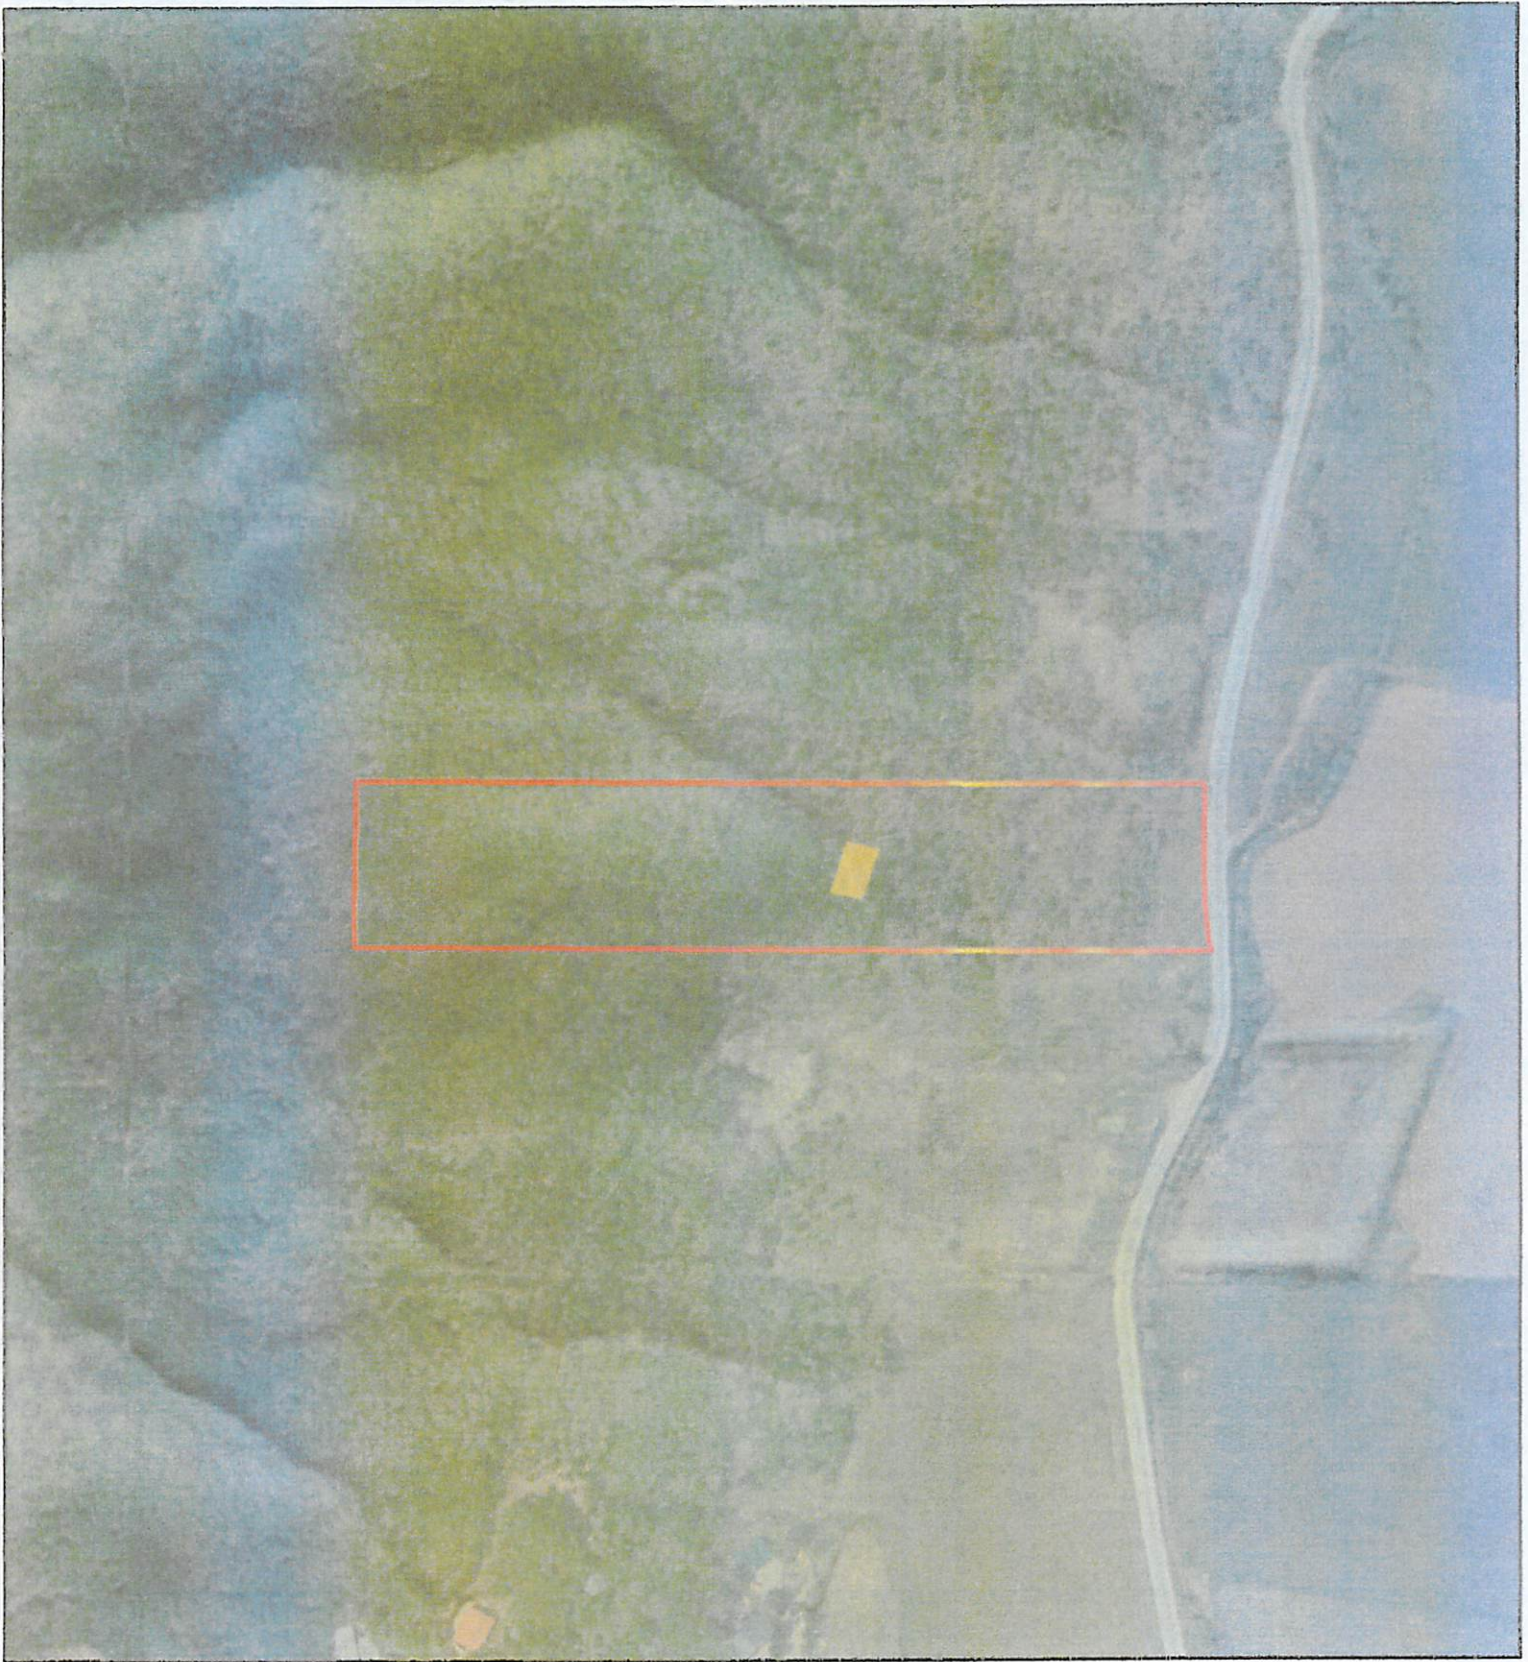
**Plate  
2**

Slope stability of the subject site was not assessed as part of this geological hazard assessment. The subject site was observed to be moderately sloping to the east and relatively flat (Plate 2 Topographic Map). Based on our understanding of the project, the proposed building site is located in the relatively flat areas of the subject site (Plate 3 Proposed Building Site). The possibility that development of the site could negatively affect slope stability within the subject site is increased if development is planned for areas of the site with slopes steeper than

As stated previously, the project site is located within the northwestern extent of Ogden Valley in Eden, Utah. The subject site is situated on a moderately to relatively flat undeveloped 5.68 acre parcel within Weber County (Plate 2 Topographic Map). The area extending from the eastern property boundary and west approximately 100 to 125 feet was observed to be relatively flat. Test pits were excavated within the subject site as part of infiltration testing and were separate from this investigation. One test pit was left open at the time of our field investigation and was observed to extend to a depth of approximately 8 feet. Areas of surface disturbance were also observed as remnants of buried test pits. Soils within the open test pit and in the areas of disturbance were observed to consist of clays with sand and gravel. The subject site was observed to be densely vegetated with large brush and scrub oaks up to 30 feet tall. No structures were observed within the subject property. The properties to the south and east of the subject site are undeveloped parcels and the area west of the subject site is a native hillside. A single family residence is currently in the development stages on the property adjacent to and immediately north of the subject site.

Slope stability of the subject site was not assessed as part of this geological hazard assessment. The subject site was observed to be moderately sloping to the east and relatively flat (Plate 2 Topographic Map). Based on our understanding of the project, the proposed building site is located in the relatively flat areas of the subject site (Plate 3 Proposed Building Site). The possibility that development of the site could negatively affect slope stability within the subject site is increased if development is planned for areas of the site with slopes steeper than approximately 3 horizontal: 1 vertical, GeoStrata recommends that slope stability at the site be assessed as part of a site specific geotechnical assessment of the subject lot. If improvements are planned as a part of the development of the lot that include cuts and fills other than excavation of the foundation, minor grading of the driveway and minimal landscaping, then it is our opinion that a site specific geotechnical investigation which includes a detailed slope stability assessment of the lot needs to be conducted prior to development of the lot and the recommendations contained in the geotechnical report be followed as a part of the grading design for the lot.
