**Geologic Hazards Assessment
Parcel #'s 23-012-0019 & 23-012-0105
Eden, Utah**

GeoStrata Job No. 1236-003

July 31, 2018

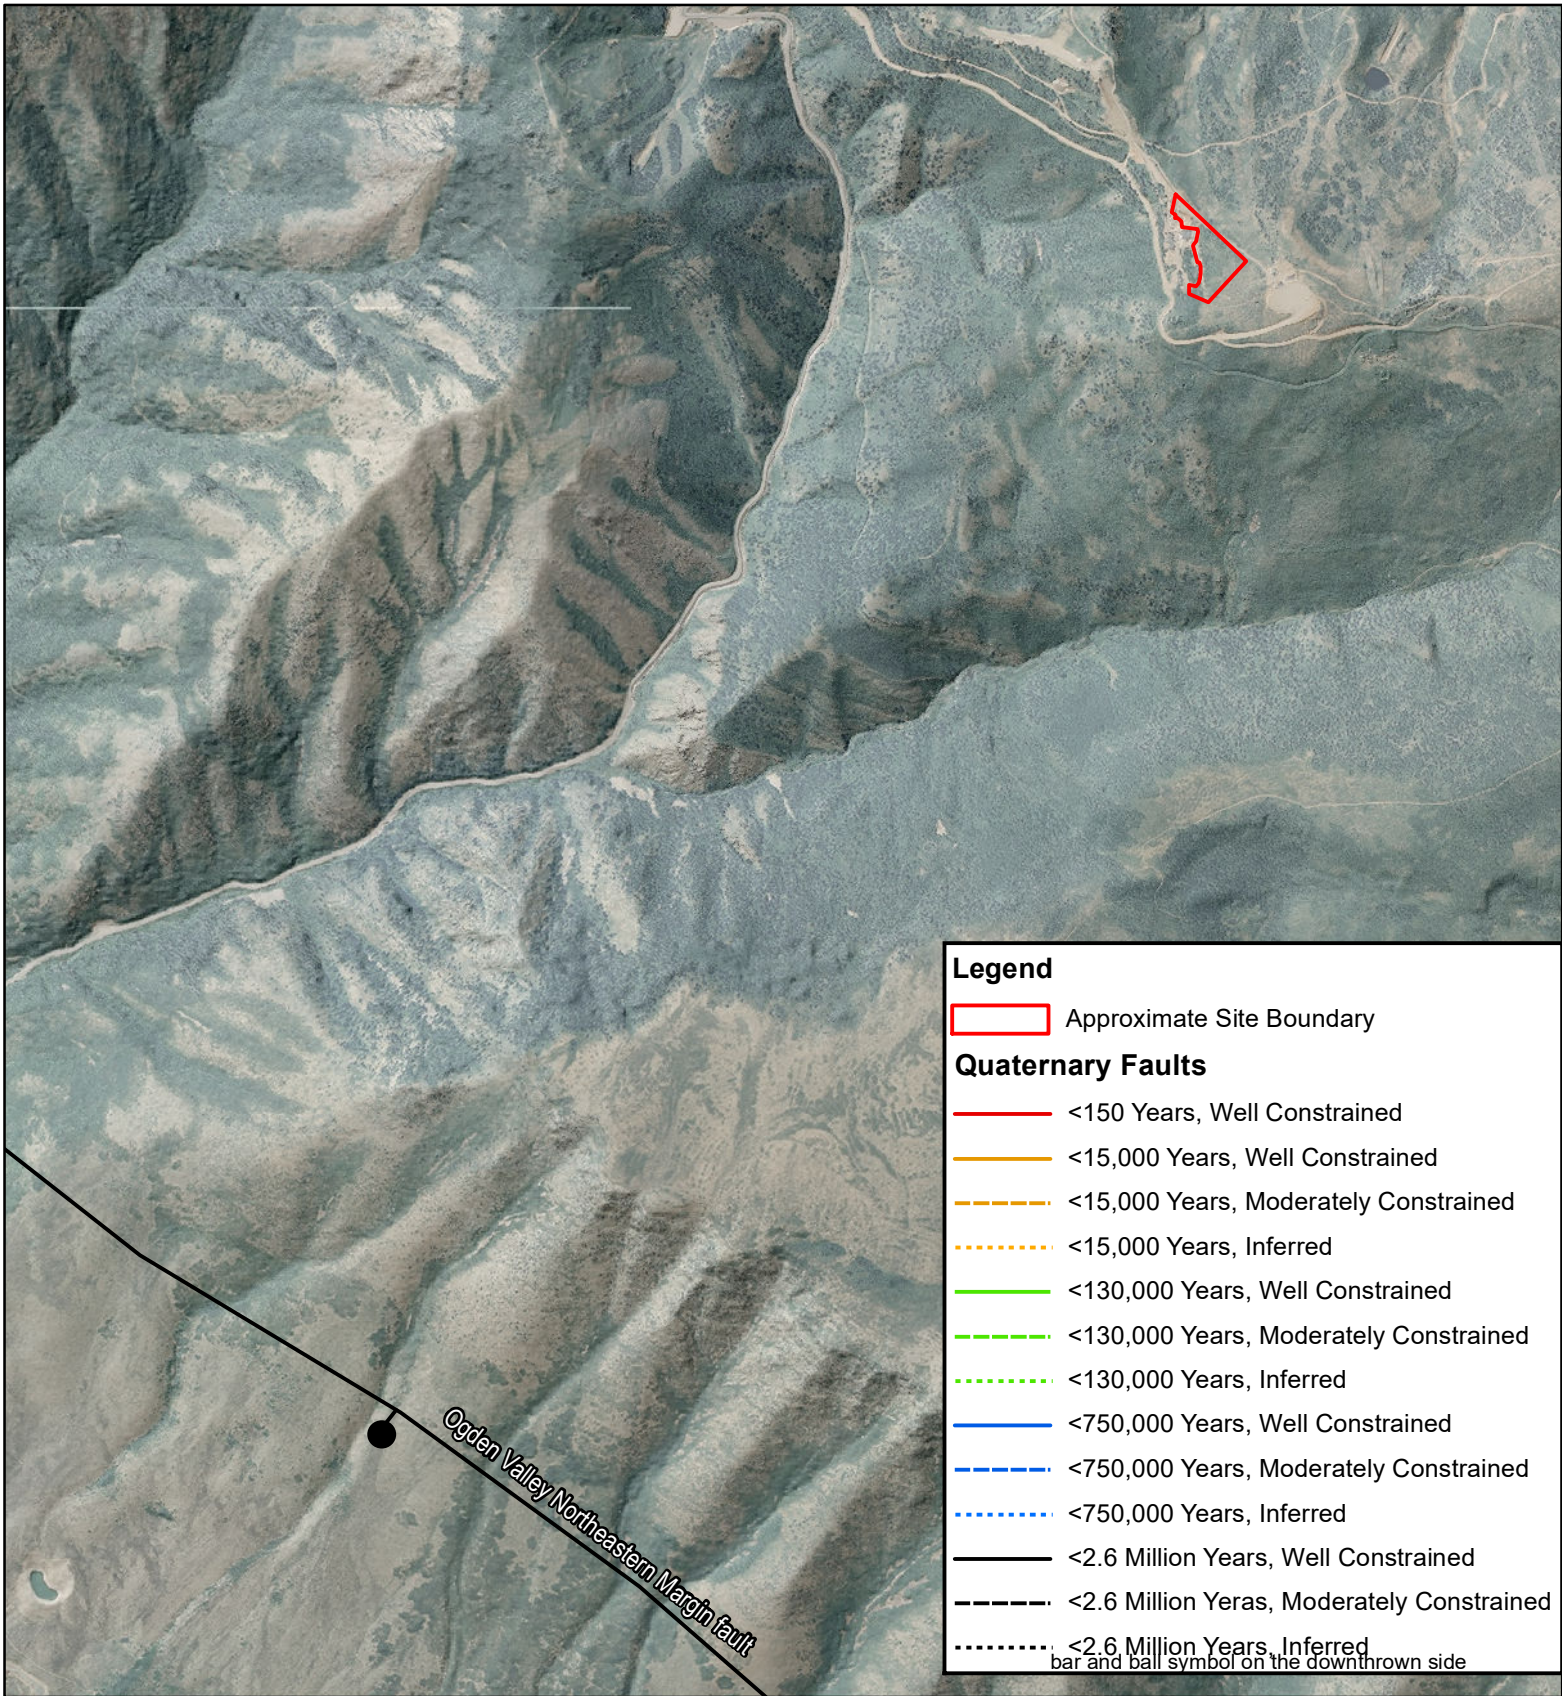
**Plate
5**

Surface deposits within the majority of subject site, as shown on Plate 4 Site Vicinity Geologic Map and Plate 5 Site Vicinity 30' X 60' Geologic Map, are mapped as Eocene, Paleocene and Upper Cretaceous(?) Wasatch and Evanston(?) Formations, Undivided (Twe) bedrock and is described as unconsolidated pale-reddish-brown Precambrian quartzite pebble, cobble and boulder conglomerate with a matrix of sand and silt (Coogan and King, 2010; Sorensen and Crittenden, 1979). Overlying the bedrock deposit described above and along the southwestern and northeastern property boundaries of the subject site, a Holocene age Landslide and colluvial deposits, undivided (Qmc) is mapped by Coogan and King, 2010 as shown on Plate 5 Site Vicinity 30' X 60' Geologic Map. Sorensen and Crittenden, 1979 map a Holocene age colluvium, slopewash and landslide deposit, undivided (Qcs-Qls) within the northwest and southwest corners of the subject site.

Based on review of published geologic maps, review of stereographic aerial photographs and hillshades derived from 2016 0.5 meter LiDAR, no Holocene age alluvial fan deposit is mapped within or adjacent to the subject site (Plate 4 Site Vicinity Geologic Map; Plate 5 Site Vicinity 30' X 60' Geologic Map). Given our field and office investigations, the alluvial fan flooding hazards within subject site is considered low and it is considered unlikely that debris flows will impact the proposed development. It is the opinion of GeoStrata that alluvial fan flooding hazard should not preclude development at the subject site.

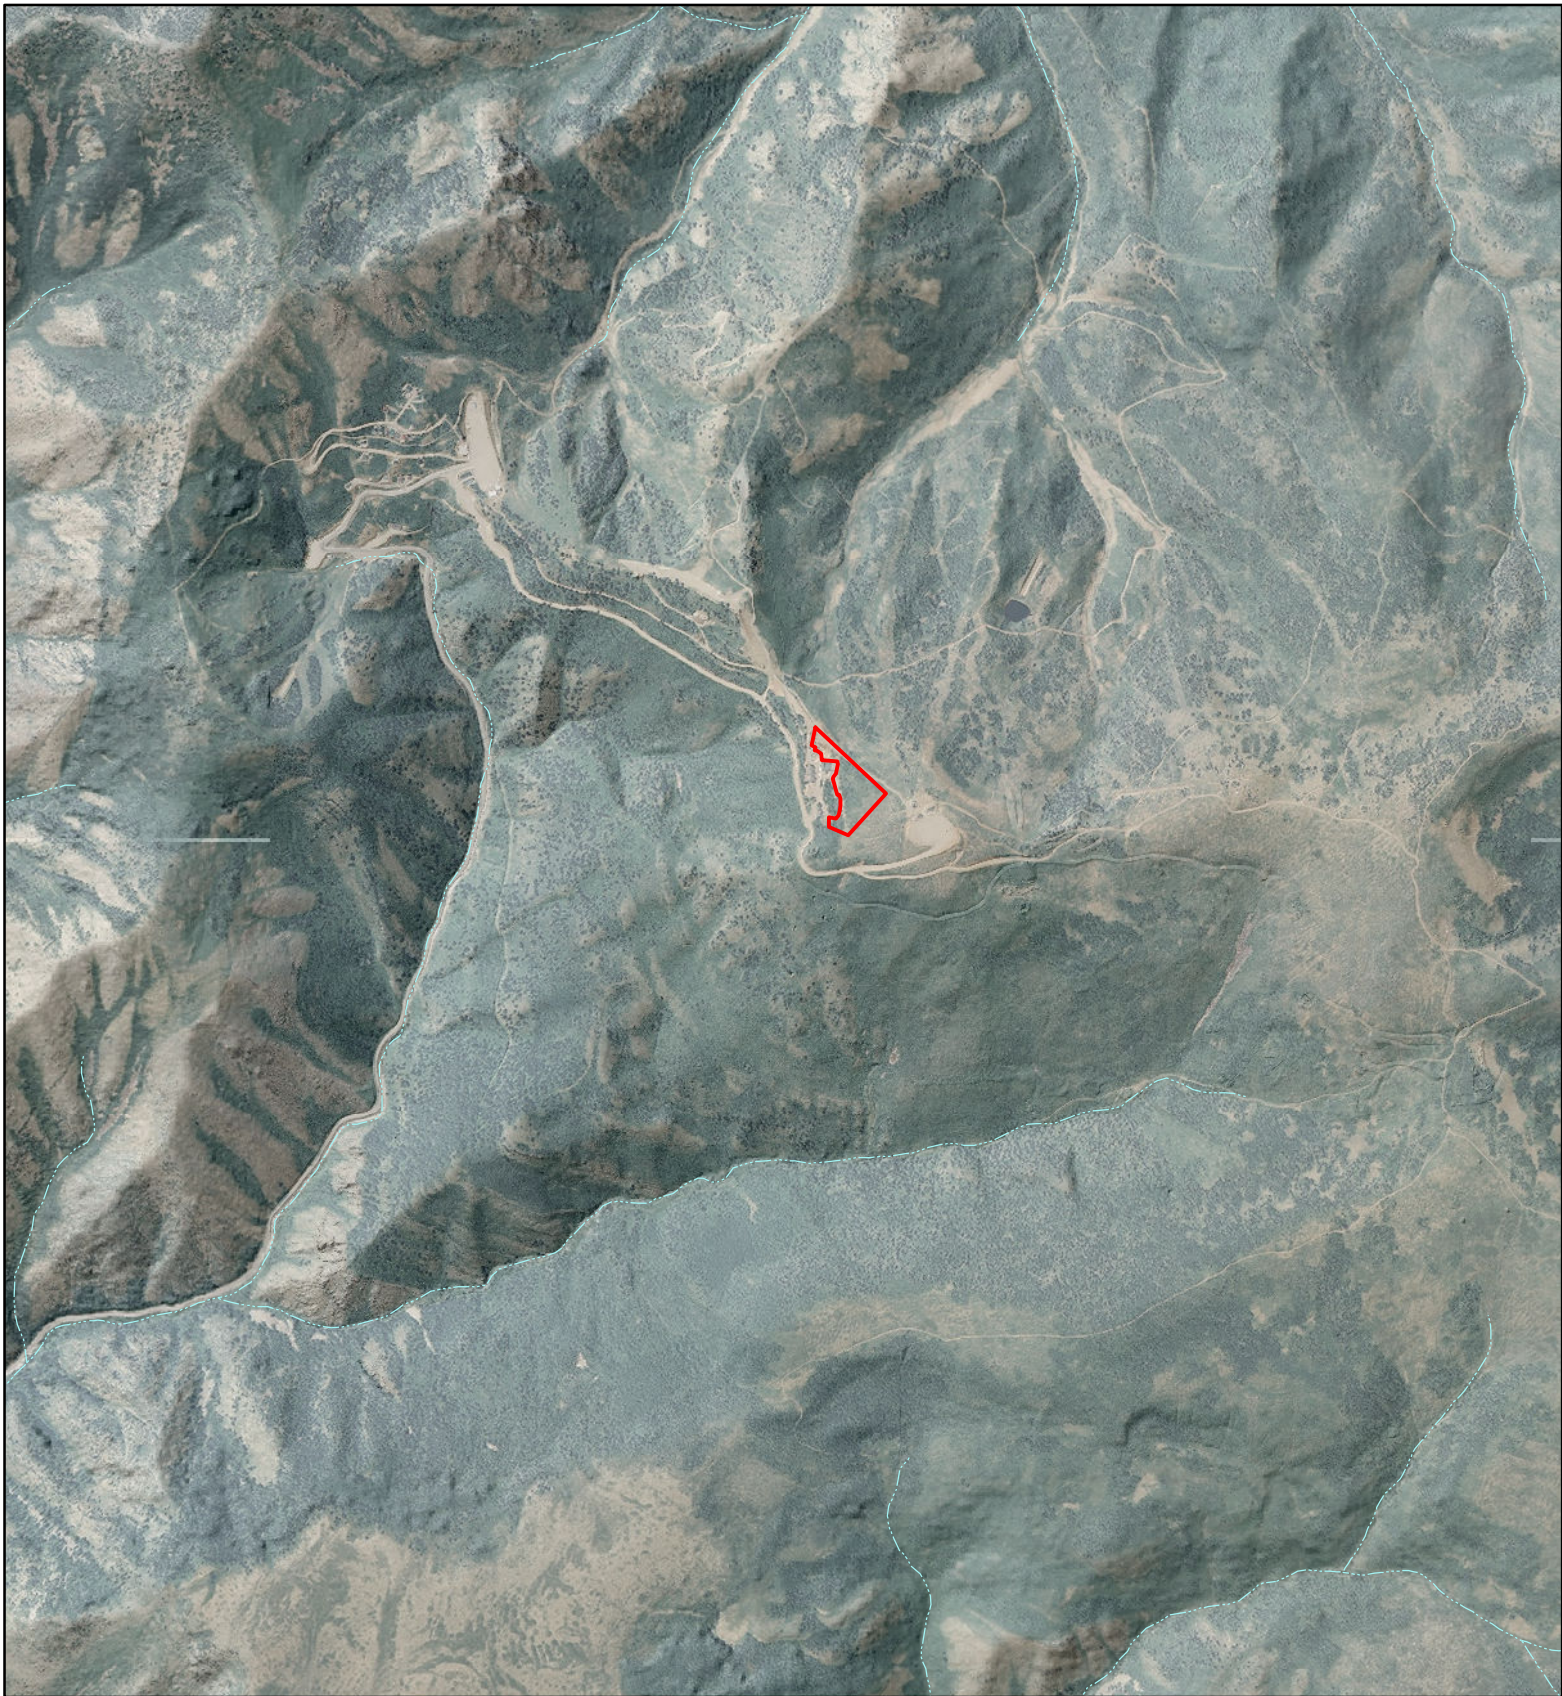
**Plate
7**

Based on review of published geologic maps, our stereographic aerial photograph interpretation, our review of hillshades derived from 2016 0.5 meter LiDAR and our field observations, no scarp features, hummocky topography, or other geomorphology features related to landslide deformation were observed. Based on our review of published geologic maps, a colluvial and landslide deposit, undivided (Qmc, Qcs-Qls) is reported within and adjacent to the subject site (Plate 4 Site Vicinity Geologic Map and Plate 5 Site Vicinity 30' X 60' Geologic Map). The area west of the subject site is mapped as a landslide and/or landslide undifferentiated from talus, colluvial, rock fall, glacial and soil creep deposits on the Landslide Maps of Utah Ogden 30' X 60' Quadrangle compiled by Elliot and Harty, 2010 (Plate 7 Landslide Hazard Map). The majority of the subject site is mapped as being underlain by Eocene, Paleocene and Upper Cretaceous(?) Wasatch and Evanston(?) Formations, Undivided (Twe) bedrock. In order to differentiate a colluvial deposit from a landslide deposit, a more in-depth study involving boreholes and trenching along the presumed scarp and across the colluvial and landslide, undivided deposit would be required which is outside the scope of this study. Based on our field and office investigations and the high density of the proposed development, GeoStrata recommends that a geotechnical report including a slope stability assessment be compiled prior to any development within the subject site.
