Subject: Proposed Residence
8900 East 1800 South
Huntsville, Utah
Project No. 1200326

This letter presents the results of a reconnaissance-level, geologic-hazard study for proposed residential development of Parcel 21071004 at 8900 East 1800 South in Huntsville, Utah.

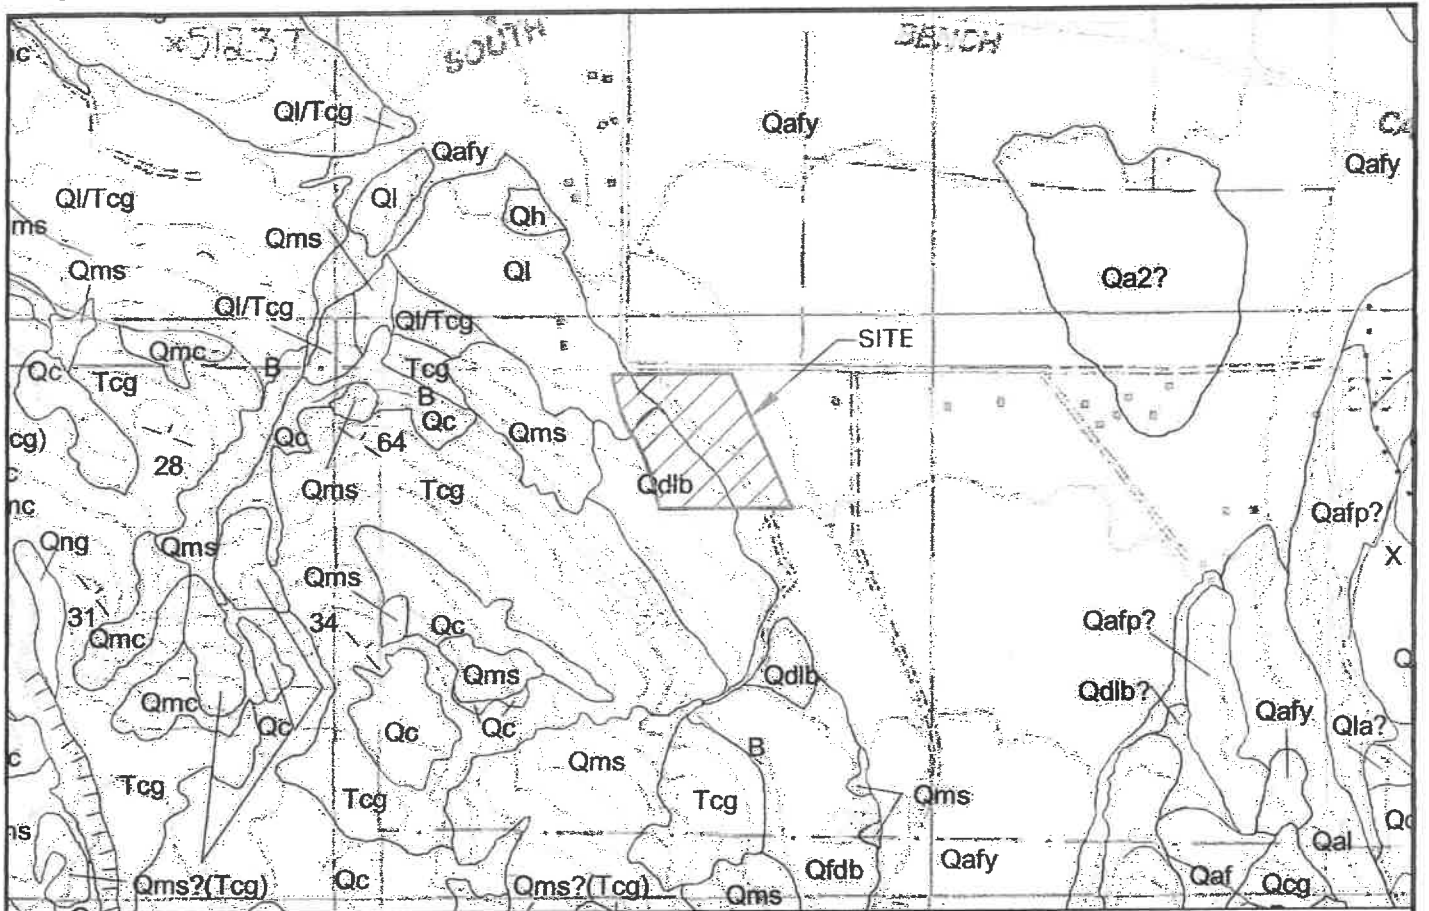
From Coogan and King (2016)

EXPLANATION OF SYMBOLS AND GEOLOGIC UNITS IN AREA OF PROPOSED DEVELOPMENT

- Qafy - Young alluvial deposits.
- Qdb - Lake Bonneville deltaic lake deposits.
- Ql - Lake Bonneville deposits.
- Geologic contact between units, dashed where approximate.
