GEOLOGIC HAZARDS REVIEW WELCOME CENTER SUBDIVISION LOT 1 3632 NORTH WOLF CREEK DRIVE EDEN, WEBER COUNTY, UTAH

September 29, 2020

SUBJECT: Geologic Hazards Review
Welcome Center Subdivision Lot 1
3632 North Wolf Creek Drive
Eden, Weber County, Utah

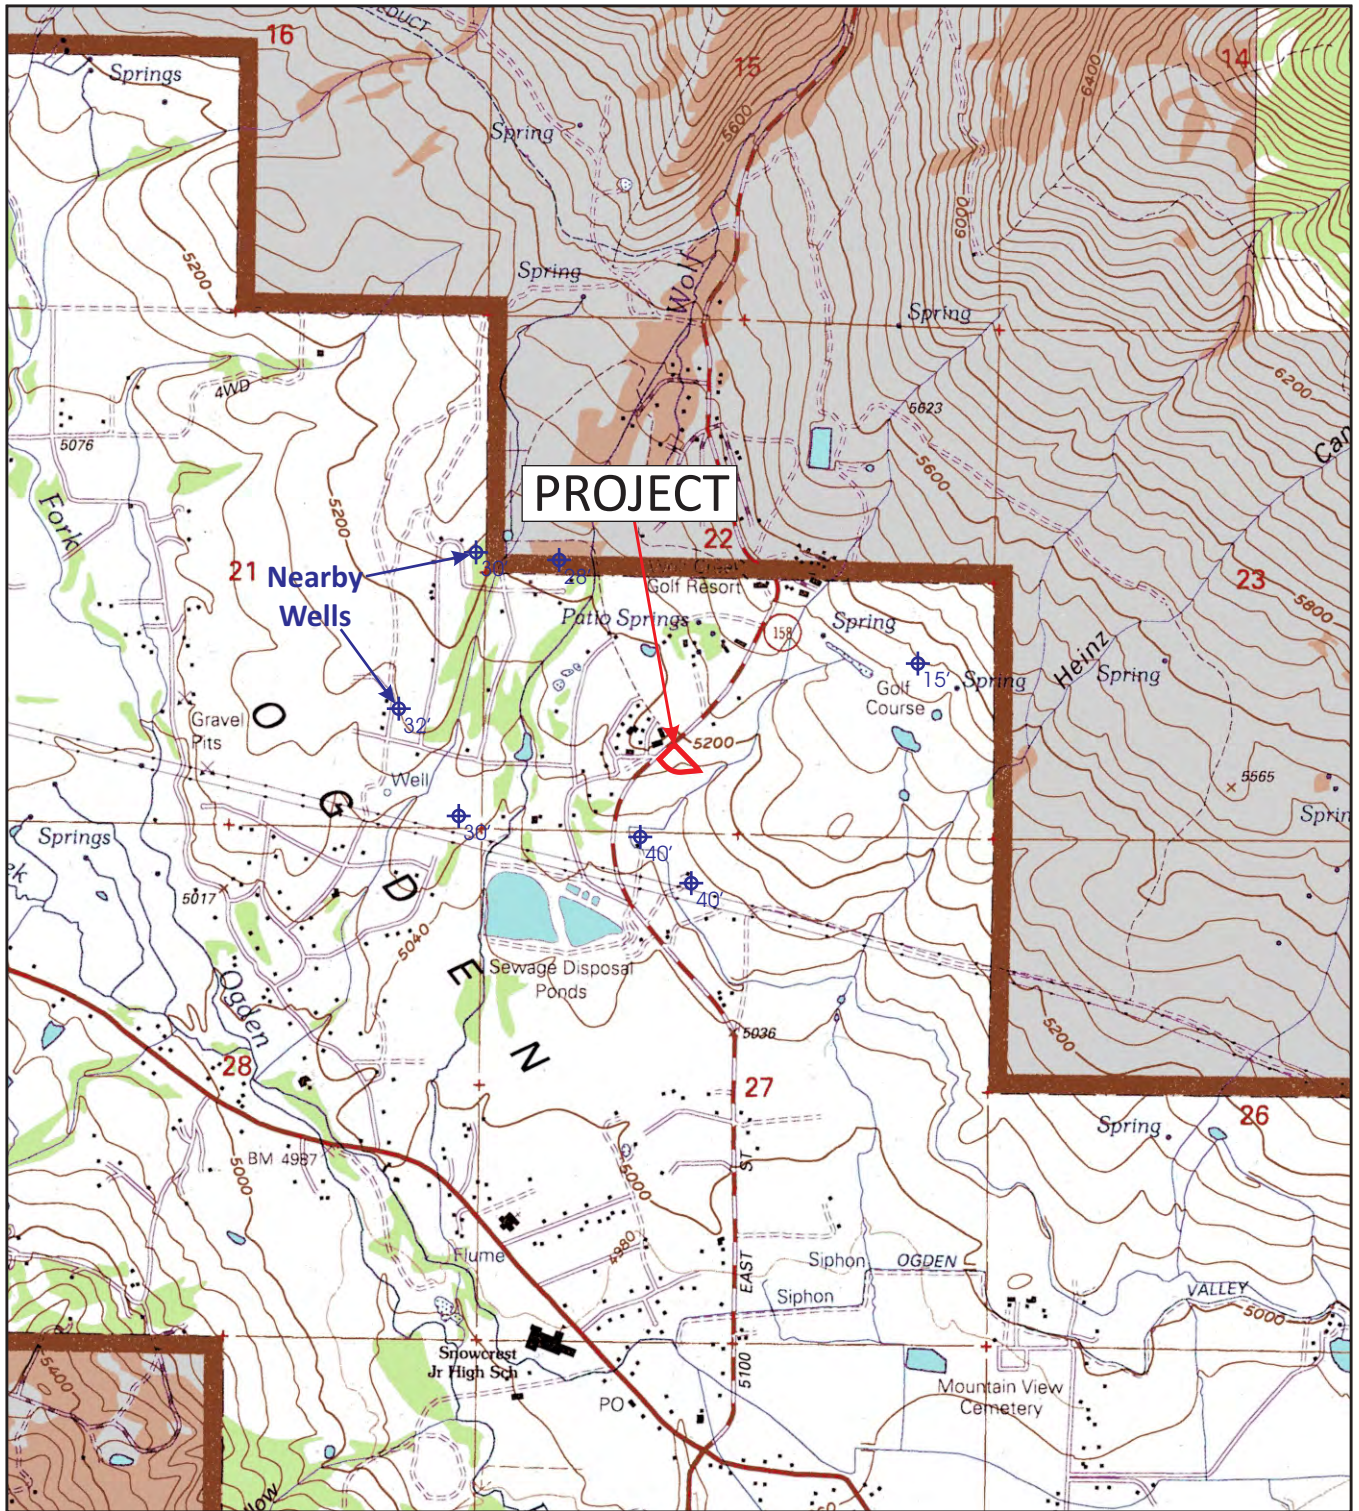
FIGURE 1

The U.S. Geological Survey (USGS) topographic map of the Huntsville Quadrangle shows the site is on the northeast margin of Ogden Valley south of the mouth of Wolf Creek Canyon (Figure 1). No perennial or intermittent drainages are mapped on Figure 1 or were observed crossing the site; although several springs are in the area (including Patio Springs), no springs are also mapped at the Project on Figure 1.

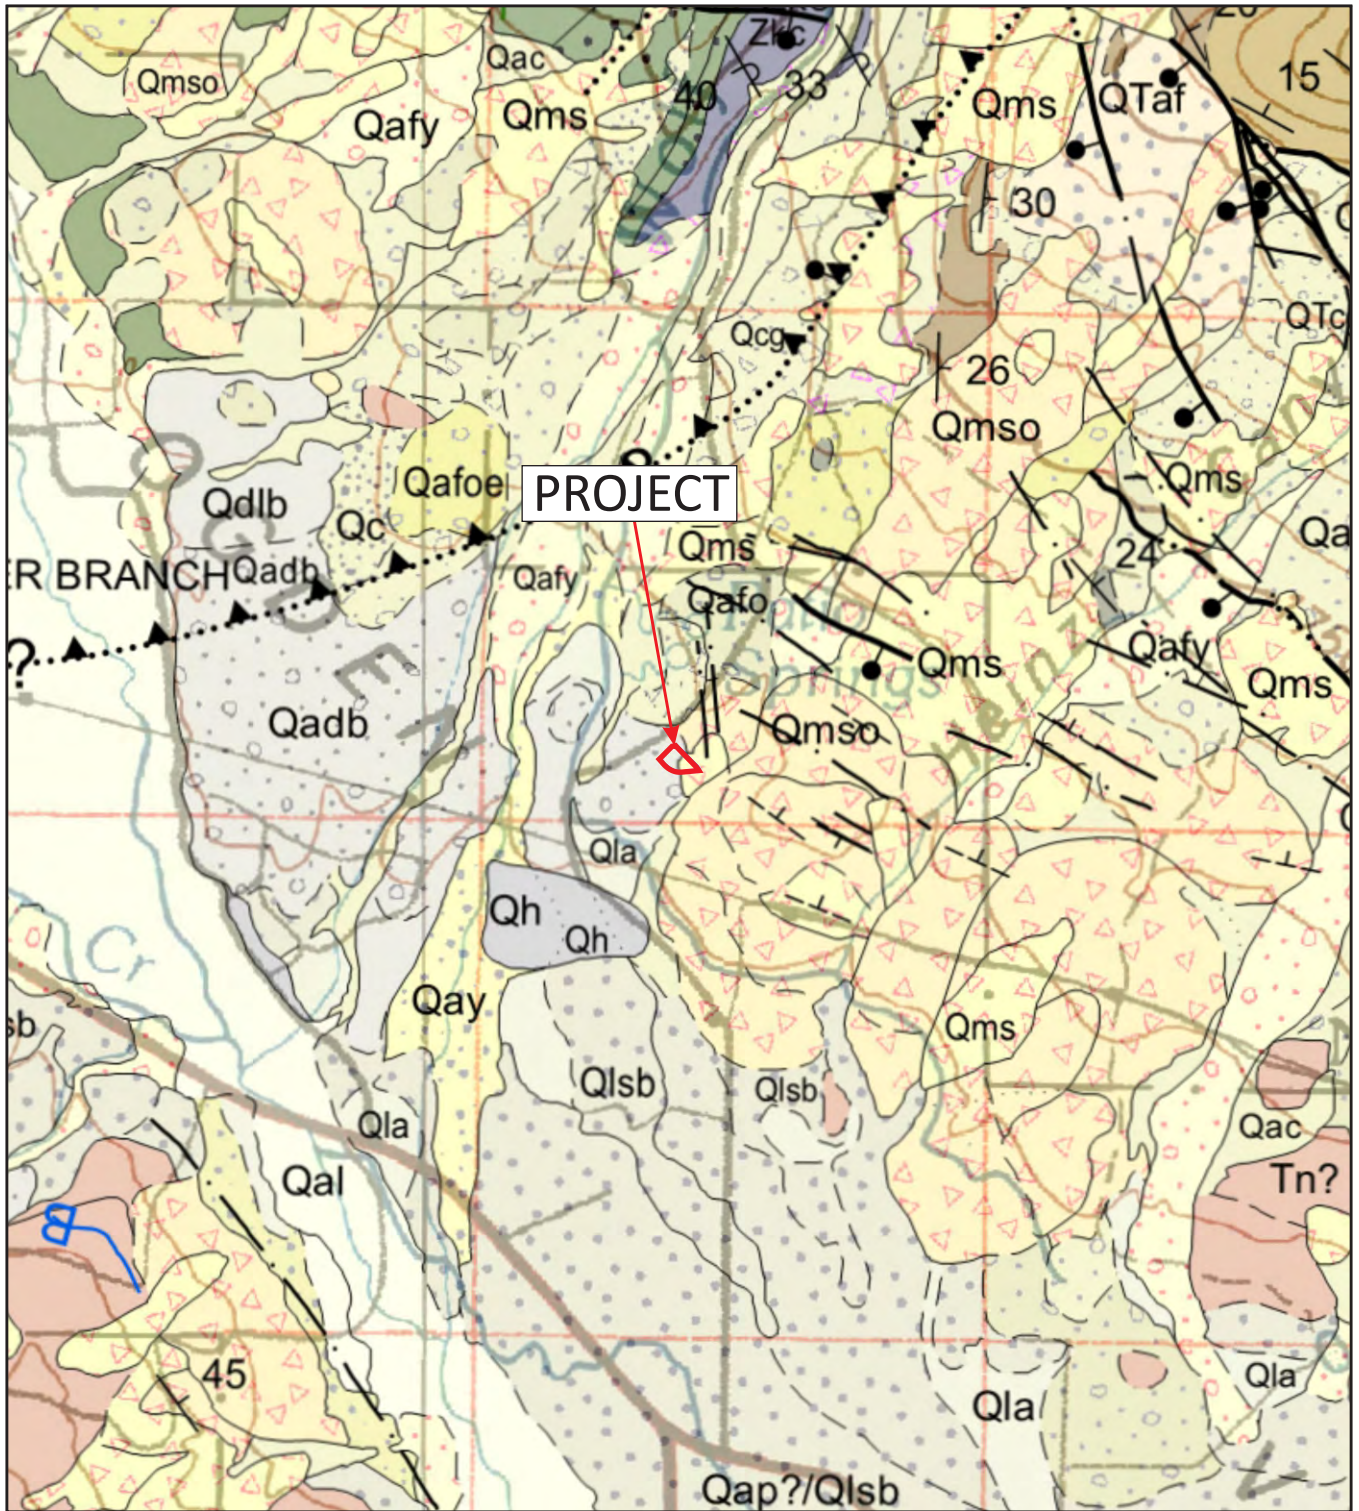
FIGURE 2

The site is located on the northeastern margin of Ogden Valley, a sediment-filled intermontane valley within the Wasatch Range, a major north-south trending mountain range marking the eastern boundary of the Basin and Range physiographic province (Stokes; 1977, 1986). Surficial geology of the site is mapped by Coogan and King (2016; Figure 2) as transgressive and Bonneville-shoreline alluvial and deltaic deposits on the northwest, and Holocene- to late Pleistocene-age landslide deposits on the southeast (units Qadb and Qms, respectively; underlined and described below).

Lakes occupied nearly 100 basins in the western United States during late-Quaternary time, the largest of which was Lake Bonneville in northwestern Utah. The Bonneville basin consists of several topographically closed basins created by regional extension in the Basin and Range (Gwynn, 1980; Miller, 1990), and has been an area of internal drainage for much of the past 15 million years. Lake Bonneville consisted of numerous topographically closed basins, including the Salt Lake and Cache Valleys (Oviatt and others, 1992). Portions of Ogden Valley were inundated by Lake Bonneville at its highstand. The lake shoreline is not mapped in the site area, but would be at an elevation similar to units Q1a and Q1sb on Figure 2.

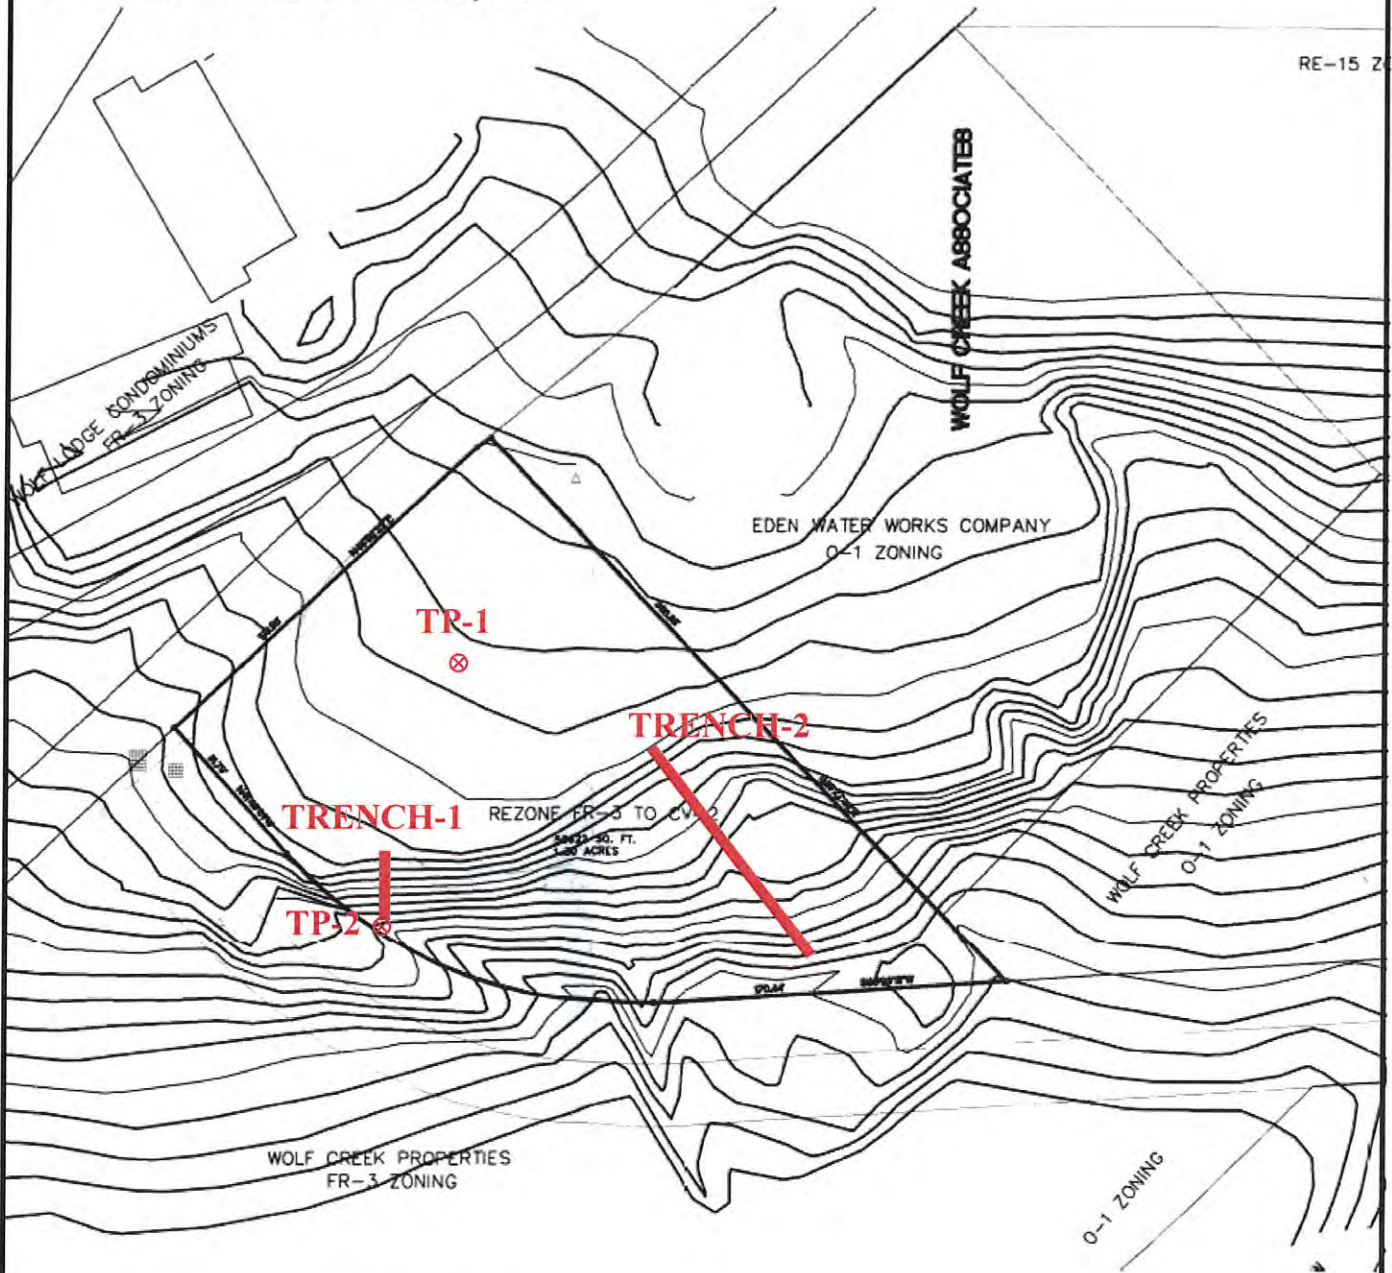
Figure 2: TEST PIT AND TRENCH LOCATIONS

7. This investigation was preformed with test pits and trenches. If a structure is constructed over an uncompacted test pit or trench significant amounts of differential settlement may occur. Test pits typically disturb an area 10 to 20 feet long and 3 to 6 feet wide extending to the depths indicated in the logs. Trenching typically disturbs an area of 10 to 200 feet long, 3 to 6 feet wide, and 5 to 10 feet in depth. If a structure is to be placed within 25 feet of a test pit or trench location, Y² Geotechnical should be contacted to verify the structure is not placed over an uncompacted test pit. If a test pit is encountered within the building pad, the disturbed test pit soils should be completely removed and properly placed and compacted structural fill should be used to return the test pit location to design grade. Approximate test pit and trench locations with approximate Pocket GPS coordinates are shown on Figure 2 at the end of this report.
