Construction Observation Report # 1

Project	Uintah Bybee Water Tanks	Project Number	20218
Location	6393 Bybee Dr, Ogden, UT	Date & Time	02/24/2023 1:30PM
Civil Engineer	Jones and Associates	Weather	Clear
Contractor	FX Construction	Observer	Jami Havens

Construction Observation Report # 2

Construction Observation Report #3

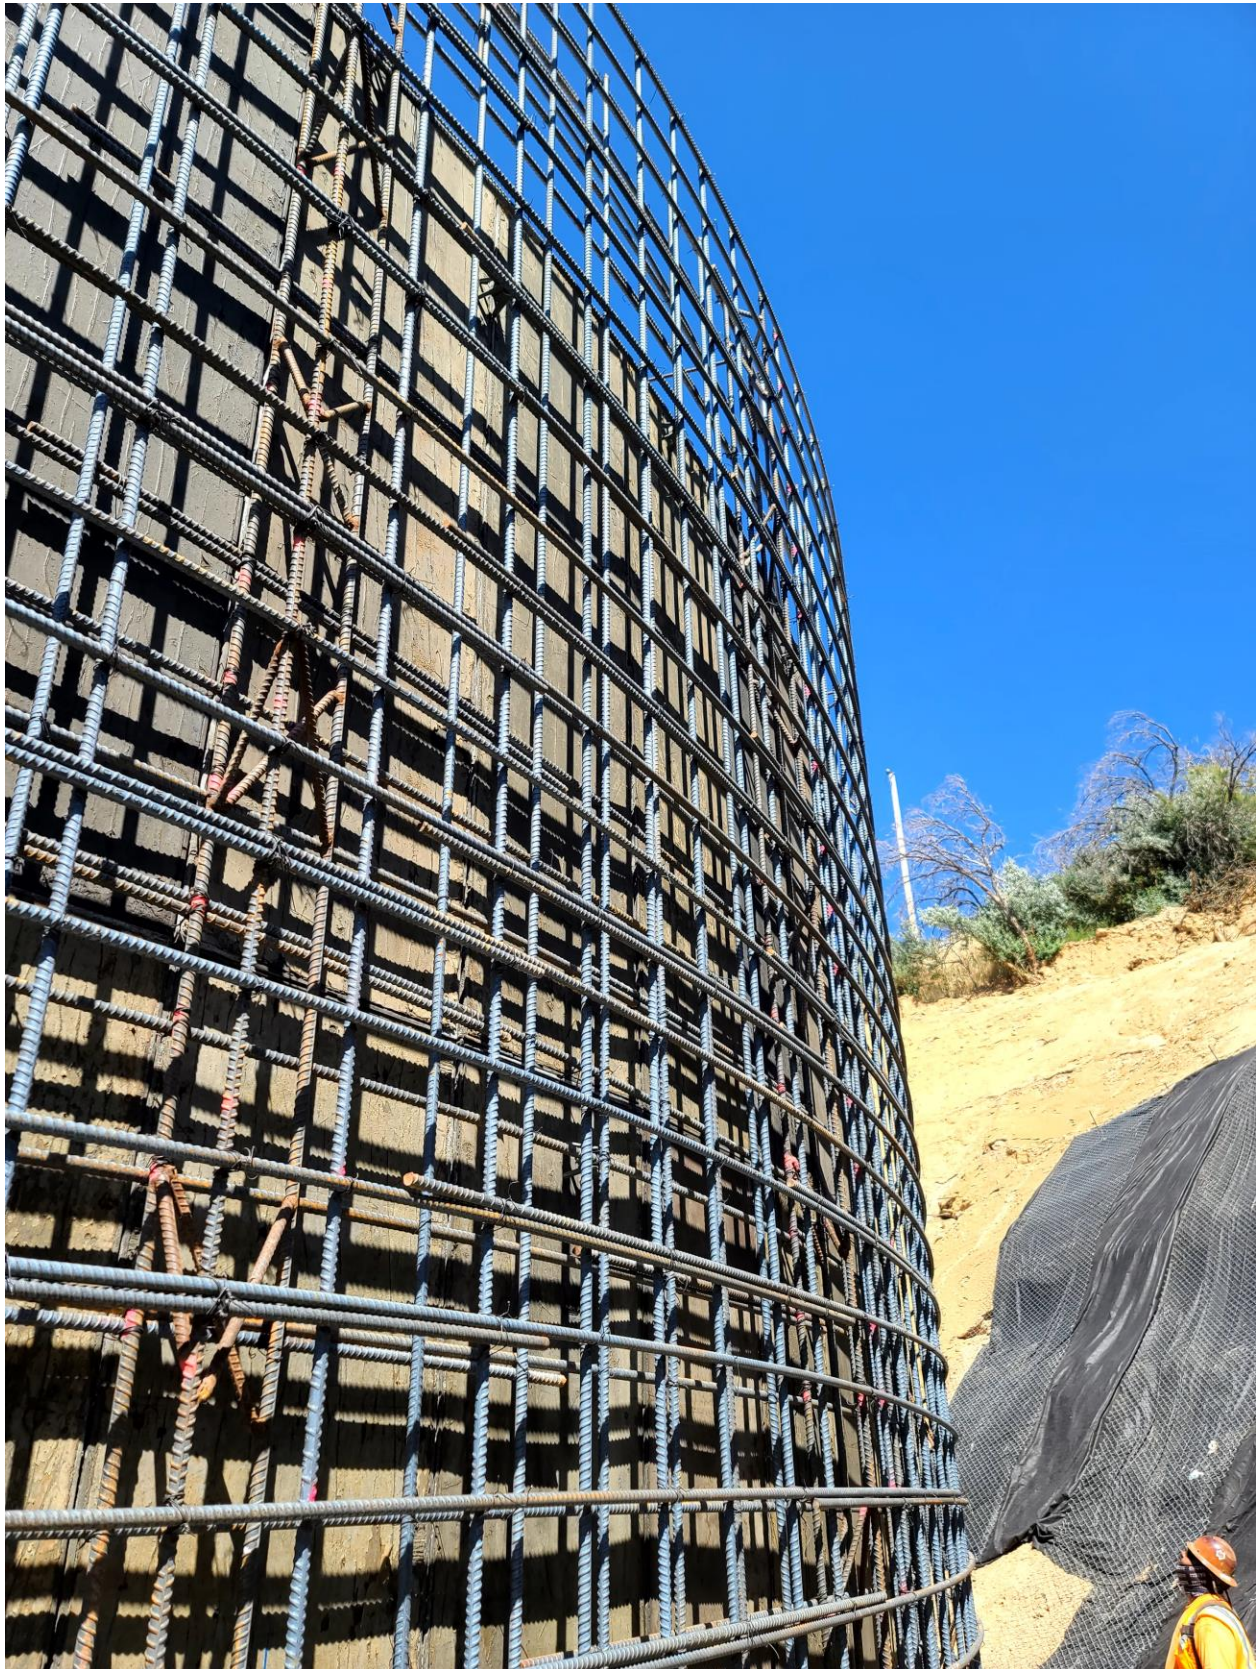
Photo 1

Items of Note:				
Item No.:	Item:	Follow-Up / Action Required:	Initials	Photo:
1-1	No items of note were observed during this visit			1
