### **GEOLOGIC EVALUATION SHANGHAI CANYON SUBDIVISION, WEBER COUNTY, UTAH**

**Shanghai Canyon Subdivision  
Weber County, Utah**

**July 27, 2015**

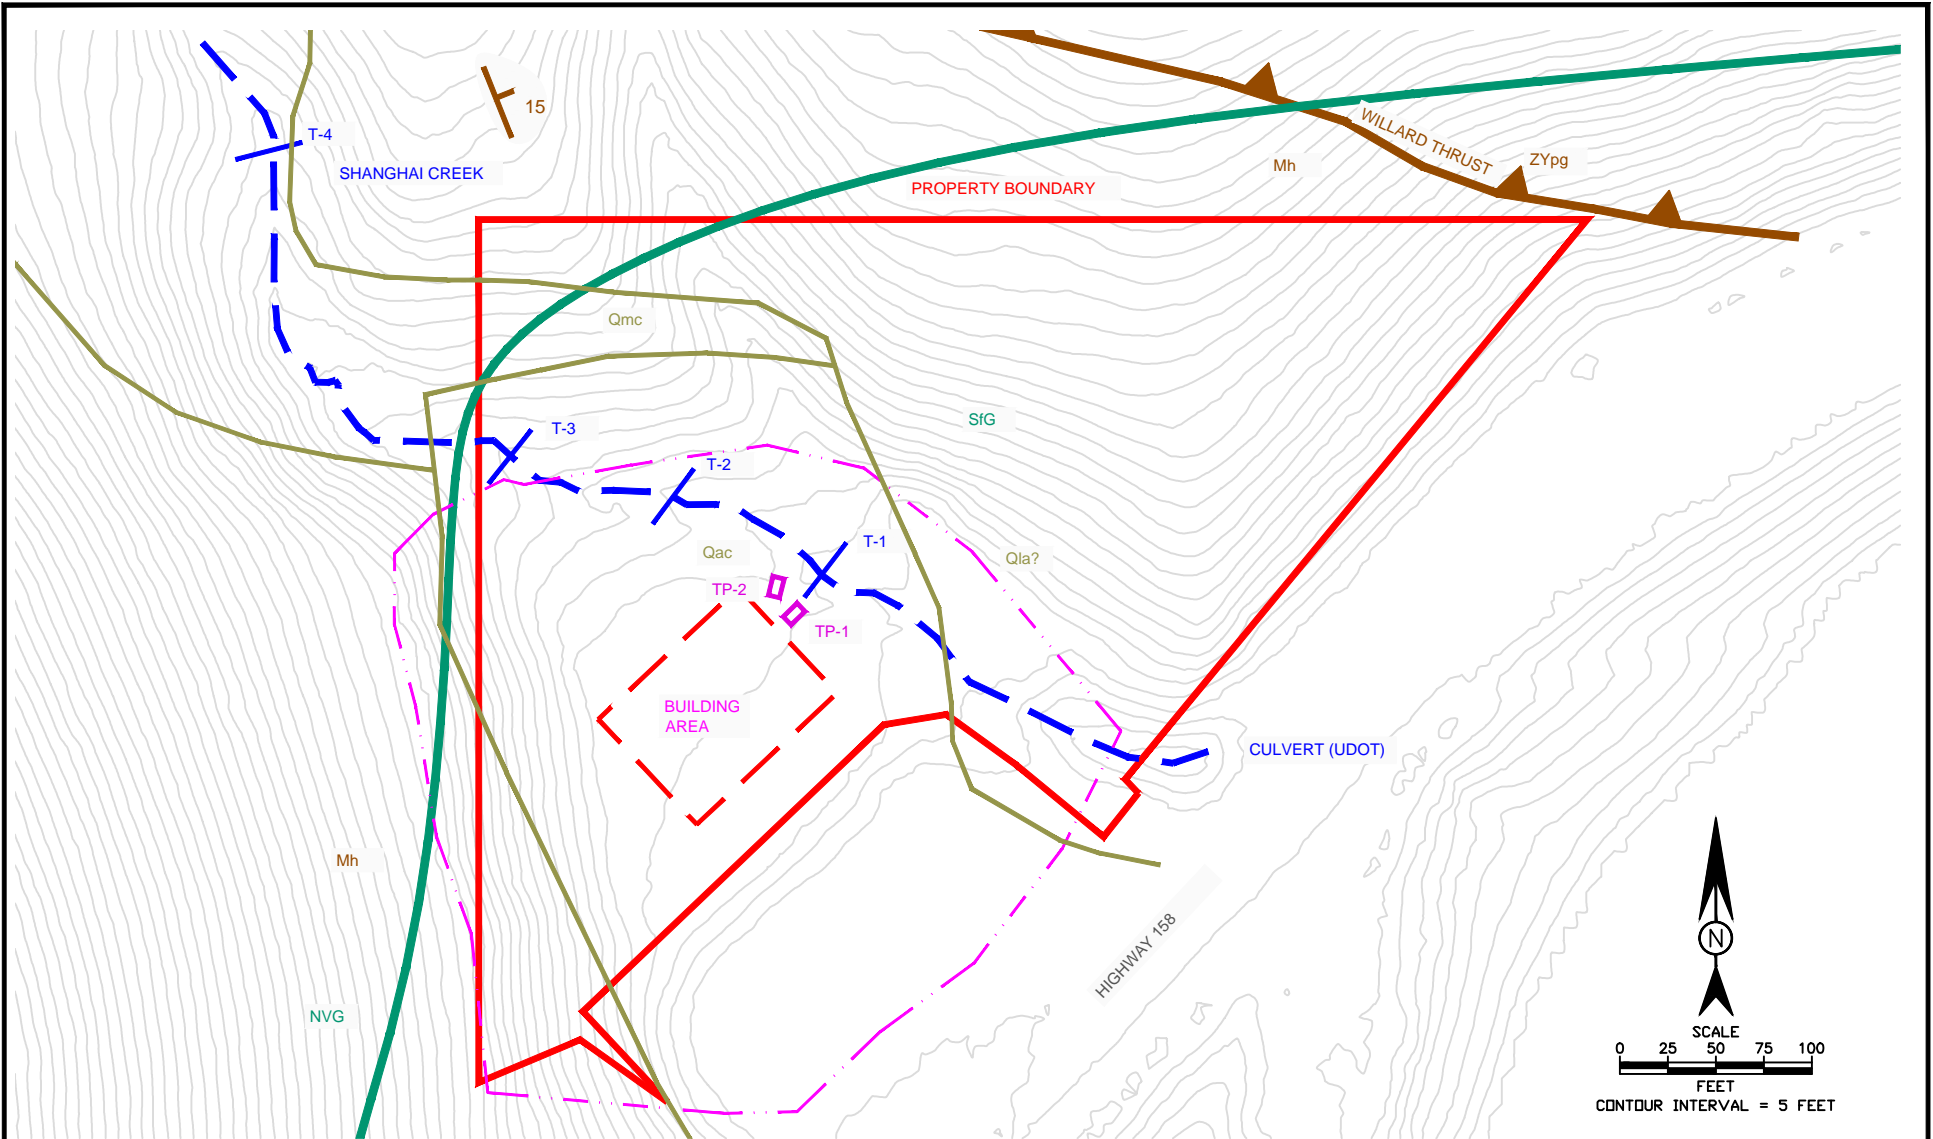
<h2>SHANGHAI CANYON</h2>	
<h3>FIGURE 4 SITE GEOLOGY</h3>	
JUNE 2015	sitemap.dwg
SUBTERRANEAN ASSOCIATES LLC WWW.SUBTERRANEANASSOCIATES.COM SUBTERRANEAN.ASSOCIATES@GMAIL.COM (801)541-9326

Two test pits were evaluated in an area adjacent to the Building Area and Shanghai Creek channel. Test pit locations are presented on Figure 4. Test pit logs are presented in Figure 10. The logs indicate that the Property is underlain by at least five and one-half feet of colluvium. Based on difficult, dense excavating conditions, this material appears to be undisturbed, native material that composed the floor of the gravel extraction area. The colluvium overlies an unknown thickness of Lake Bonneville lacustrine deposits consisting of clay, gravel and cobbles.

No indications of debris flows were observed in the two test pits. One test pit was inspected by Greg McDonald of the UGS during a site visit on June 18, 2015. Mr. McDonald inspected Test Pit 2 and confirmed the occurrence of colluvium and Lake Bonneville lacustrine deposits. Mr. McDonald hypothesized that the lacustrine deposits may be of a transgressive regime.

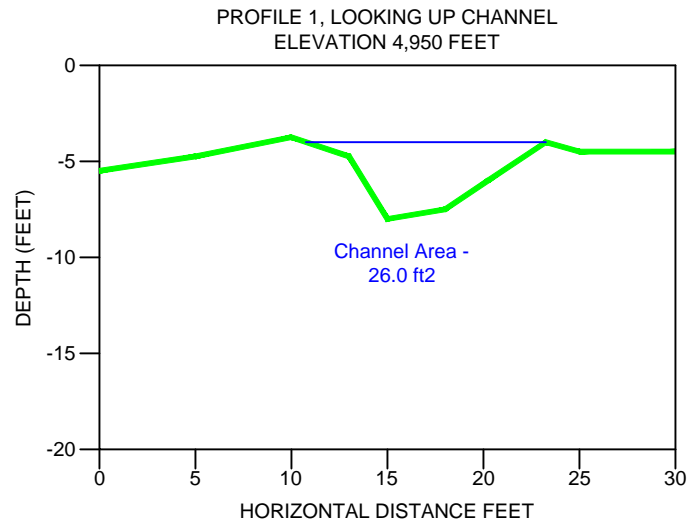
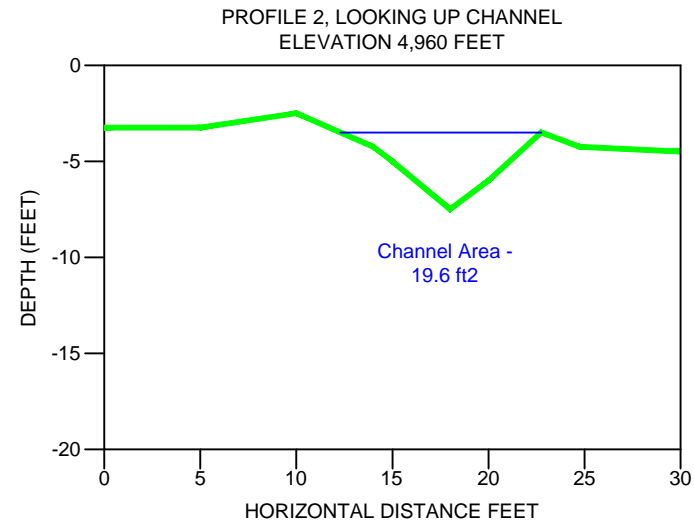
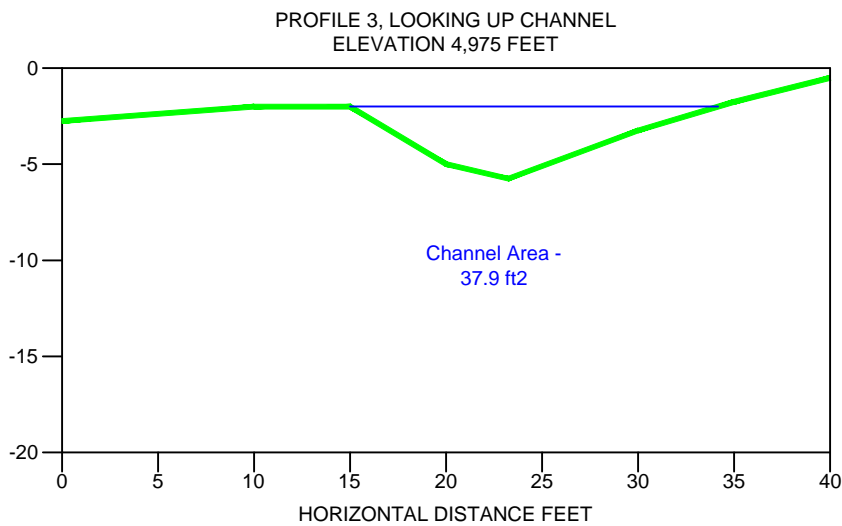
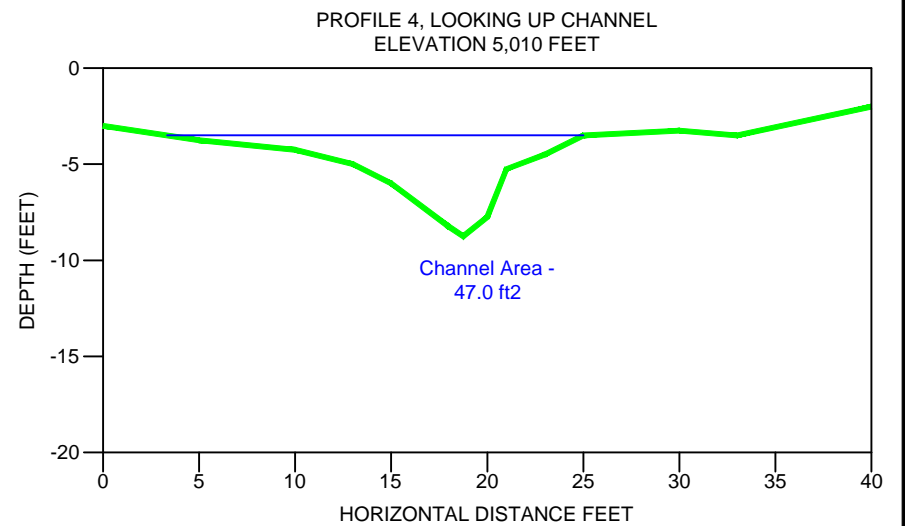
Due to excavation that occurred during gravel extraction, any debris flow history in the area immediately adjacent to the Building Area would be limited to the last 85 years. Any debris flow occurring prior to gravel extraction would have been confined to the channel. A visual inspection of the area surrounding the Building Area did not result in any observations or indications of debris flow. The channel directly upgradient from the Building Area and Property were inspected for indications of debris flow. No indications of debris flow were observed in this area. Channel profile transects are presented in Figure 8.
