October 9, 2015

**Re: Engineering Geology Assessment-Revised
Lot 15, Ski Lake Estates No. 3
6640 East 1100 South
Huntsville, Utah
Job No. 145150**

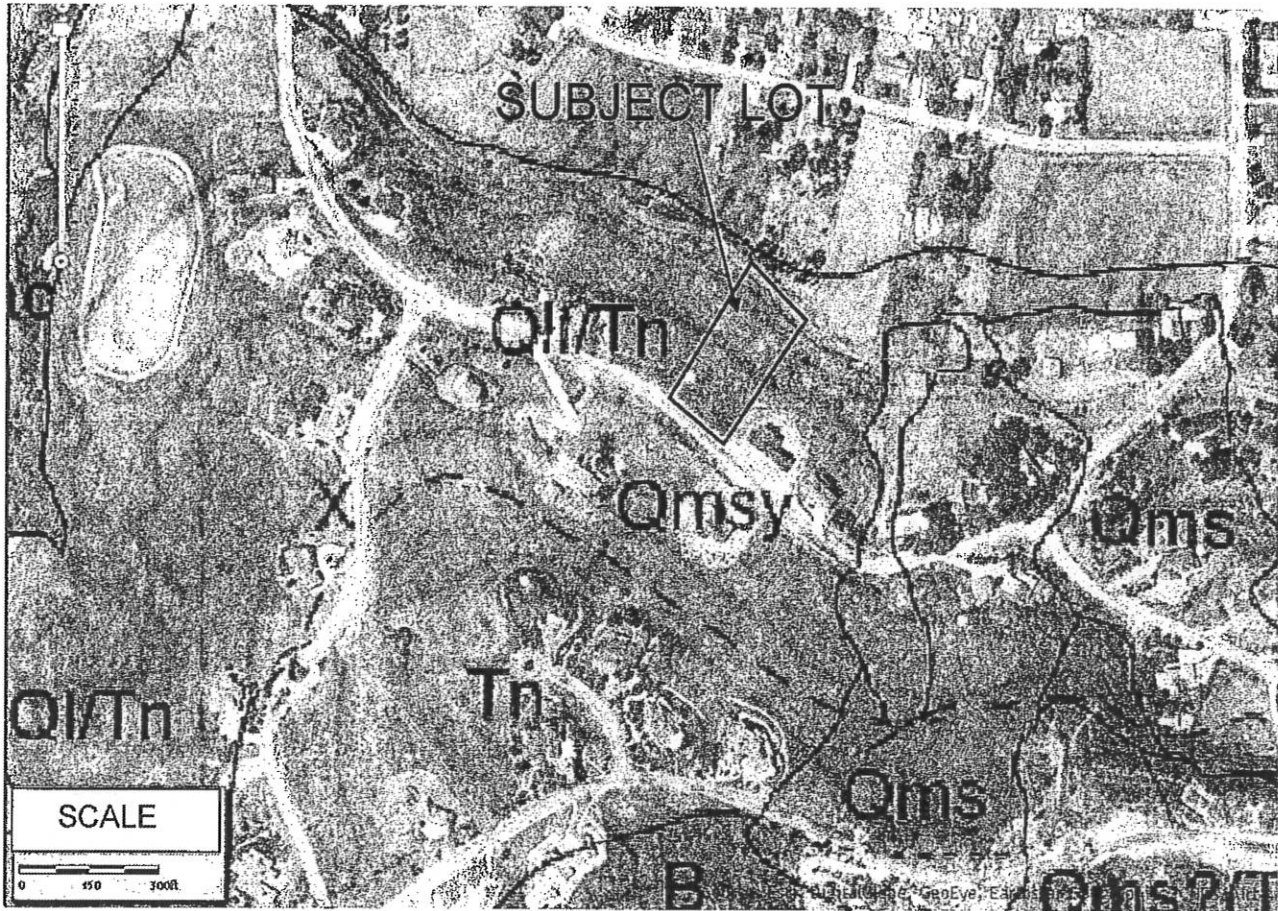
SITE GEOLOGIC MAP
LOT 15, SKI LAKE ESTATES NO. 3
6640 EAST 1100 SOUTH
HUNTSVILLE, UTAH

Yonkee, and Coogan⁵. The geology at the location of the subject lot as shown on the referenced map is Lake Bonneville fine-grained deposits (Map Unit Qlf, upper Pleistocene) overlying older deposits of the Norwood Formation (Map Unit Tn, lower Oligocene and upper Eocene). The Norwood Formation is extensive along the margins of the Ogden Valley, the Morgan Valley to the south, and in the hilly terrain between the valleys. The formation is known to be very prone to experiencing landslide activity. Several landslides (Map Units Qmsy and Qms) are mapped approximately 200 to 360 feet to the east of the subject lot on the referenced geologic map. These mapped landslides appear to have occurred within the Norwood Formation. No landslide deposits or features are mapped on or immediately adjacent to the subject lot on the referenced map. However, the literature accompanying the referenced map states that some landslides and other slope failure features may not have been mapped due to scale. A portion of the referenced geologic map that includes the location of the subject property and surrounding area is included as Figure No. 2, *Site Geologic Map*, at the end of this report. It should be noted that the geologic units included on Figure No. 2 are only those mapped at the location of the subject lot and immediate surrounding areas.

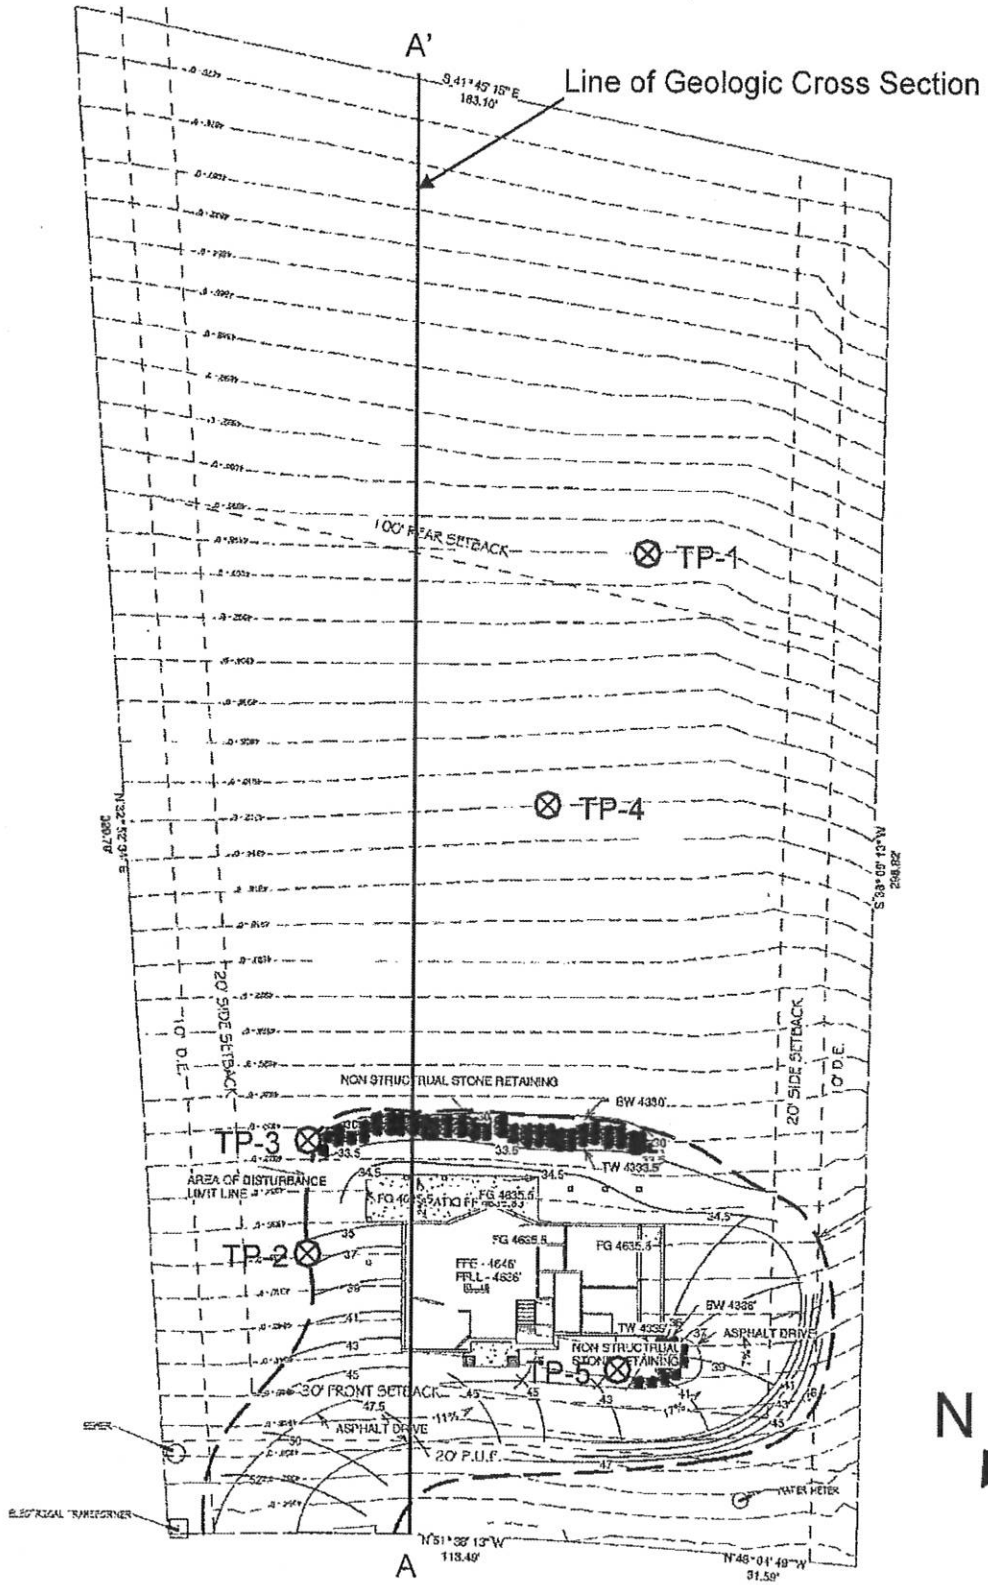
LOT 15, SKI LAKE ESTATES NO. 3

At the time of the original geotechnical report for the subject lot, two test pits were excavated on the lot and logged by a geotechnical engineer with Earthtec Engineering. The original test pits were designated as TP-1 and TP-2 in the referenced geotechnical report and the approximate locations of the test pits were shown on a aerial photograph of the lot included in the report. On June 19, 2015, two additional test pits were excavated on the subject lot using a track-mounted excavator. These additional test pits were designated as TP-3 and TP-4. The approximate locations of the original test pits and the additional test pits on the lot are shown on Figure No. 3, *Site Plan and Locations of Test Pits*, at the end of this report. The additional test pits (TP-3 and TP-4) were logged by an experienced engineering geologist from Earthtec Engineering. As previously discussed, a representative from the Weber County Engineering Department as well as the third-party geotechnical engineer and engineering geologist, retained by the County, were present on-site on the afternoon of June 19th to observe the test pits and review the logs. On June 22, 2015, a geotechnical engineer from Earthtec Engineering returned to the lot with the excavator and oversaw the excavation of an addition test pit (TP-5) in the area of the proposed house on the lot as well as extending TP-3 down slope to the elevation of TP-4. This was done to provide additional subsurface observation in order to better understand the shallow subsurface geology at the site. Test Pit TP-5 and the extension of TP-3 were not logged but extension of TP-3 was photographed by the engineer. Photographs of TP-5 were not recovered. In addition to observing and logging the test pits, additional samples were obtained from TP-3 and TP-4 for the purpose of providing additional lab testing data to aid in additional slope stability modeling for the subject lot. All of the test pits on the lot were back-filled following the completion of our field work on June 22nd.
