Project Number 2014-023 Date Issued 05/27/2015 Drawn by Karl Lundin Checked by Cristofer Scale 1" = 20' ±	The Nobs Residence 6640 E 1100 S - SKI LAKE LOT #3
	Topo Site
	C1

LUNDIN DESIGN GROUP
 THE NOBS RESIDENCE
 GRADING PLAN
 6640 E 1100 S - SKI LAKE LOT #3

**Re: Engineering Geology Assessment
Lot 15, Ski Lake Estates No. 3
6640 East 1100 South
Huntsville, Utah
Job No. 145150**

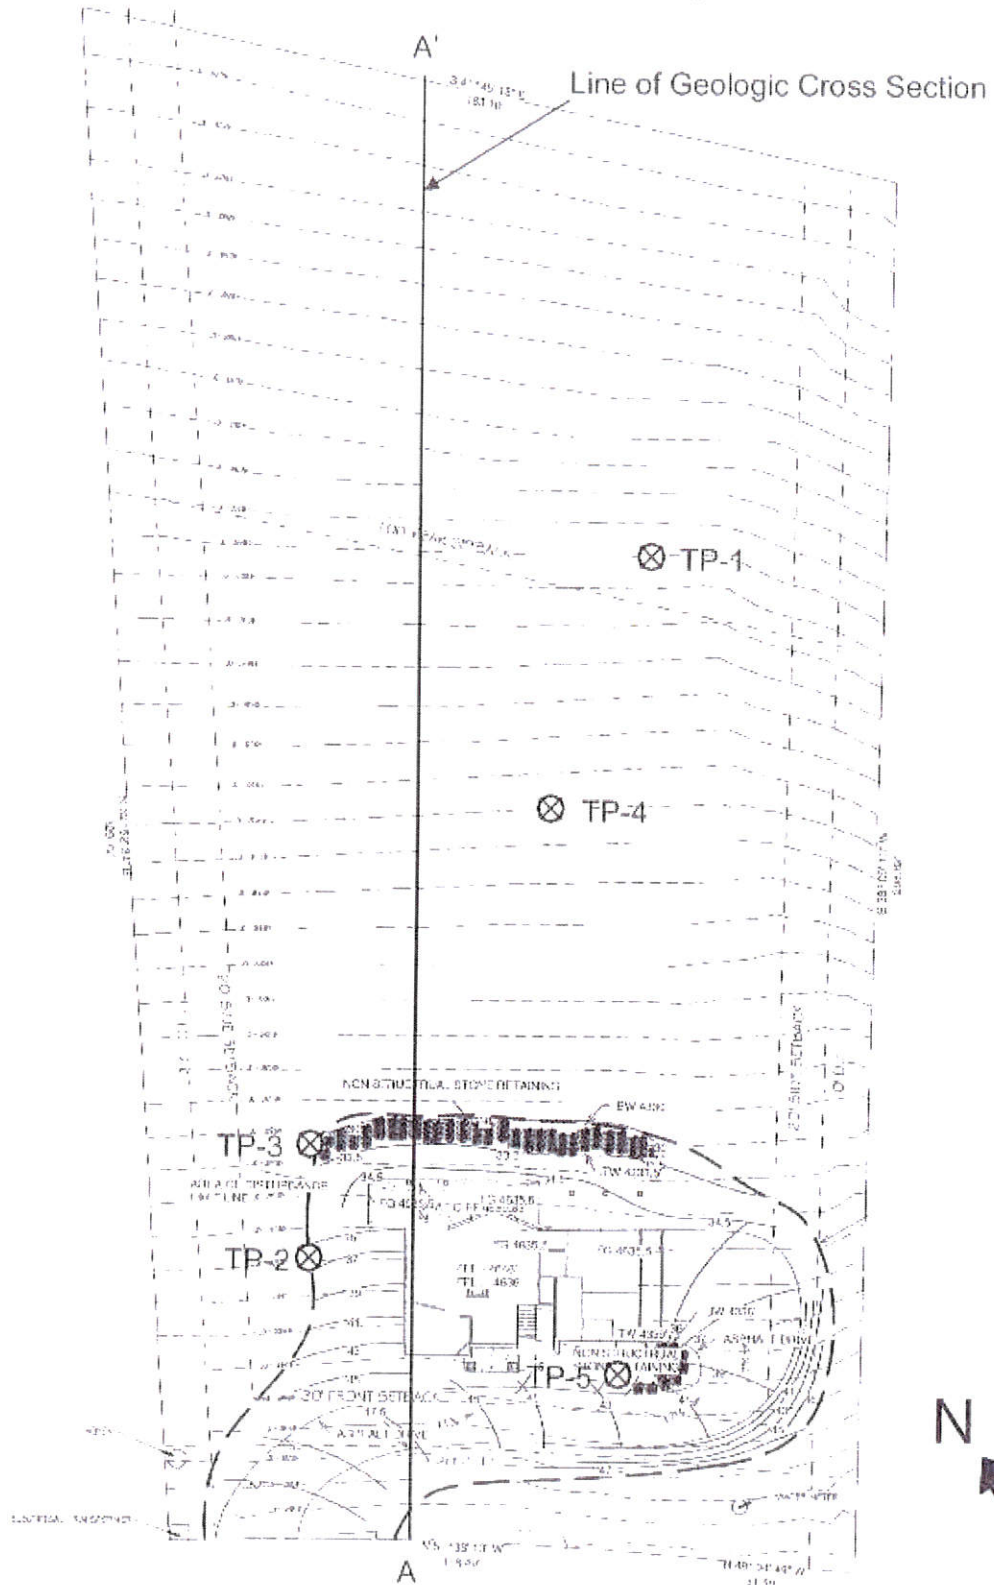
LOT 15, SKI LAKE ESTATES NO. 3

At the time of the original geotechnical report for the subject lot, two test pits were excavated on the lot and logged by a geotechnical engineer with Earthtec Engineering. The original test pits were designated as TP-1 and TP-2 in the referenced geotechnical report and the approximate locations of the test pits were shown on an aerial photograph of the lot included in the report. On June 19, 2015, two additional test pits were excavated on the subject lot using a track-mounted excavator. These additional test pits were designated as TP-3 and TP-4. The approximate locations of the original test pits and the additional test pits on the lot are shown on Figure No. 3, *Site Plan and Locations of Test Pits*, at the end of this report. The additional test pits (TP-3 and TP-4) were logged by an experienced engineering geologist from Earthtec Engineering. As previously discussed, a representative from the Weber County Engineering Department as well as the third-party geotechnical engineer and engineering geologist, retained by the County, were present on-site on the afternoon of June 19th to observe the test pits and review the logs. On June 22, 2015, a geotechnical engineer from Earthtec Engineering returned to the lot with the excavator and oversaw the excavation of an additional test pit (TP-5) in the area of the proposed house on the lot as well as extending TP-3 down slope to the elevation of TP-4. This was done to provide additional subsurface observation in order to better understand the shallow subsurface geology at the site. Test Pit TP-5 and the extension of TP-3 were not logged but were photographed by the engineer. In addition to observing and logging the test pits, additional samples were obtained from TP-3 and TP-4 for the purpose of providing additional lab testing data to aid in additional slope stability modeling for the subject lot. All of the test pits on the lot were back-filled following the completion of our field work on June 22nd.
