September 12, 2016

IGES Project No. 02348-001

Subject: Geologic Hazards Assessment The Ridge Subdivision Phases 3, 4, and 5 Eden, Utah

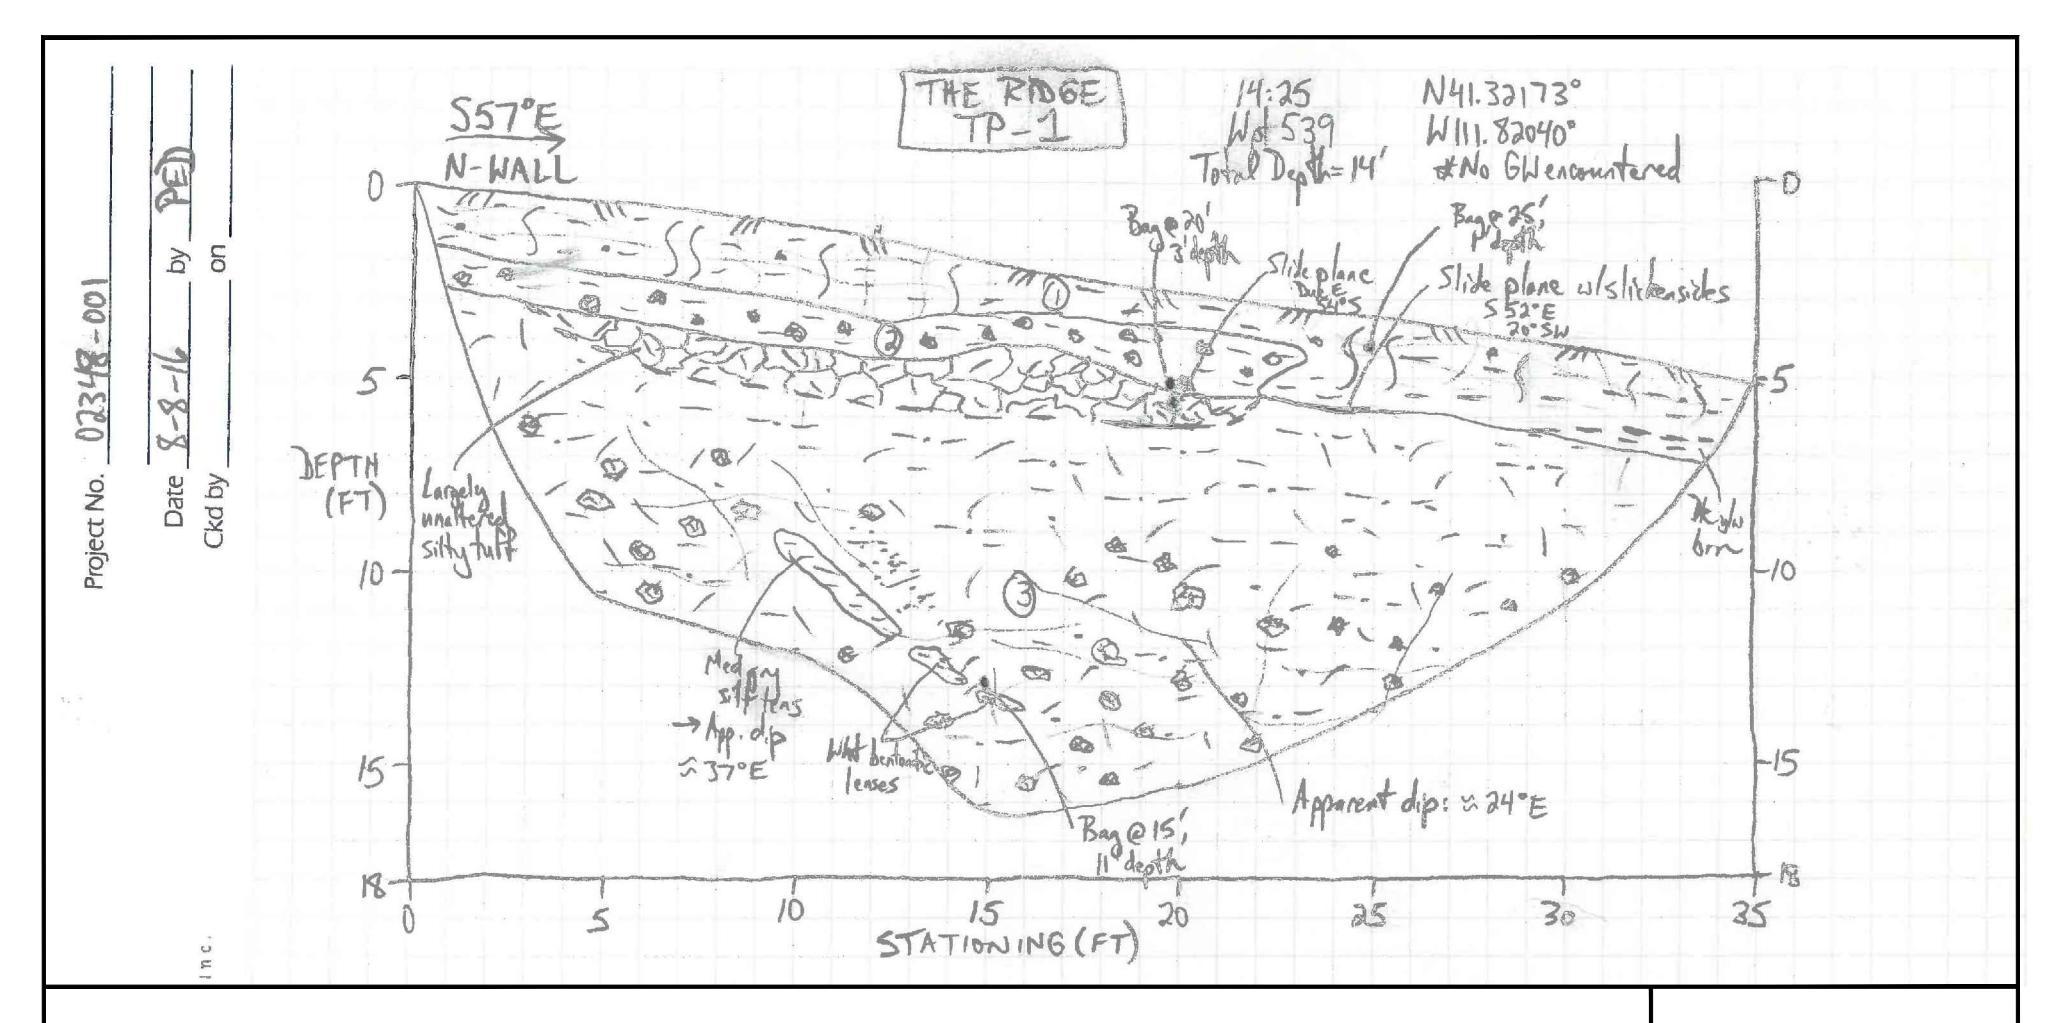
1. A/B Soil Horizon: ~1-3' thick; brownish black (5YR 2/1) fat CLAY, very stiff, slightly moist, moderate to high plasticity, massive, though blocky appearance due to abundant desiccation cracks; very similar to A/B horizon seen in TP-3, except slightly moist and therefore does not exhibit as large, wide, and prevalent desiccation cracks as seen in other test pits; subrounded quartzite clasts up to 2" diameter; abundant plant and tree roots, especially uppermost ~6"; irregular, sharp basal contact exhibits slickensides in places.

2. Highly Weathered Norwood Tuff Bedrock: ~1-2' thick; mottled grayish brown (5Y 3/2) and white (N9) mix of topsoil (Unit 1) and abundant small, angular Norwood Tuff clasts; gradational between gravelly fat CLAY and clayey GRAVEL, dense to very stiff, slightly moist, moderate plasticity, massive; common plant roots; irregular, gradational basal contact; basal contact largely characterized by thin brown shear plane, though slickensides not well defined; likely represents a shallow landslide deposit.

3. Norwood Tuff: >10' thick; light gray (N7) to medium light gray (N6) tuff partially to largely weathered to various masses of silt, sand, and clay; uppermost ~1.5' is lens of largely competent silty tuff, the top of which is a slide plane upon which the overlying material passes; contains common calcite-filled fractures, both along bedding planes and subvertical; basal ~6' exposed in pit exhibits highly irregular, possibly chaotic structure with hard and soft areas scattered throughout; calcium carbonate and manganese oxide dendrites and nodules commonly found scattered through basal ~6''; occasional white (N9) lenses largely decomposed to bentonite; uppermost ~4' of unit is predominantly silty tuff largely decomposed to silt; no quartzite observed.

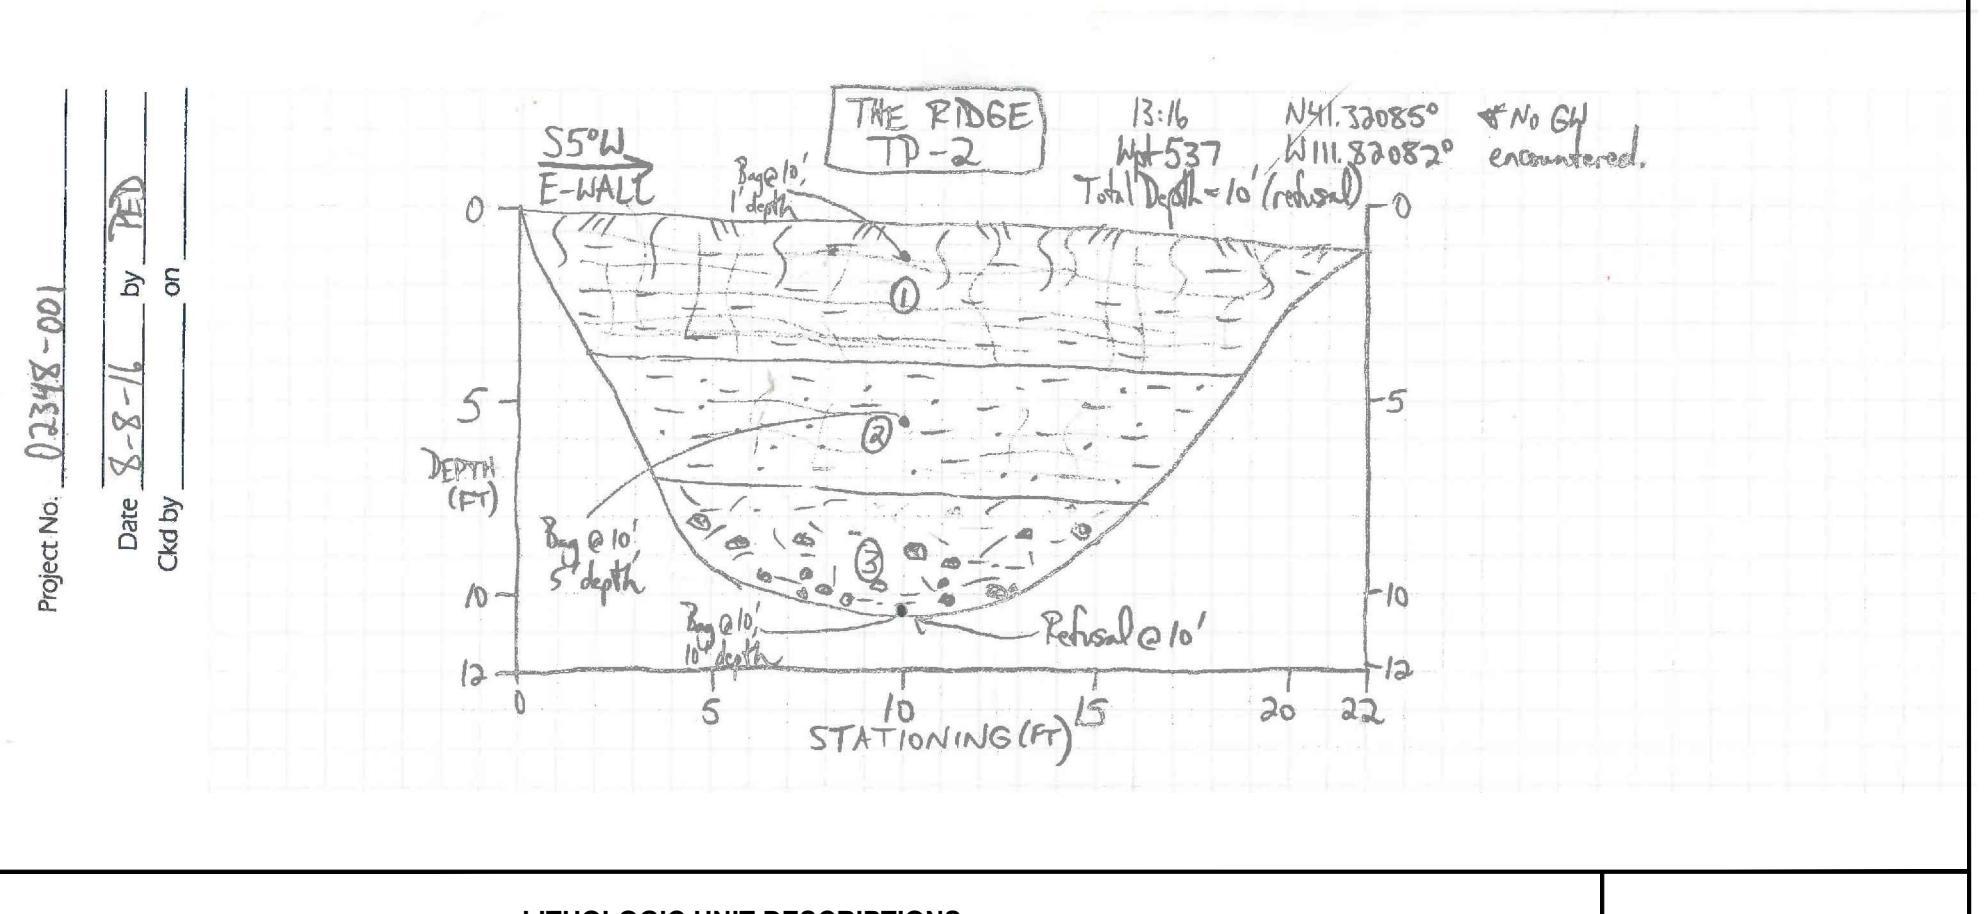
1. A/B Soil Horizon: ~3.5' thick; brownish black (5YR 2/1) to grayish brown (5Y 3/2) fat CLAY, very stiff, dry, moderate to high plasticity, massive, though blocky appearance due to abundant desiccation cracks; very similar to as seen in TP-3, except unit is thicker, contains fewer clasts (~1%), and displays wider desiccation cracks (seen to extend to the base of unit at up to 1" wide); common small plant roots throughout, though abundant in uppermost ~6" of unit; sharp, planar basal contact.

2. Weathered Norwood Tuff Ash: ~3' thick; dark yellowish brown (10YR 4/2), mottled with white (N9) specks; fat CLAY, stiff to very stiff, slightly moist, moderate to high plasticity, massive; abundant small white CaCO3 nodules scattered throughout unit, up to 1 cm in diameter; ash almost entirely decomposed to fat clay, though possibly a B-horizon; exhibits mechanically-induced slickensides, though no natural slickensides observed; minor desiccation cracking; sharp, planar basal contact.

3. Norwood Tuff Block-and-Ash: >3.5' thick; moderate yellowish brown (10YR 5/4) to dark yellowish brown (10YR 4/2) silty lean CLAY with gravel, very stiff to stiff, slightly moist, low to moderate plasticity, massive; gravel and larger sized clasts comprise ~30-40% of unit; clasts are ~60% very light gray (N8), subangular to subrounded, silty, soft tuff, and ~40% dark yellowish orange (10YR 6/6), very hard, subrounded to subangular quartzite clasts up to 4" in diameter, though mode size ~1"; uppermost ~1' is largely deviod of clasts and exhibits a blocky structure due to possible desiccation cracks; clast concentration increases with depth.

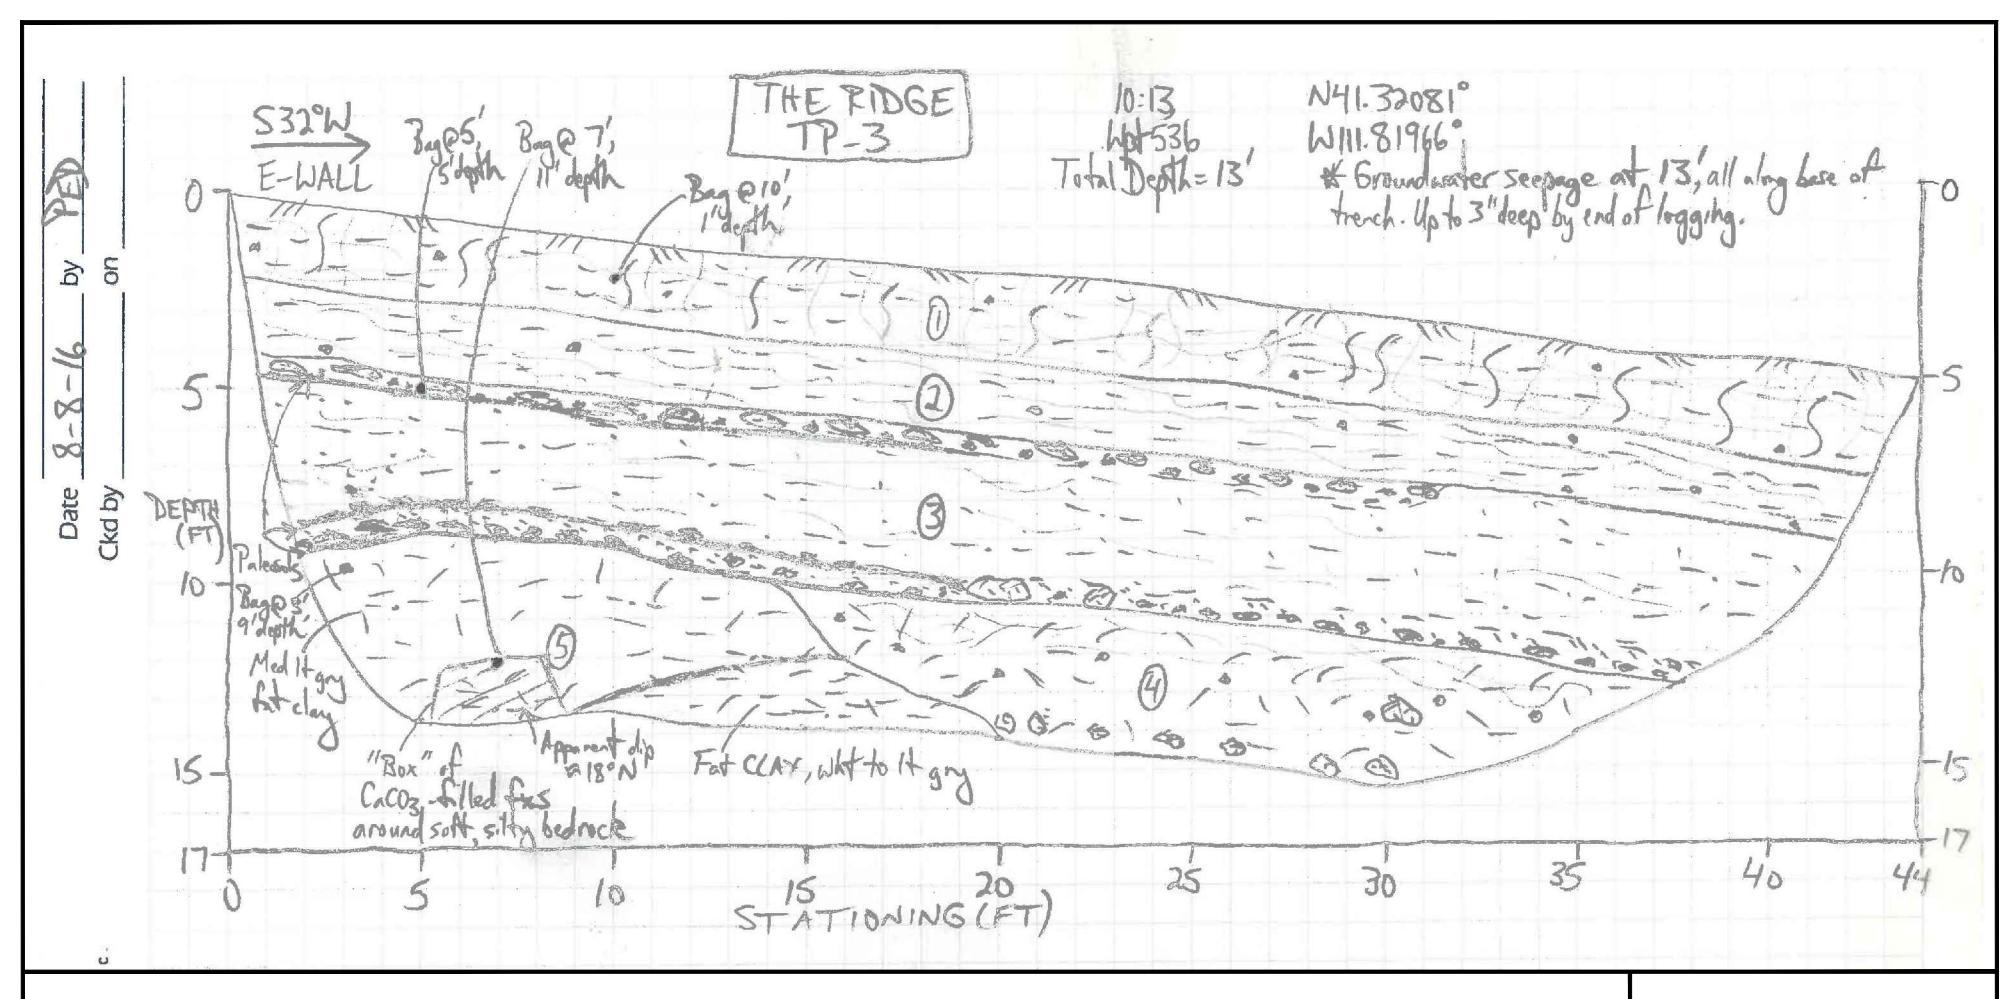
1. A/B Soil Horizon: ~2-2.5' thick; brownish black (5YR 2/1) to grayish brown (5Y 3/2) fat CLAY, very stiff, dry, moderate to high plasticity, massive, though blocky appearance due to abundant desiccation cracks; very well developed soil horizon; desiccation cracks are spaced between 1-2", and extend to base of unit; aperture of cracks seen to be 1" or greater on the surface in places, and generally 1-5 mm in subsurface; minor (<5%) gravel and larger sized clasts; clasts are entirely pink to dark yellowish orange (10YR 6/6) subrounded to subangular quartzite up to 1" in diameter; common plant and tree roots in uppermost 1', but decrease with depth; sharp, planar basal contact.

2. Alluvial?: ~2' thick; mottled very light gray (N8) and dark yellowish brown (10YR 4/2) lean CLAY with gravel; stiff, slightly moist, low plasticity, weakly thinly bedded (<1/2"); mottled due to abundant CaCO3 stringers, flour, and bedding plane infilling throughout; uppermost ~1' is highly calcareous and CaCO3 decreases with depth; gravel and larger sized clasts comprise ~5% of unit, ~80% of which is subrounded quartzite and ~20% is subrounded white (N9) Norwood Tuff; clasts up to 2.5" diameter; gradational, planar basal contact; possibly hyperconcentrated flow deposit.

3. Debris-Flow?: ~4' thick; dark yellowish brown (10YR 4/2) and mottled with white (N9) CaCO3 stringers and flour in places; silty lean CLAY with gravel gradational to clayey GRAVEL in places; stiff to dense, moist, low to medium plasticity, thinly to moderately bedded (up to 3.5"), blocky in places; top and bottom of unit has ~6"-1' thick clayey, sandy gravel lenses with imbricated quartzite clasts and associated thin (~3 mm) paleosols; clasts predominantly ~80% subrounded quartzite, ~20% Norwood Tuff weathered to clay; common 1 mm pinholes; sharp, irregular basal contact.

4. Norwood Tuff Block-and-Ash: >4' thick; mottled dark yellowish brown (10YR 4/2) and white (N9); top 1-2' has abundant CaCO3 stringers; silty fat CLAY with gravel; stiff, moist, moderate to high plasticity, massive; fat clay content and clast frequency increases with depth; gravel and larger sized clasts comprise ~5-10% of unit; clasts predominantly quartzite up to 5" in diameter.

5. Weathered Bedrock: >4' thick; medium light gray (N6) to light gray (N7); Norwood Tuff bedrock largely disaggregated to silty fat CLAY and clayey SILT; stiff to very stiff, moist, moderate to high plasticity, possibly thickly bedded; common organic or MnO2 smear in fat clay, as seen in silty tuff; some CaCO3 filled fractures; no natural slickensides observed.
