**Geologic Hazards Screening Assessment
4400 North 2900 East, Liberty, Utah
Northern 5 Acres of Parcel ID# 22-008-0060**

GeoStrata Job No. 1193-001

July 21, 2016

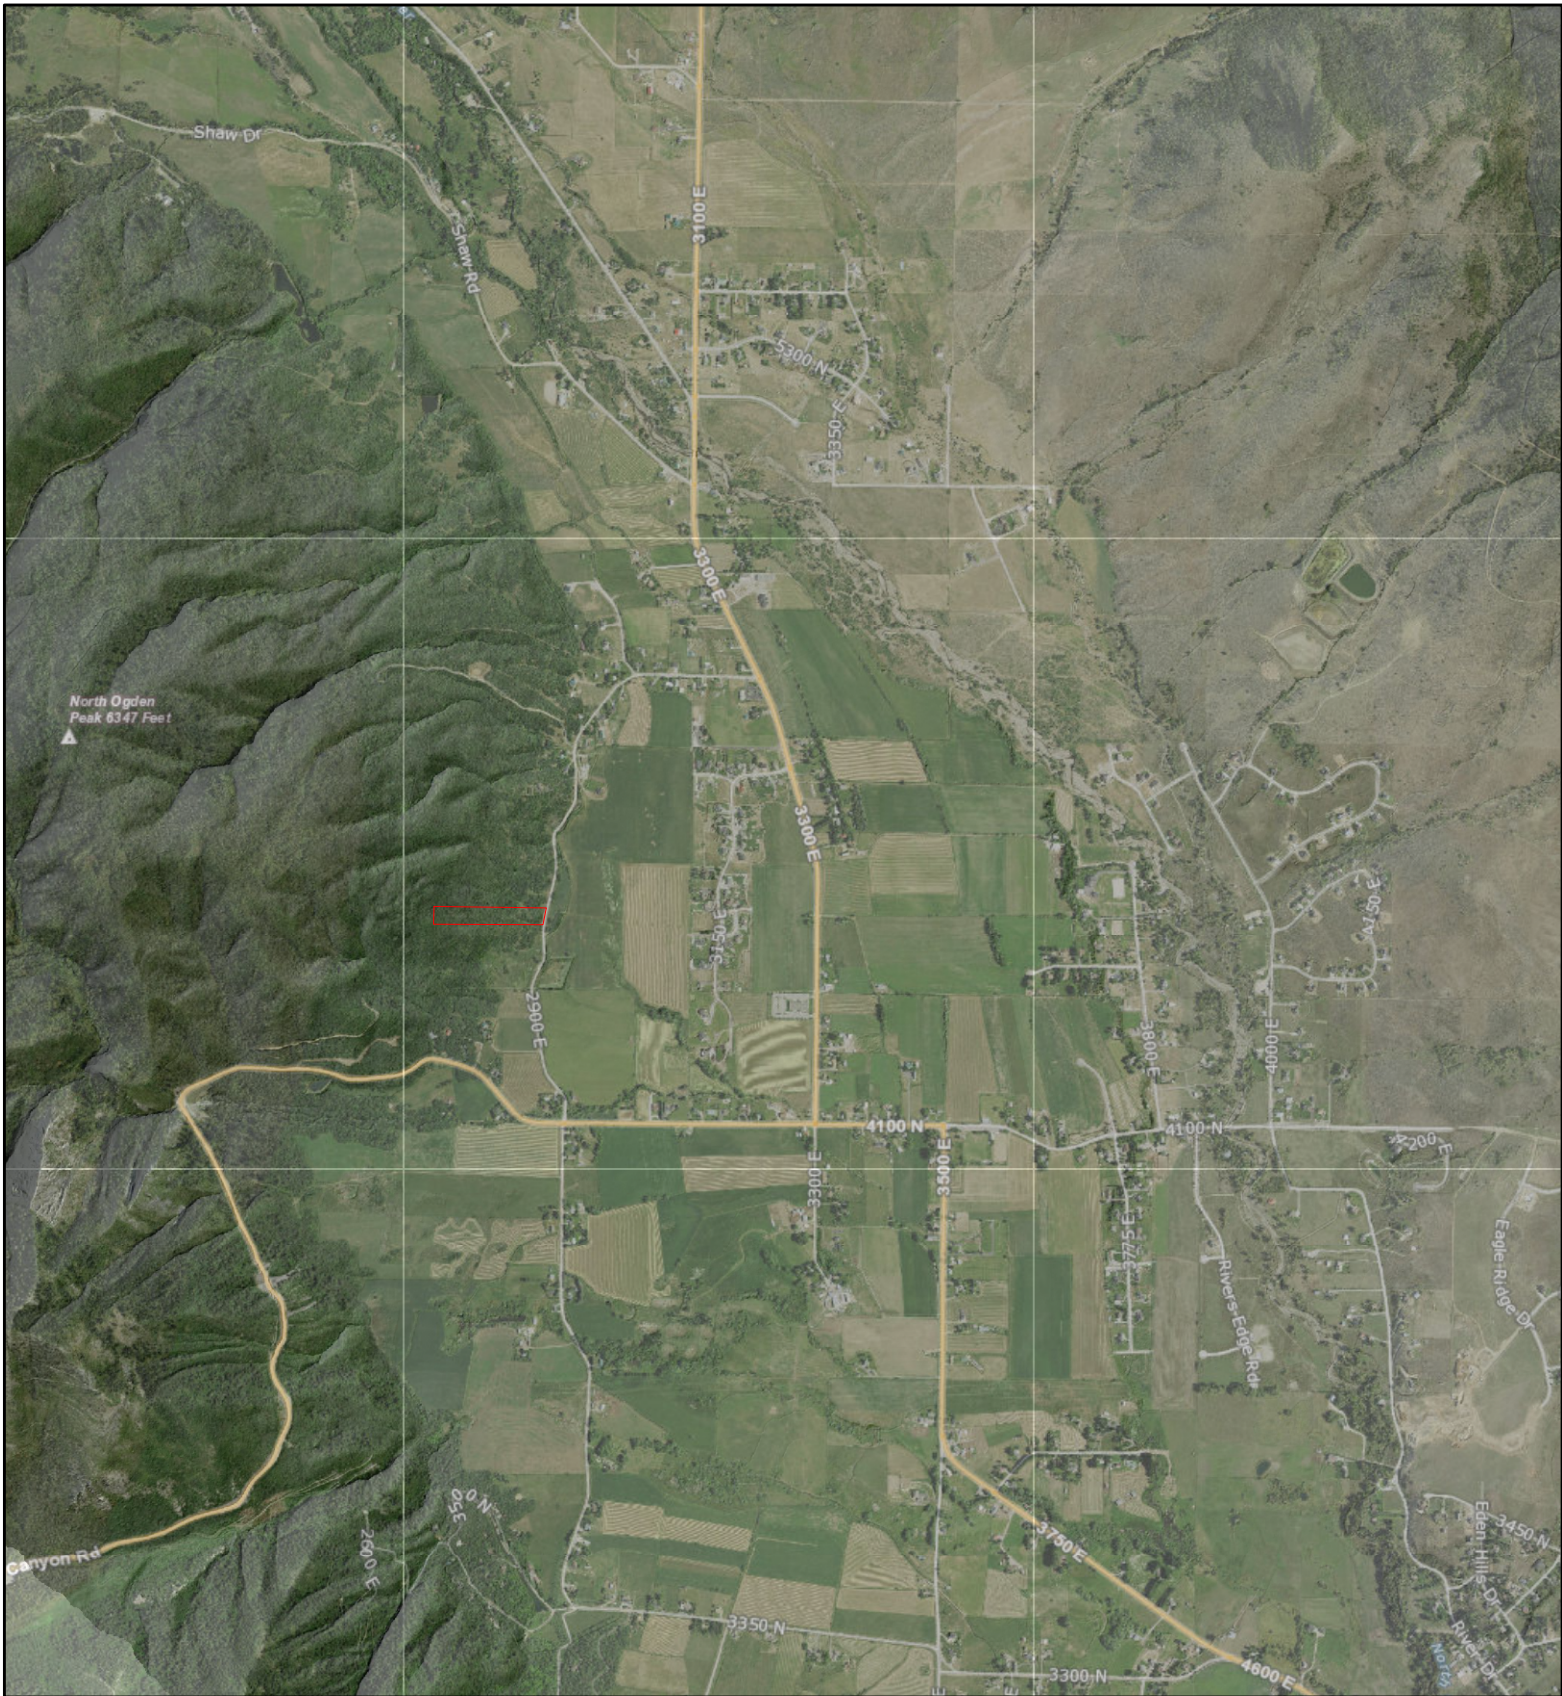
**Plate
 1**

on a native hillside. Proposed development, as currently planned, will consist of a single family residential structure as well as associated driveway, utilities and landscape areas. The hillside in the area of the subject lot gently slopes generally to the east and toward Ogden Valley. It is our understanding that the general area of the subject lot was first developed in the 1960's. The subject site and much of the hillside south of the site remains in a native condition. The areas adjacent to the subject site remains in a native condition. The areas approximately 0.3 miles north, south, and east of the subject site are established residential building lots. The subject lot is shown on the Site Vicinity Map included in the Appendix of this report (Plate 1).

Site Vicinity Map
