GEOTECHNICAL AND GEOLOGIC HAZARD INVESTIGATION
Building 4 Lodge, Development Parcel D7R
8569 E. Spring Park
Summit Powder Mountain Resort
Weber County, Utah

IGES Project No. 01628-024

August 7, 2017

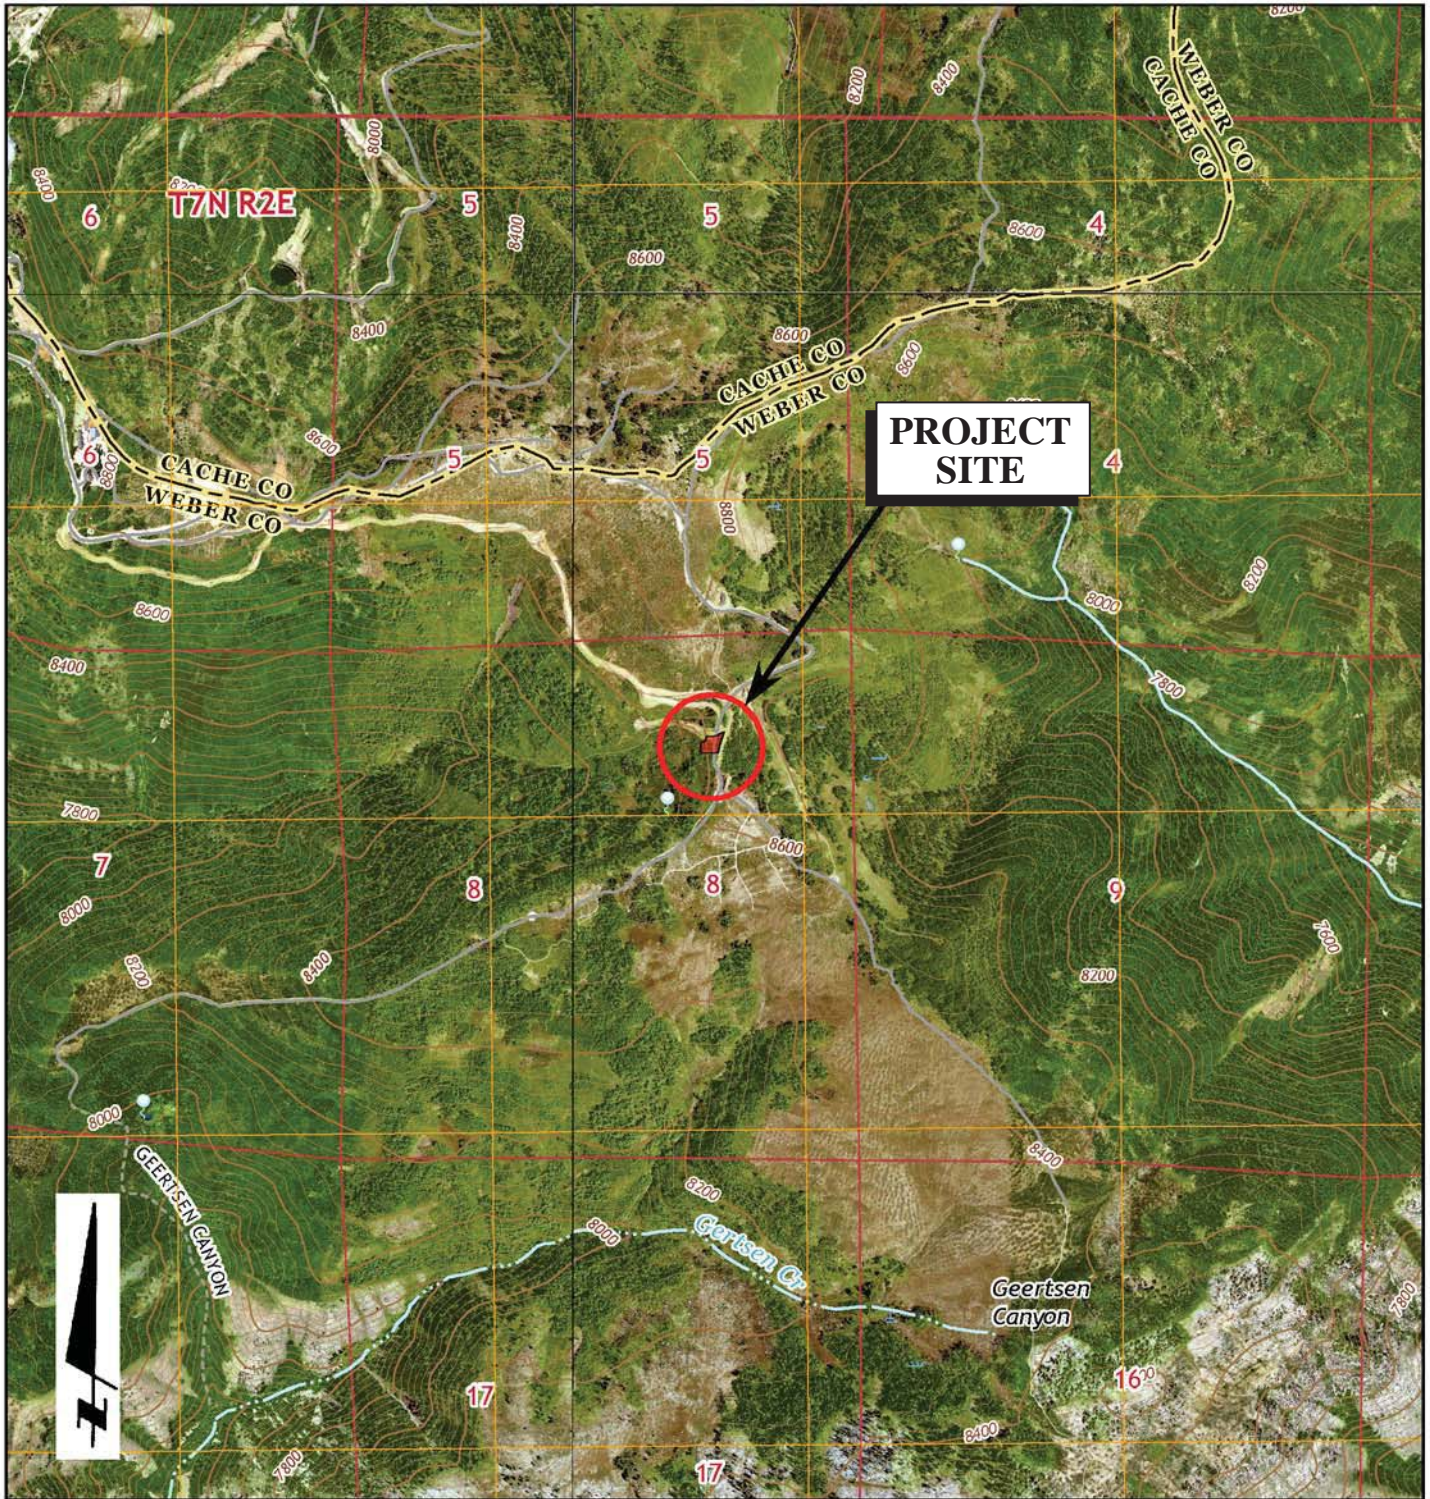
Figure
A-2

Approximately 100 feet west of the western margin of the property, a small, localized lobe of material interpreted to be possible landslide deposits was observed at the surface, though no associated headscarp was observed (see Figure A-2).

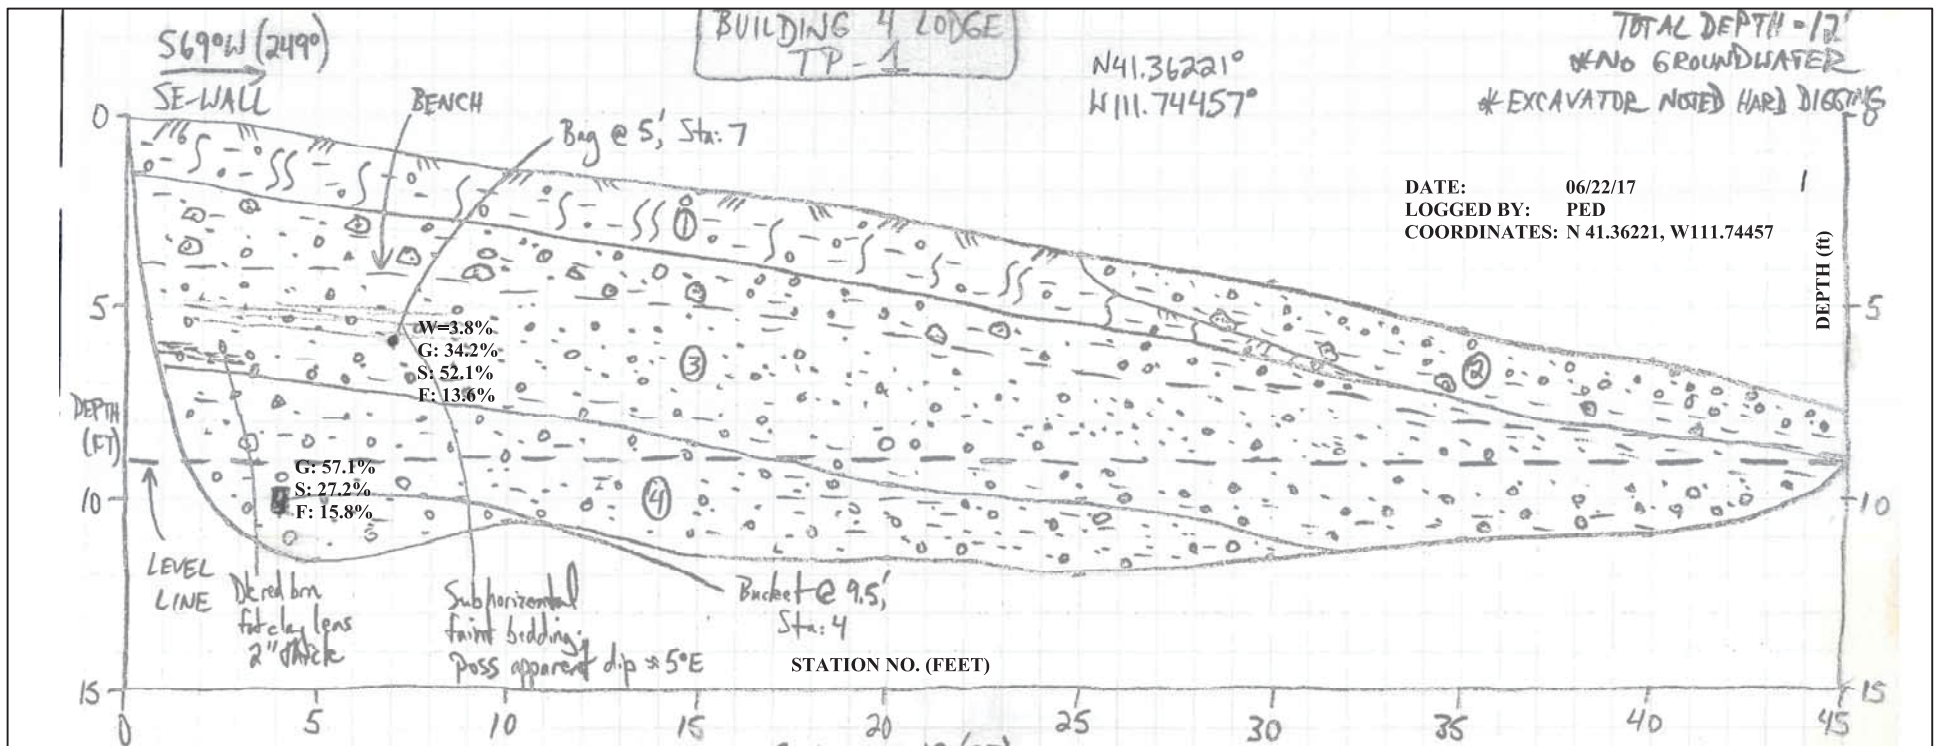
A-3

- 1) **A/B Soil Horizon:** ~1.5-2' thick; grayish brown (5Y 3/2) sandy lean CLAY with gravel (CL), medium stiff, moist, low plasticity, massive; gravel and larger sized clasts comprise ~15% of unit; clasts entirely subrounded medium light gray (N6) to pale yellowish orange (10YR 8/6) quartzite up to 1' in diameter, though mode size ~1"; abundant plant and tree roots; thickens slightly downslope; gradational, planar basal contact.

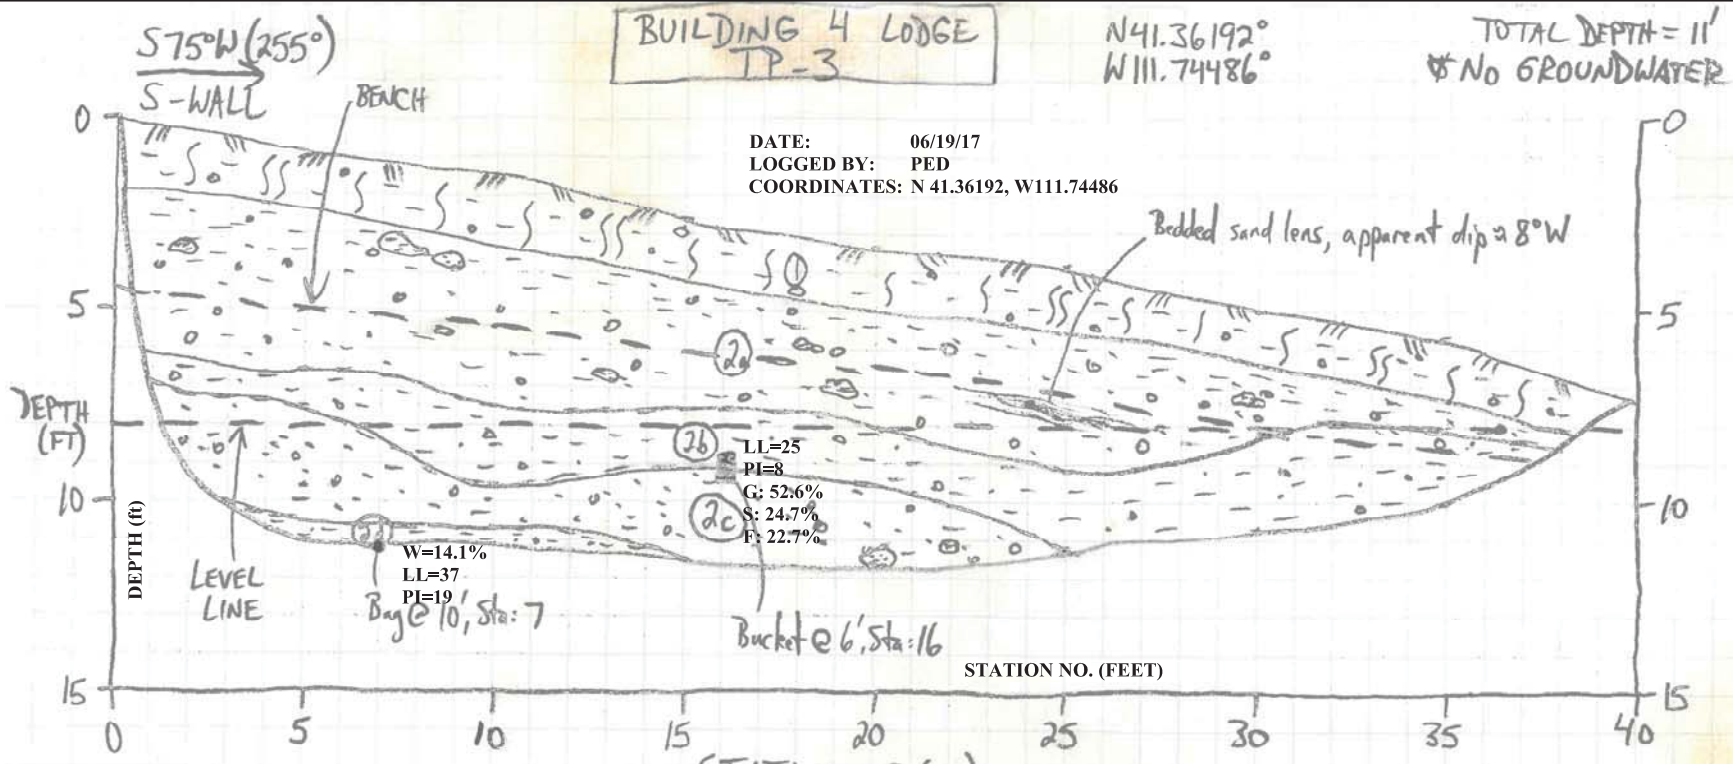
1) A/B Soil Horizon: ~1.5-2' thick; grayish brown (5Y 3/2) to brownish black (5YR 2/1) lean CLAY with gravel (CL), medium stiff, moist, low plasticity, massive; gravel and larger sized clasts comprise ~5-10% of unit; clasts entirely medium light gray (N6) to dark yellowish orange (10YR 6/6) subrounded quartzite up to 5" in diameter, though mode size ~1/2"; abundant plant and tree roots; sharp, irregular basal contact.
