GEOTECHNICAL AND GEOLOGIC HAZARD INVESTIGATION The Overlook – Phase I Summit Powder Mountain Resort Weber County, Utah

IGES Project No. 01628-021

January 30, 2017

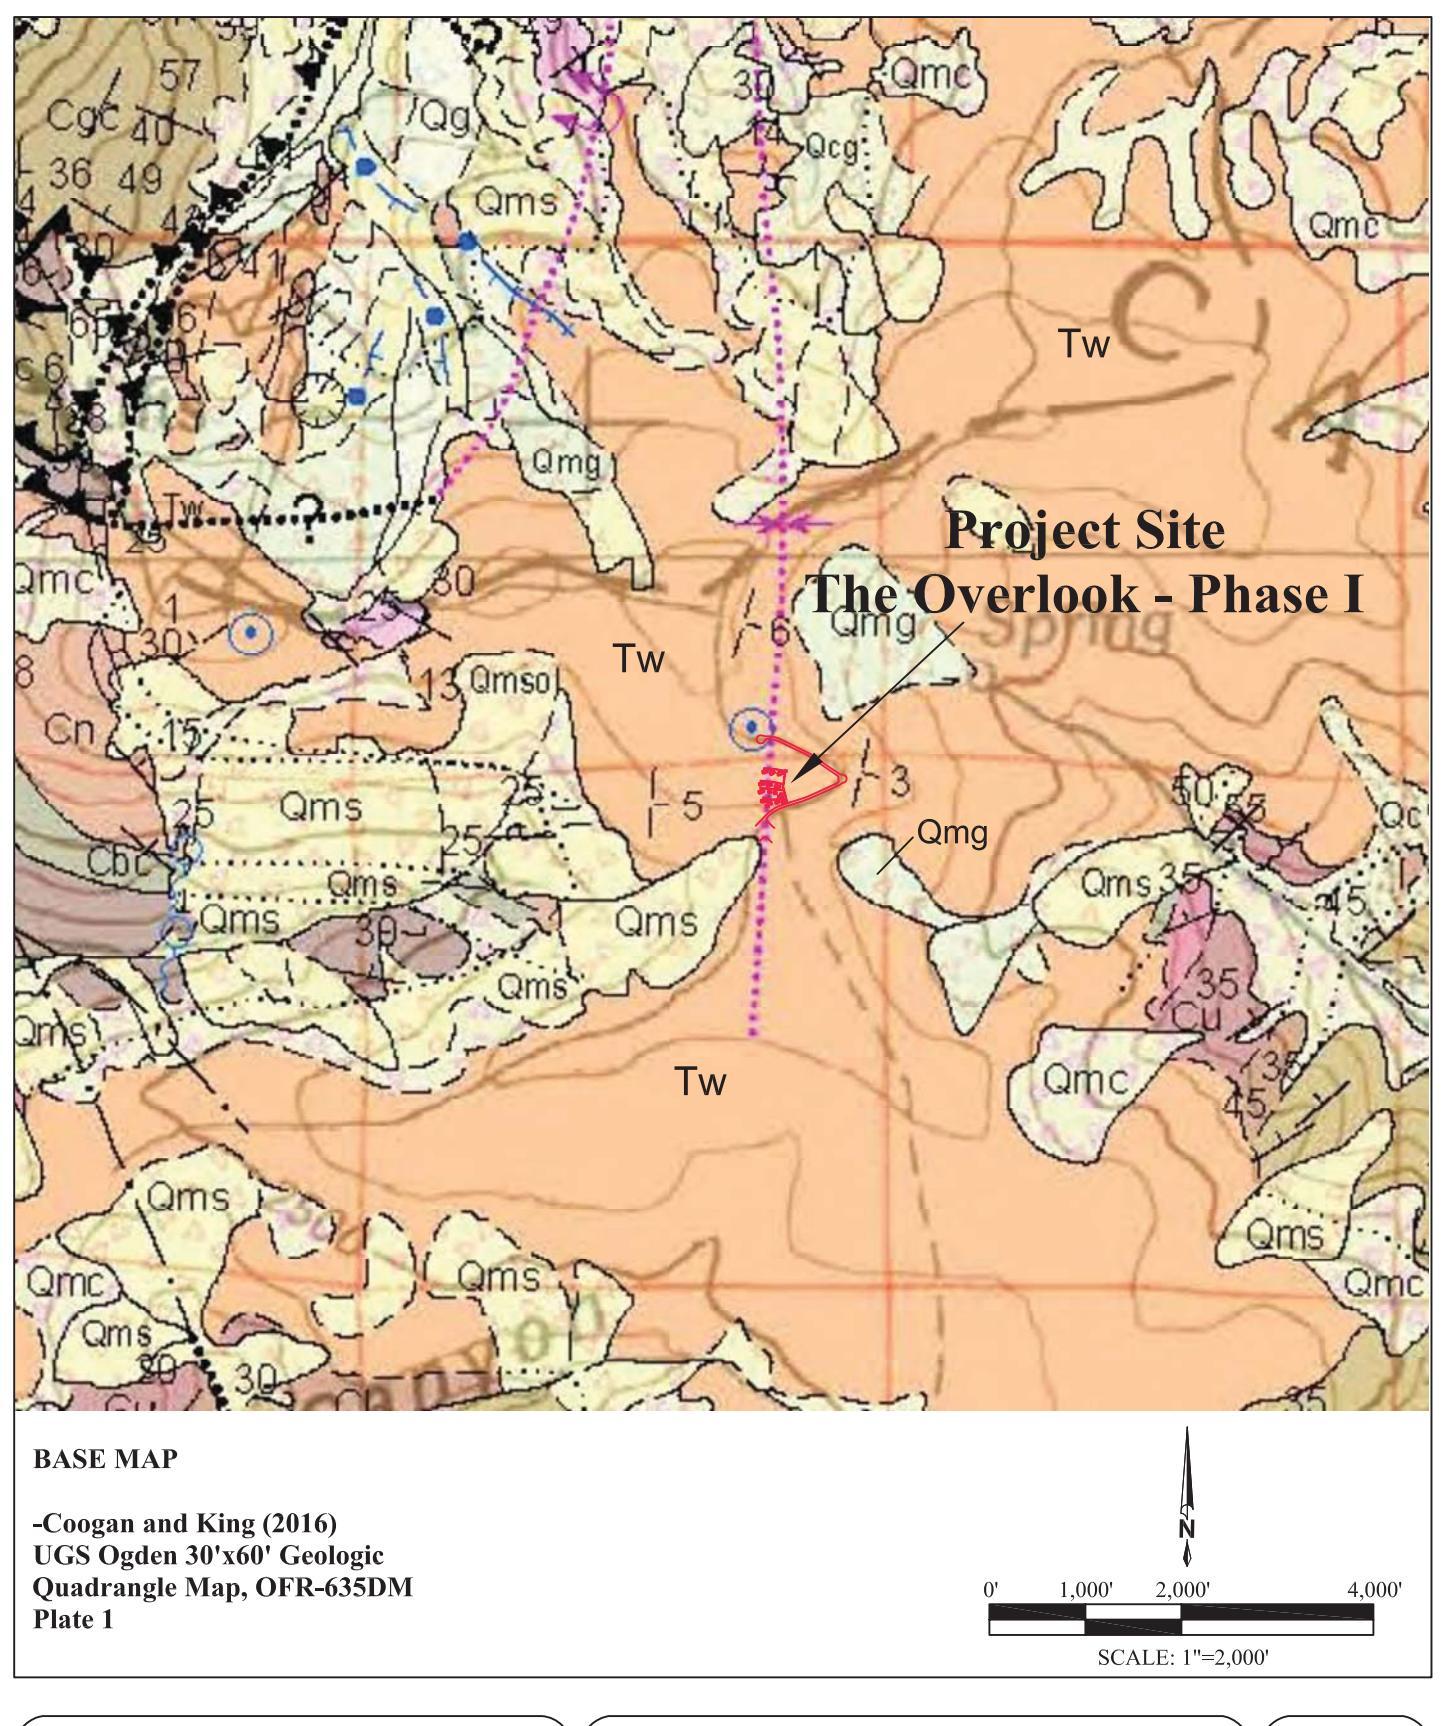
A-9

Two regional-scale landslide hazard maps have been produced that cover the project area. Colton (1991) does not show the property to be underlain by or adjacent to landslide deposits, though landslides are mapped near the northeastern and southeastern margins of the property. Consistent with Colton (1991), Elliott and Harty (2010) shows deposits mapped as "Landslide undifferentiated from talus and/or colluvial deposits" near the northeastern and southeastern margins of the property. Most recently and more site-specific, Western Geologic (2012) used the Elliott and Harty (2010) map as a base map, which shows Pleistocene landslide deposits northeast of the property, though the landslide deposits shown to the southeast of the property on Colton (1991) and Elliott and Harty (2010) are not present (see Figure A-9).
