**Geologic Hazards Screening Assessment
Lot 70R Summit Eden Phase 1C
8492 East Spring Park Road
Eden, Utah
Parcel # 23-130-0037**

GeoStrata Job No. 594-005

July 17, 2018

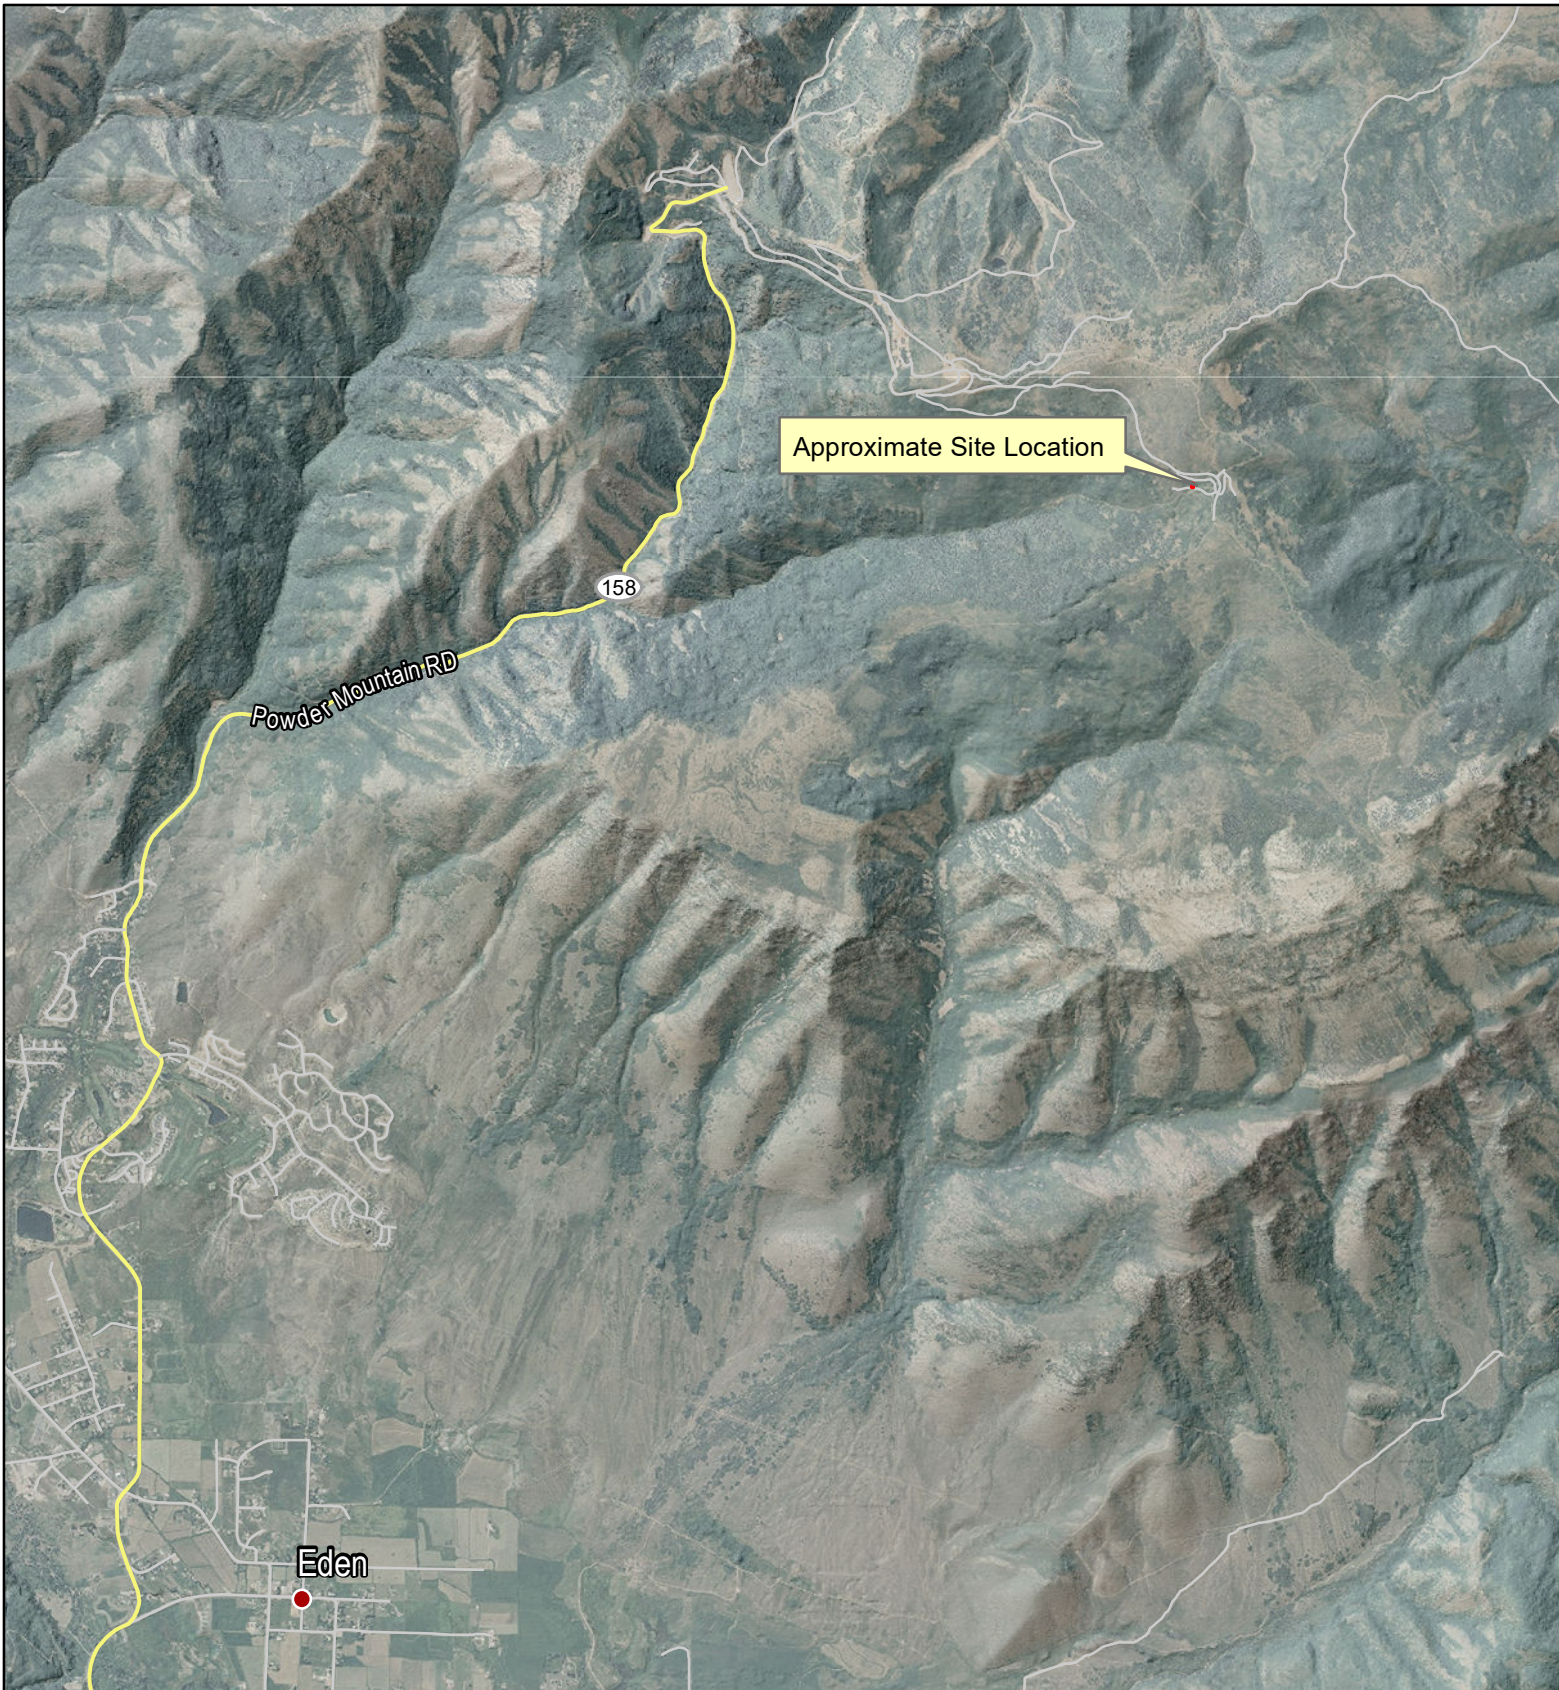
Plate
2

Slope stability of the subject site was not assessed as part of this geological hazard assessment. The subject site was observed to be moderately to steeply sloping to the south toward a nearby drainage (Plate 2 Topographic Map). The possibility that development of the site could negatively affect slope stability within the subject site is increased if development is planned for areas of the site with slopes steeper than approximately 3 horizontal: 1 vertical. It should be noted that grading or development adjacent to the subject site could potentially impact the stability of the area within the subject site and assessment of that hazard is out of the scope of this assessment.

Slope stability of the subject site was not assessed as part of this geological hazard assessment. The subject site was observed to be moderately to steeply sloping to the south toward a nearby drainage (Plate 2 Topographic Map). The possibility that development of the site could negatively affect slope stability within the subject site is increased if development is planned for areas of the site with slopes steeper than approximately 3 horizontal: 1 vertical. It should be noted that grading or development adjacent to the subject site could potentially impact the stability of the area within the subject site and is out of the scope of this assessment. Due to the presence of mapped landslide deposits near the subject site and the steep grade observed within the subject site, GeoStrata recommends that a geotechnical report that evaluates the slope stability within the subject

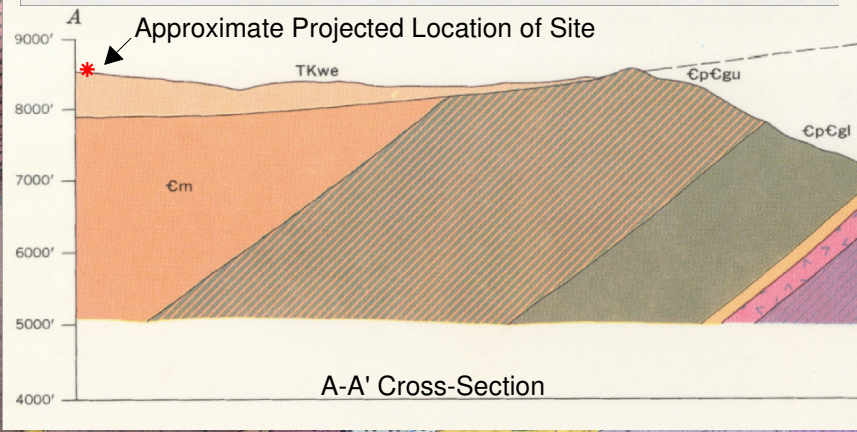
**Plate
5**

Based on review of the Interim Geologic Map of the Ogden 30x60 Quadrangle, a landslide deposit (Qms) is mapped immediately south of the subject site (Plate 5 Site Vicinity 30x60 Geologic Map). A deposit described as landslide undifferentiated from talus and/or colluvial is mapped south and in the vicinity of the subject site as shown on Plate 7 Landslide Hazard Map. No landslide deposit is mapped within or immediately adjacent to the subject site on the Geologic Map of the Browns Hole and Huntsville Quadrangles as indicated on and Plate 4 Site Vicinity Geologic Map. A trench trending north-northwest to south-southeast through the middle of the subject site and at a depth of approximately 5 to 9 feet below existing site grade was excavated as part of the geotechnical study compiled for the subject site. Geologic observations of the near surface geology in the trench exposure were made during our site visit. It is the opinion of GeoStrata that the soils observed in the trench were observed to comprise of colluvium deposits. No shears or deformation features related to a landslide deposit were observed in the trench. Based on our stereographic aerial photograph interpretation, our review of the hillshades derived from 2016 0.5 meter LiDAR and our field observations, no landslide features such as hummocky topography, slumps or scarps were identified within the subject site or observed in the trench excavation. The subject site was observed to be moderately to steeply sloping and to contain outcroppings of well-rounded quartzite cobbles and boulders that were partially buried. Based on the landslide mapped south of the subject site and the moderate to steep grade within the subject site, it is the opinion of GeoStrata that the landslide hazard within the subject site is considered low to moderate. GeoStrata recommends that a slope stability analysis be performed by a professional engineer as part of a comprehensive site specific geotechnical investigation to assess the potential for slope failure. Slope stability modeling should take landslide deposits and potential landslide deposits into consideration and evaluate all portions of the subject site being considered for development to provide recommendations for construction that will aid in reducing the risk for mass movement within the subject site.

Based on review of published geologic maps, review of stereographic aerial photographs and hillshades derived from 2016 0.5 meter LiDAR, no Holocene age alluvial fan deposit is mapped within or adjacent to the subject site (Plate 4 Site Vicinity Geologic Map; Plate 5 Site Vicinity 30’ X 60’ Geologic Map). Given our field and office investigations, the alluvial fan flooding hazards within subject site is considered low and it is considered unlikely that debris flows will

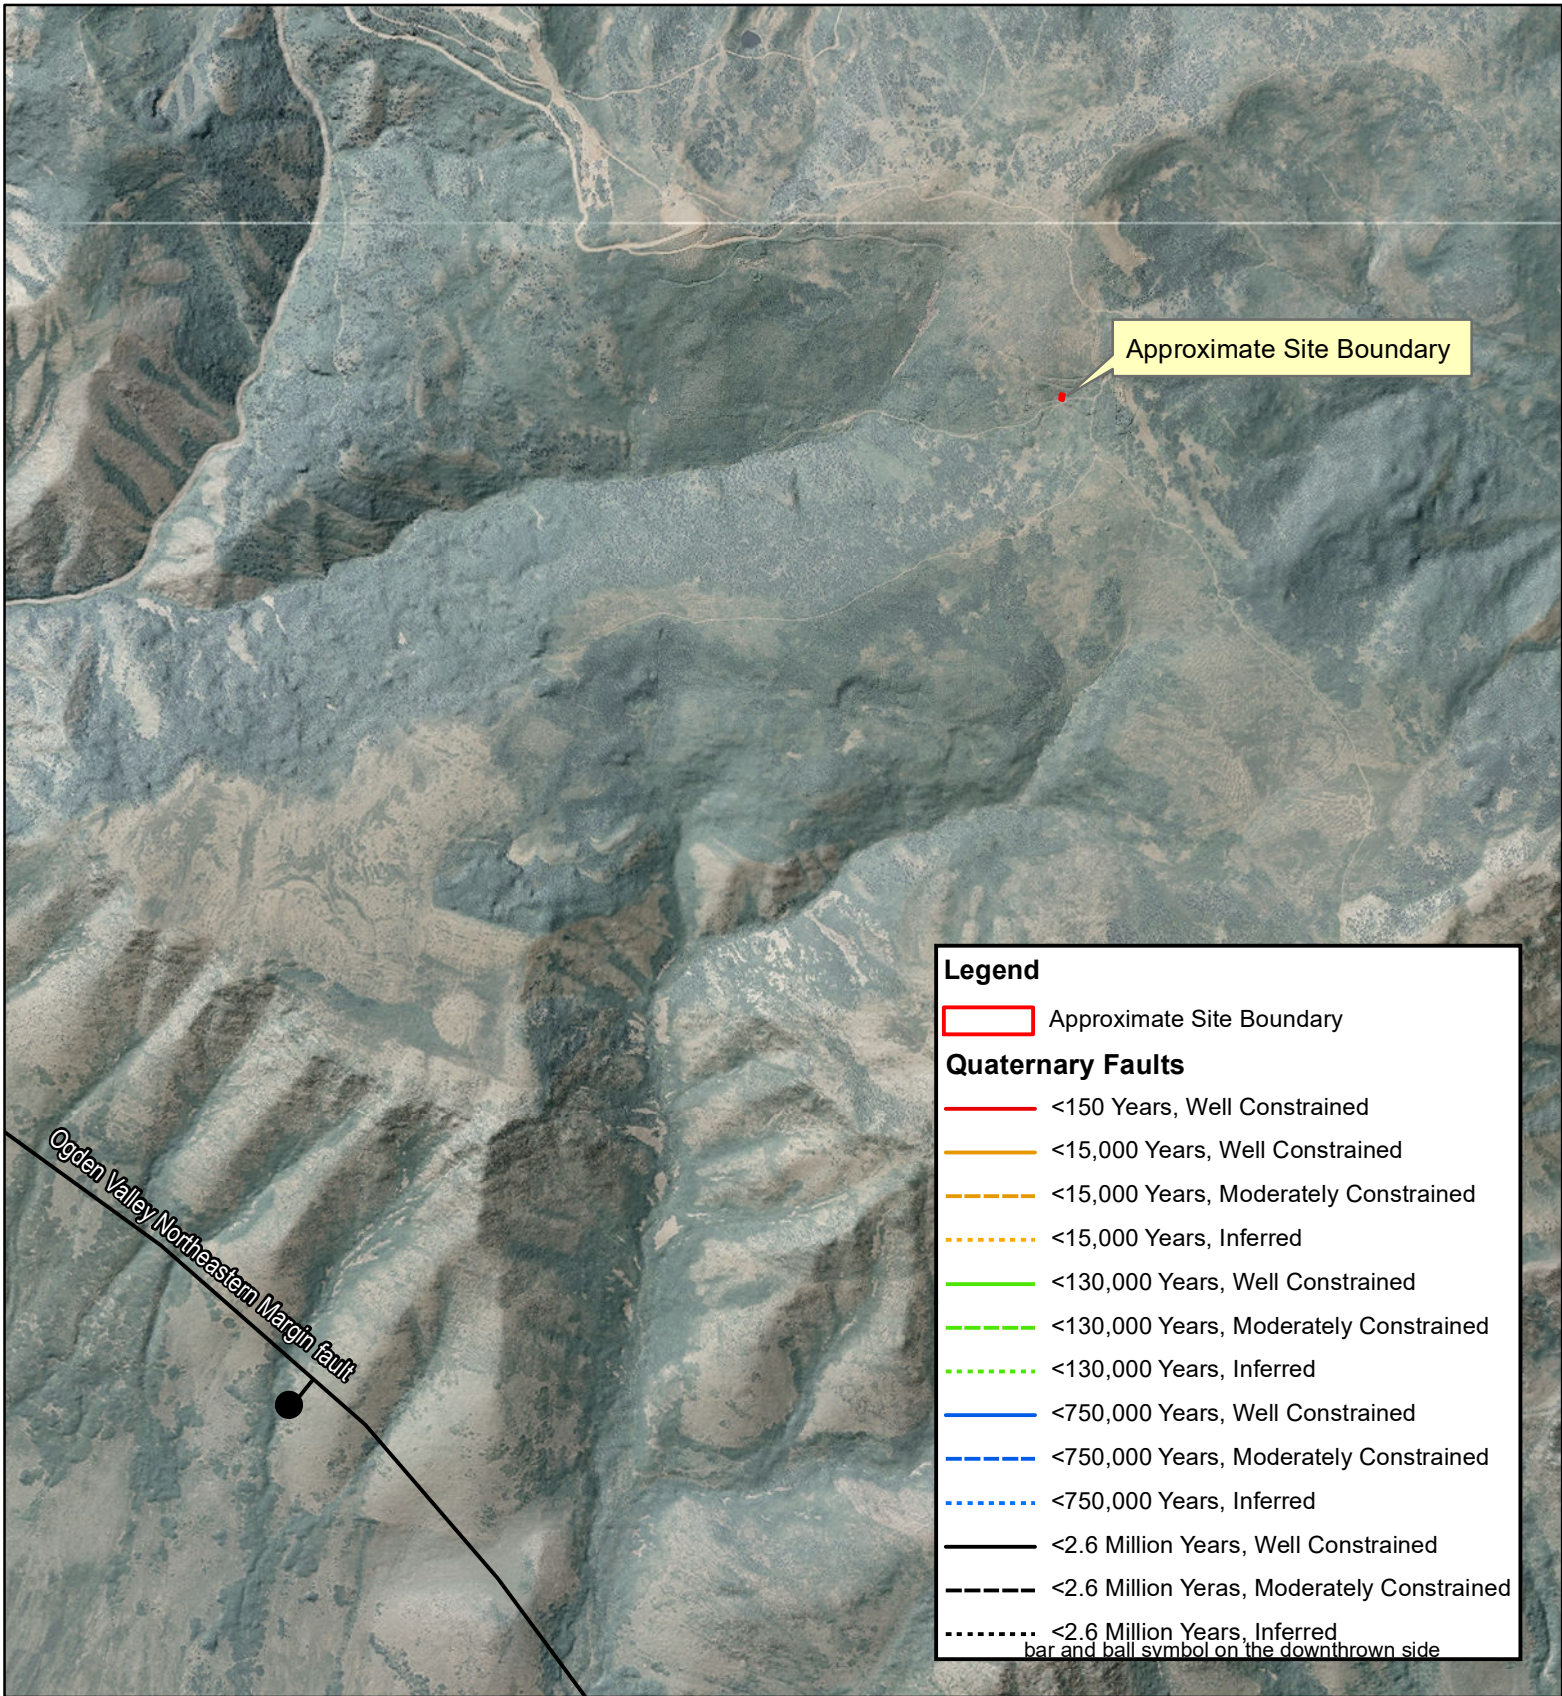
**Plate
6**

Based on review of published geologic maps, our stereographic aerial photograph interpretation, our review of the hillshades derived from 2016 0.5 meter LiDAR and our field observations, no active faults are located near the subject site (Plate 6 UGS Quaternary Fault Map). The nearest fault is the Ogden Valley Northeastern Margin Fault which is between 0.75 and 2.6 million years
