SURFACE GEOLOGIC HAZARD STUDY

PROPOSED PAS DE CALAIS SUBDIVISION

WEBER COUNTY, UTAH

Re: Report
Surface Fault Rupture Hazard Study
Pas De Calais Subdivision
Between Melanie Lane and 2900 East
Ogden, Utah

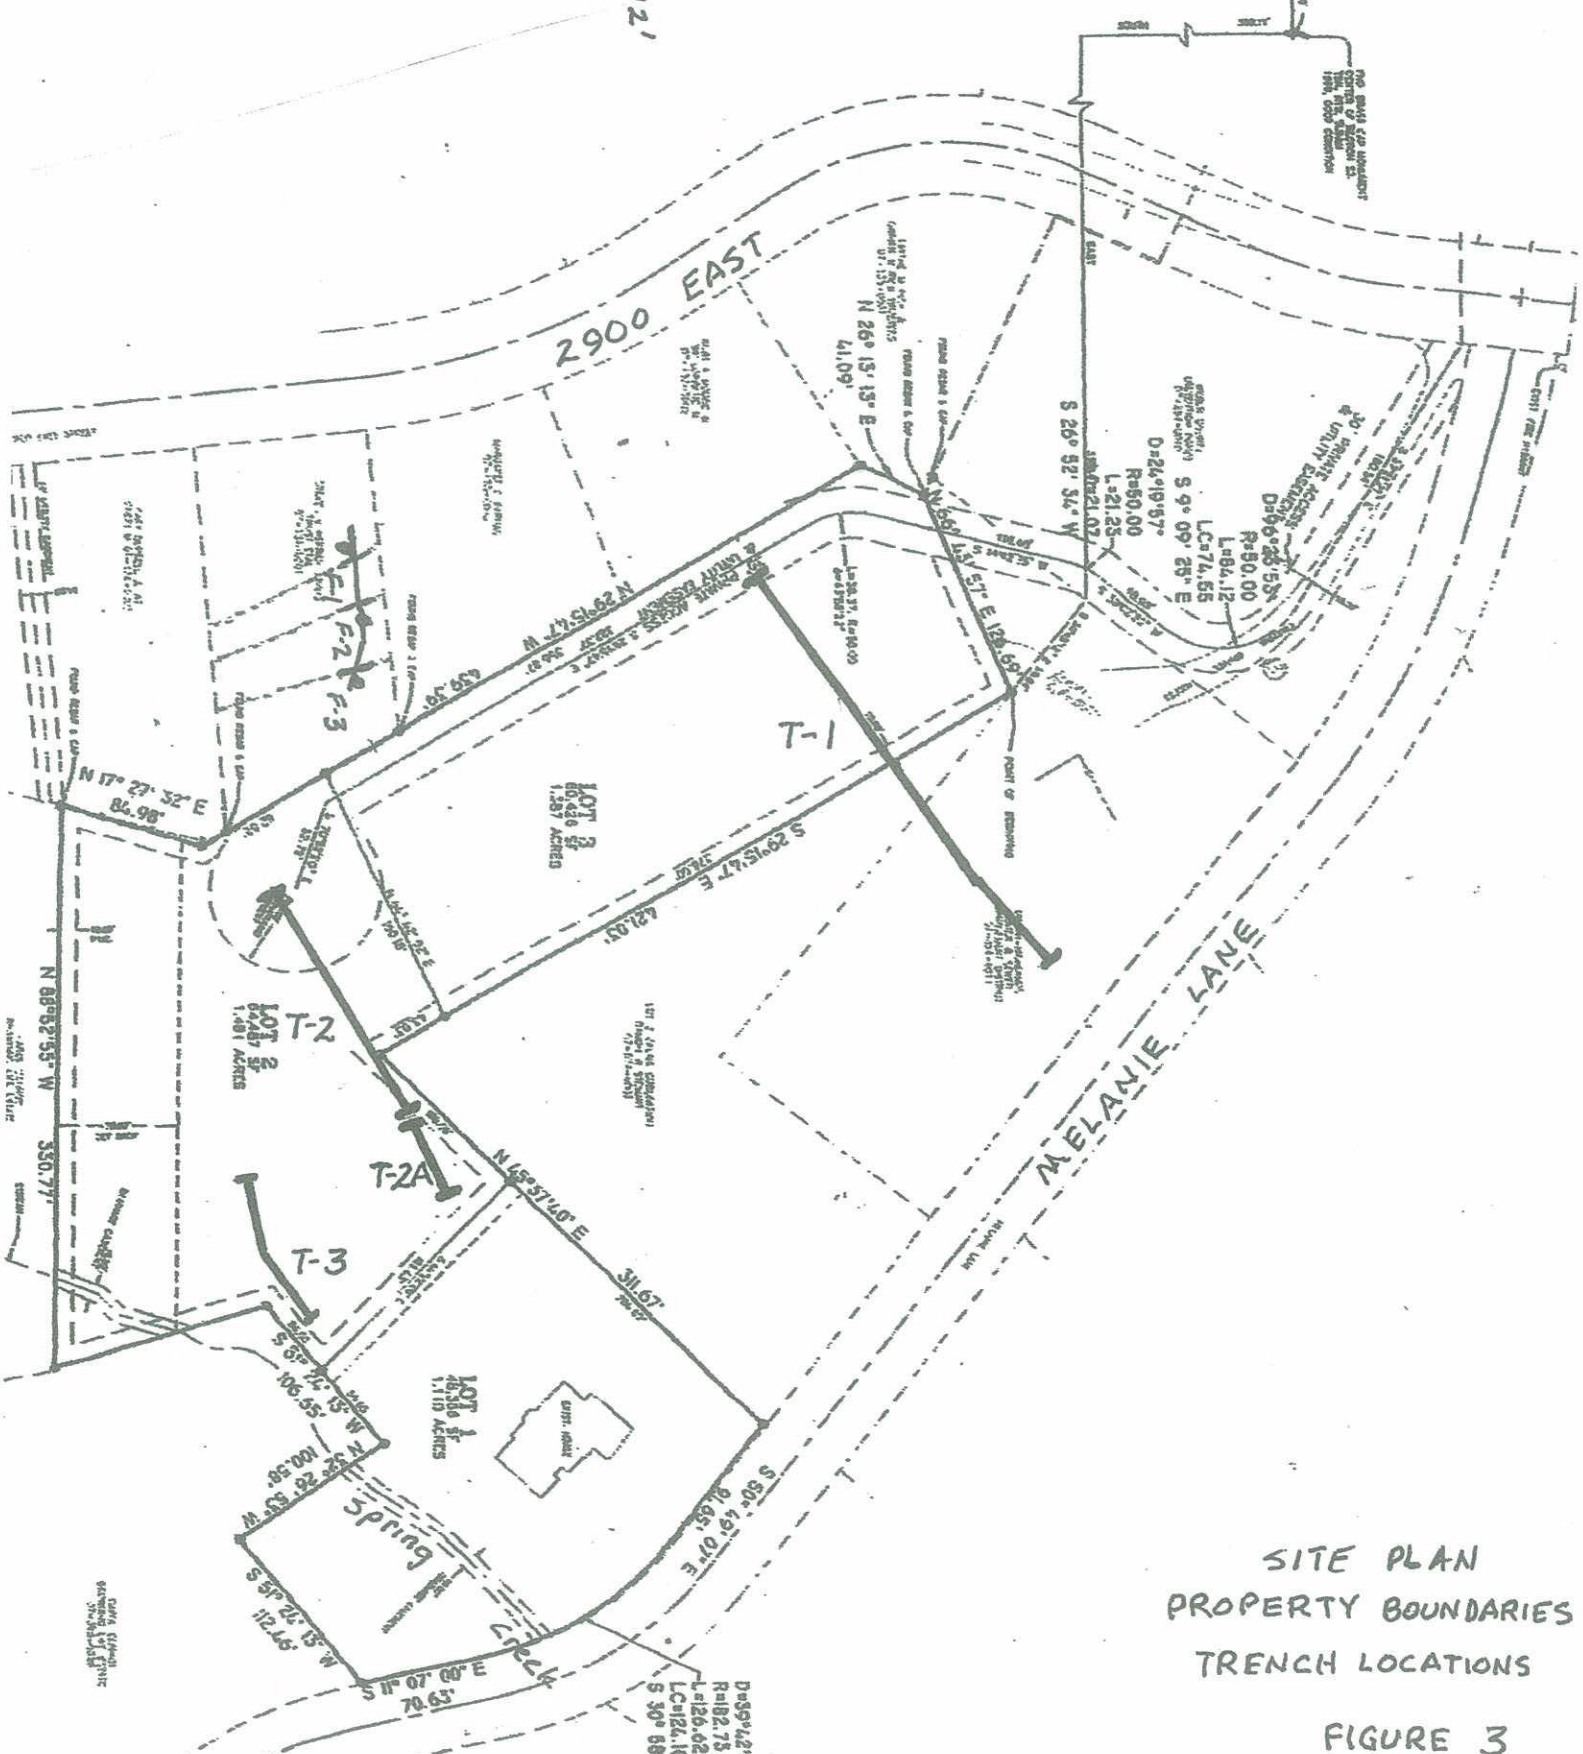
FIGURE 3

SITE PLAN
PROPERTY BOUNDARIES
TRENCH LOCATIONS

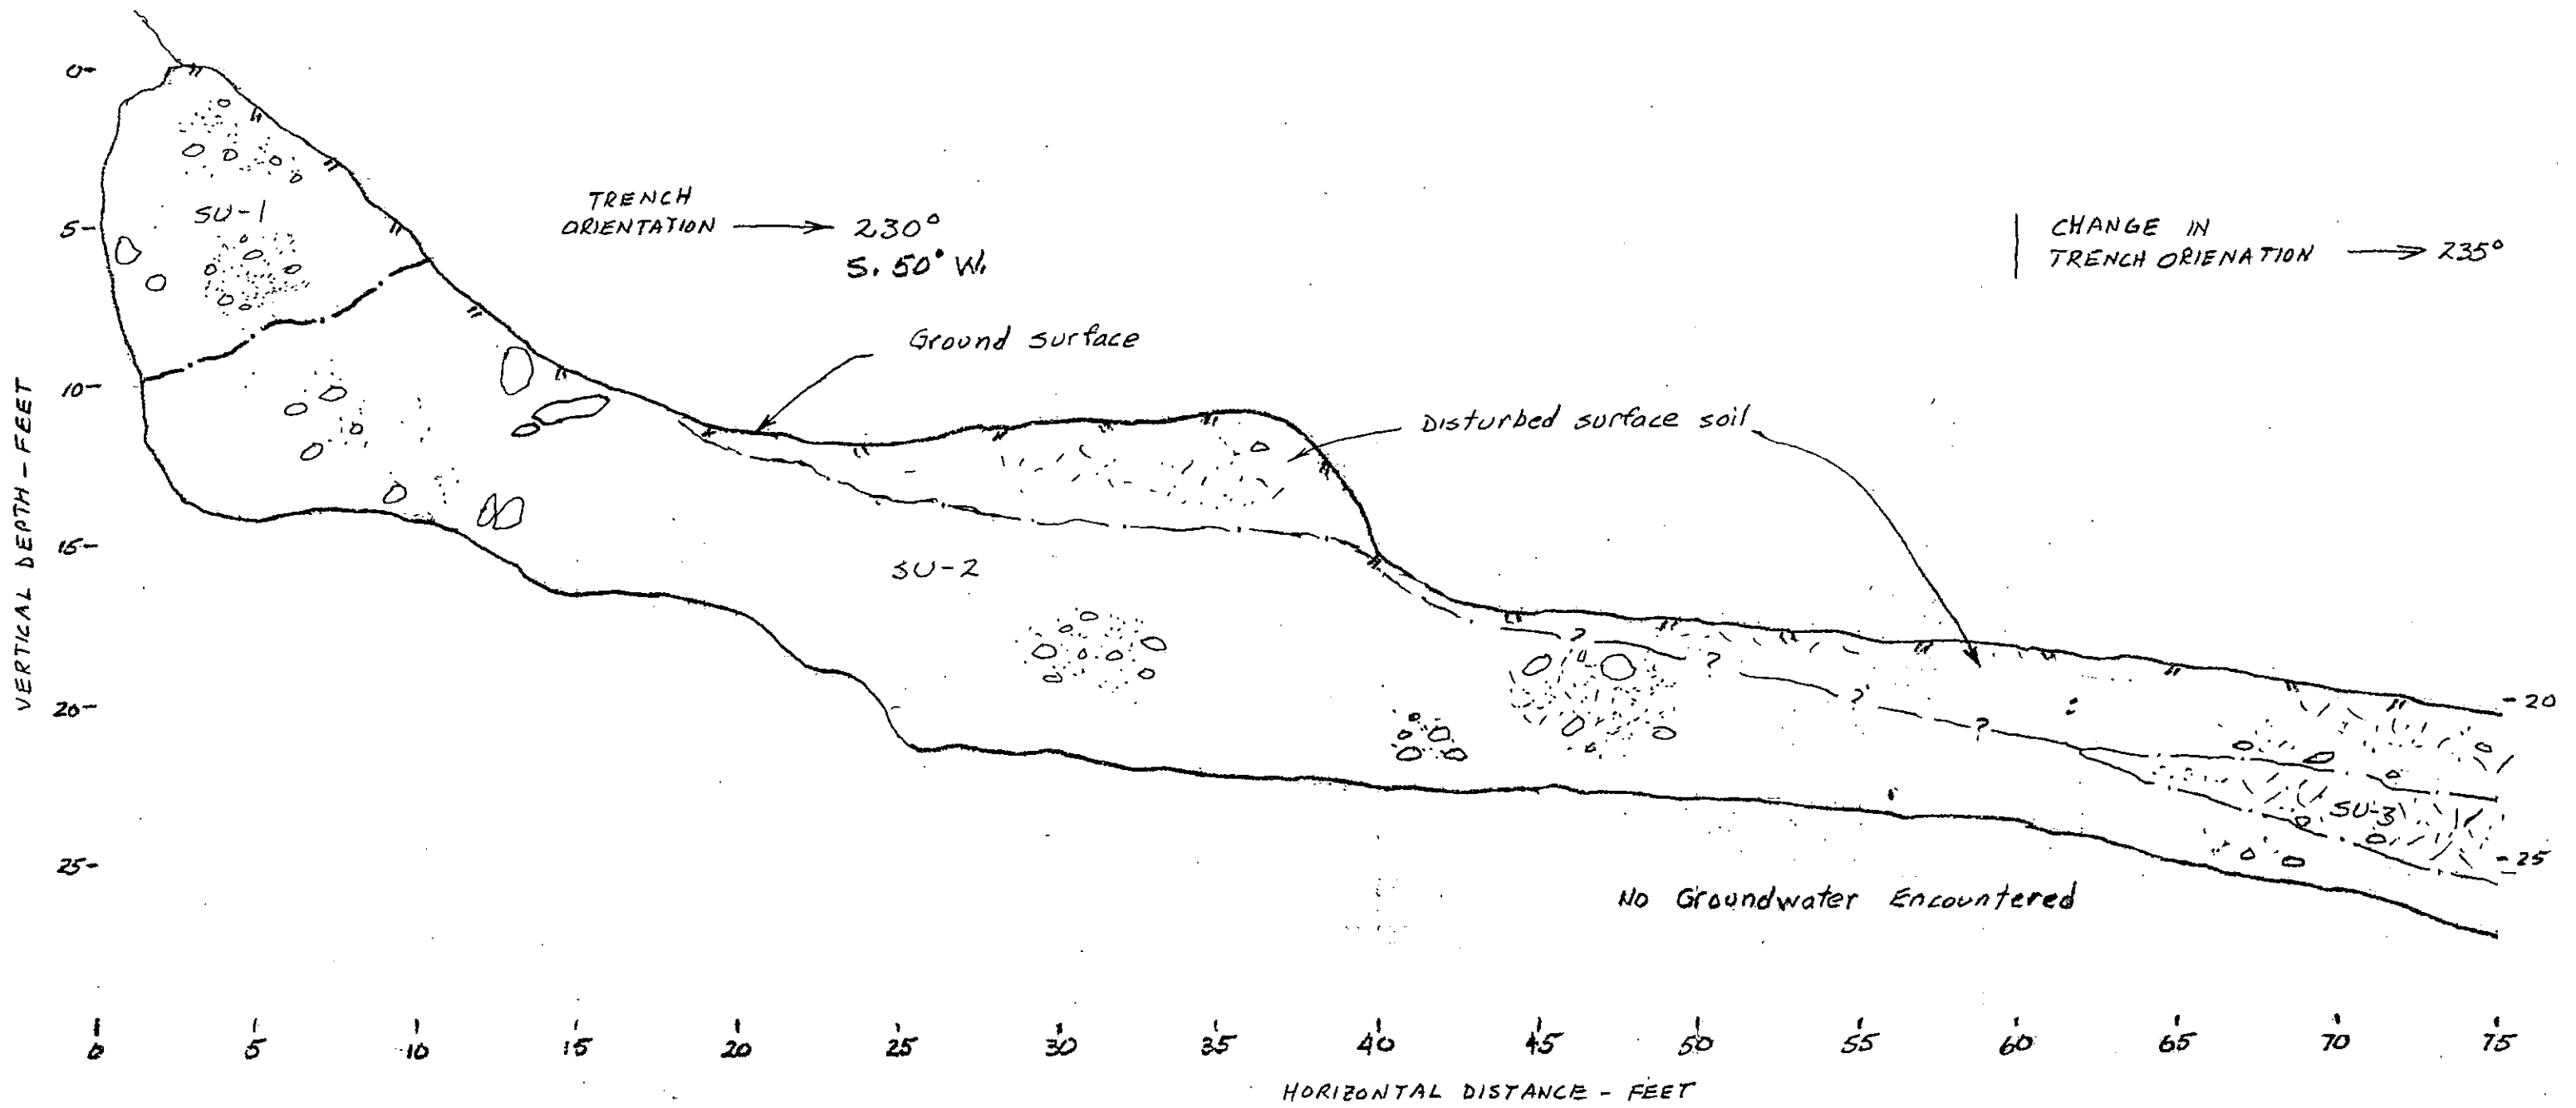
FIGURE 4

Trench 1 was excavated across the northern third of Lot 3 as shown on Figure 3. Debris flow and lacustrine deposits are exposed in the trench and are partly covered by some disturbed surface soil most likely disturbed during the construction of Bybee Pond. The soil units that are debris flow deposits are designated SU-1 and SU-2. They consist of light brown to light silver gray, fine sand, silt and rounded very hard gravel and cobbles. The soils are massive, dense, and dry. The gravel and cobbles make up between 10 % and 20% of the deposit. The remainder is fine sand with some silt, which is friable and non-plastic. SU-3 and SU-4 soil units are lacustrine sand and silt, which is interpreted as transgressive

In the disturbed soil area at Station 0+94 at a depth of approximately 2 feet is a white golf ball. The log of this trench is shown on three figures (Figures 4, 4a, and 4b) due to the length of the trench.

EXPLORATION TRENCH NO. 1
SOUTHEAST WALL LOG

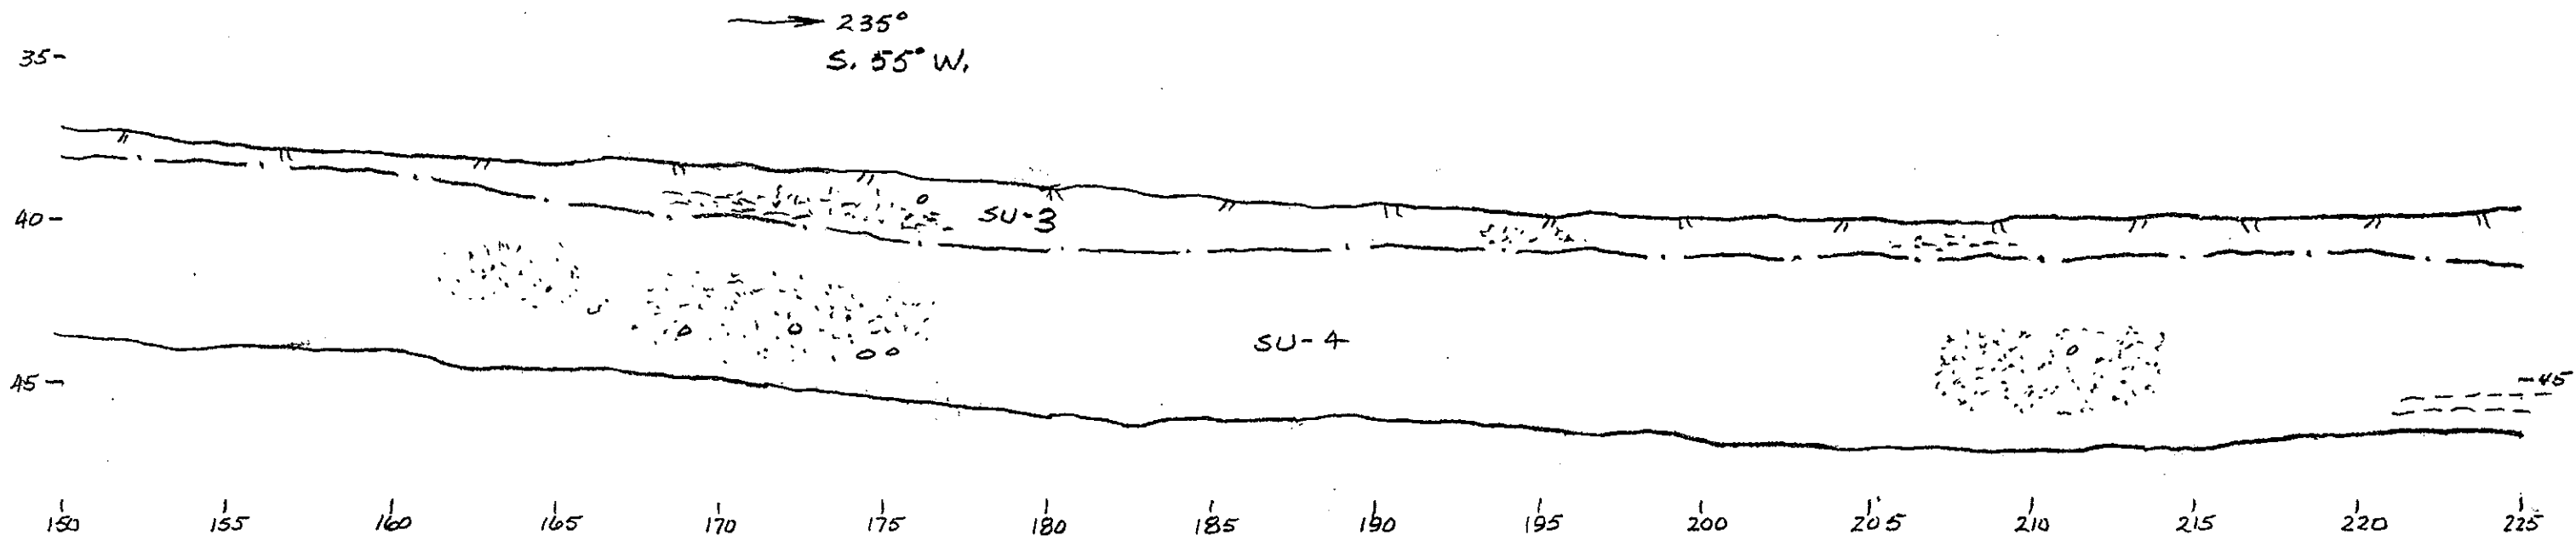
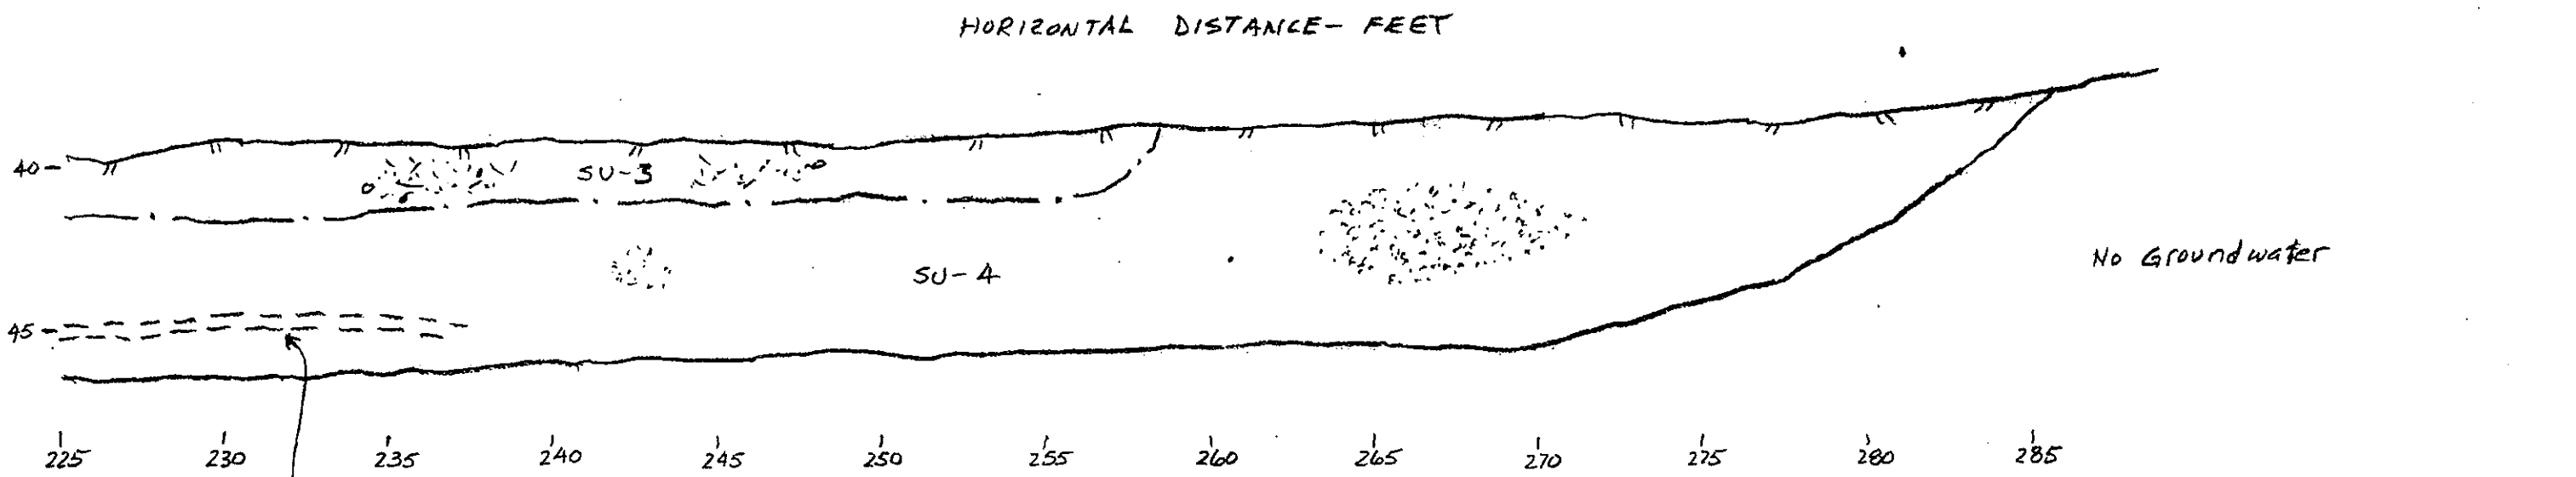
Thin clay layers, moist plastic dark brown, approx 1" thick

- SU-3 Dark gray, fine sand and silt, some hard rounded gravel, massive - some local thin bedded areas, friable - slightly plastic with added water; scattered small roots.
- SU-4 Light orange brown, massive fine sand and silt, dry to damp, non plastic, SM sharp contact with SU-3 in this area. Lacustrine Deposit.
