January 15, 2021

**Subject:** Ogden 3 West Weber Property Preliminary Wetlands Assessment

Property Parcel #15:078:0002

Approximately 40.8-acre Project Area, West Weber, Weber County, Utah

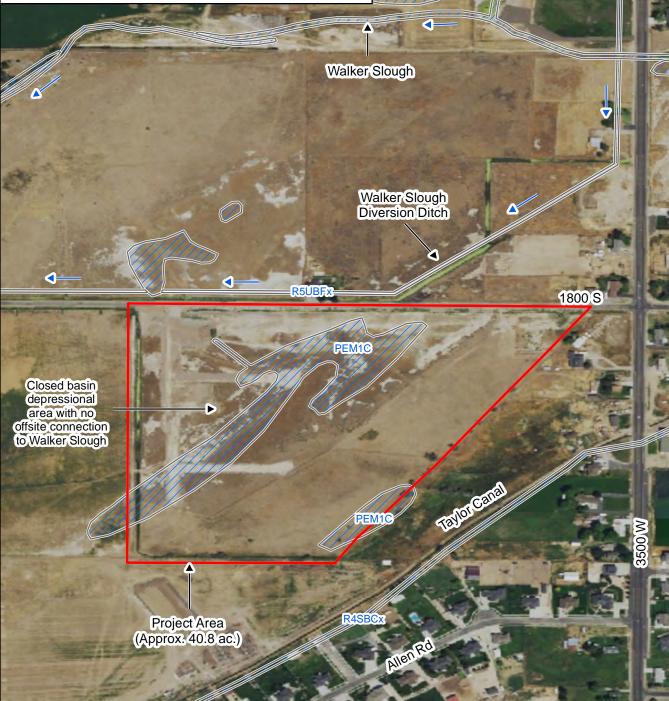
Figure 3. National Wetlands Inventory Map.

The NWI mapping shows two palustrine emergent persistent, seasonally flooded (PEM1C) wetlands within the Project Area (Figure 3). PEM1C wetlands are commonly associated with areas that are flood irrigated.

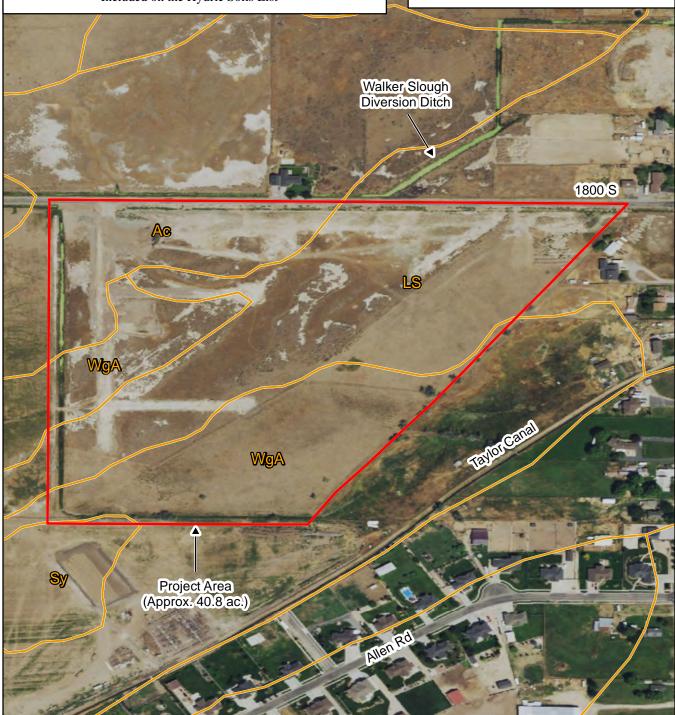
Figure 5. USDA - Natural Resources Conservation Service Soil Survey Map.

The soil survey indicates that the Project Area is underlain by four soil units (Figure 5):

All four of the soil units are identified on the hydric soils list for Weber County, Utah. The regular use and liberal application of flood irrigation water would be an ample source of hydrology to artificially establish wetland conditions on these soil units at this Project Area.
