SUMMARY OF CHEN AND ASSOCIATES (1980) RECOMMENDATIONS  
FOR DEVELOPMENT OF SITE OF SPRING CREEK ESTATES

#### SUBSOIL CONDITIONS

#### GEOLOGIC CONDITIONS AFFECTING THE PROPOSED DEVELOPMENT

#### SITE DEVELOPMENT RECOMMENDATION

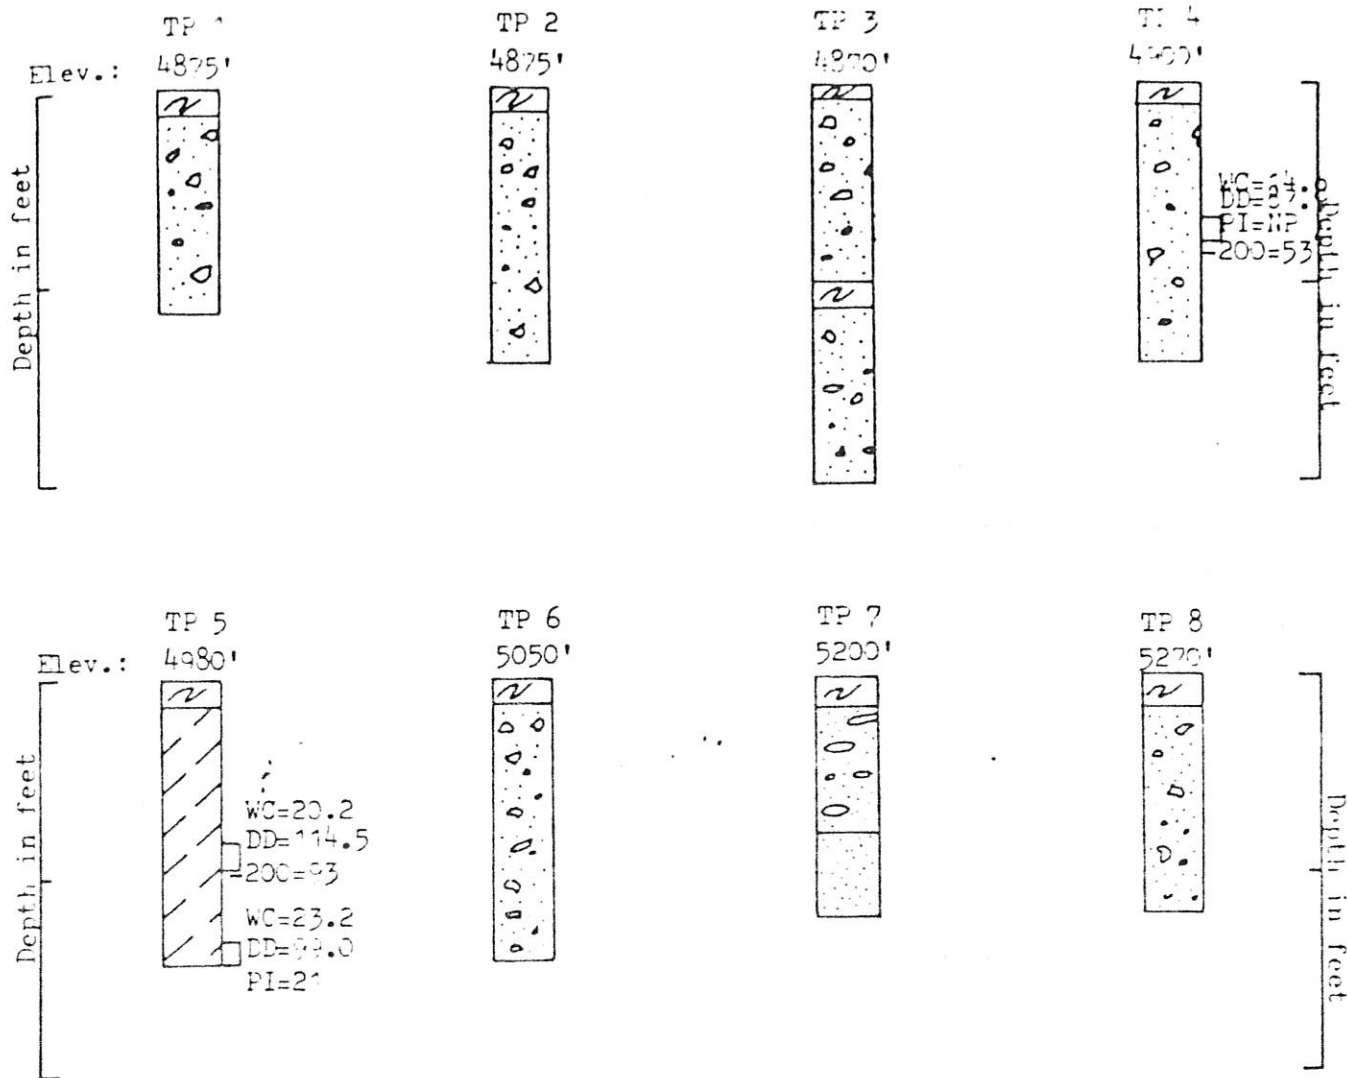
LEGEND

Topsoil, silty sand w/angular and rounded pebbles. Loose, dry, gray.
-

Gravel, sandy to sand, gravelly (GP, GM, SP) w/ang. cobbles, boulders. Med. dense-dense, sltly moist, brown.
-

Sand (SW) medium dense, moist, brown to rust to gray.
-

Clay (CL) thinly interlayered with silt, stiff-hard with depth, medium moist, tan to light salmon.

- (1) Test pits excavated July 22, 23, 1980 using standard backhoe
  - (2) Elevations approximate, based on topo. map by Great Basin Egr.
  - (3) Free water or appreciable sub-surface moisture was not encountered in the excavations.
  - (4) Location of Test Pits shown on Plates I and II.
- WC = water content (%).  
 DD = dry density (pcf).  
 PI = plasticity index (%).  
 -200 = amount passing #200 sieve (%).
